Corrective Actions Report

API#: 057-06625

Site Name: Eagle Hill 1-32

Operator: Gulf Exploration

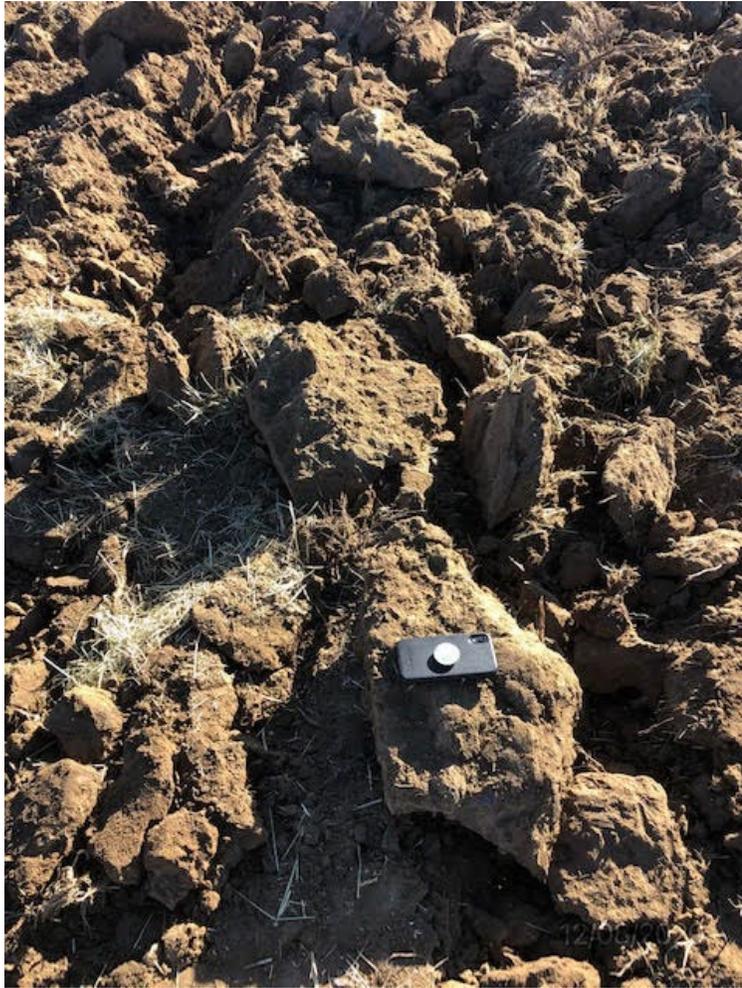
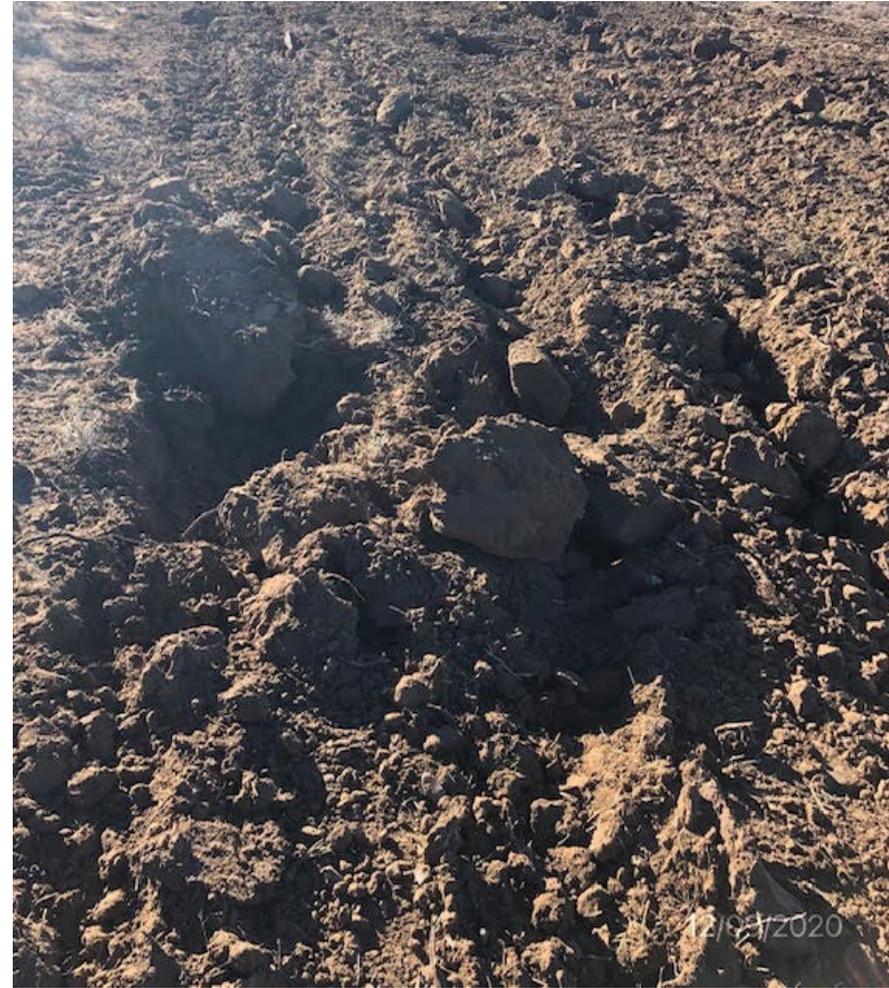
Picture 1 & 2: Contractor tried several operations to alleviate soil compaction but with the frost in the soil this proved to create large clumps and ultimately an improper seed bed.
