# Final Reclamation Inspection

Operator: BONANZA CREEK ENERGY OPERATING COMPANY LLC - #8960

Location ID: 439738

Inspection Photos  
Location Name: Bobcat #O-K-31HNB  
Location ID: 439738

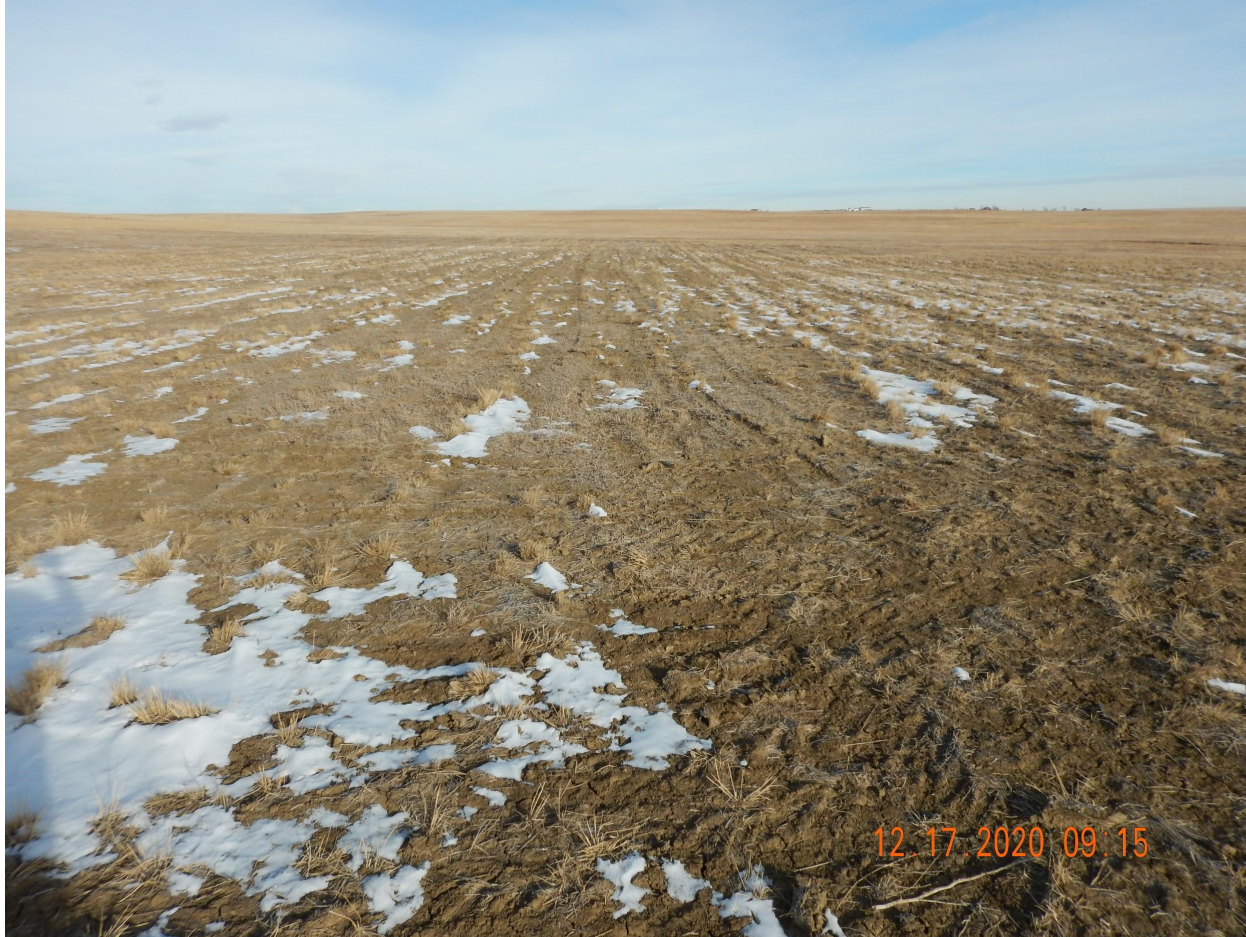
**Photo 1.** Photo taken from the southern location, facing North. Photo illustrates the Operator performed the previous corrective to conduct final reclamation. Location is not reflective of reference areas, as a number of bare patches were observed and annual, weedy vegetation as established.

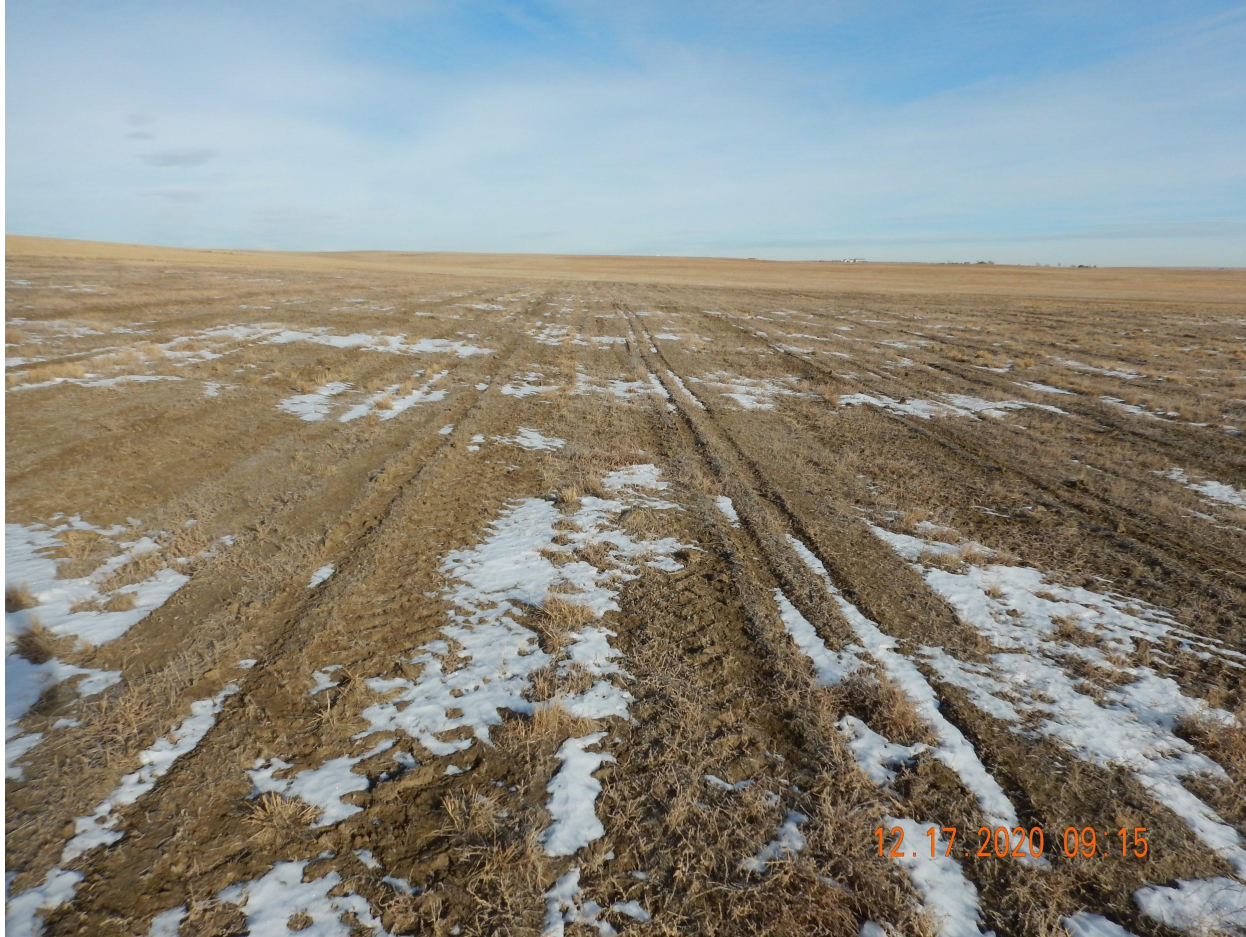
**Photo 2.** Photo taken from the southwestern location, facing North. See comments under Photo 1.

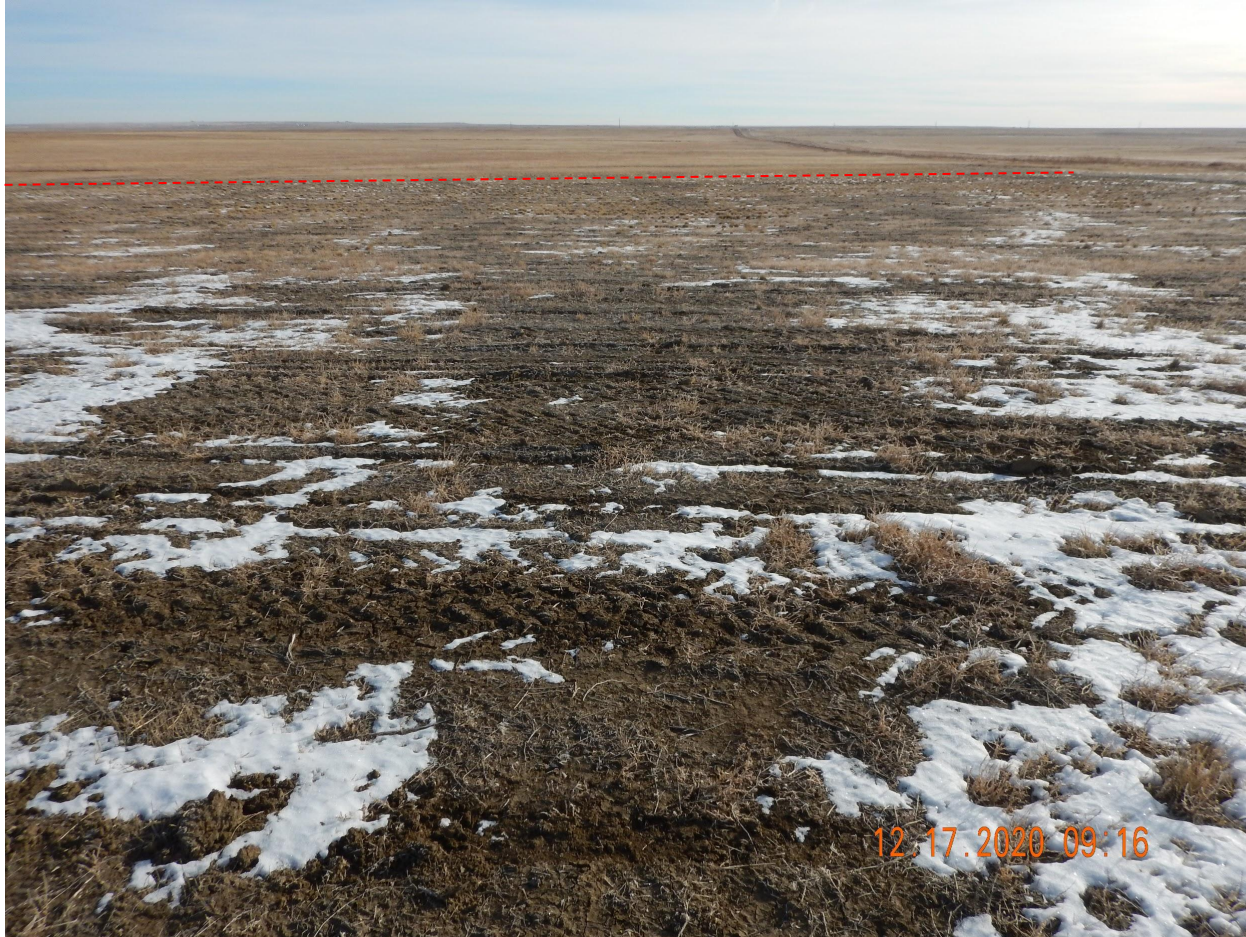
**Photo 3.** Photo taken from the western location, facing East. See comments under Photo 1. Location is below the red-dashed line; reference area is above the red-dashed line.

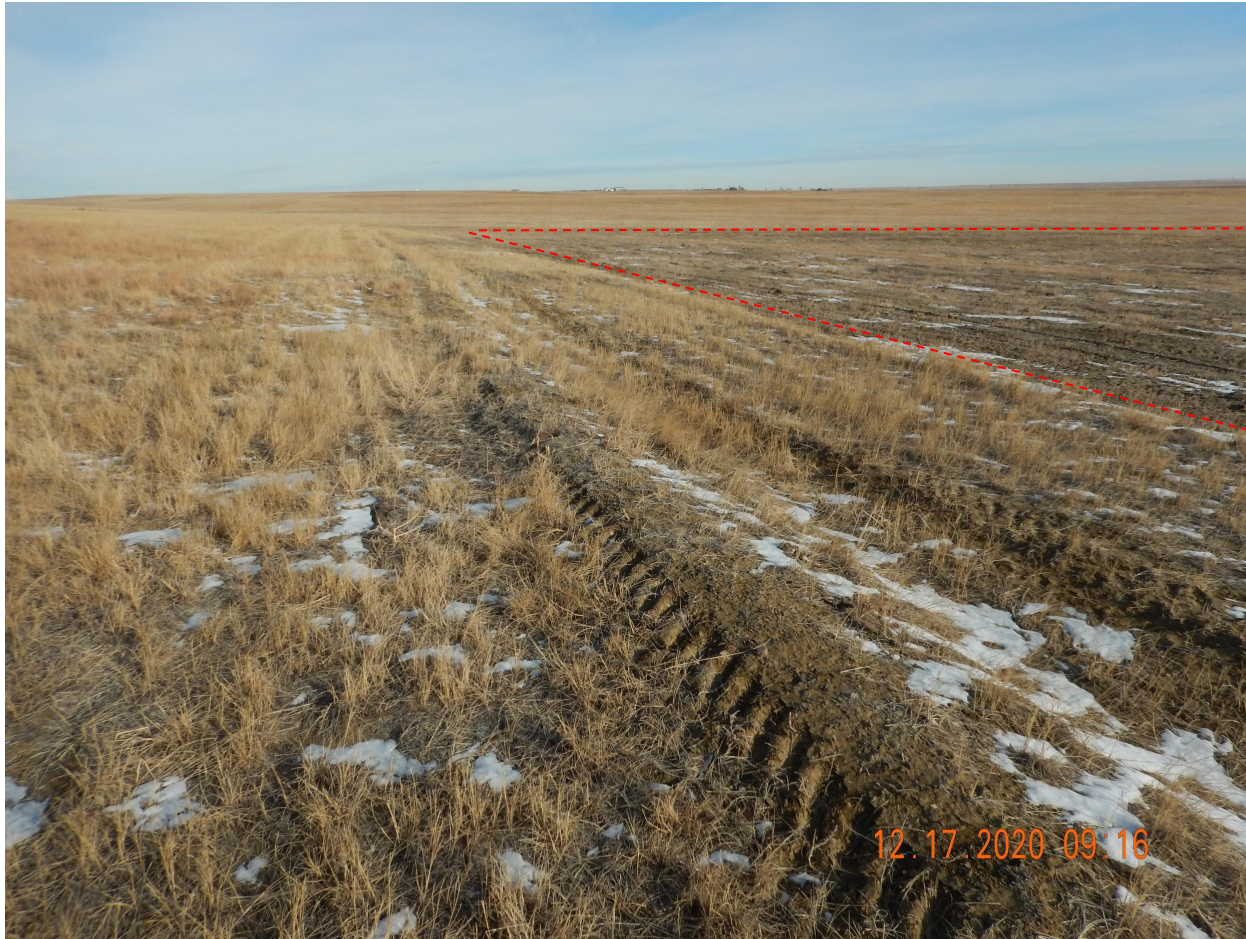
**Photo 4.** Photo taken from the western location, facing North. Photo illustrates the vegetative difference between the reference area (outside the red-dashed line) and the location (inside the red-dashed line).

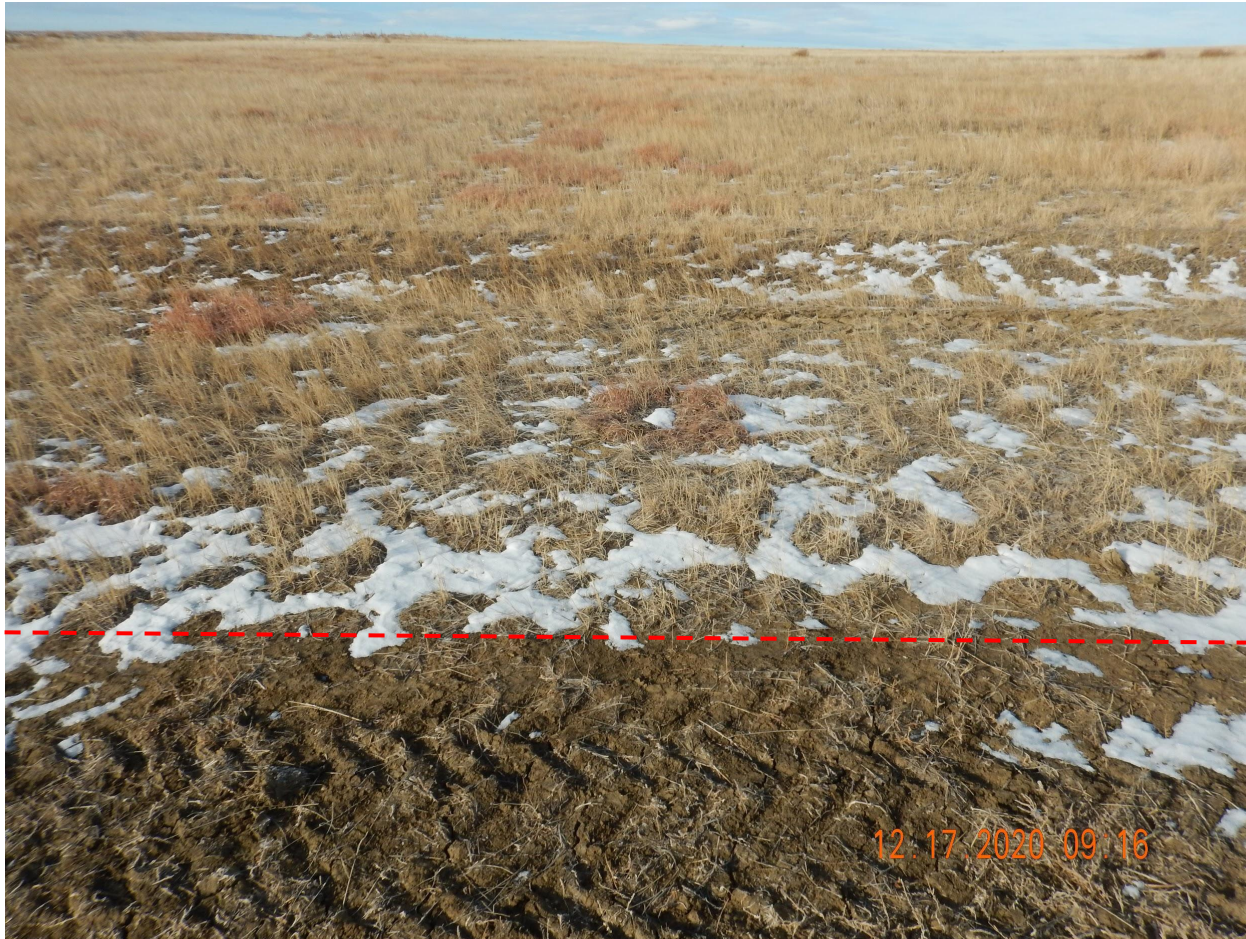
**Photo 5.** Photo taken from the western location, facing West. See comments under Photo 4.

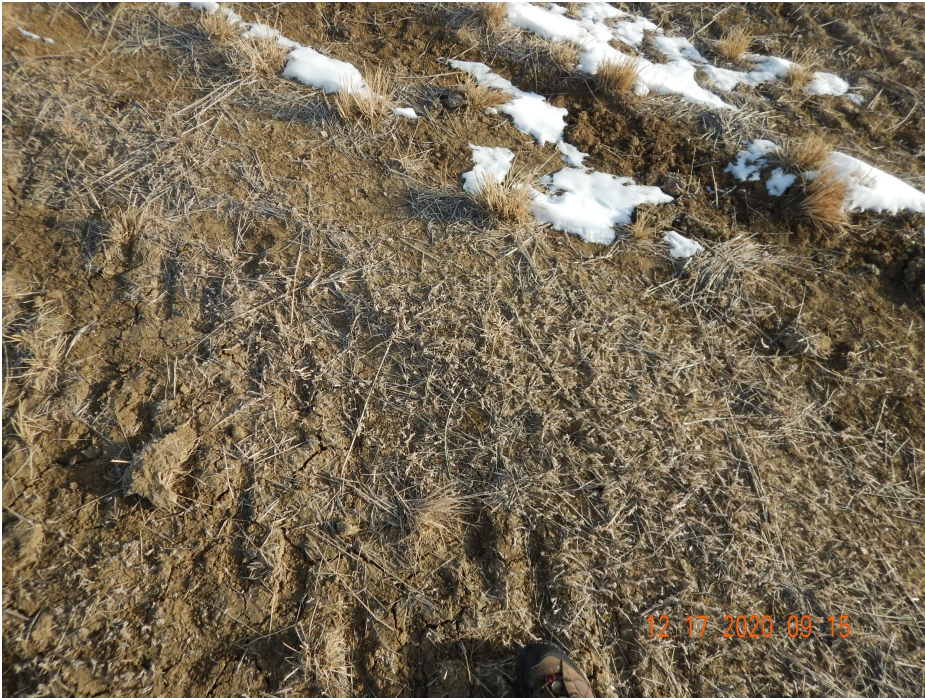
**Photo 6.** Close up photo taken from the location. Photo illustrates the lack of vegetation.

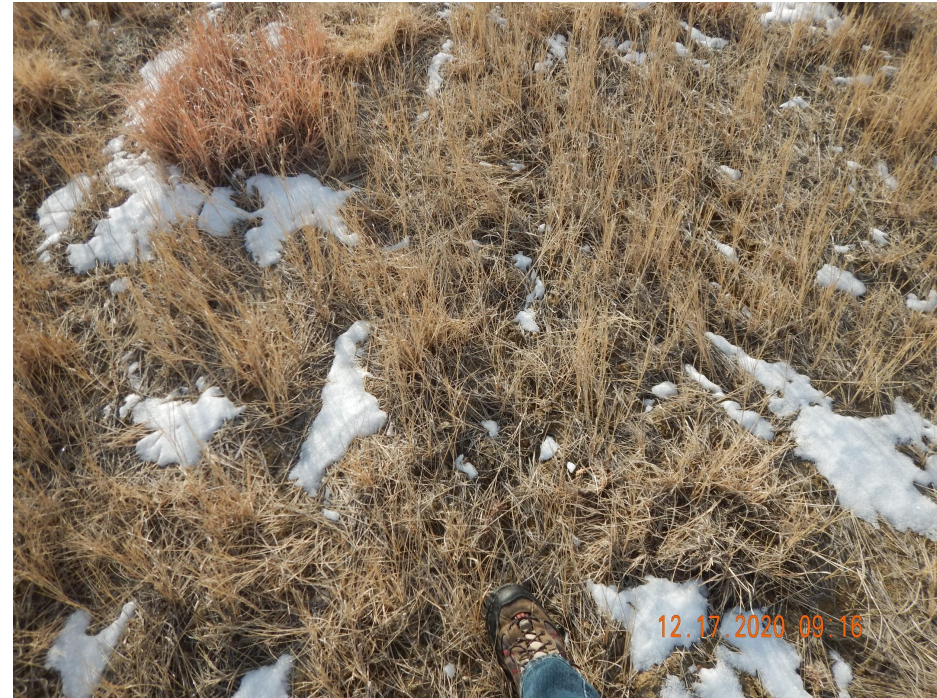
**Photo 7.** Close up photo taken from the western reference area. Photo illustrates the location is not reflective of reference area vegetative cover and composition.
