Final Reclamation Inspection

Operator: AXIS EXPLORATION LLC - #10646

Location ID: 320193

Inspection Photos
Location Name: QUALLS #5-13
Location ID: 320193

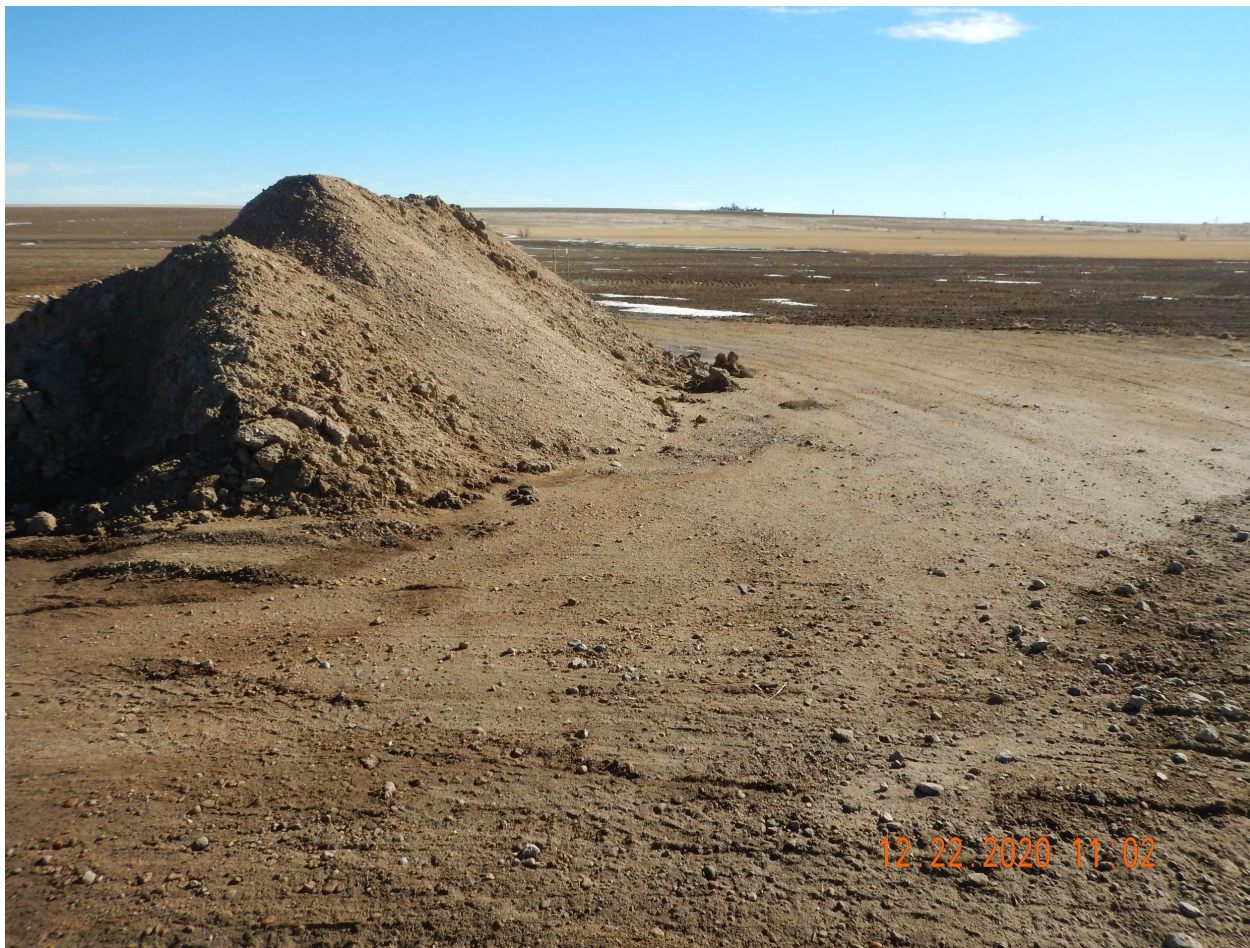
Photo 1. Photo taken from the southern tank battery location, facing East. Photo illustrates Operator has failed to removed all gravel and perform final reclamation activities.

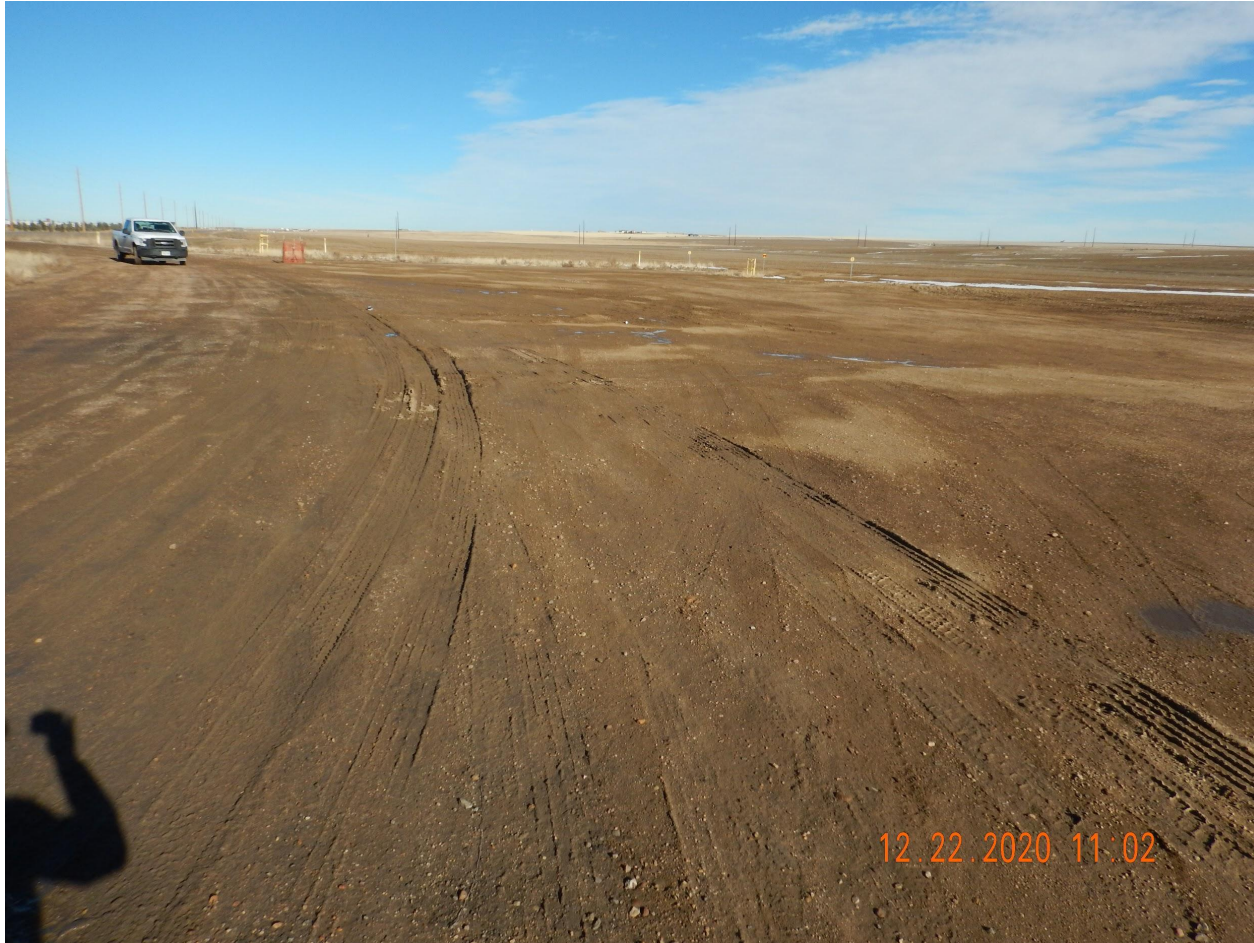
Photo 2. Photo taken from the southern tank battery location, facing North. See comments under Photo 1.

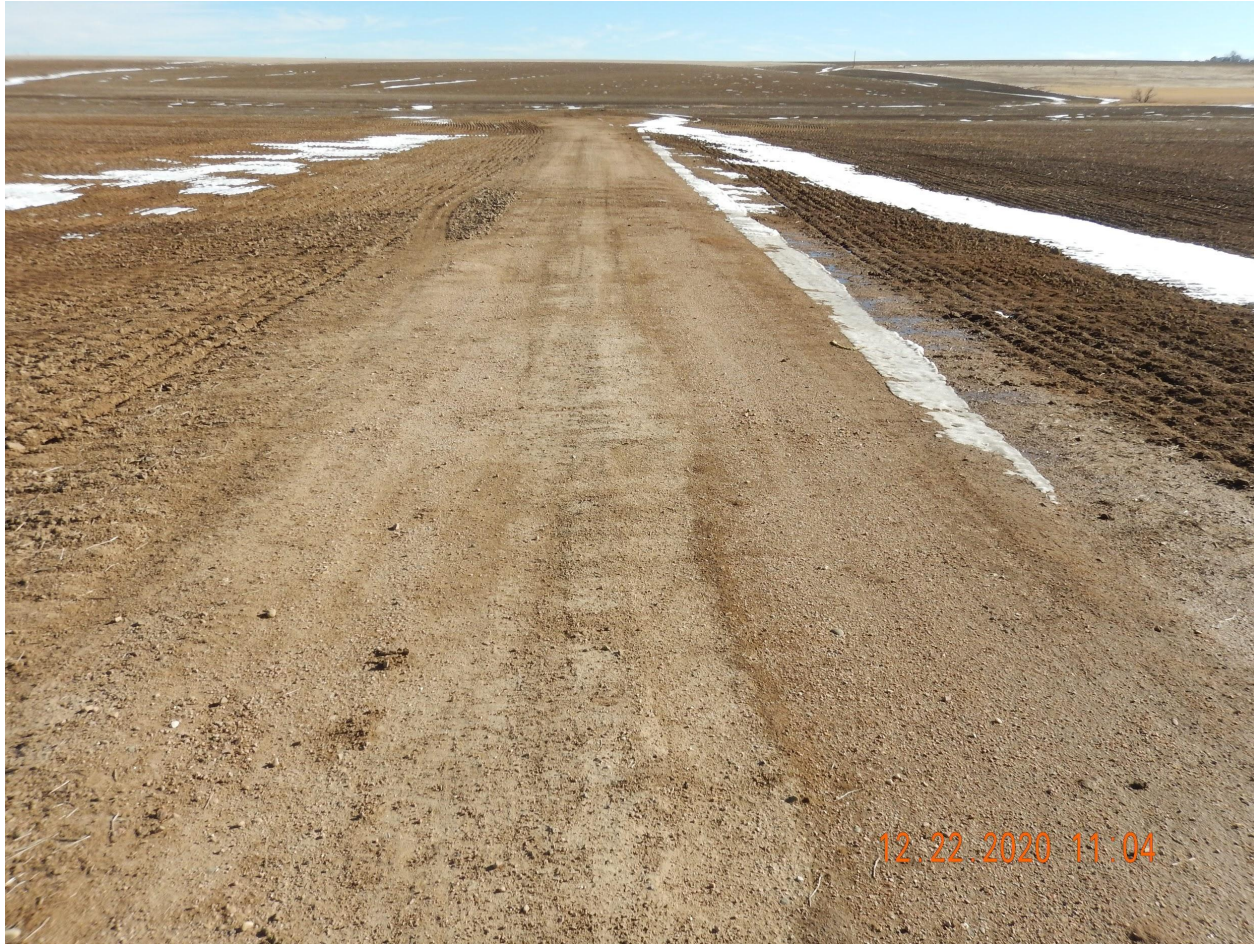
Photo 3. Photo taken from the well location access road, facing East. Operator has failed to properly contour and perform final reclamation activities.

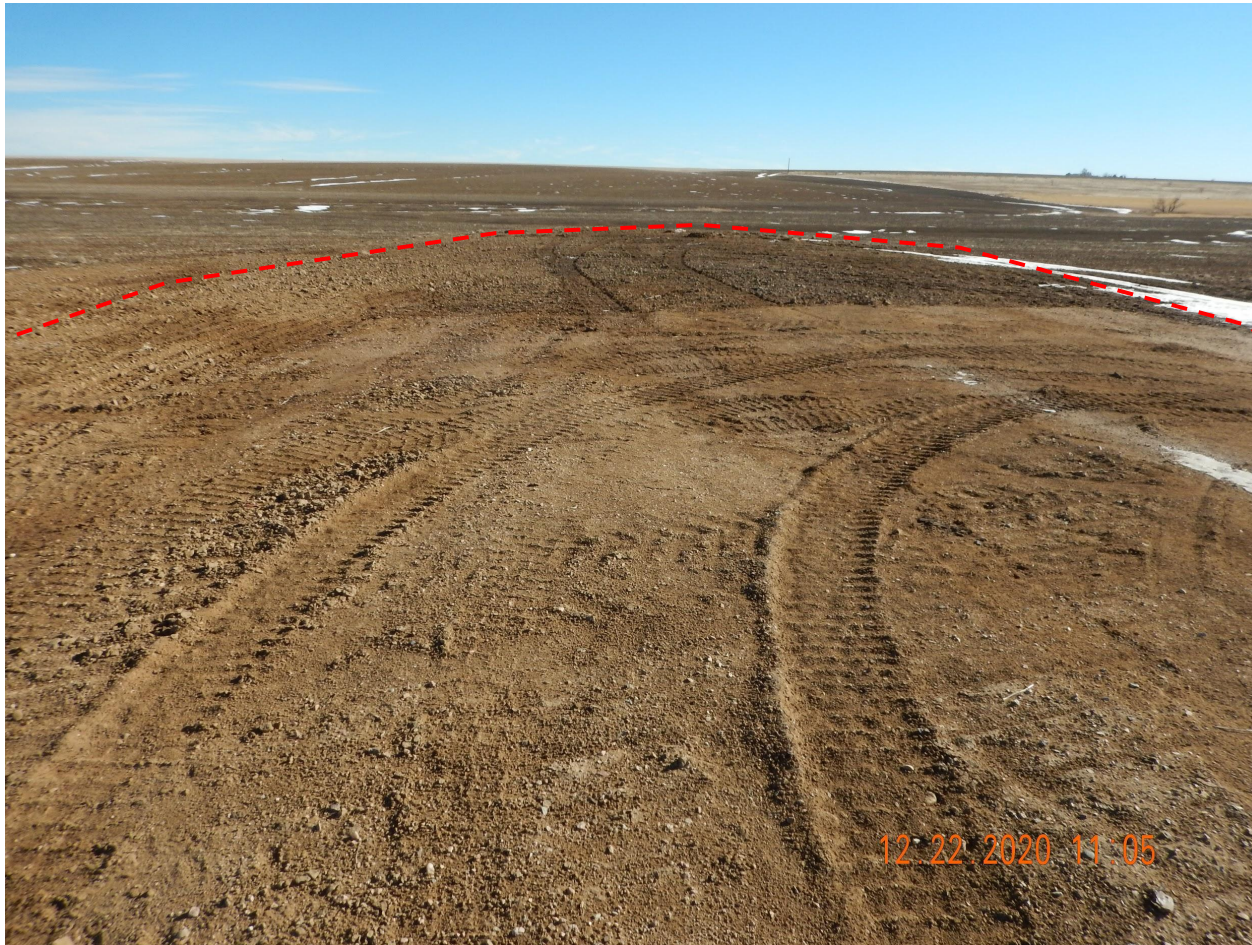
Photo 4. Photo taken from the well location, facing East. Operator has failed to properly contour and perform final reclamation activities.

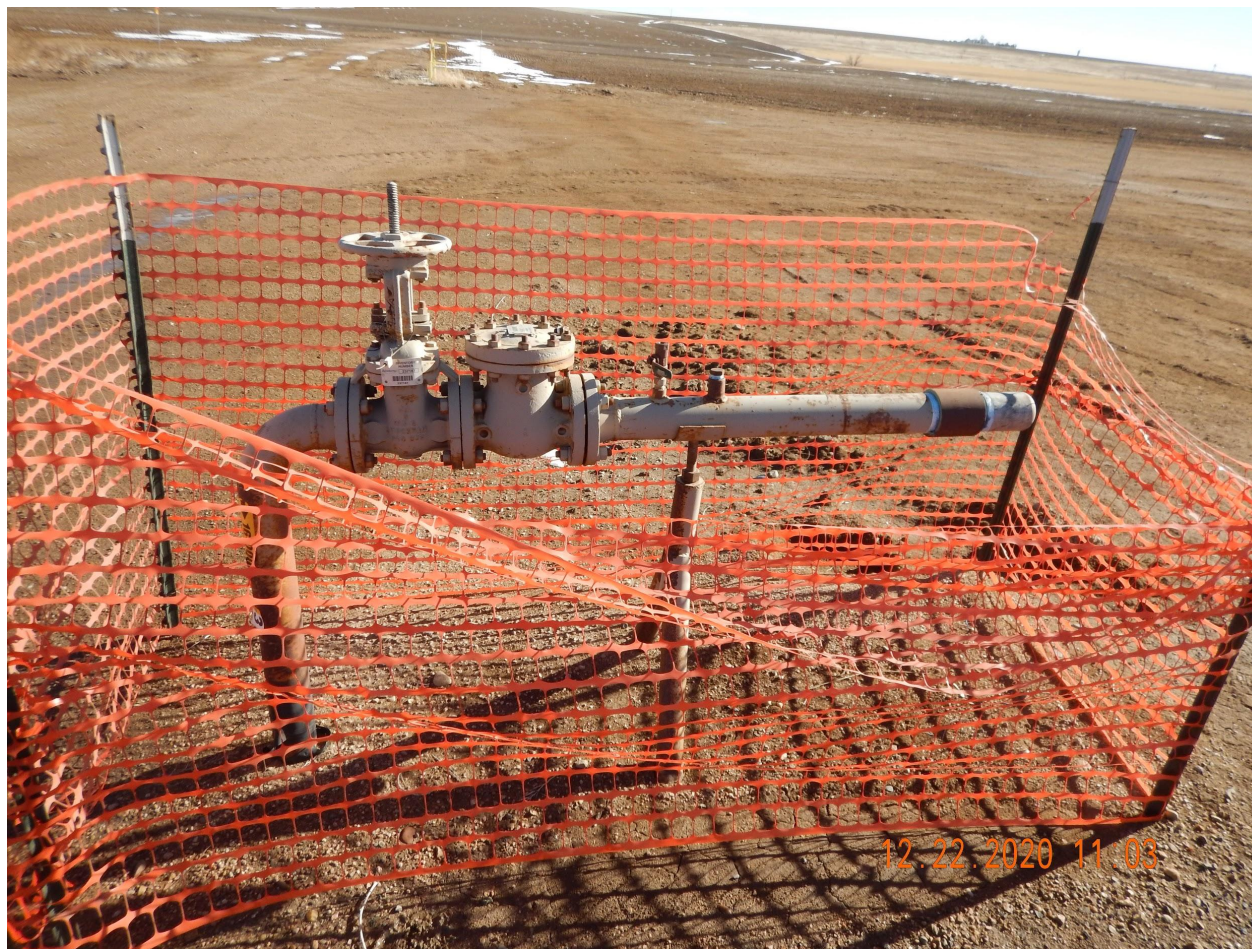
Photo 5. Photo taken from the northern location, facing East. Operator has failed to remove all equipment, regardless of ownership.
