Inspection Photos

11/24/2020

Operator: CAERUS PICEANCE LLC - 10456

Location ID: 312406

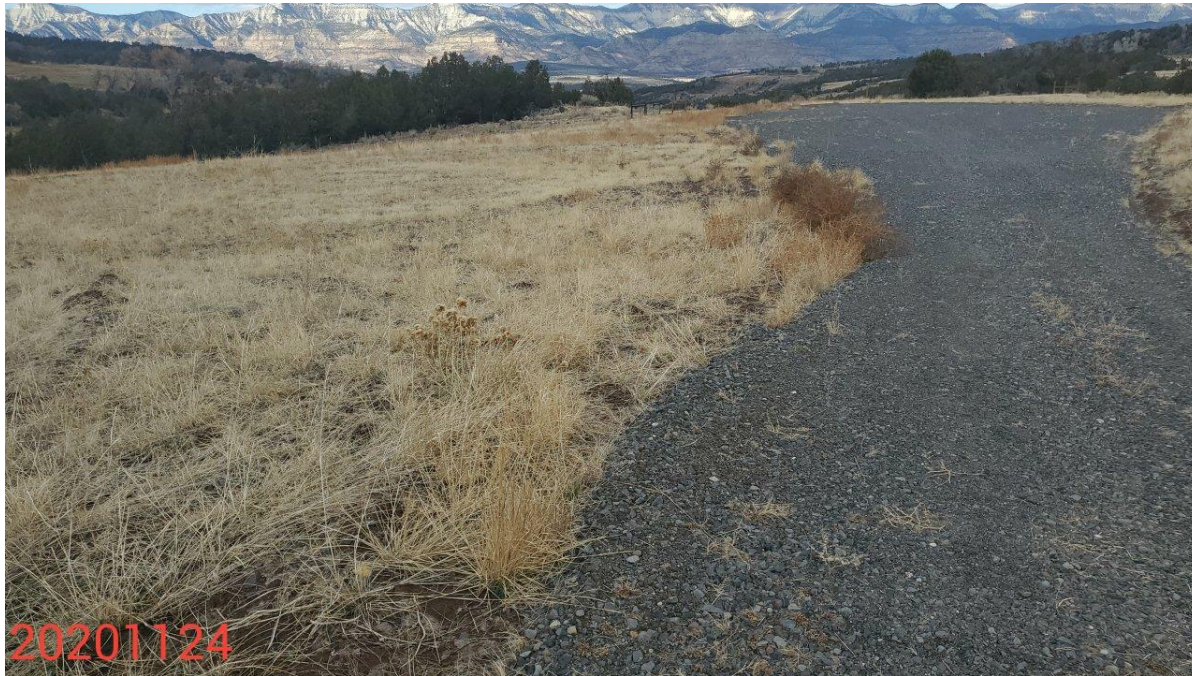
Photo 1: Photo taken from the Location entrance on the south end of the site, facing north. Photo provides an overview of the Location.

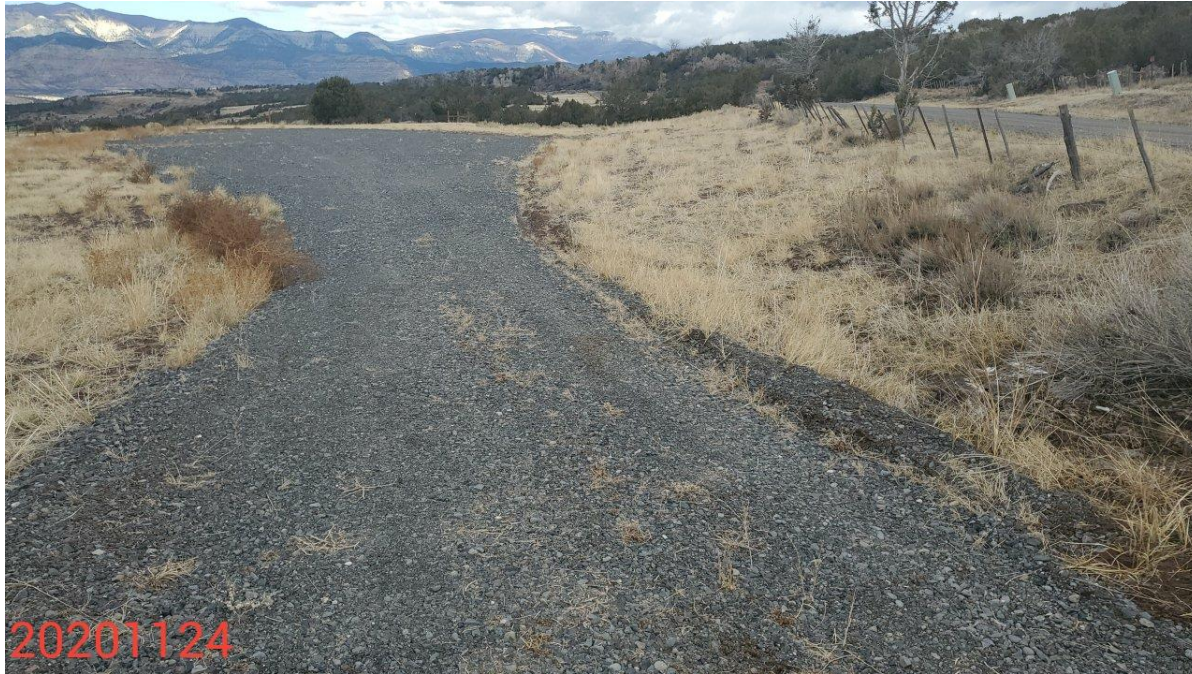
Photo 2: Photo taken from the Location entrance on the south end of the site, facing north. Photos provides an overview of the Location.

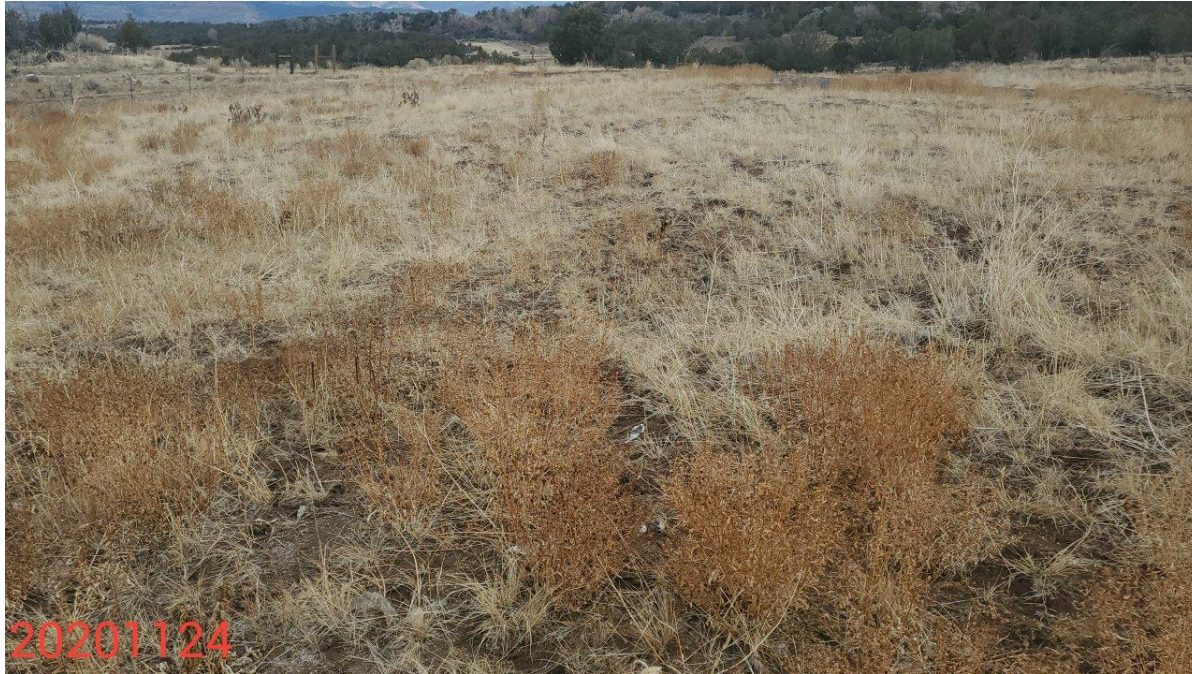
Photo 3: Photo taken from the western areas of the Location, facing north. Photo shows desirable perennial vegetative establishment appears to be progressing towards final reclamation standards.

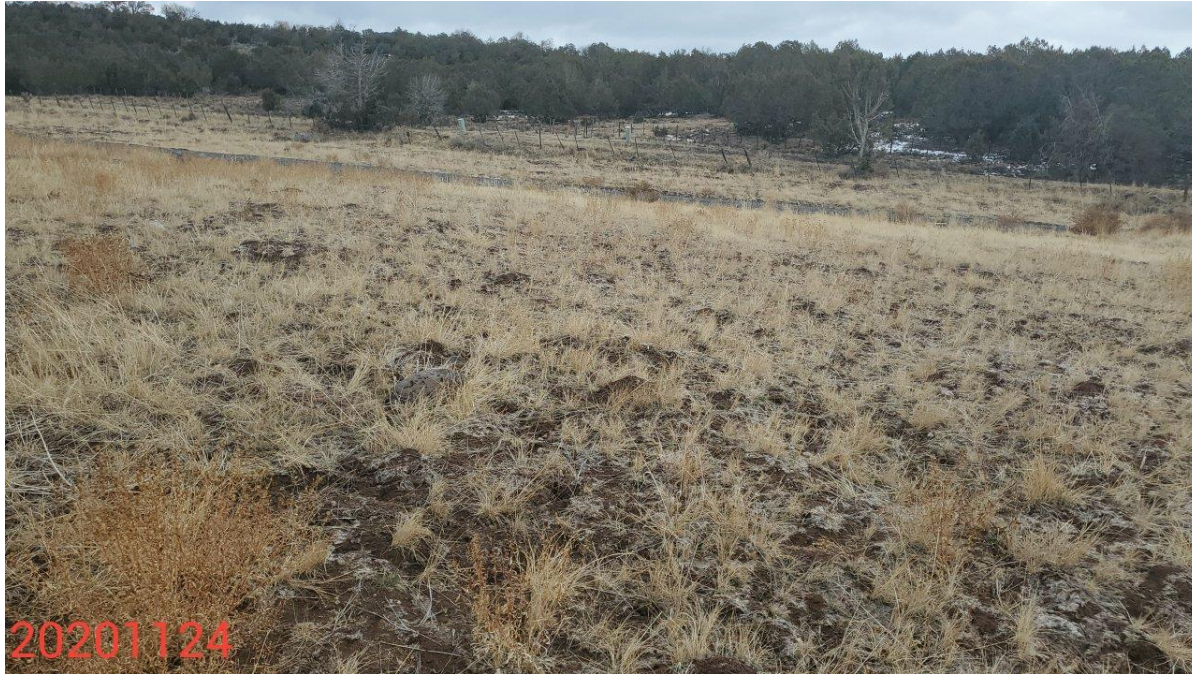
Photo 4: Photo taken from the western areas of the Location, facing east. Photo shows desirable perennial vegetative establishment appears to be progressing towards final reclamation standards.

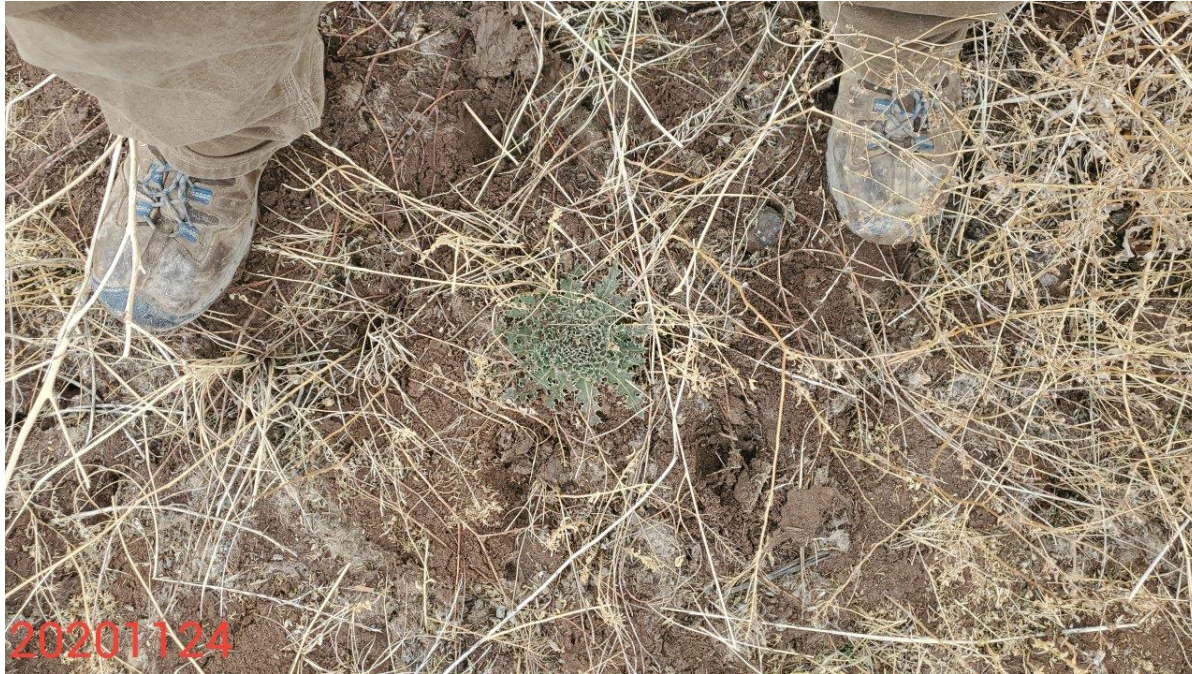
Photo 5: Photo shows example of noxious weed rosettes observed on the Location that appear to be viable.

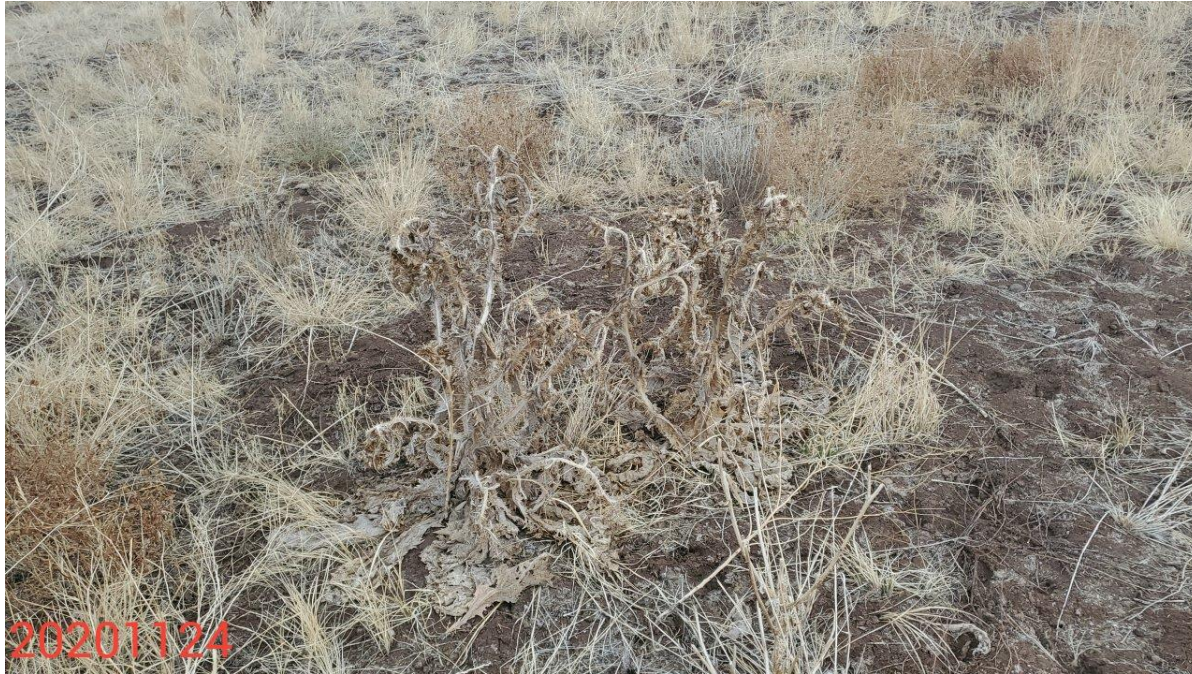
Photo 6: Photo shows dead scotch thistles observed on the Location. Mature plants observed were dead at time of inspection.

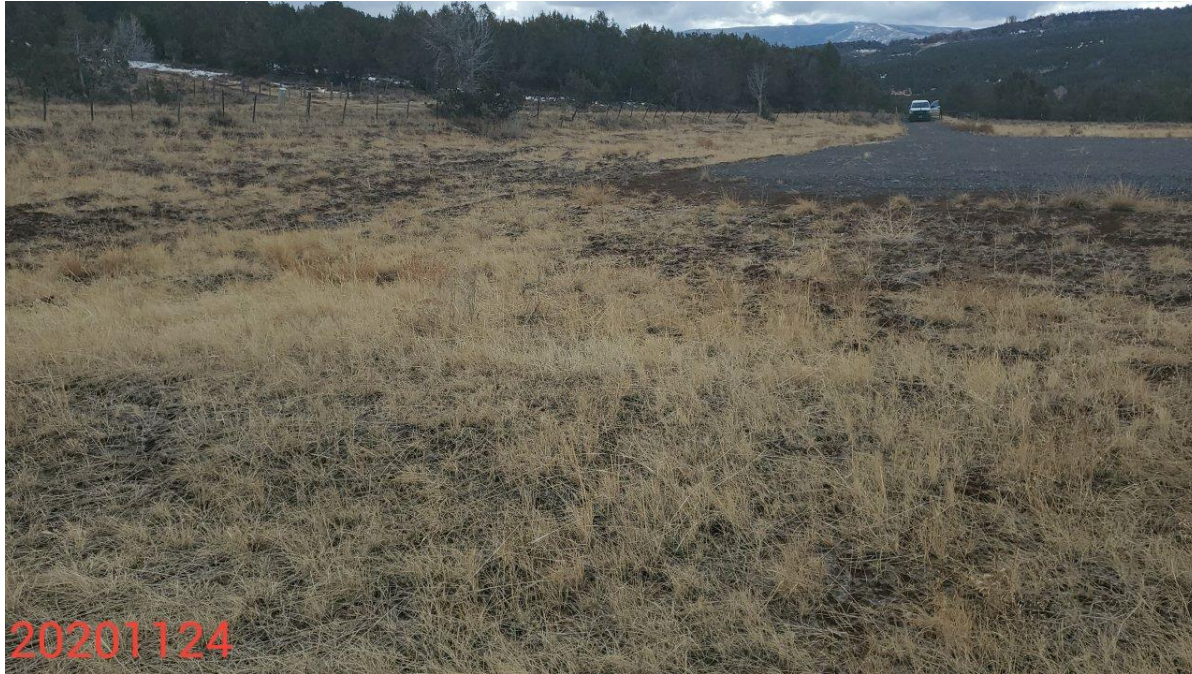
Photo 7: Photo taken from the northeastern end of the Location, facing south. Photo provides an overview of the Location.

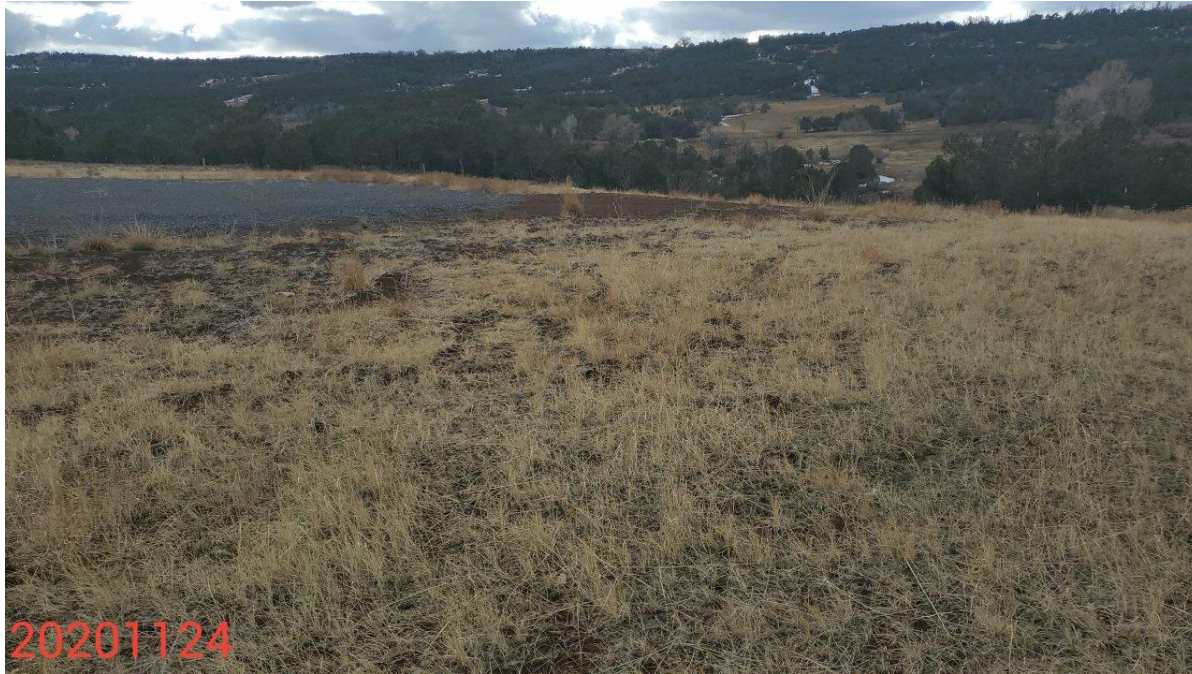
Photo 8: Photo taken from the northeastern end of the Location, facing west. Photo provides an overview of the Location.

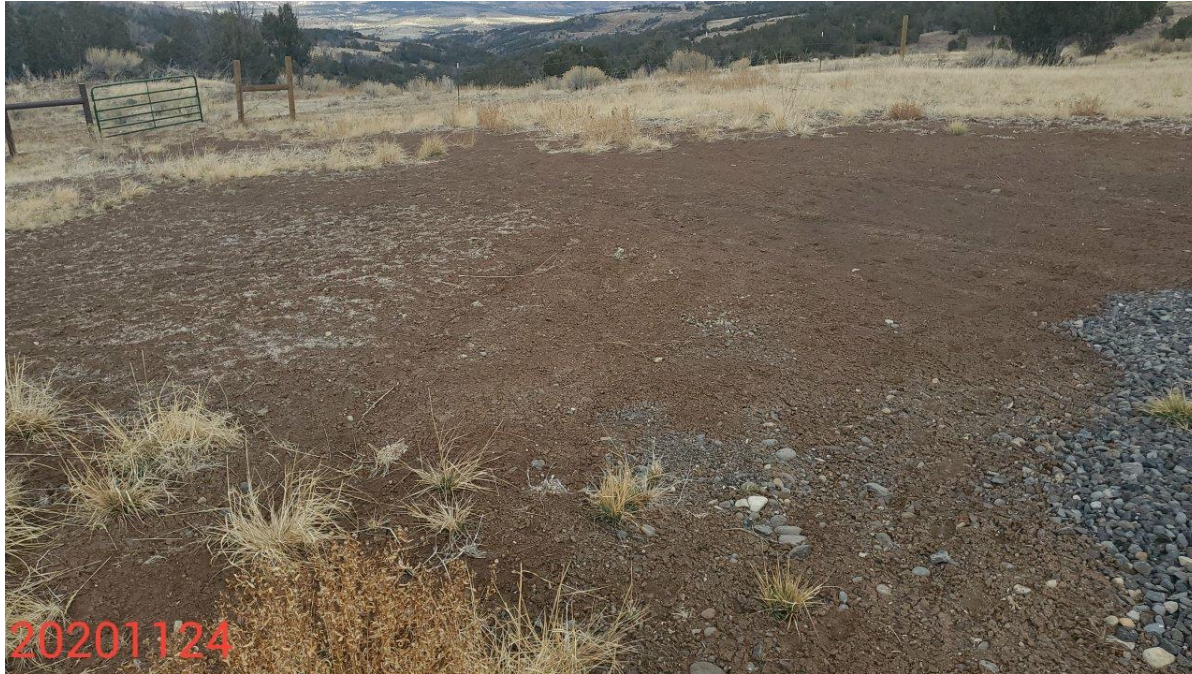
Photo 9: Photo taken from the north end of the Location, facing northeast. Photo shows areas of the "Reclaimed Disturbance" as indicated within figures of the SOVR that remain bare; desirable perennial vegetation was not observed to be establishing in these areas.

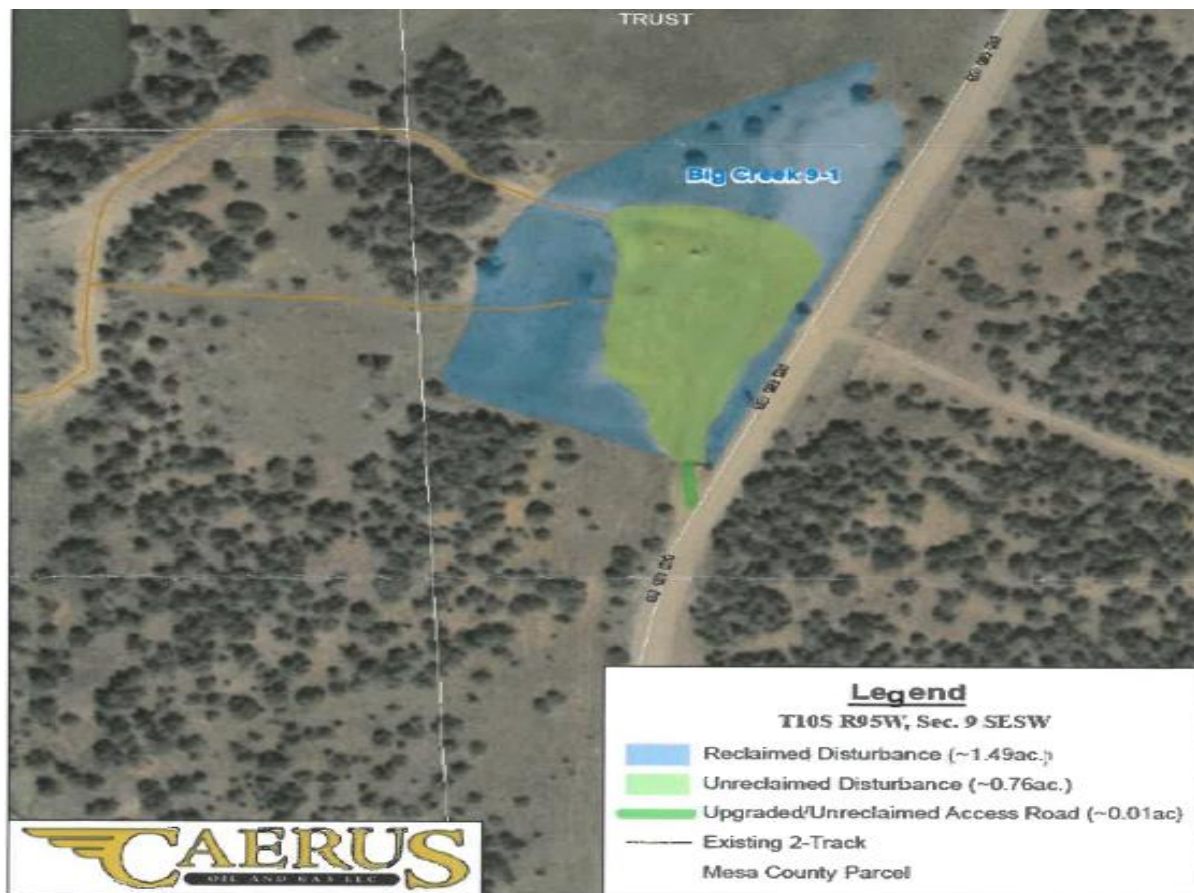
Photo 10: Figure attached to SOVR #402010401 provided by Caerus; Photo shows access road and “turn-around” (green) not to be reclaimed, and the well Location (Blue) that remains subject to COGCC 1000 series requirements.
