# Inspection Photos

11/24/2020

Operator: CAERUS PICEANCE LLC - 10456

Location ID: 334411

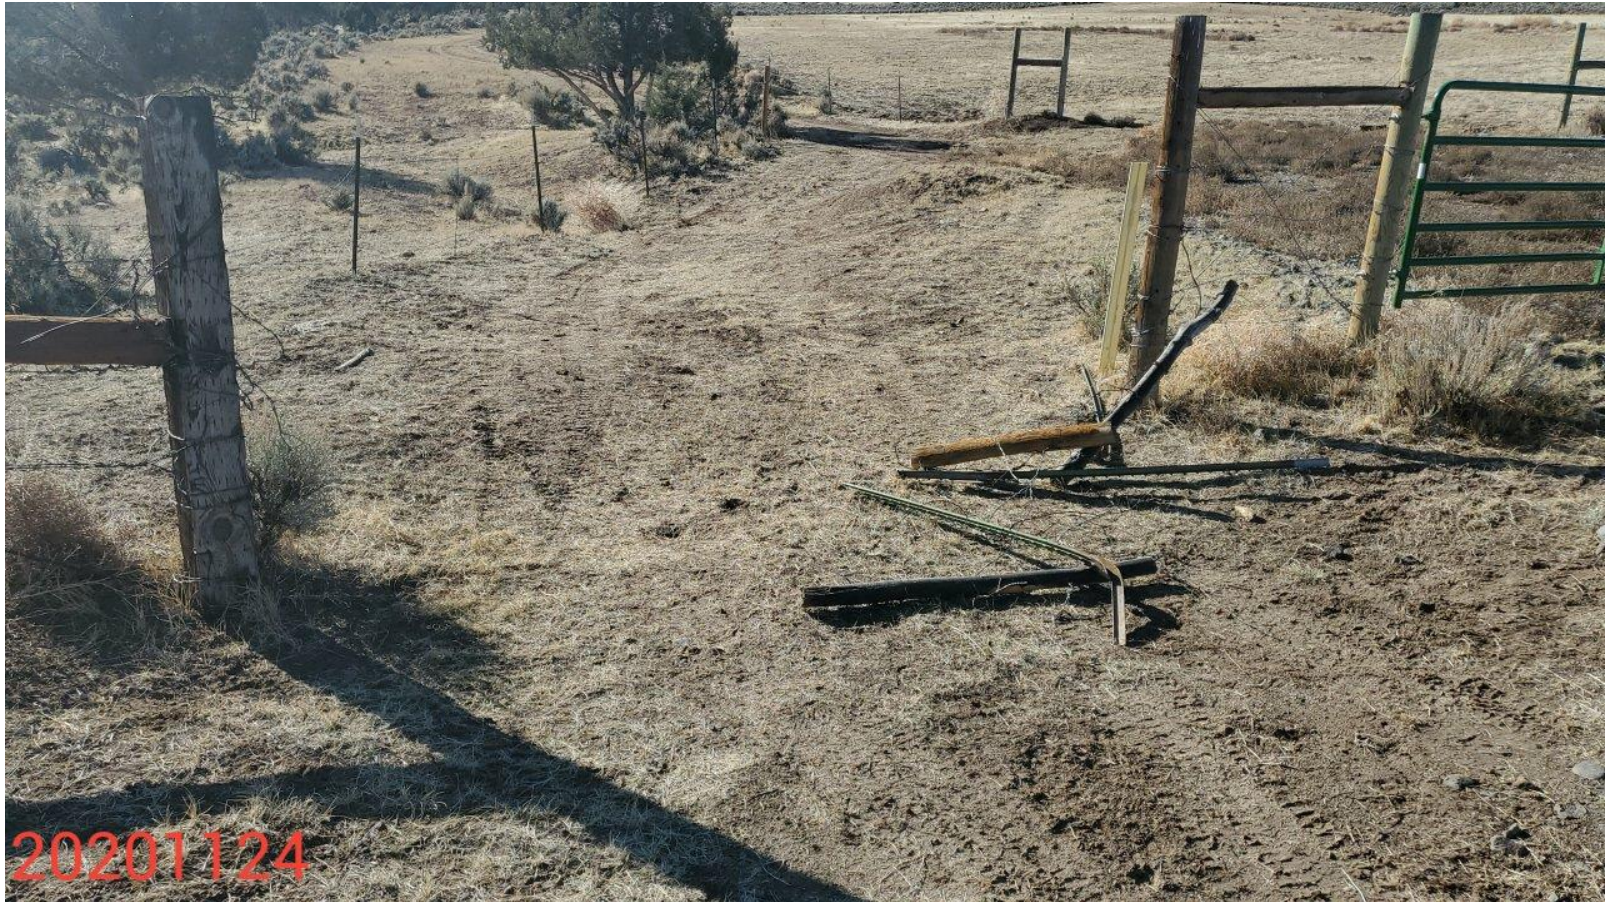
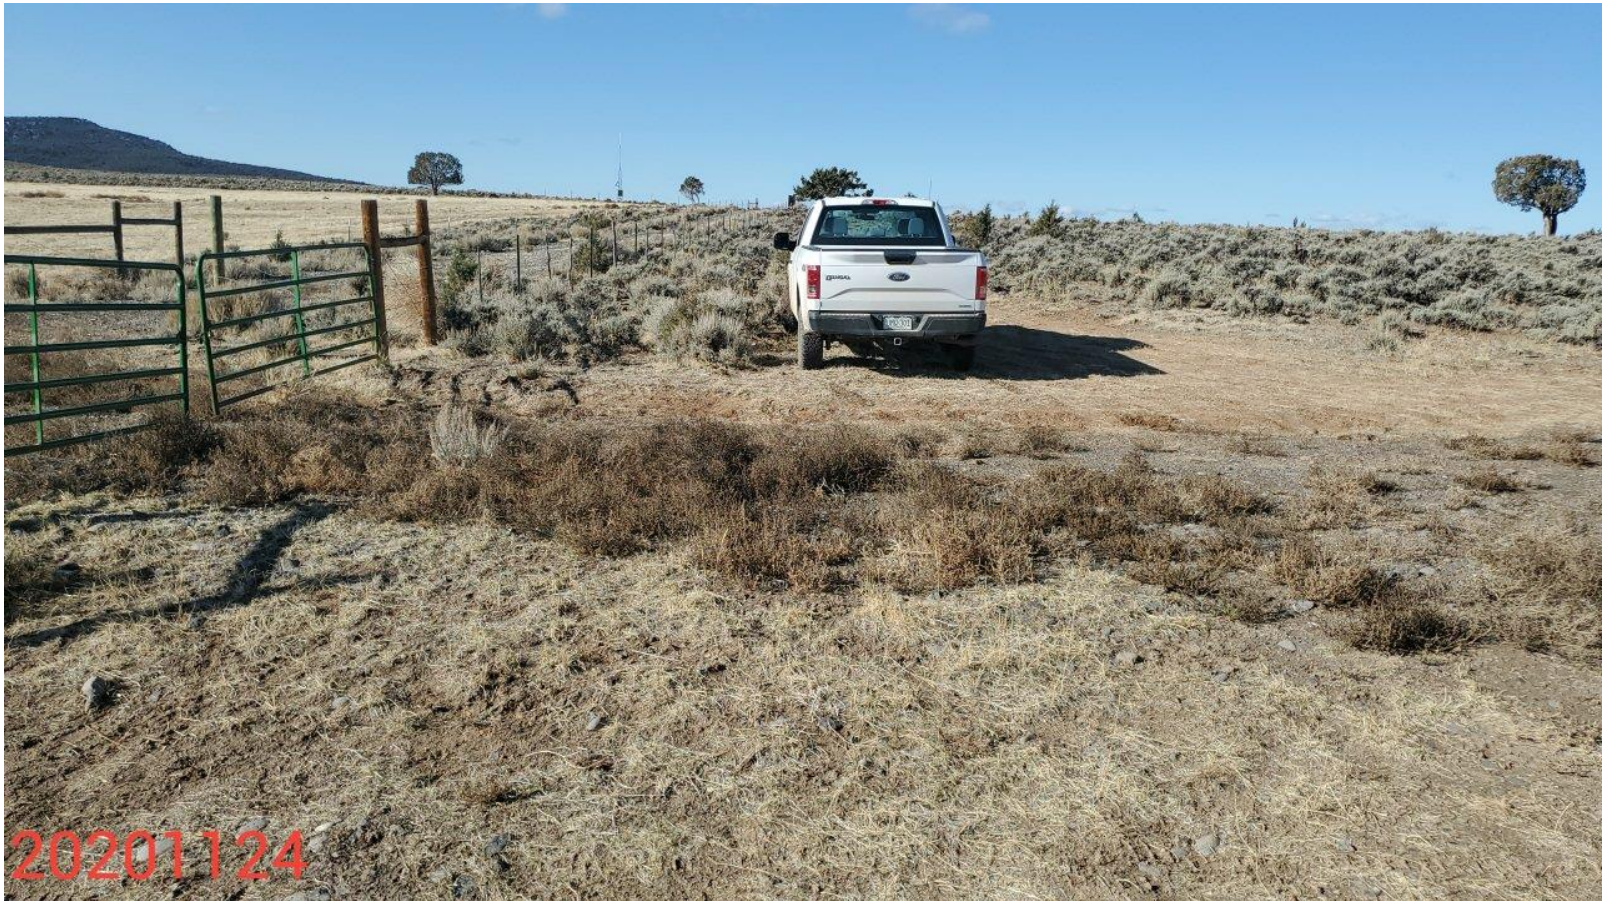
**Photo 1:** Photo taken northeast of the Location. Photo for documentation purposes. Photo shows gate along access road to Location is broken. Reclamation specialist accessed location on foot and did not travel through gate with a vehicle.

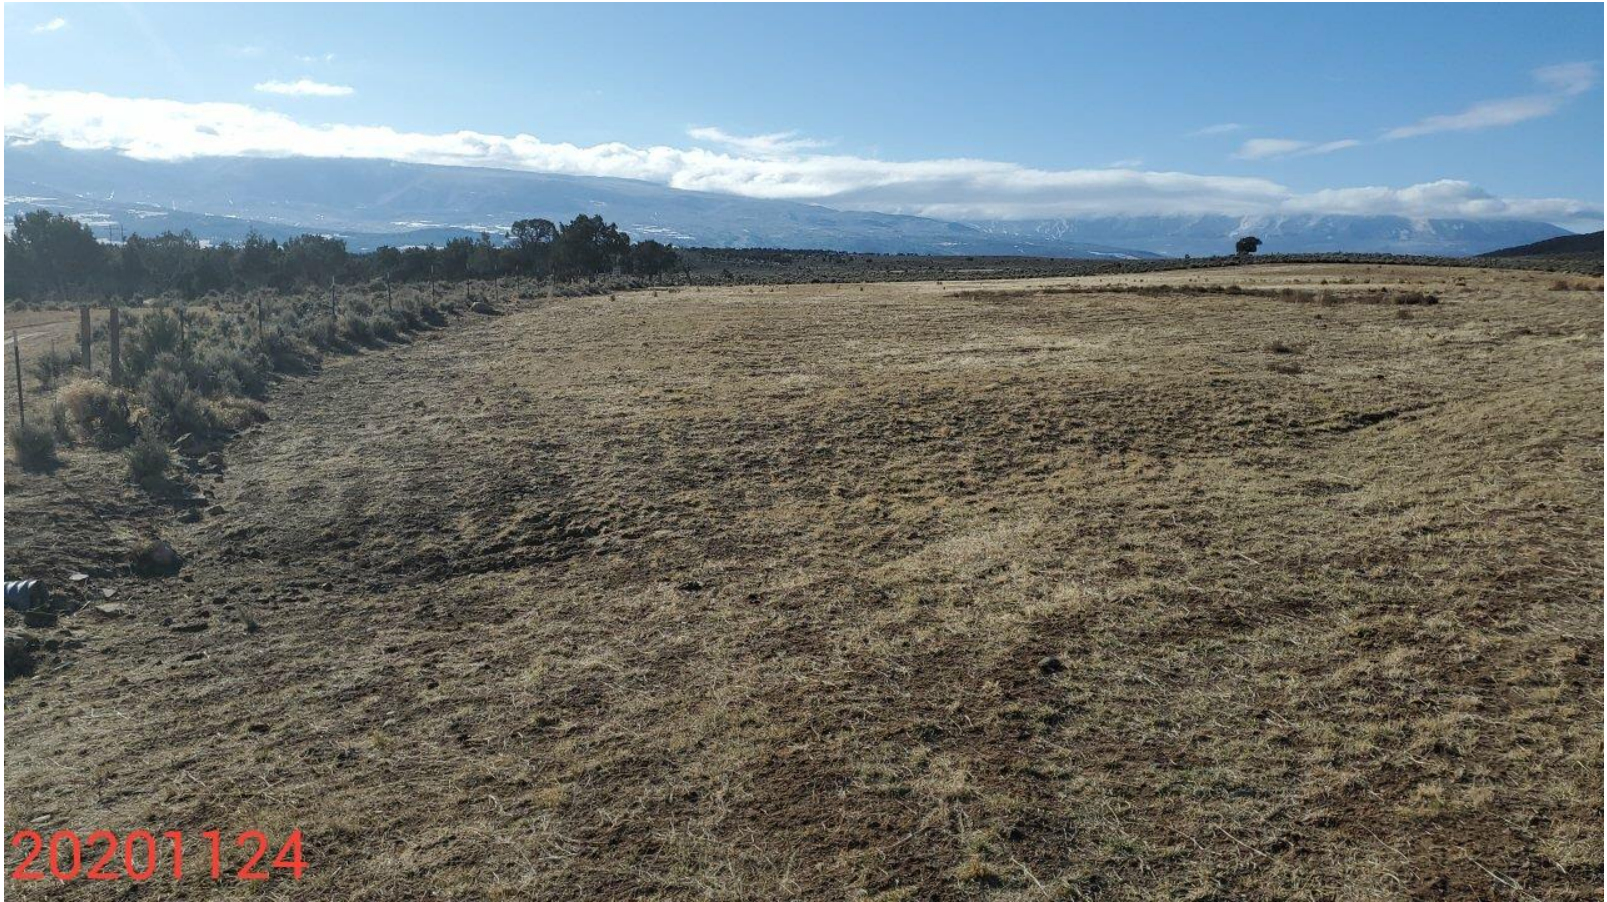
**Photo 3:** Photo taken from the northeast corner of the Location, facing south. Photo provides an overview of the Location and reclamation area.

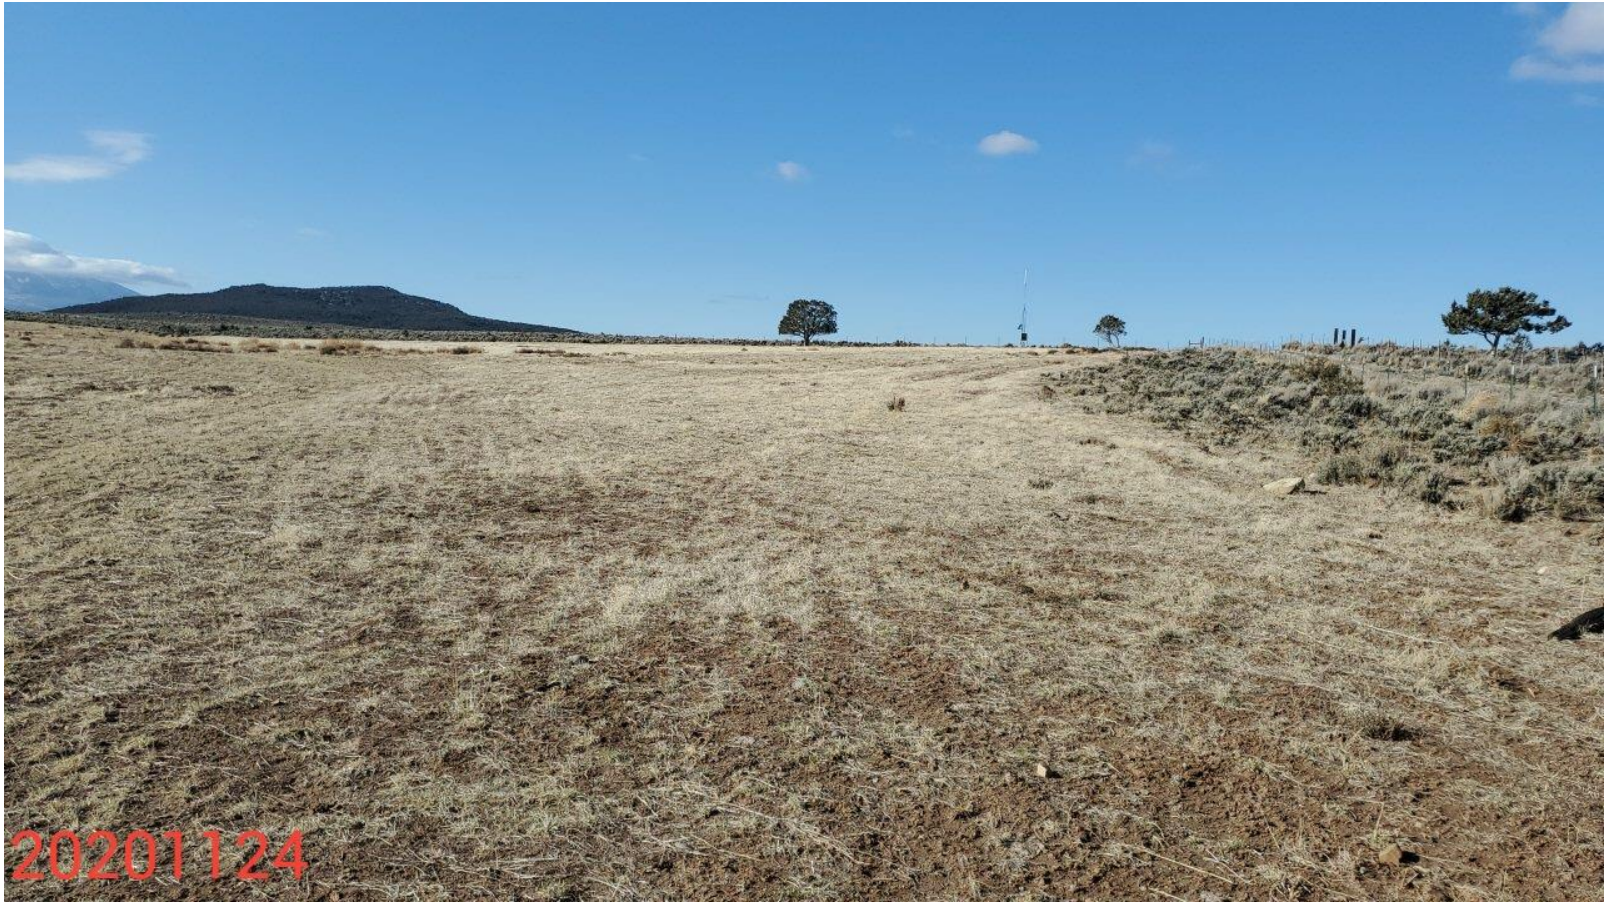
**Photo 4:** Photo taken from the northeast corner of the Location, facing west. Photo provides an overview of the Location and reclamation area. .

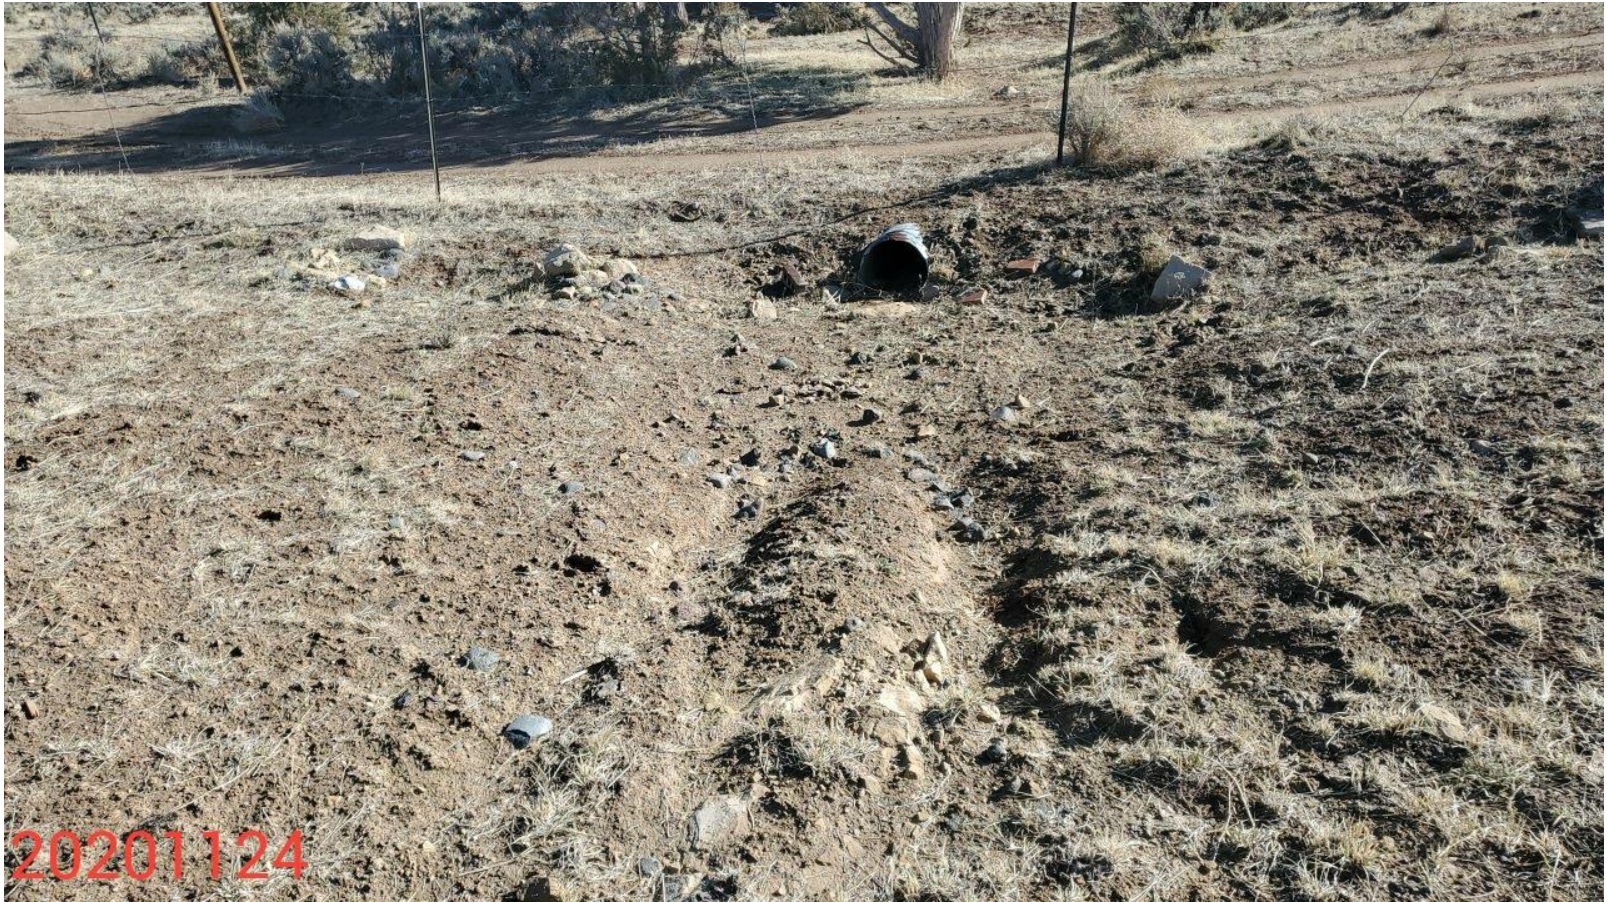
**Photo 5:** Photo taken from the northwest end of the Location. Photo shows culvert and drainage. Culvert has not been installed in accordance with good engineering practices and is missing proper inlet/outlet protection.

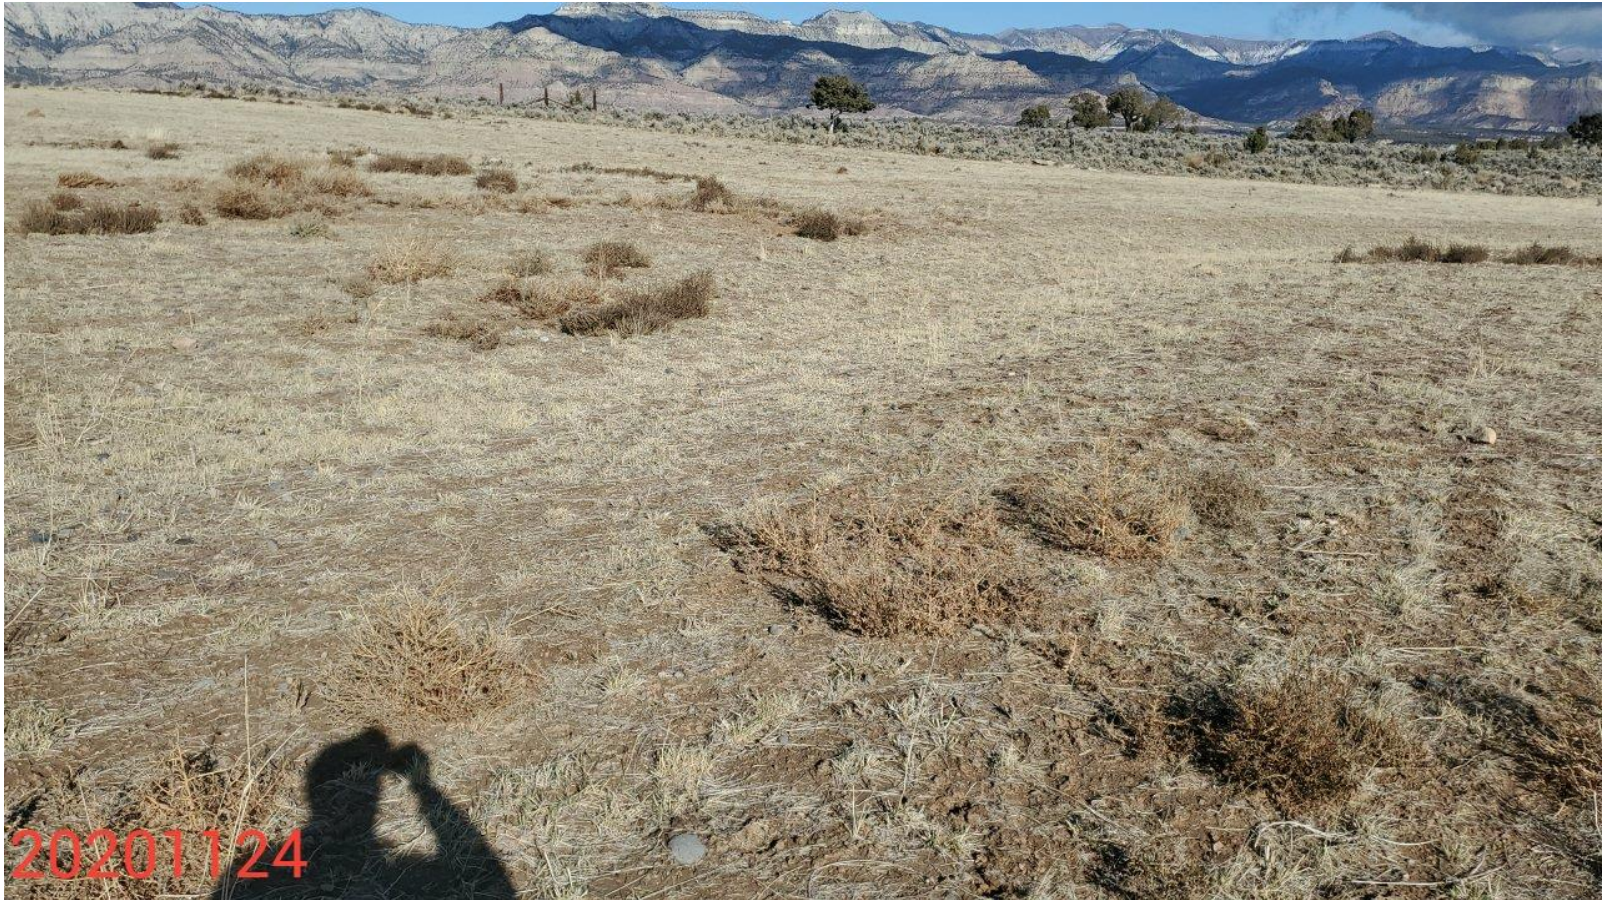
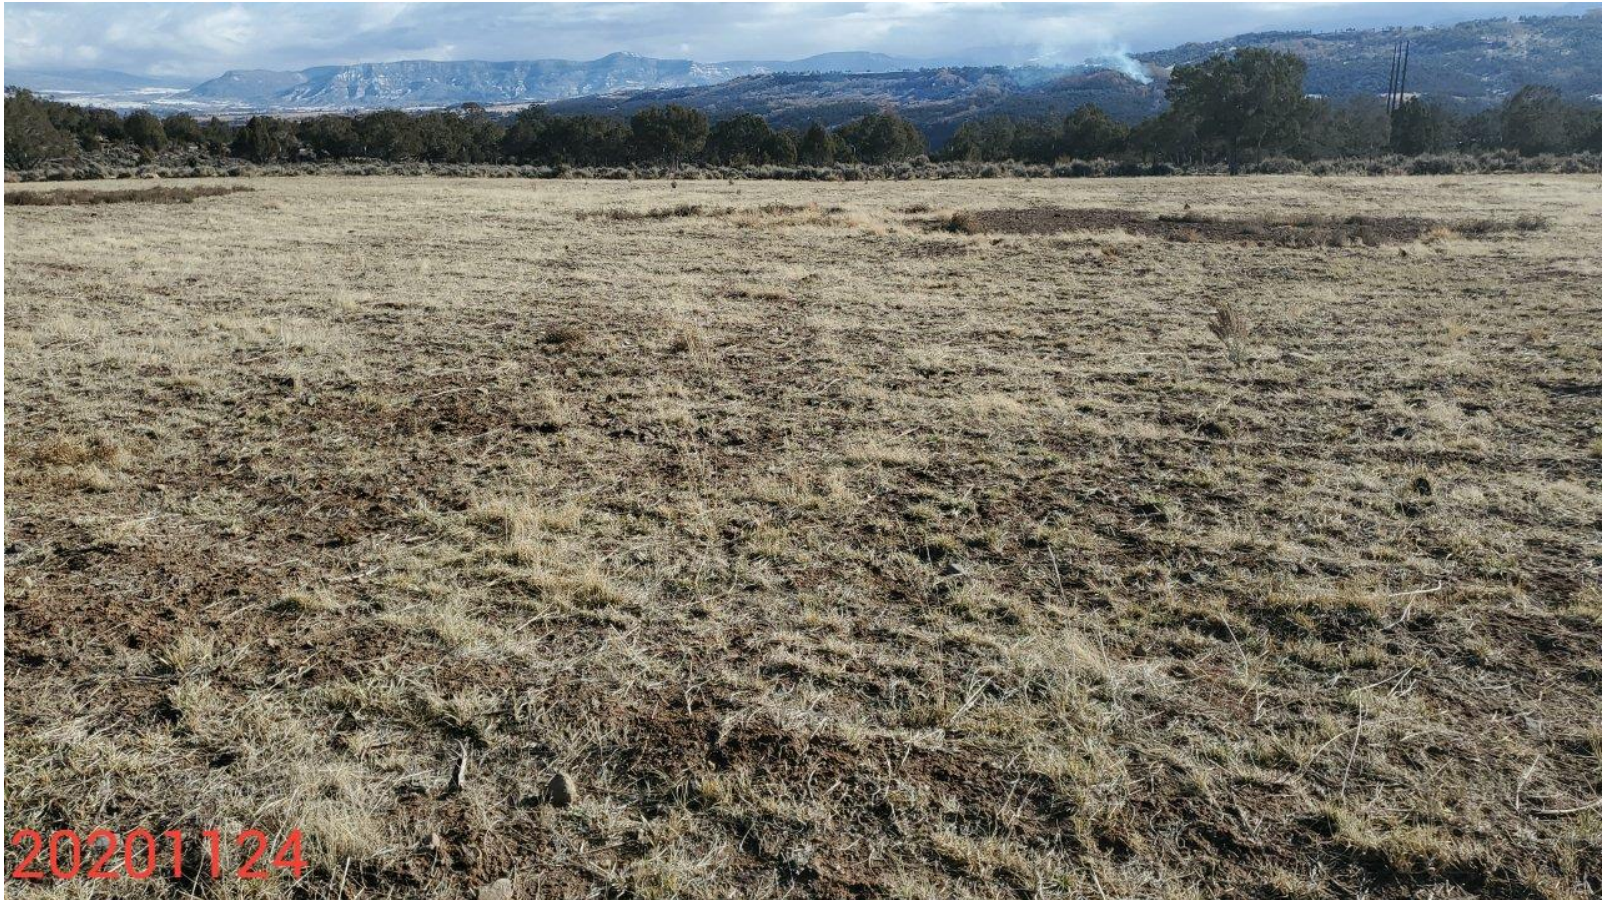
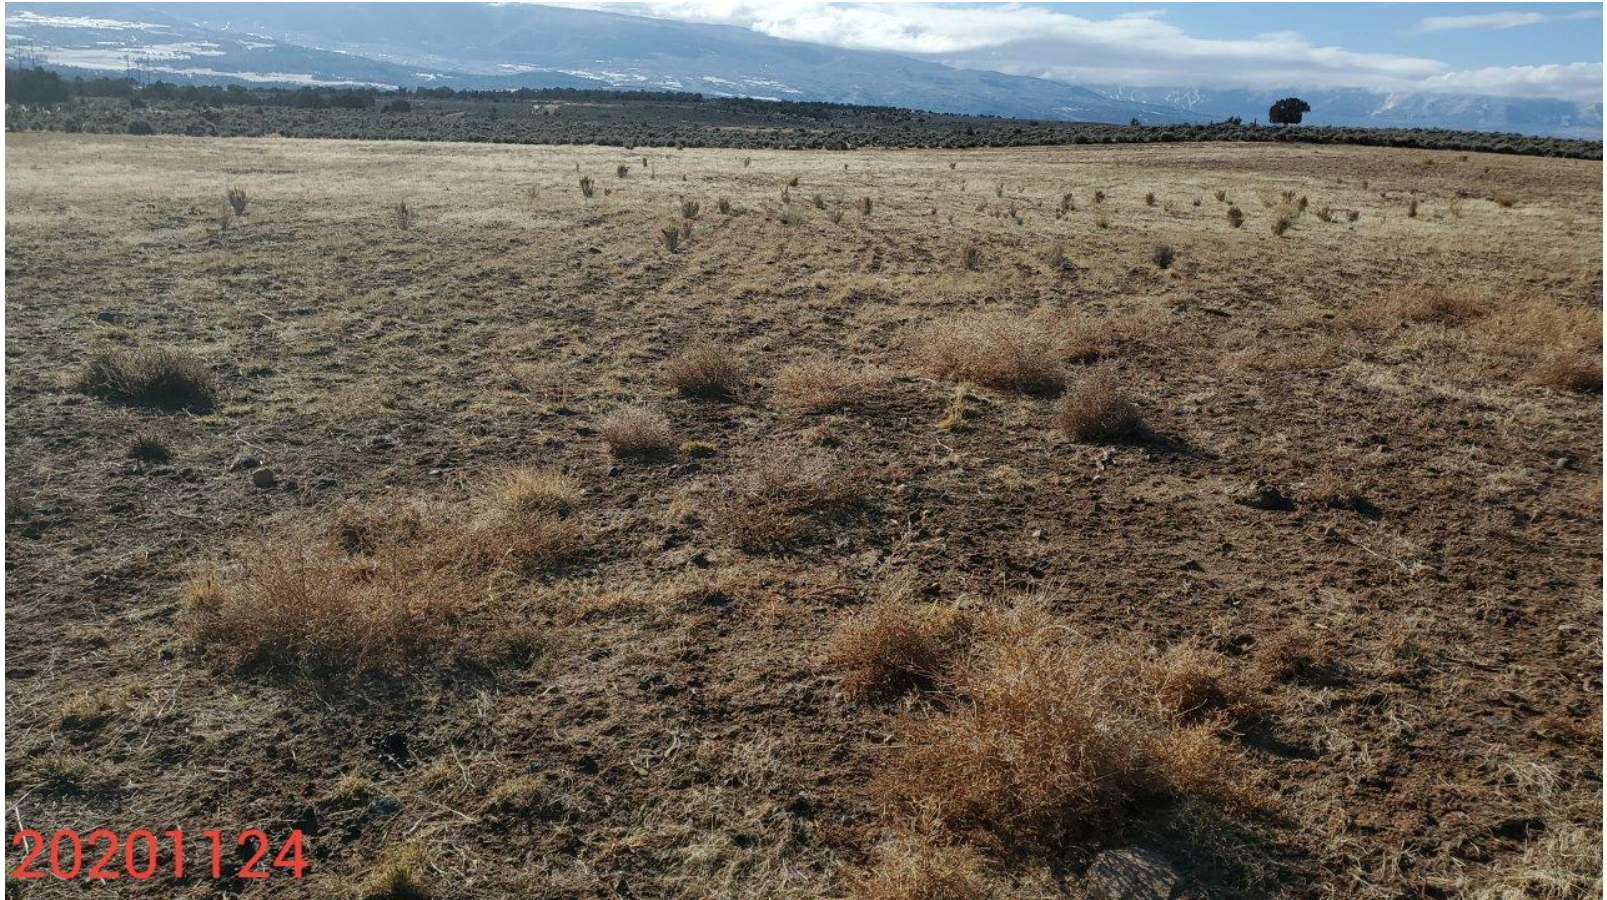
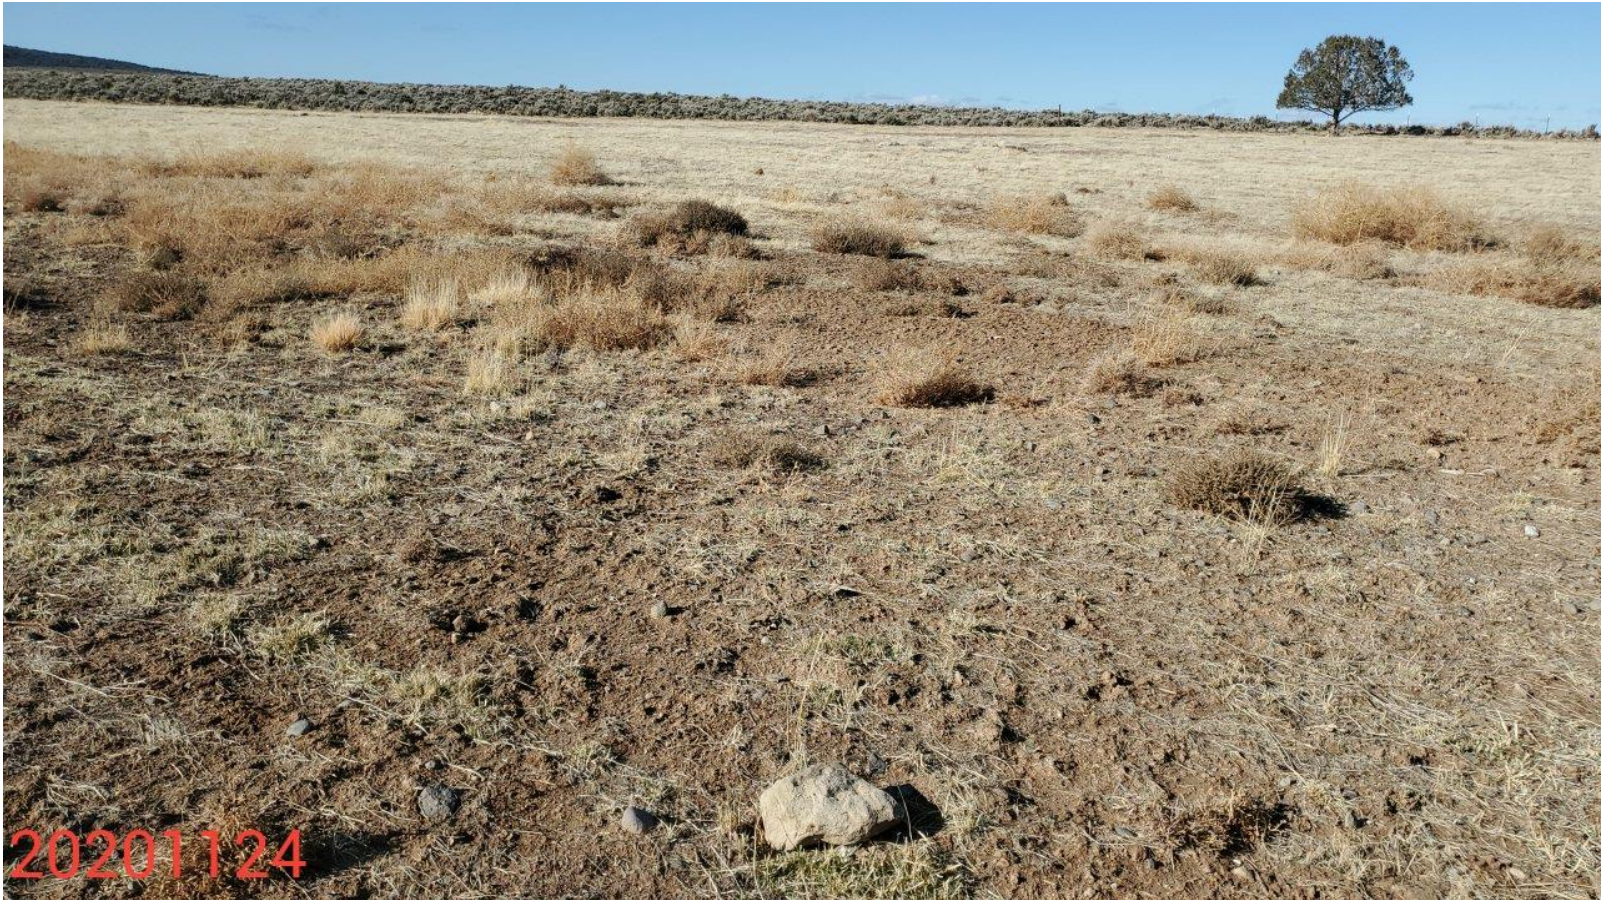
**Photo 6:** Photo taken from the central area of the Location, facing north. Photos 6-9 provide an overview of the Location from north, east, south to west.

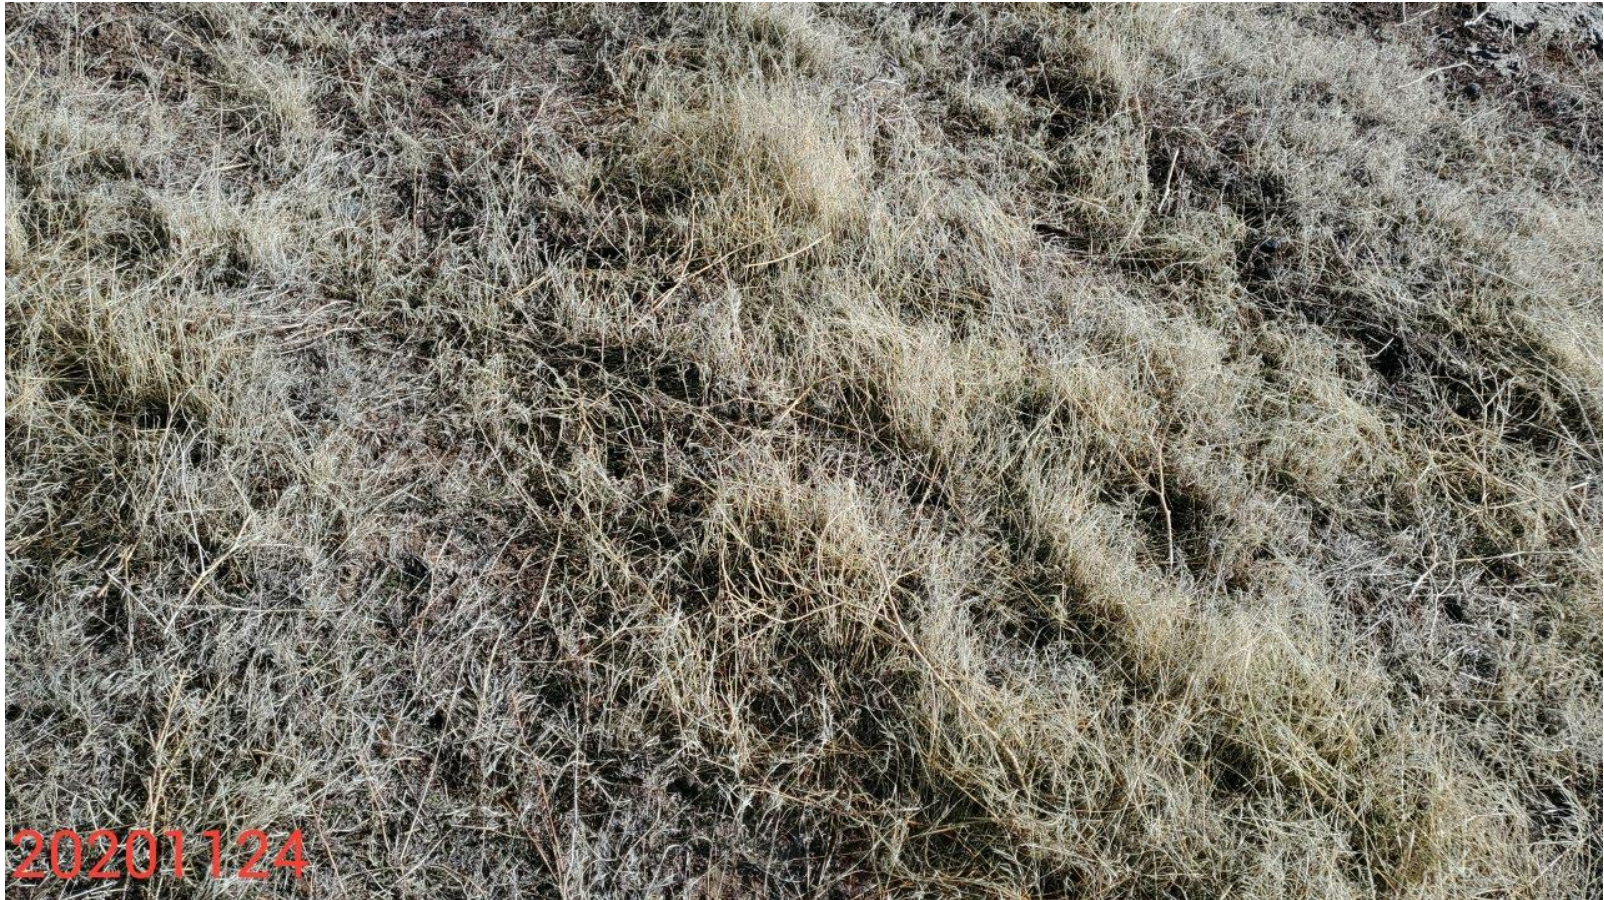
**Photo 10:** Photo taken from the west end of the Location. Photo shows vegetation establishment on the west and northwestern areas of the Location is predominantly weedy annual grass species such as cheat grass. Cheat grass may be hindering desirable vegetative establishment and additional seeding and weed management may be required to facilitate reclamation
