Inspection Photos

11/24/2020

Operator: CAERUS PICEANCE LLC - 10456

Location ID: 312508

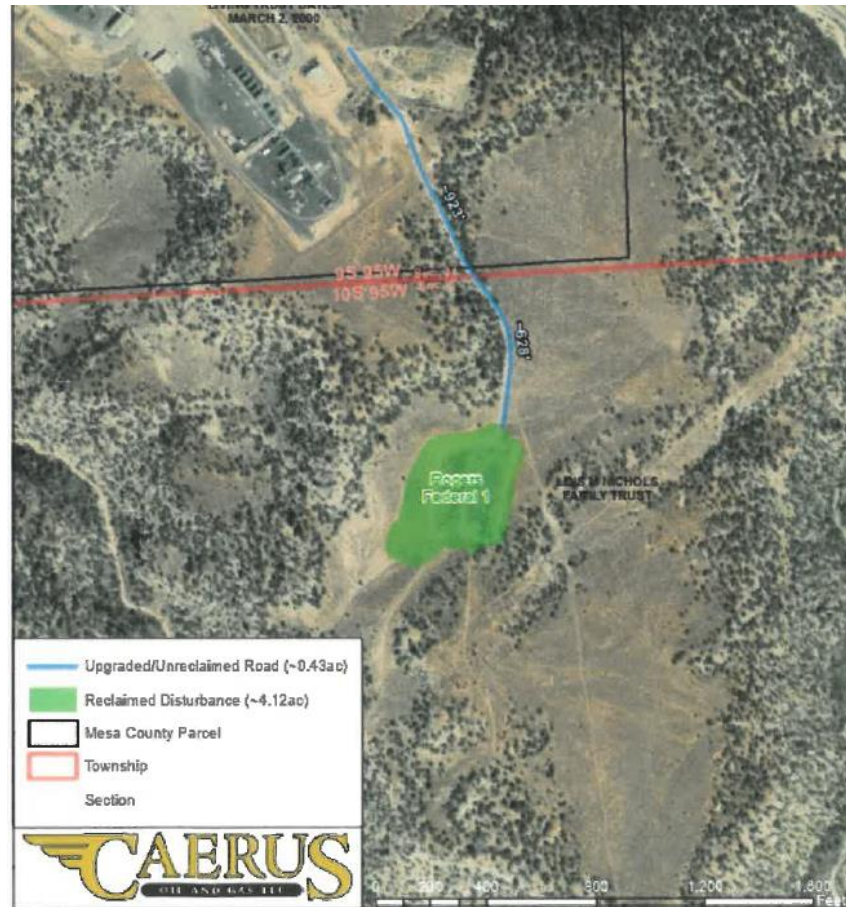
Photo 1: Figure attached to SOVR #402525467 provided by Caerus; Photo shows access road (blue) not to be reclaimed. Access road requires graveling per COAs.

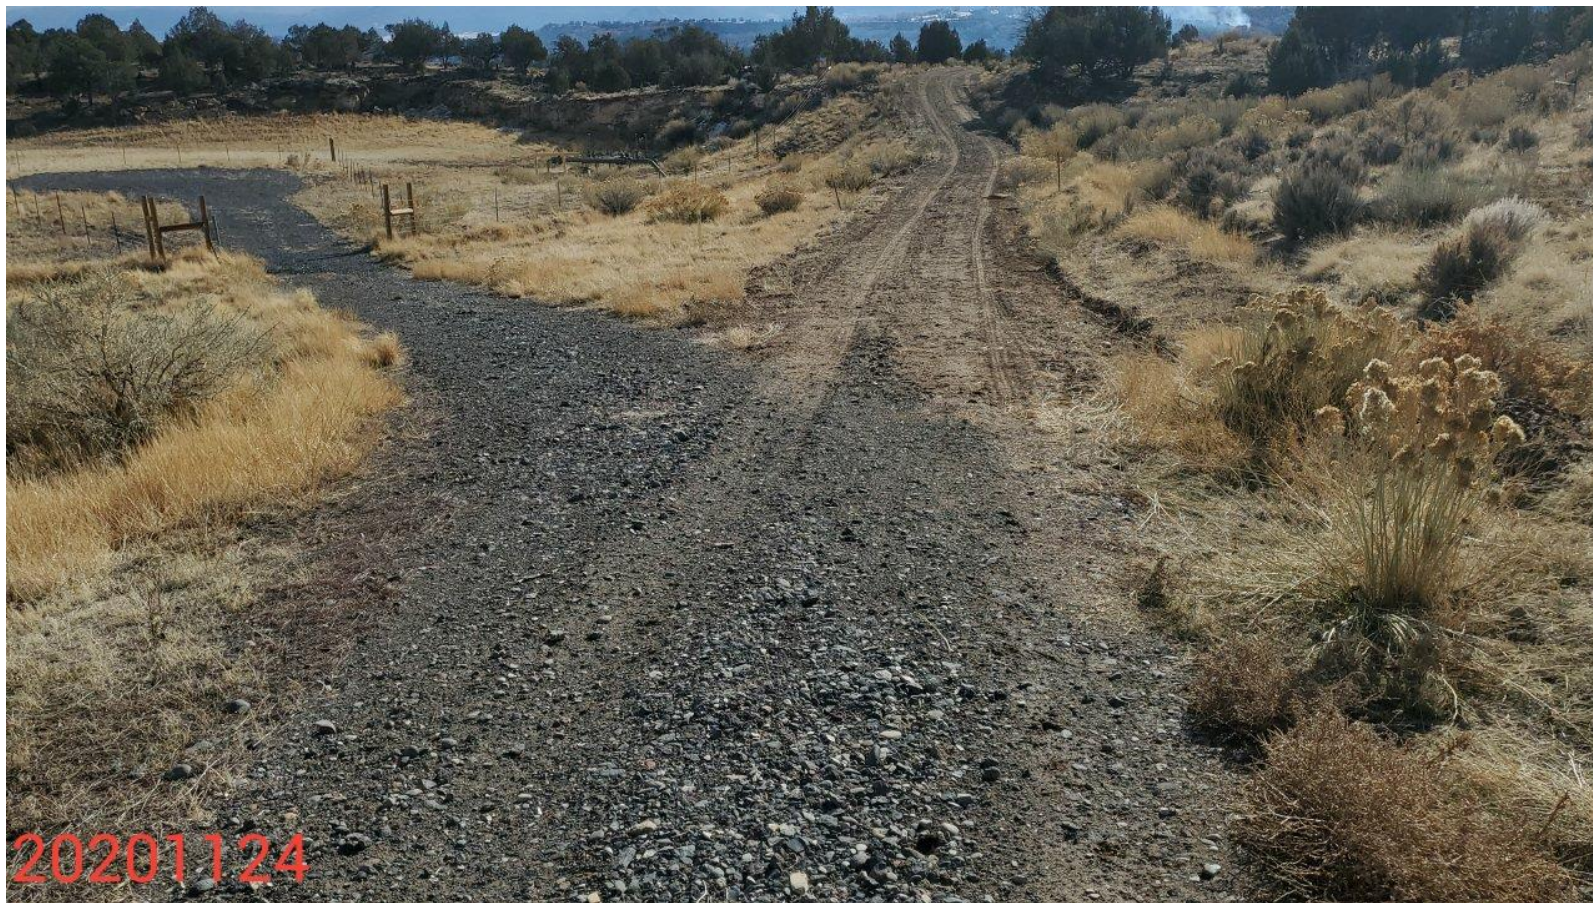
Photo 2: Photo taken from the west of the Plateau Nichols 31-42 Location, facing south. Photo shows access road that leads to the Rogers Federal 1 Location. SOVR #402525467 states access road is graveled. Photo shows only the section of access road leading to the Nichols has been graveled. Gravel required to be installed along access road to the Rogers Federal 1 as indicated within the SOVR.

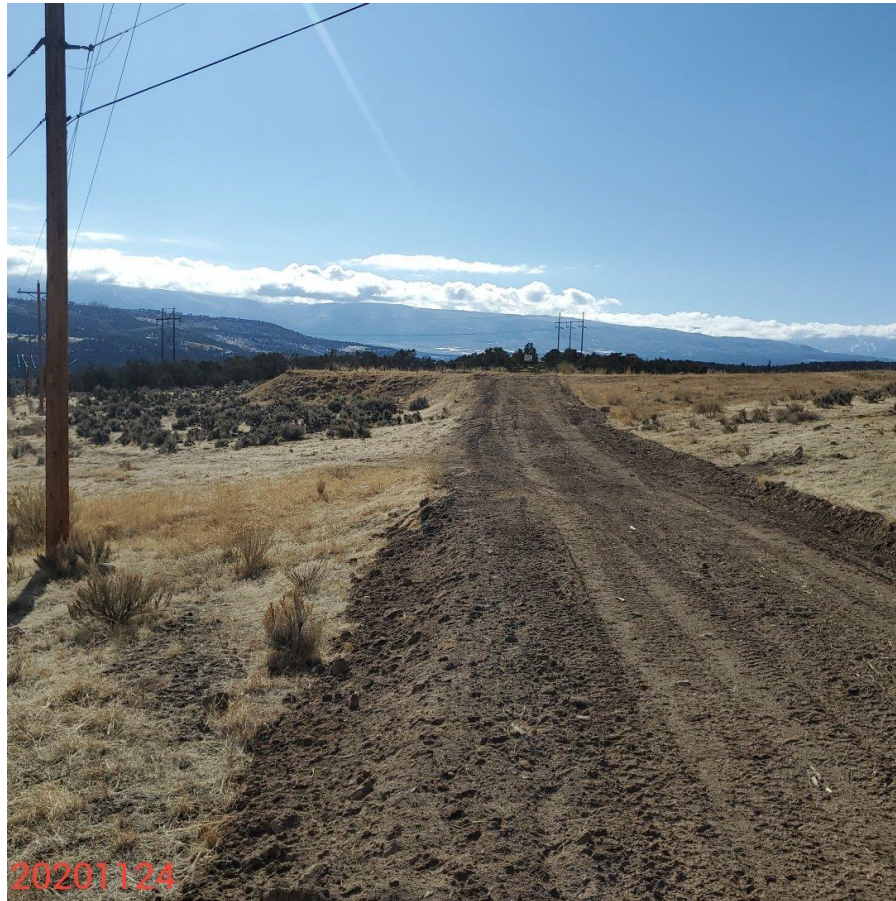
Photo 3: Photo taken from the access road north of the Location, facing south. See comments under photo 2.

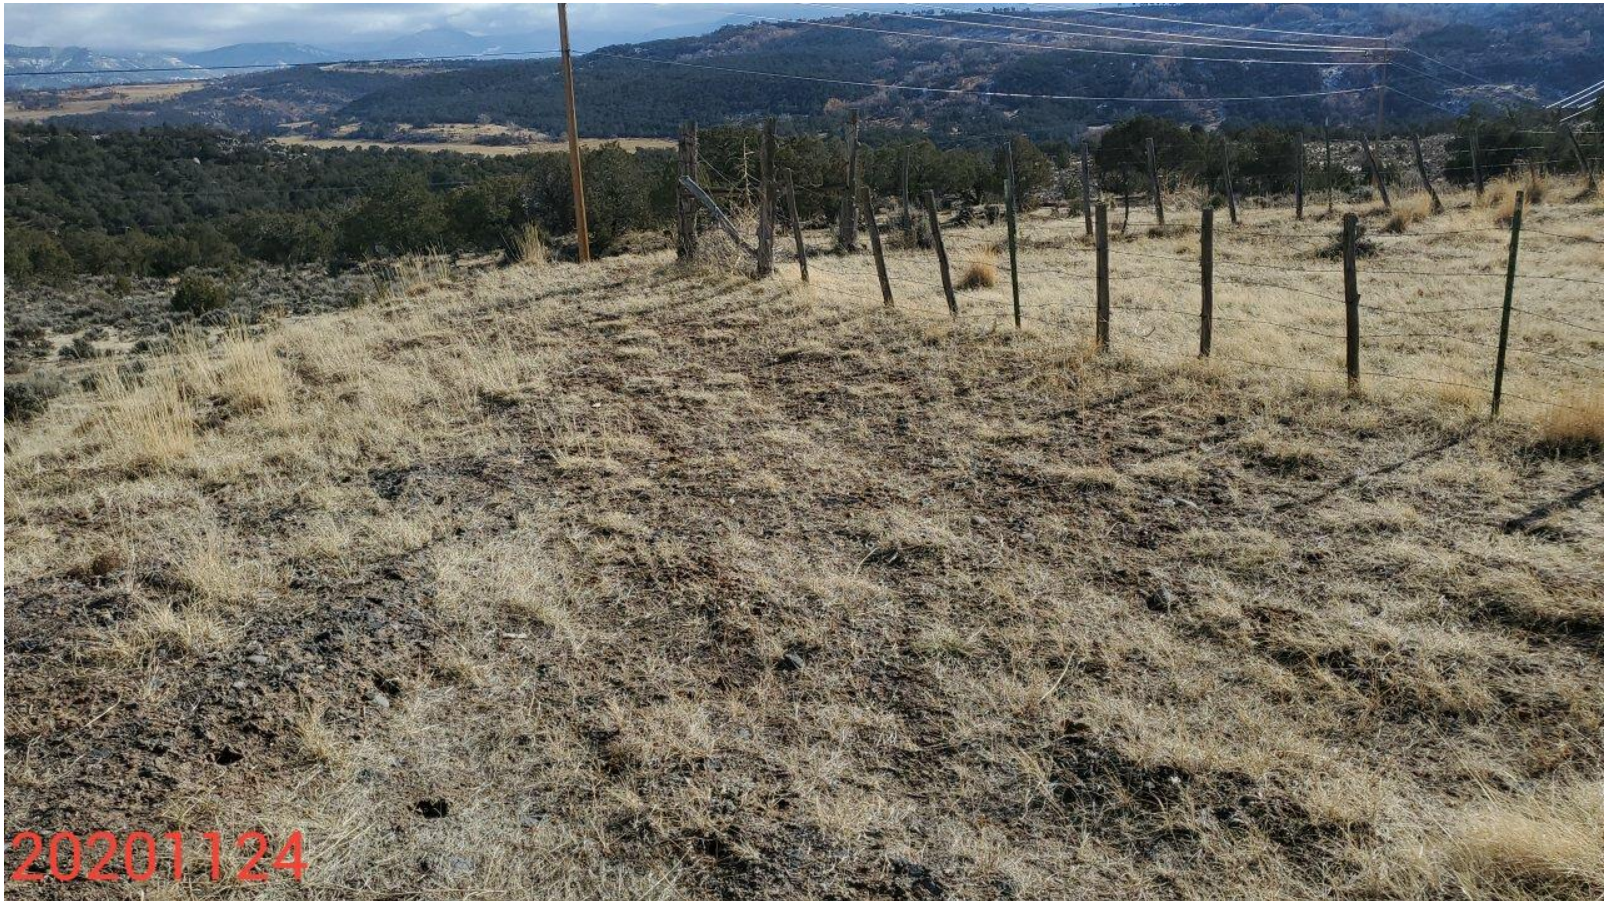
Photo 4: Photo taken from the north end of the Location, facing east. Photos 4-7 provide an overview of the Location from east, southeast, southwest to west.

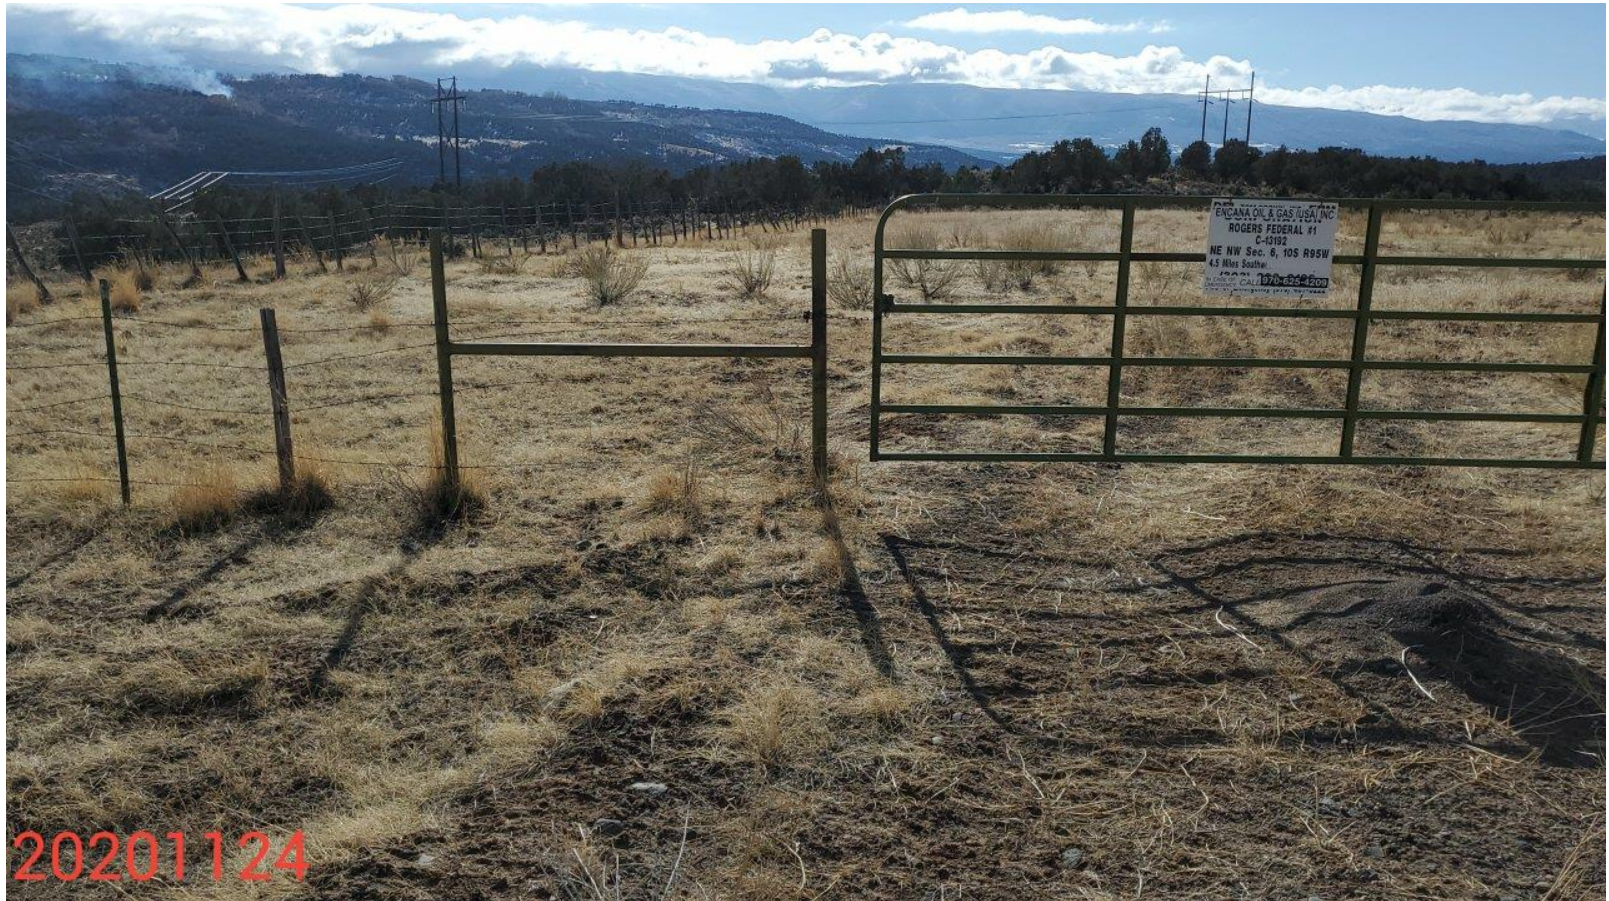
Photo 5: See comments under photo 4.

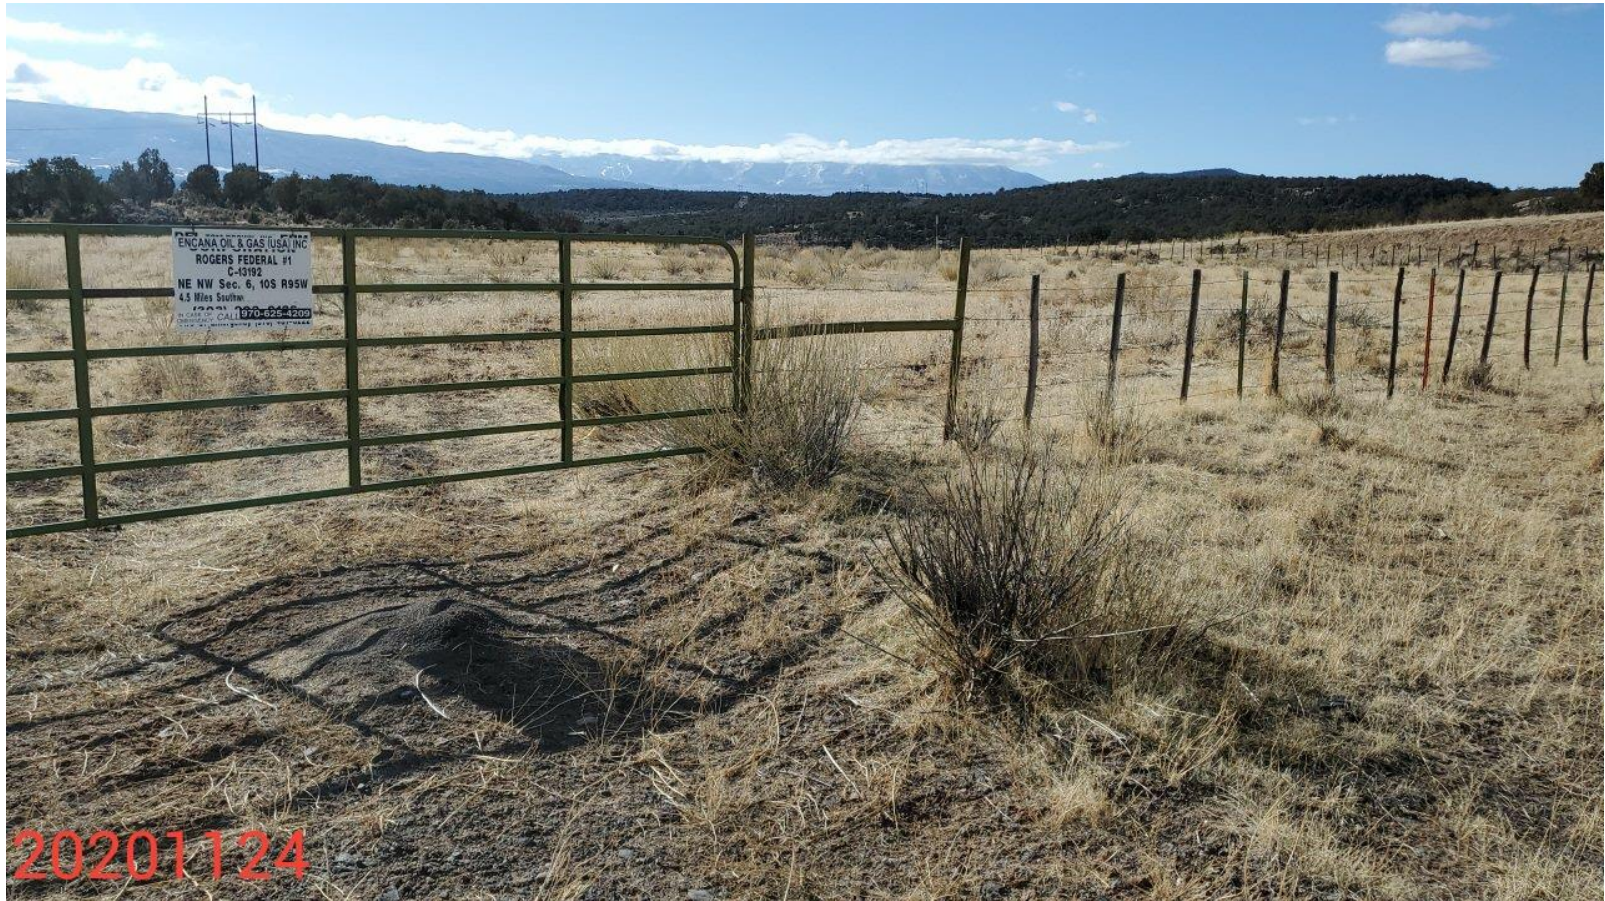
Photo 6: See comments under photo 4.

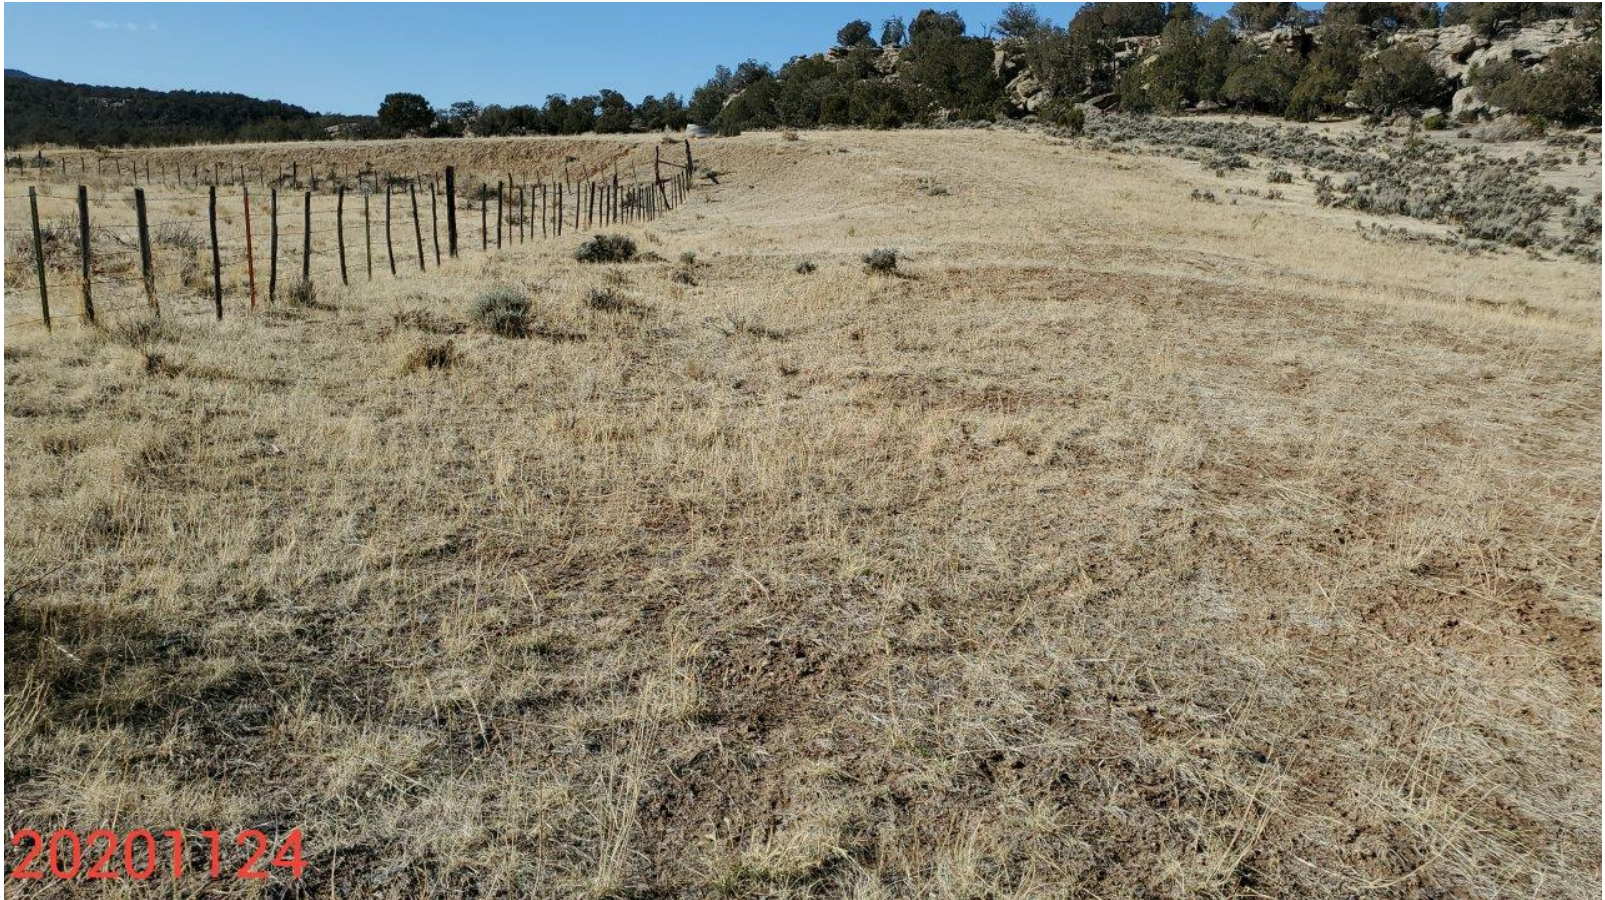
Photo 7: See comments under photo 4.

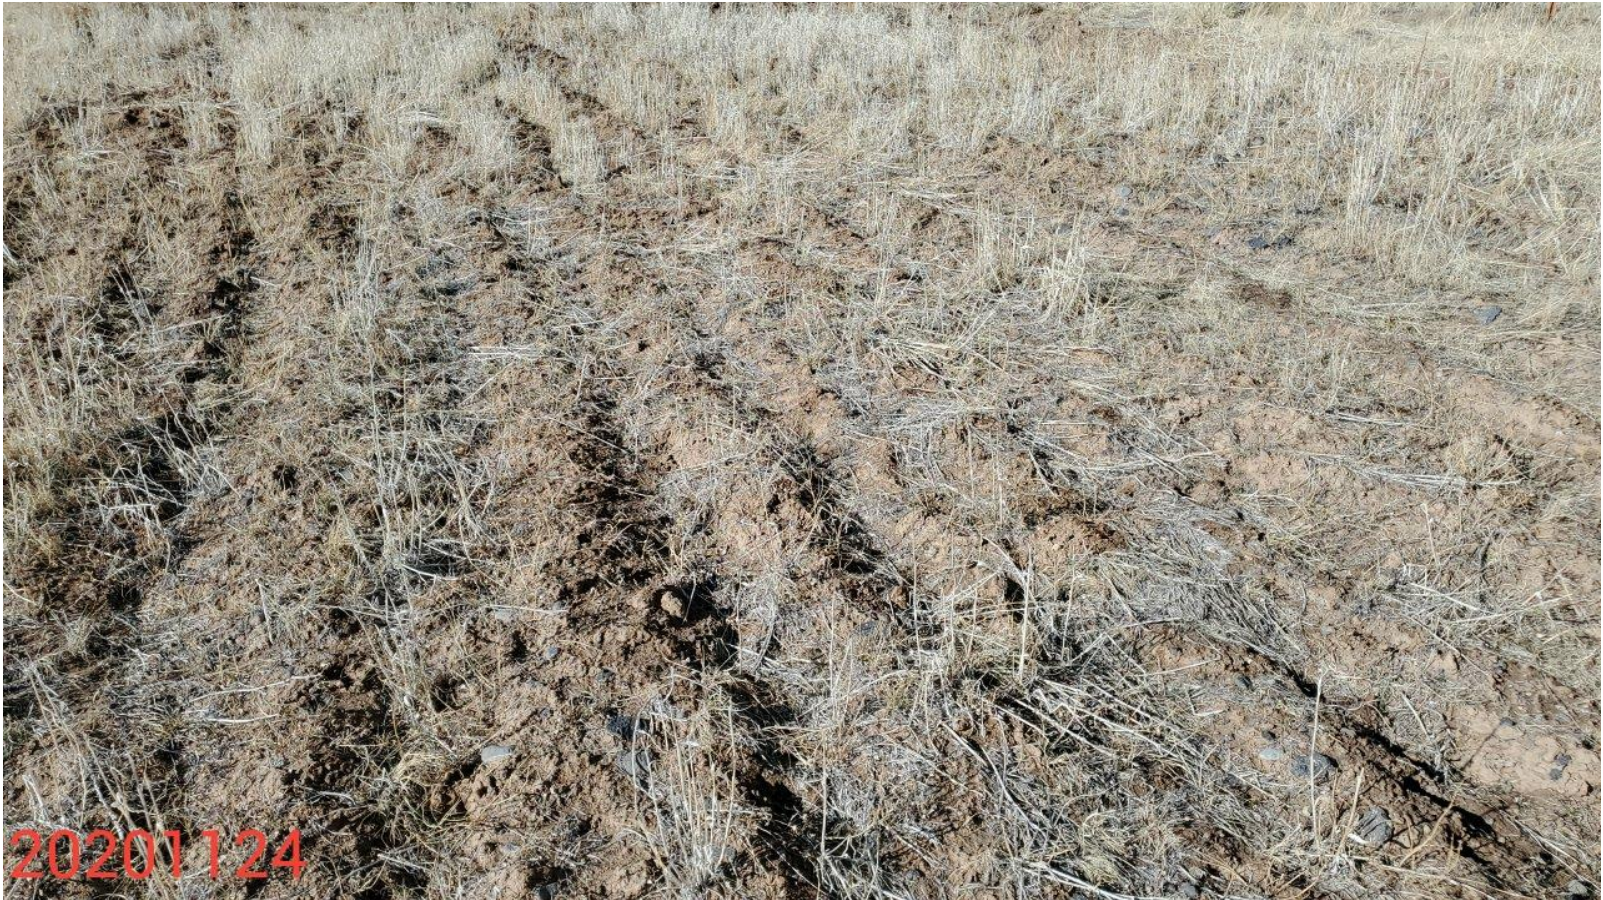
Photo 8: Photo taken from the southeastern areas of the Location. Photo shows areas where additional reclamation activities appear to recently have been conducted. Reclamation in process.

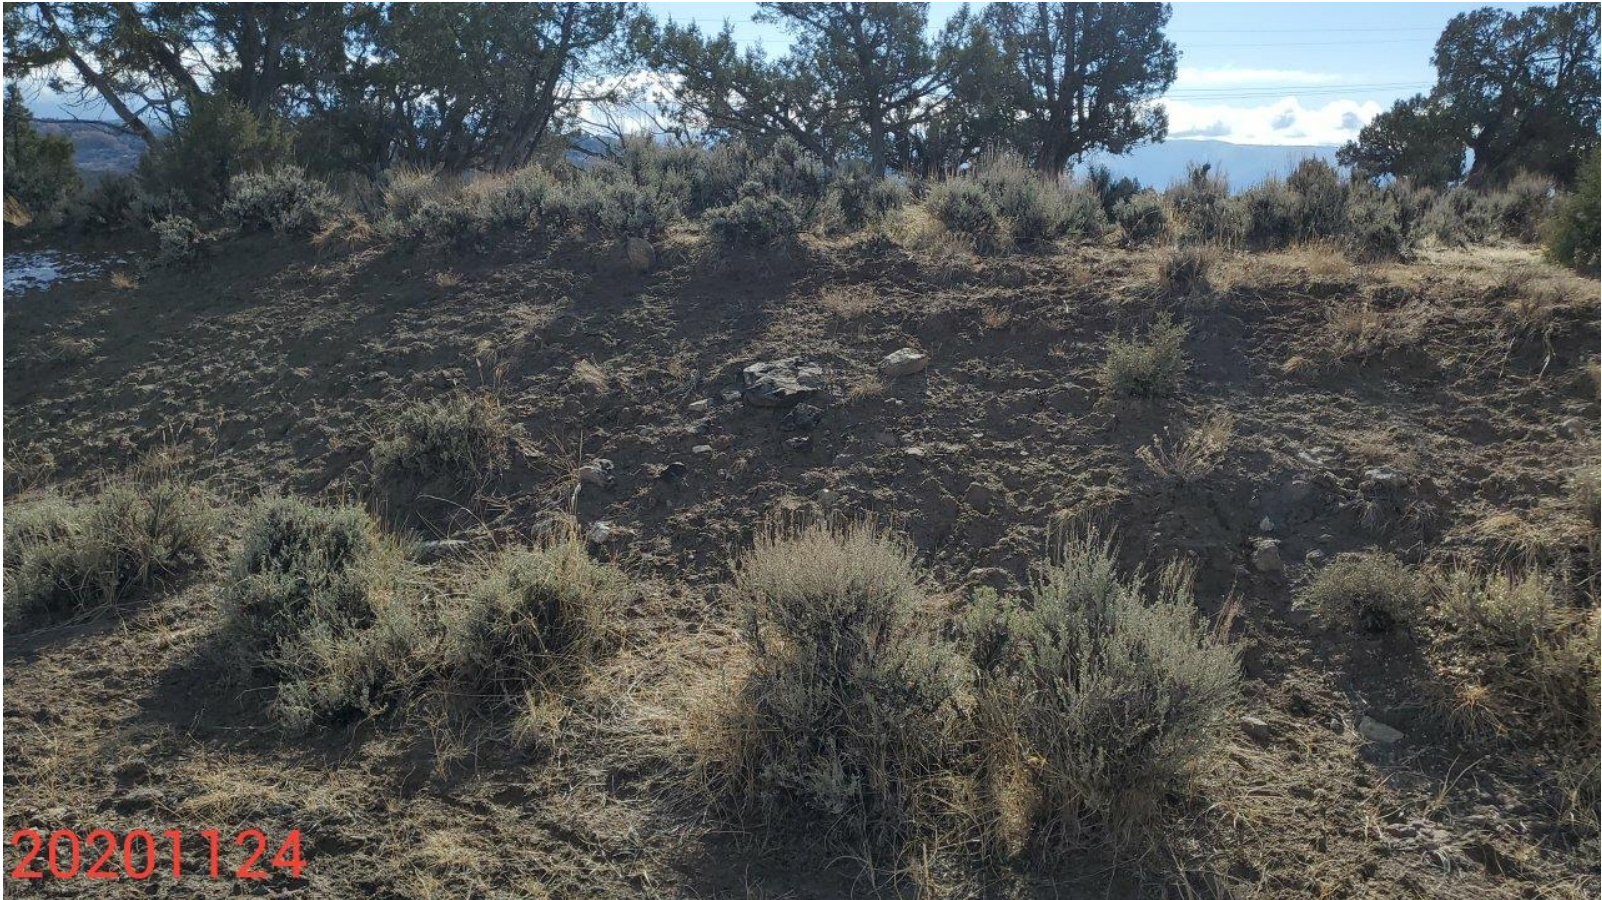
Photo 9: Photo taken from the cut slopes on the south end of the Location, facing south. Photo shows vegetation establishment on the cut slopes is not uniform.
