Inspection Photos

Operator: CAERUS PICEANCE LLC - 10456

Location ID: 312461

Mesa County, CO

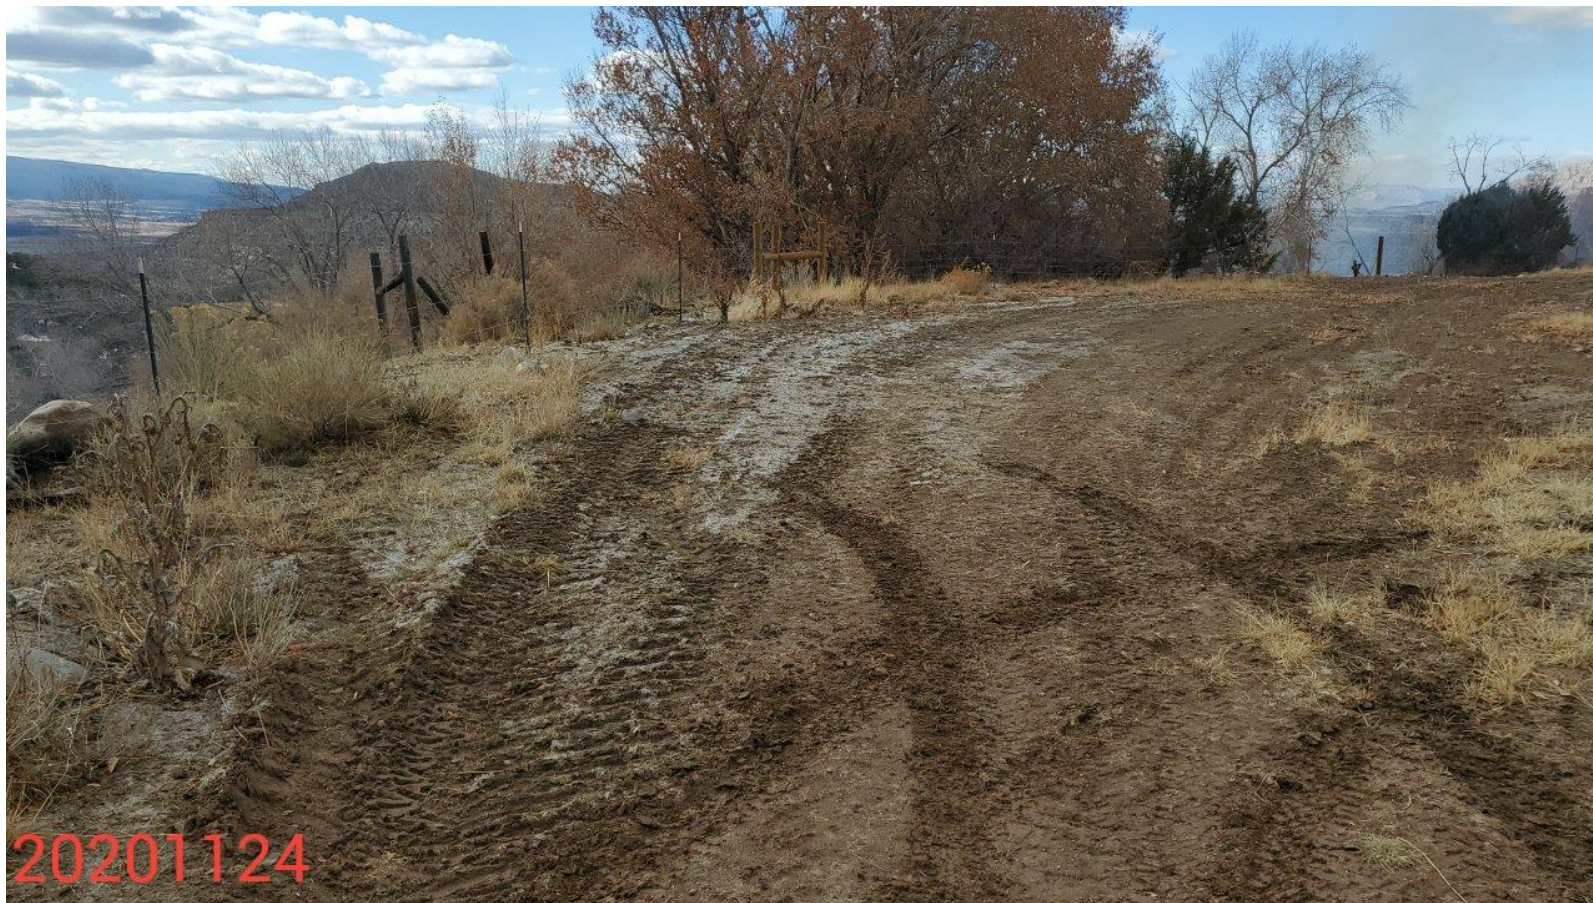
Photo 1: Photo taken from the south end of the Location, facing northwest. Photo shows areas on the west end of the Location that remain bare and will likely require additional reclamation work for Location to meet 1004 Standards; At least 2 growing seasons have passed since well was PA, plant germination should be evident on these areas. Evidence of equipment/vehicle travel also observed on the areas; Additional compaction alleviation may also be necessary.

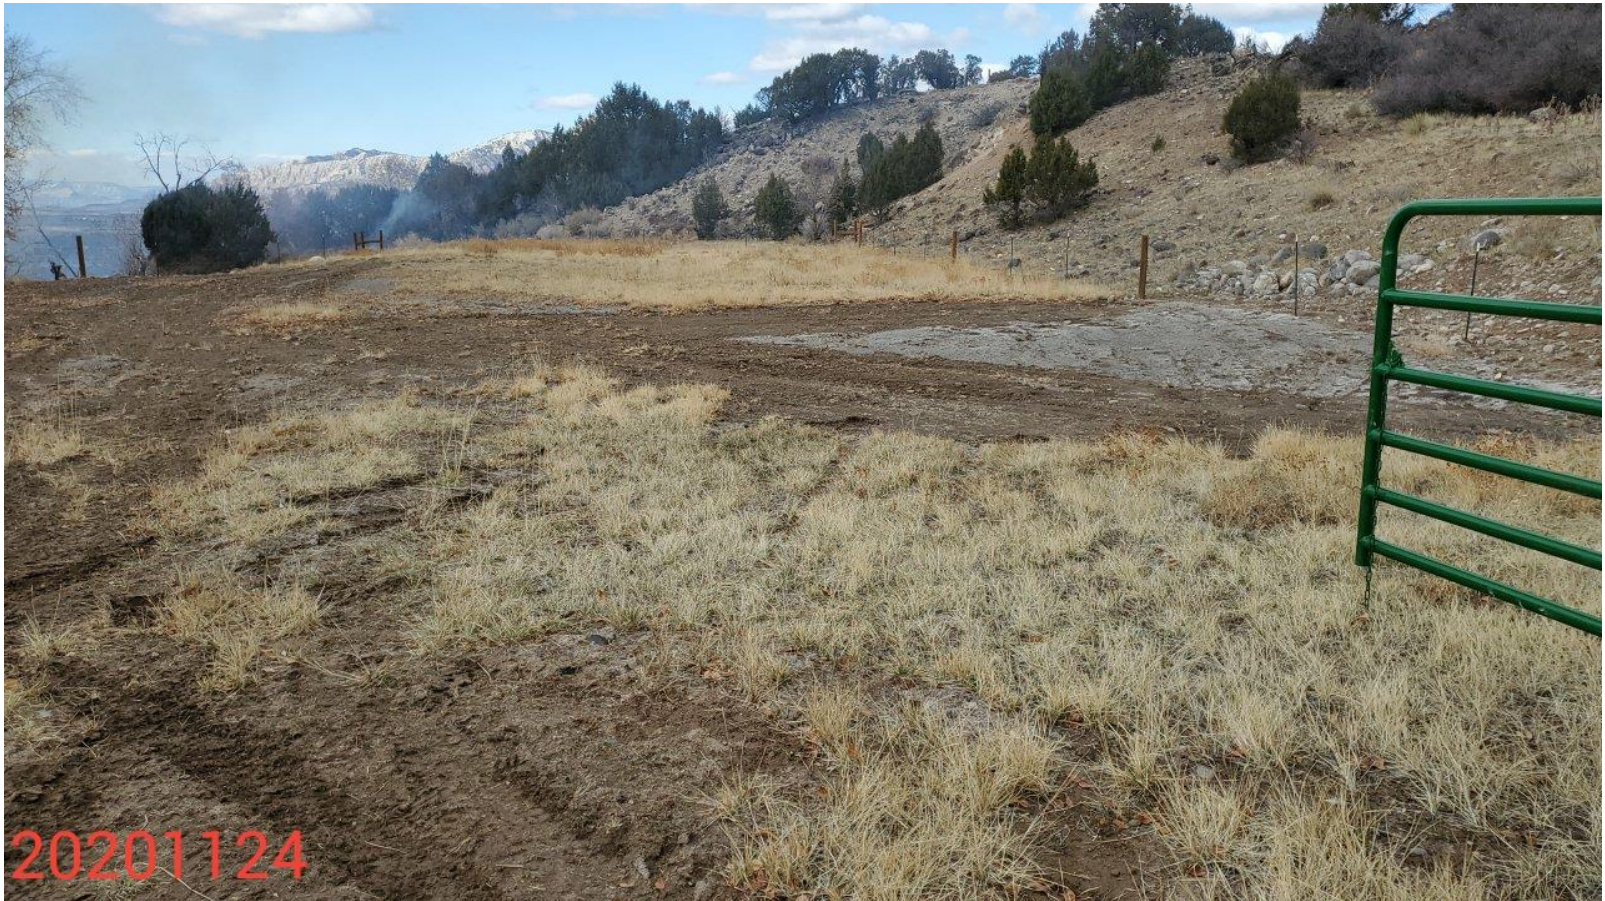
Photo 2: Photo taken from the south end of the Location, facing north. See comments under photo 1.

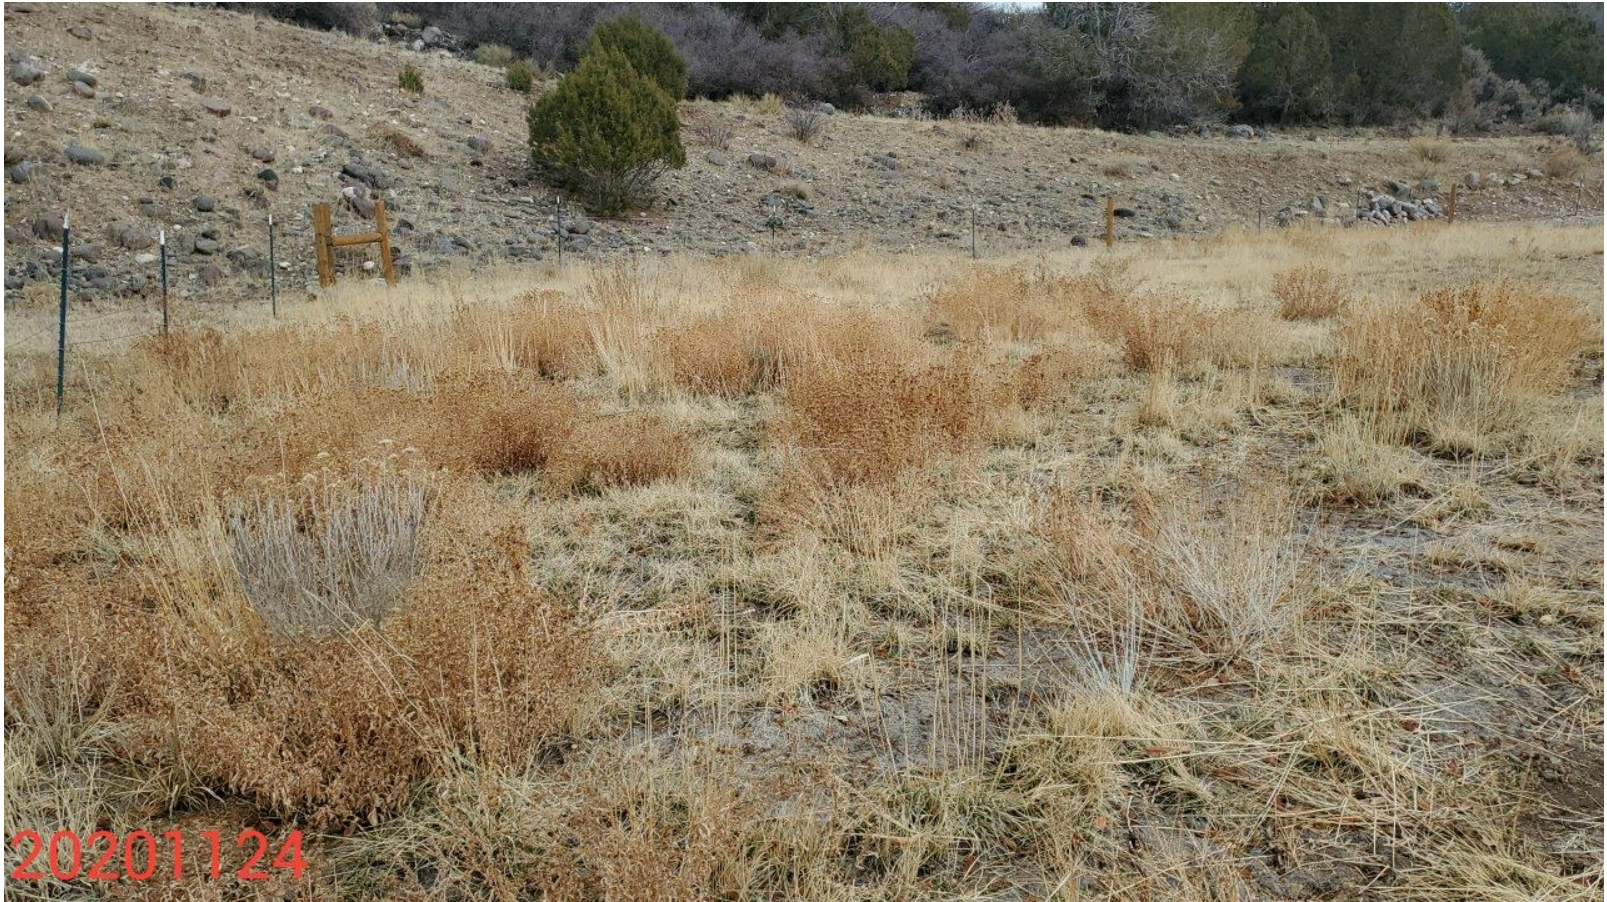
Photo 3: Photo taken from the north end of the Location, facing southeast. Vegetation establishment in these areas appears to be progressing towards COGCC reclamation requirements.

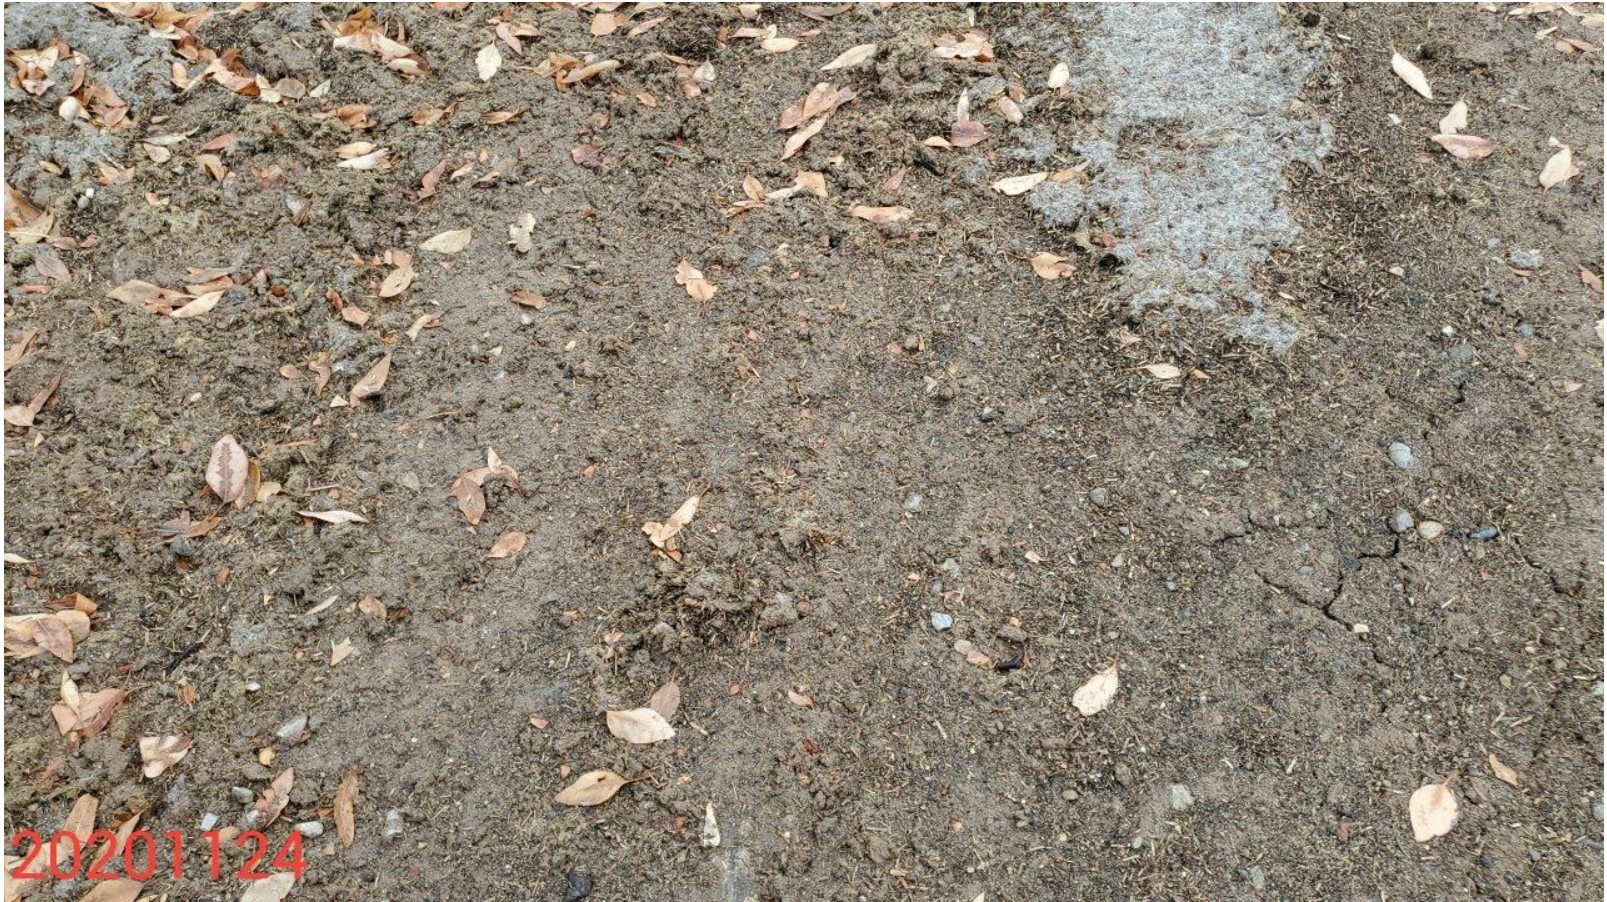
Photo 4: Photo taken from the north end of the Location, facing south. Photo shows areas on the west end of the Location that remain bare and will likely require additional reclamation work for Location to meet 1004 Standards; At least 2 growing seasons have passed since well was PA, plant germination should be evident on these areas. Evidence of equipment/vehicle travel also observed on the areas; Additional compaction alleviation may also be necessary.

Photo 5: See comments under photo 4.

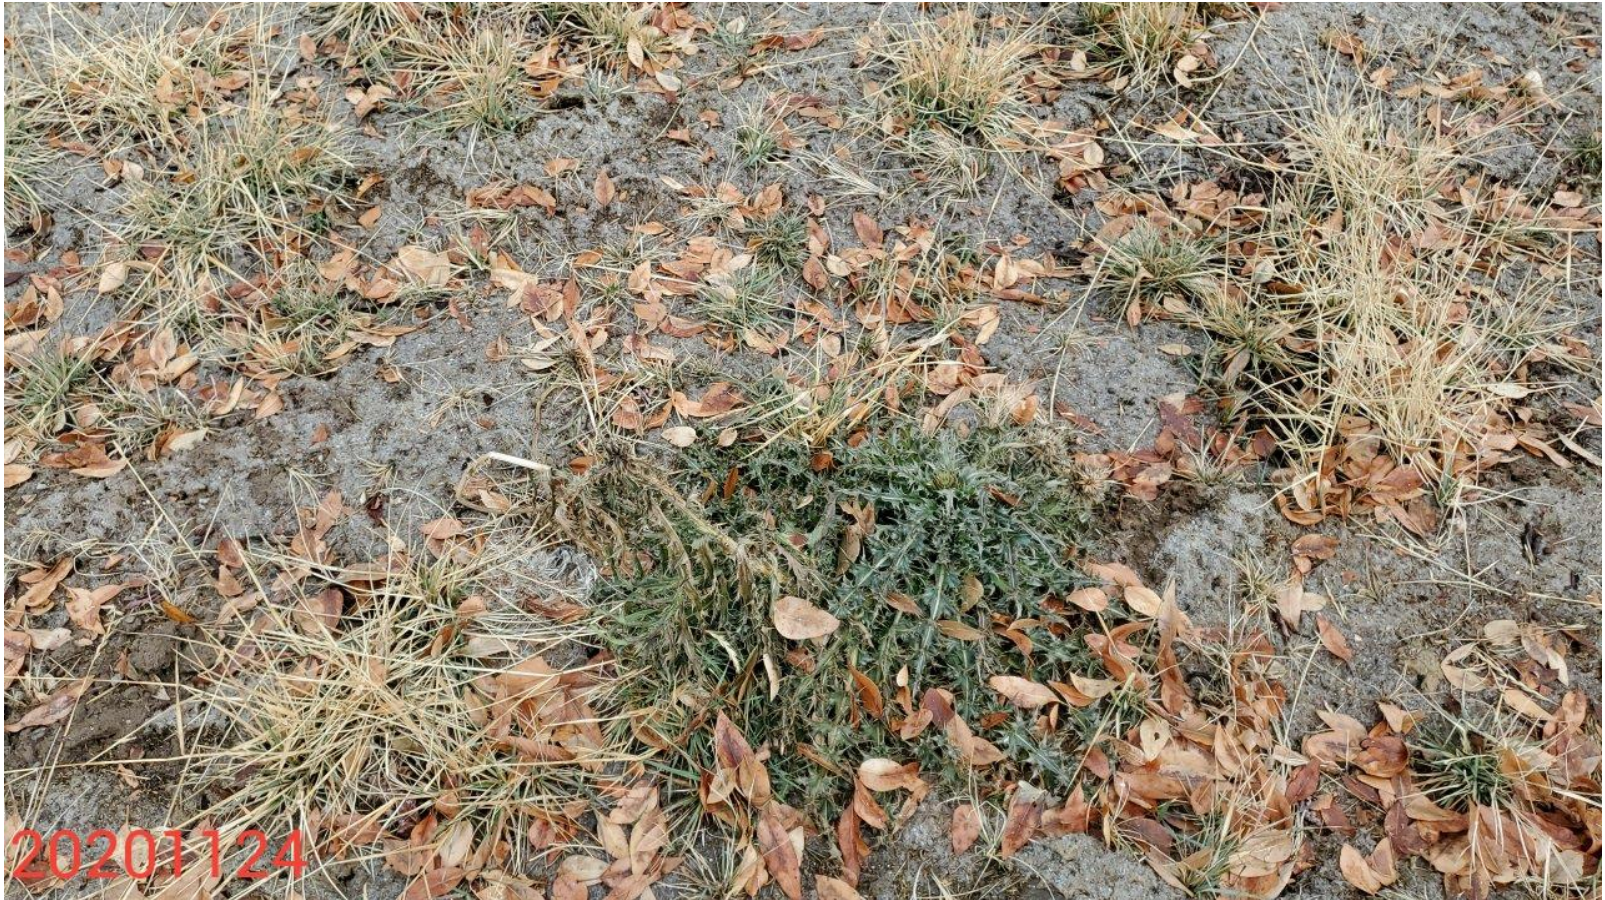
Photo 6: Photo shows example of Noxious weed rosettes observed on the Location.
