# Final Reclamation Inspection

Operator: CRESTONE PEAK RESOURCES OPERATING LLC - 10633

Location ID: 319592

Inspection Photos  
Location Name: WENZEL #1  
Location ID: 319592

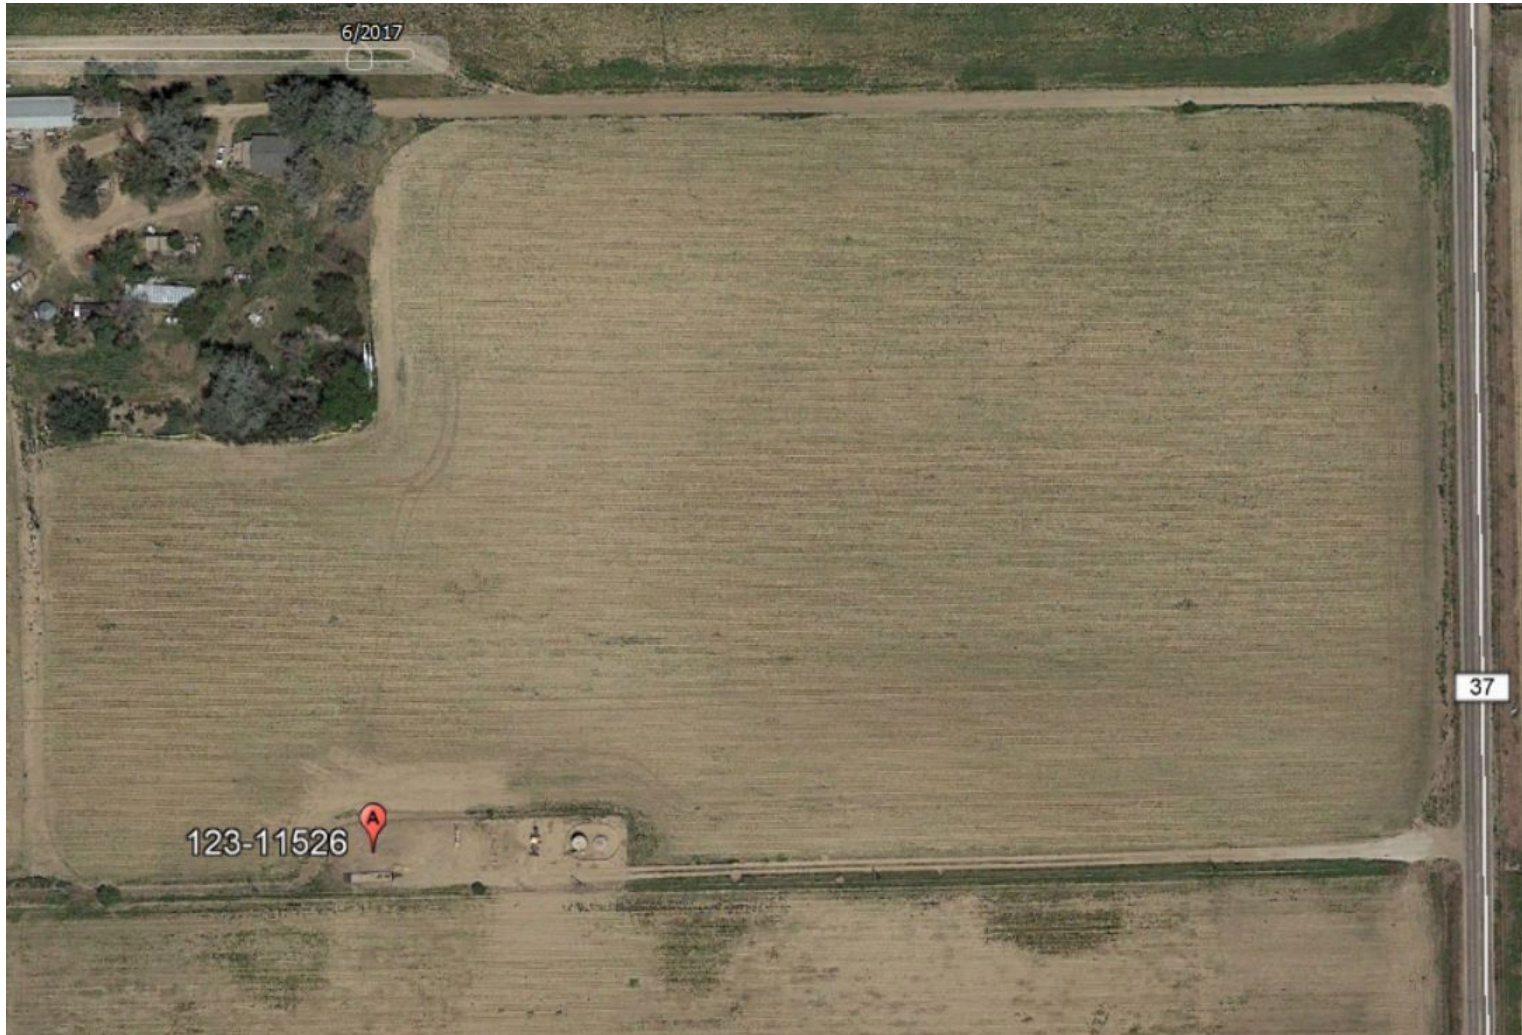
**Photo 1.** Google Earth aerial from 6/9/2017 illustrating active operations.

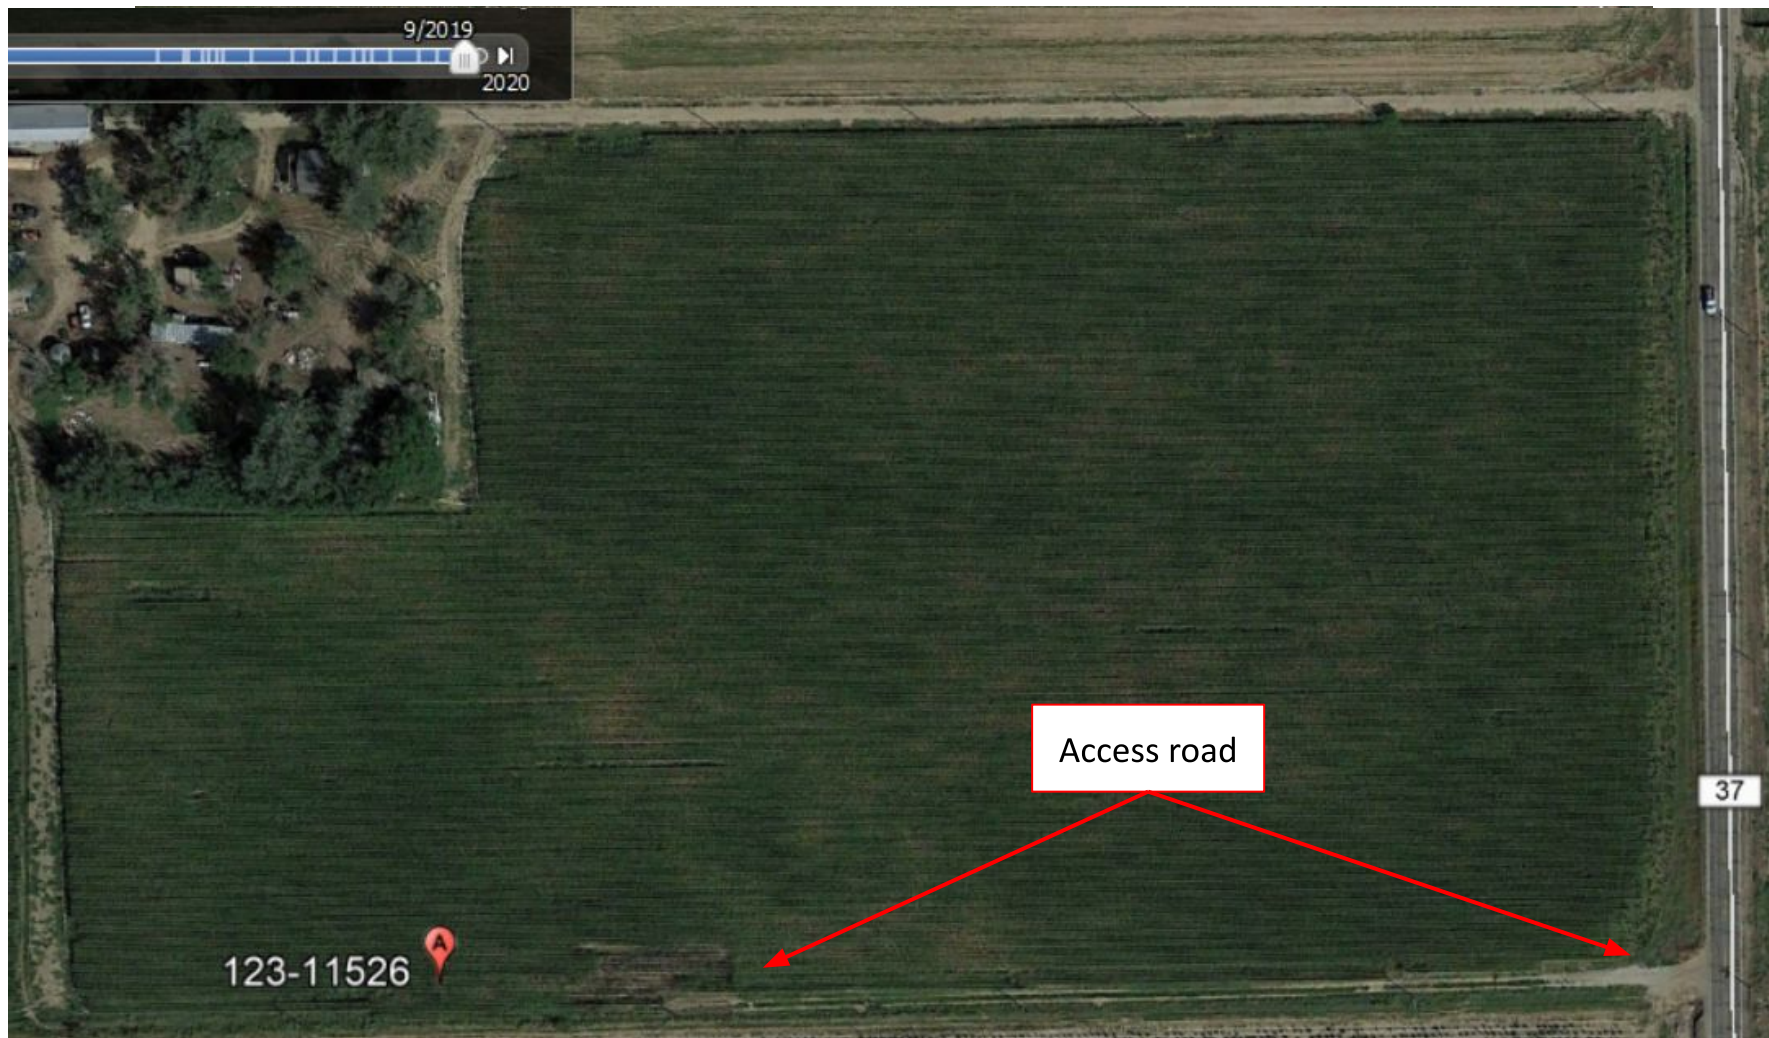
**Photo 2.** Google Earth aerial from 9/12/2019 illustrating conditions after plugging and abandonment. Photo illustrates the Operator has failed to reclaim the access road.

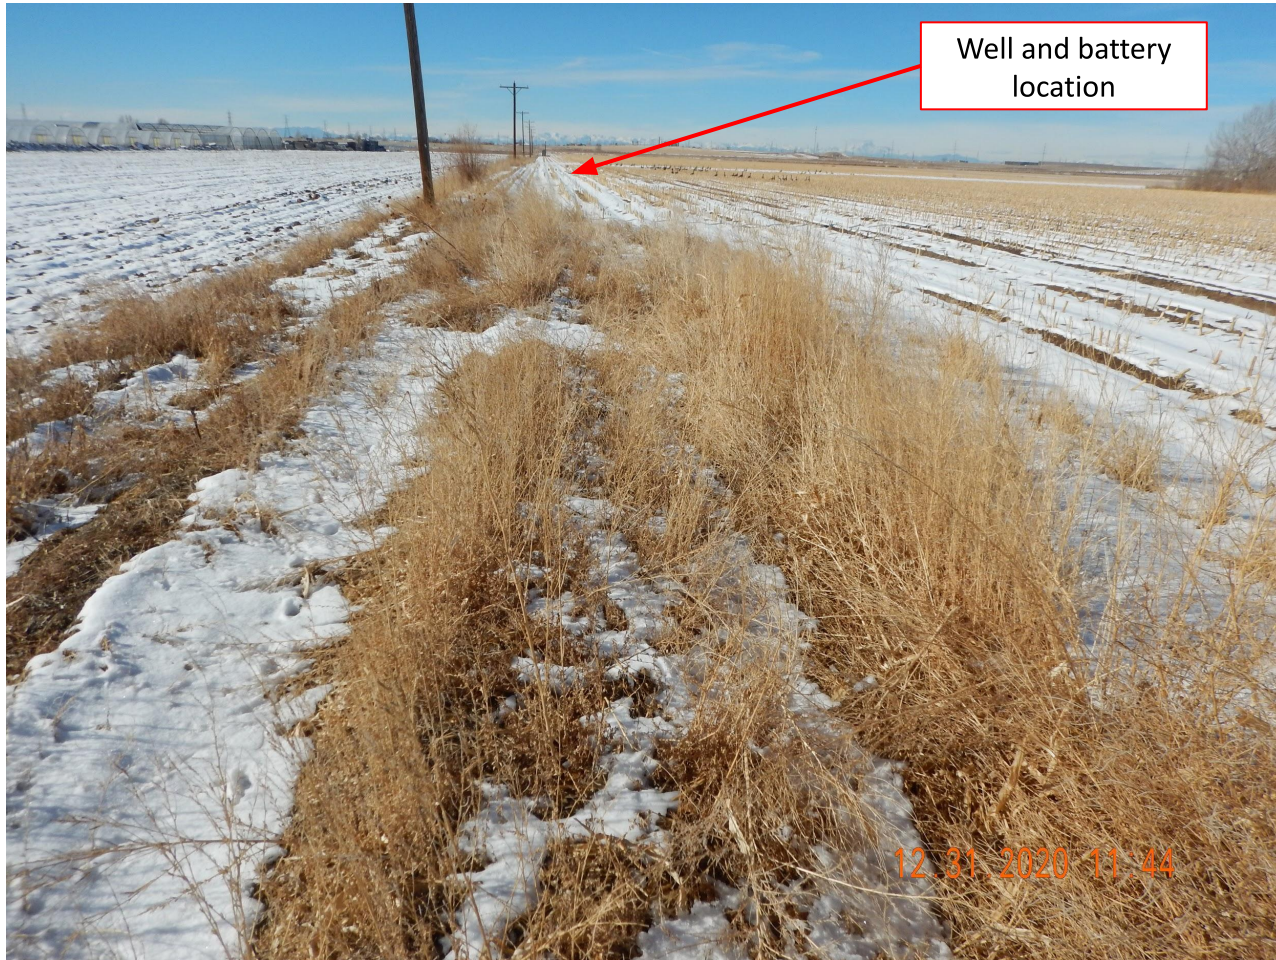
**Photo 3.** Photo taken from the western access road, facing West. Photo illustrates unmanaged weeds along the access road. Gravel remains along the access road and has not been returned back to cropland.

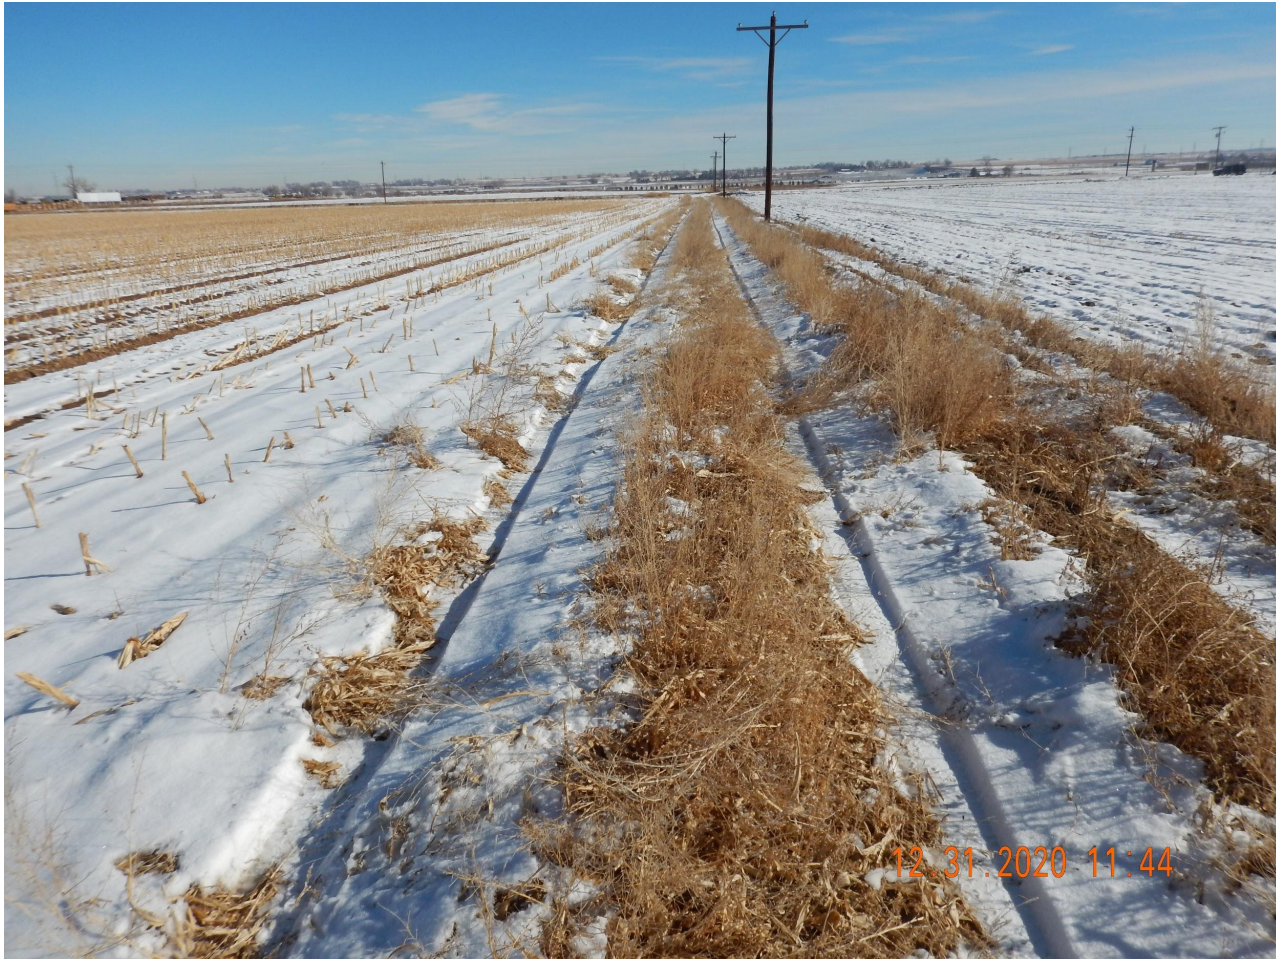
**Photo 4.** Photo taken from the western access road, facing East. See comments under Photo 3.
