Final Reclamation Inspection

Operator: NOBLE ENERGY INC - #100322

Location ID: 422552

Location Name: KUMMER PC LE #23-17

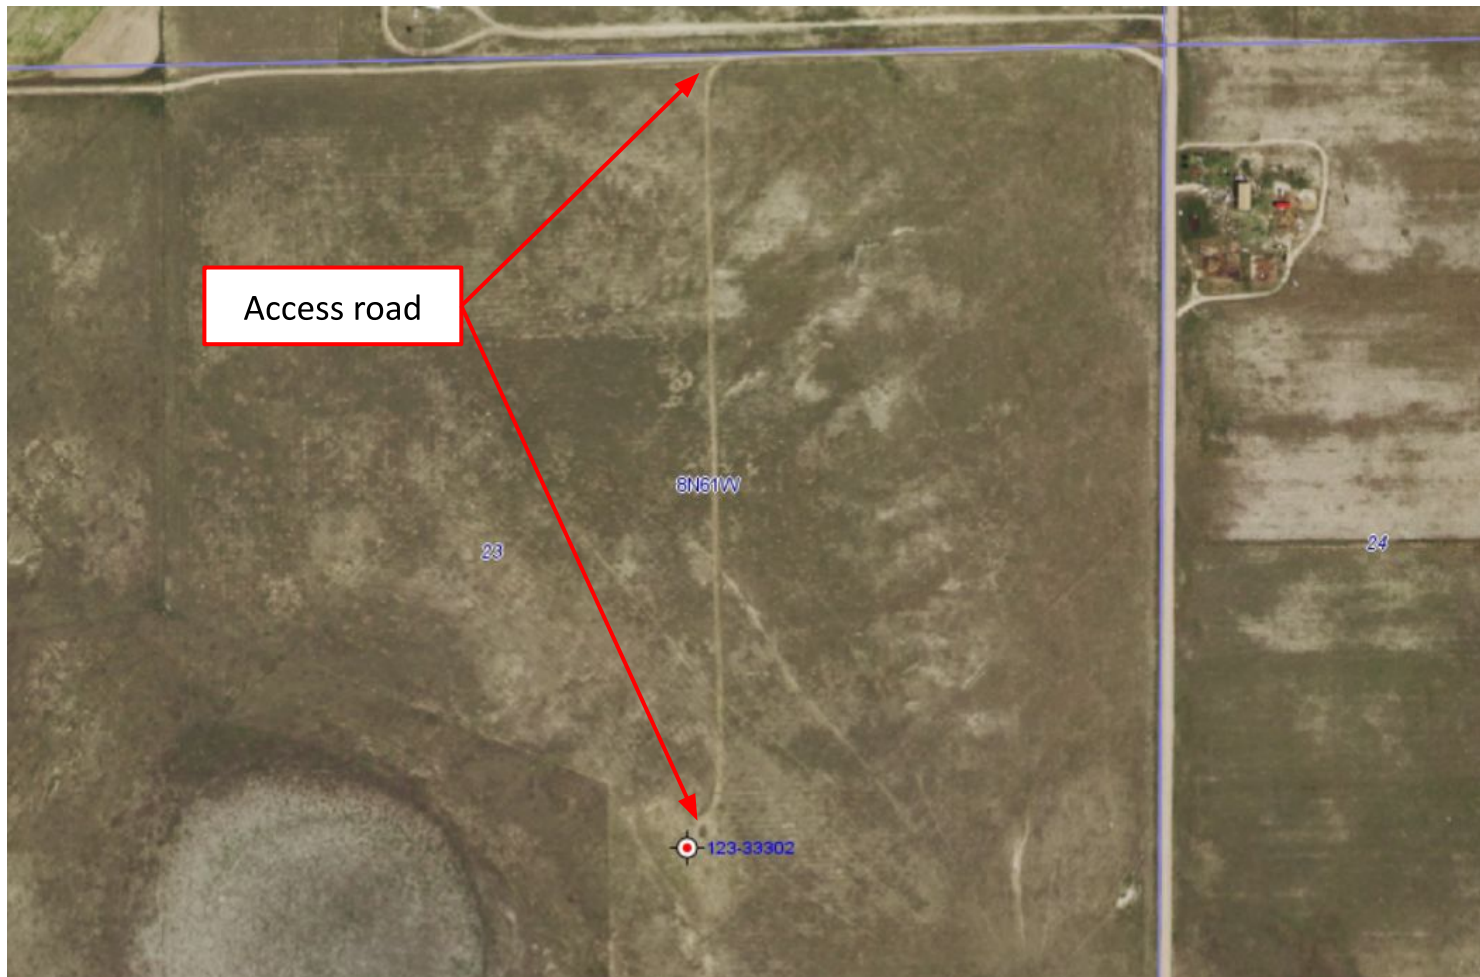
Photo 1. COGCC GISOnline aerial imagery from 2019 illustrates the access road which has not been reclaimed per Rule 1004.

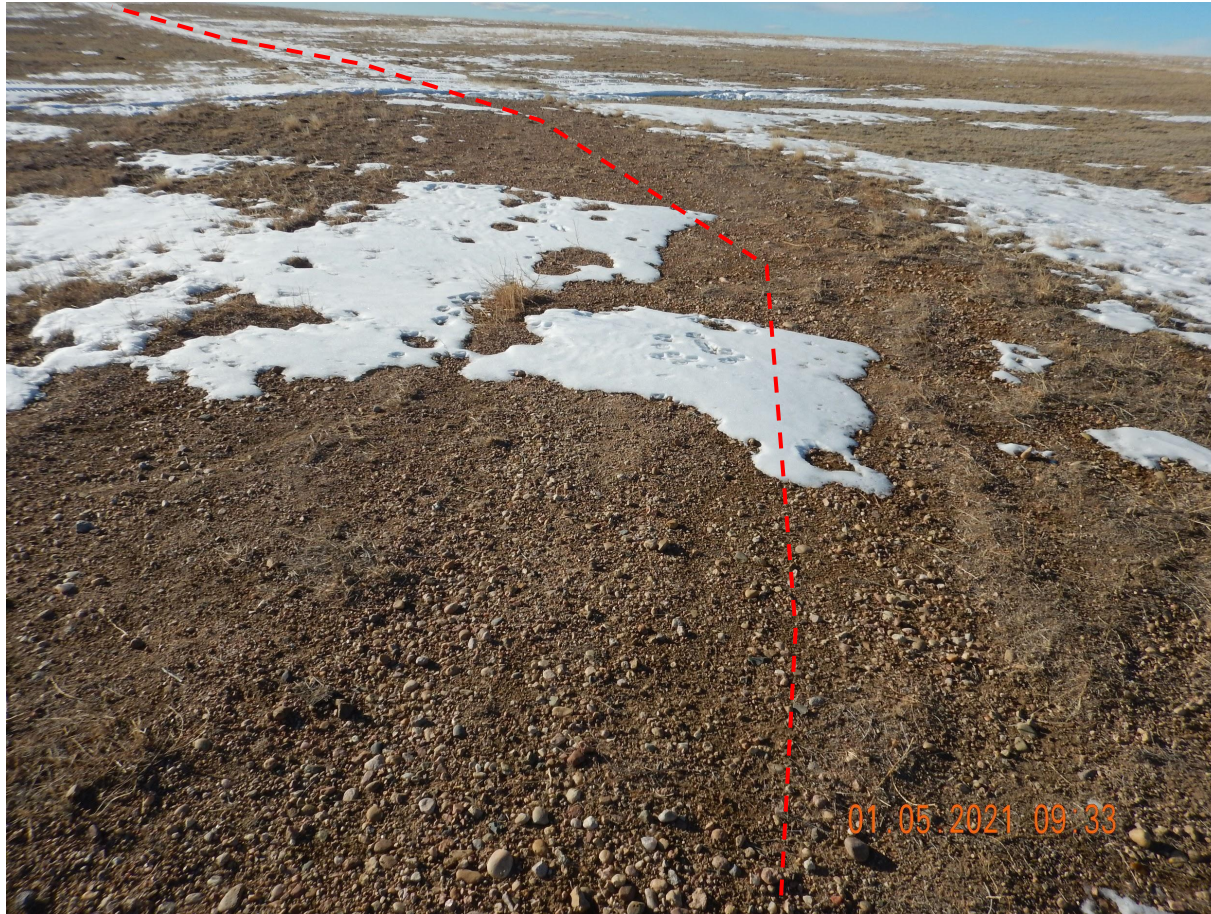
Photo 2. Photo taken from the northern access road, facing West. Photo illustrates the Operator has failed to remove gravel and perform final reclamation activities.

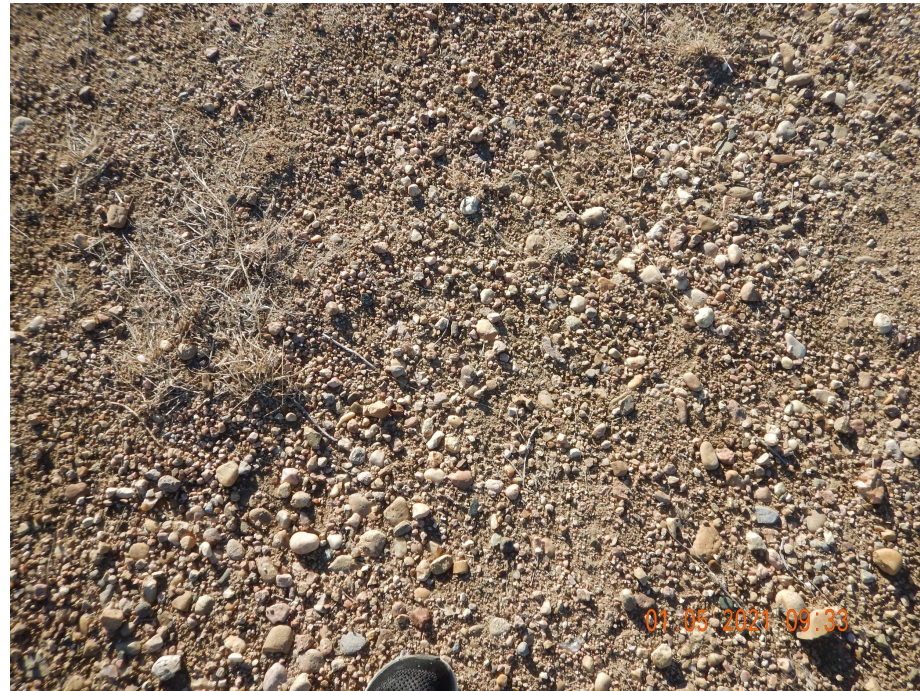
Photo 3. Close up photo taken from the northern access road. Photo illustrates the Operator has failed to remove gravel and perform final reclamation activities.

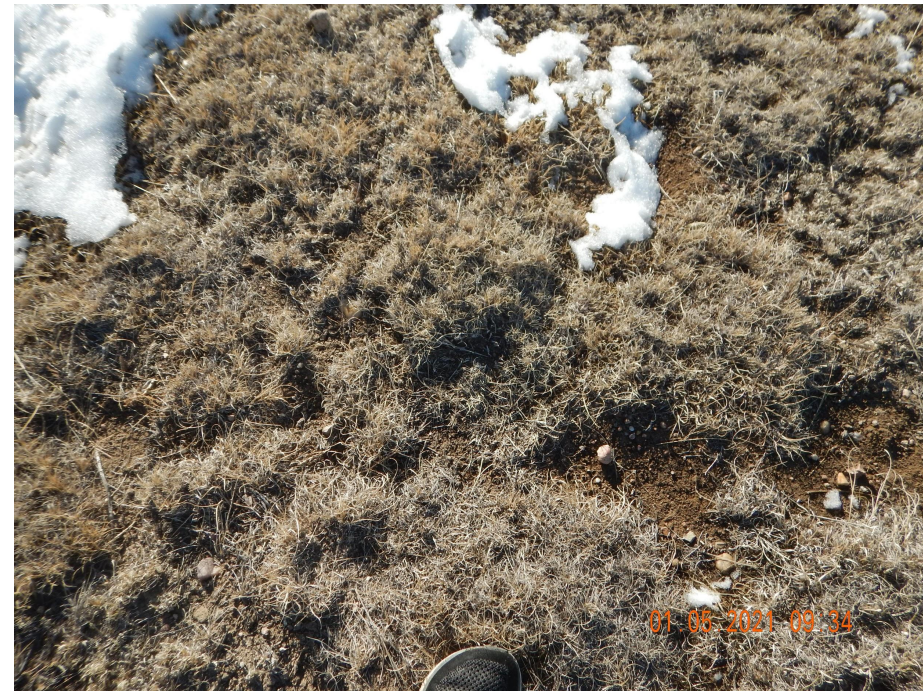
Photo 4. Close up reference photo taken west of the access road, illustrating the failure to remove gravel and perform final reclamation activities.

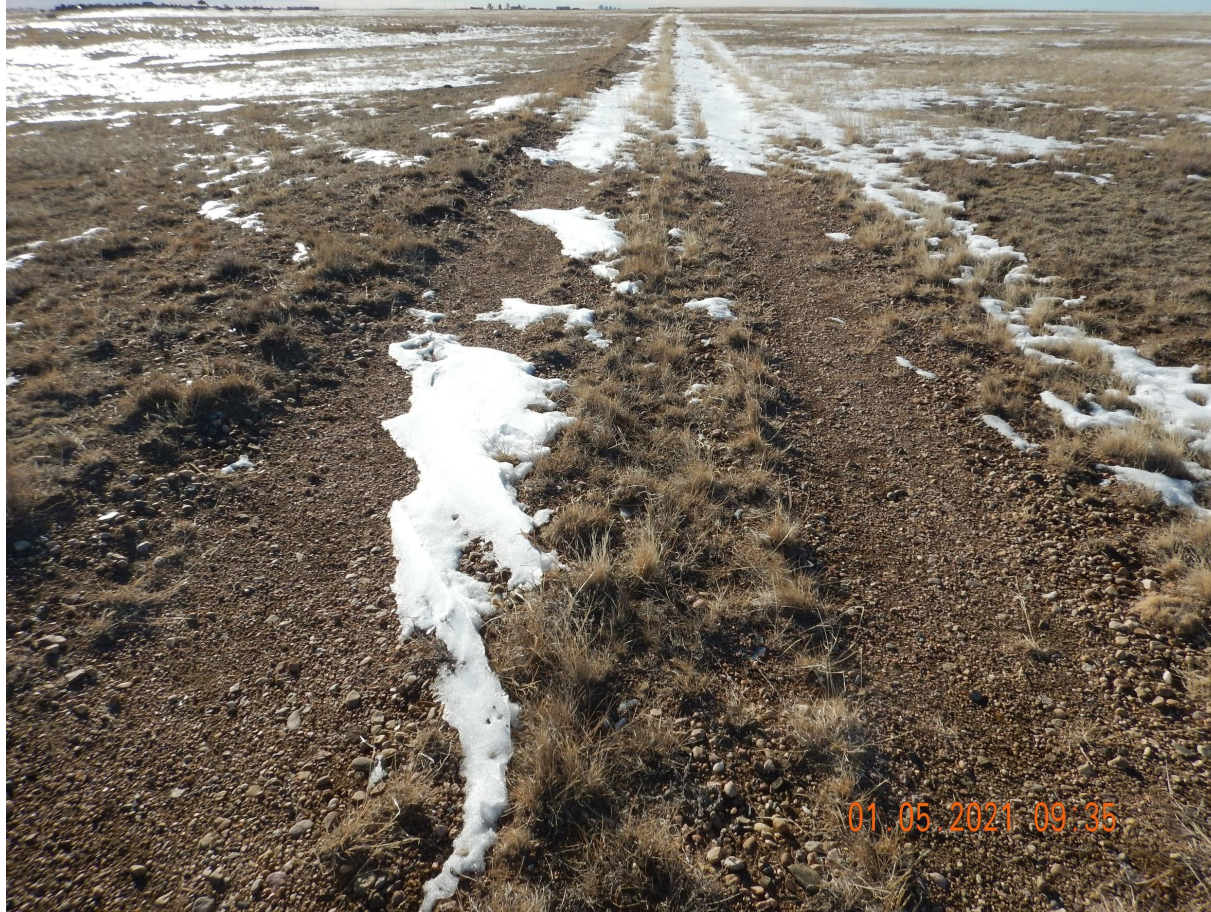
Photo 5. Photo taken from a portion of the access road, facing South. See comments under Photo 1 and 2.

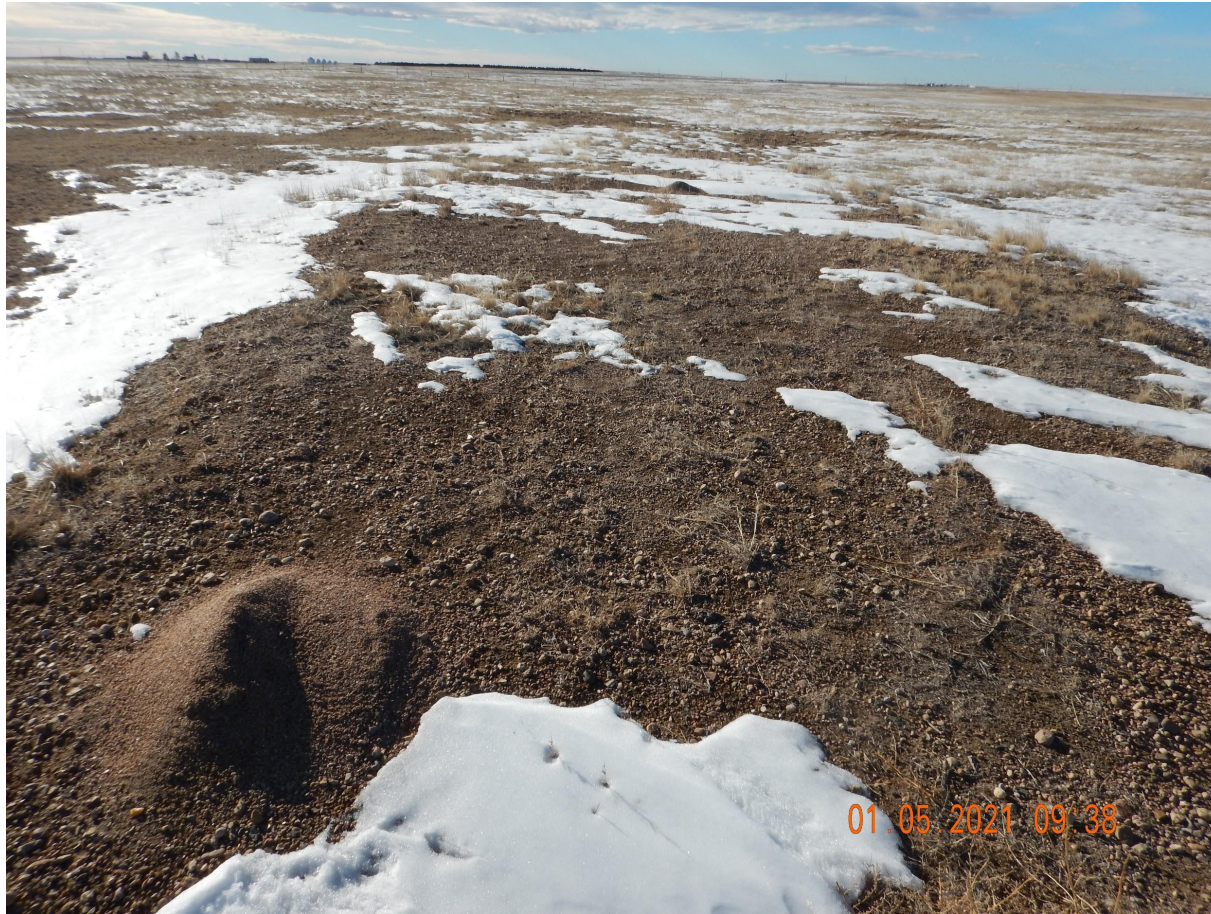
Photo 6. Photo taken from the DA location, facing South. Photo illustrates a mound of gravel which has not been removed and reclaimed.
