Inspection Photos
Operator: Epic Energy
API: 067-05404
Date: 1/6/2021

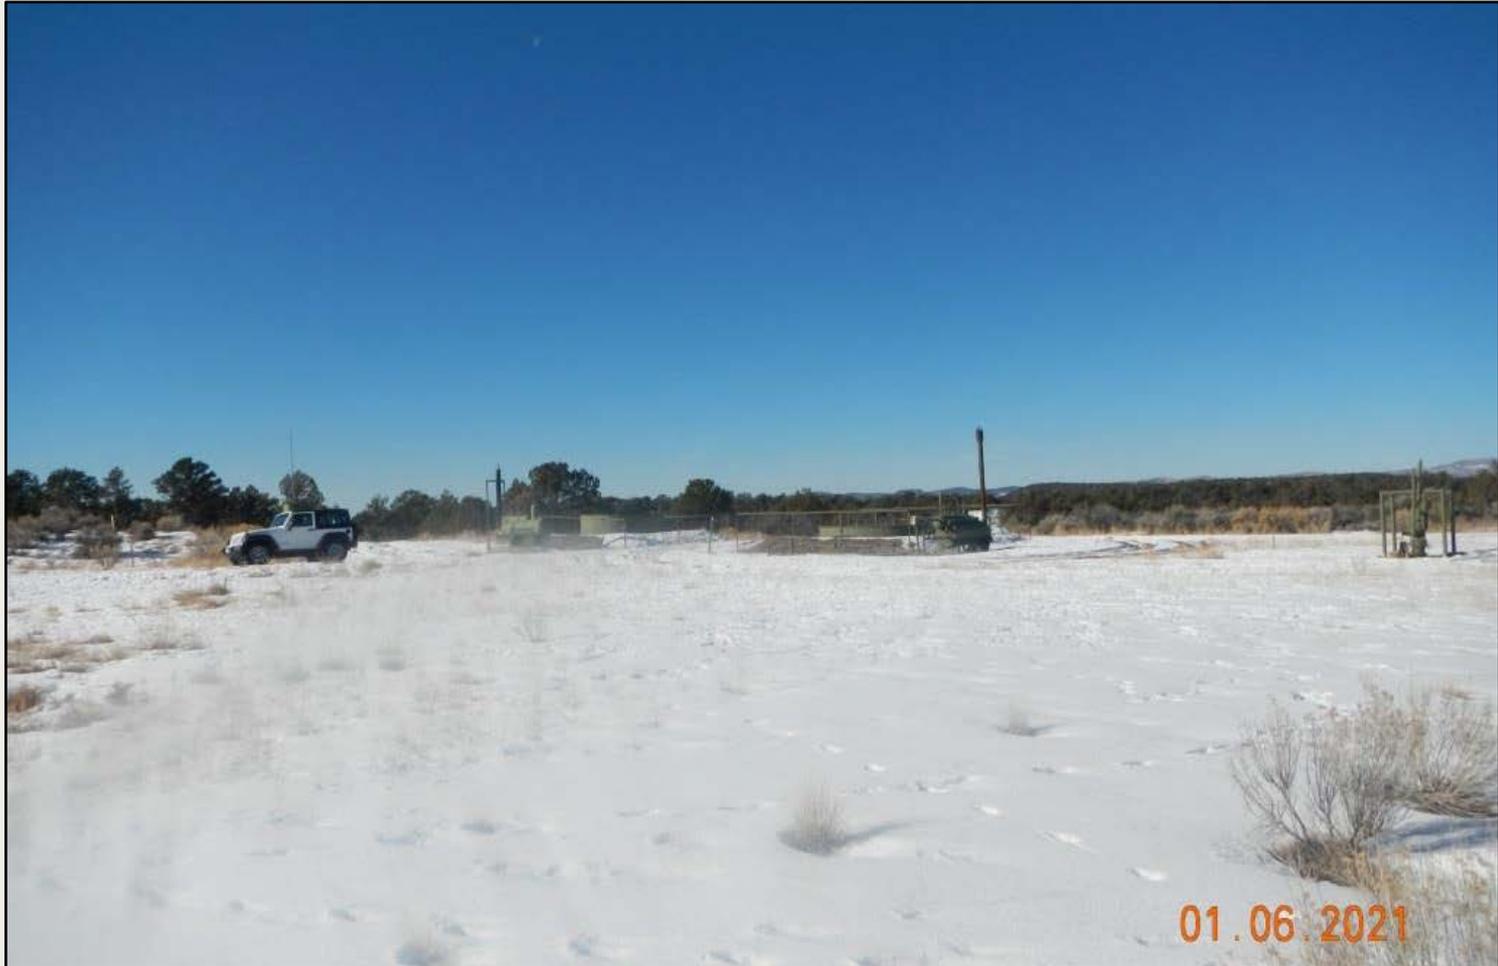
Photo 1. View of the project area from the southeastern corner facing center.

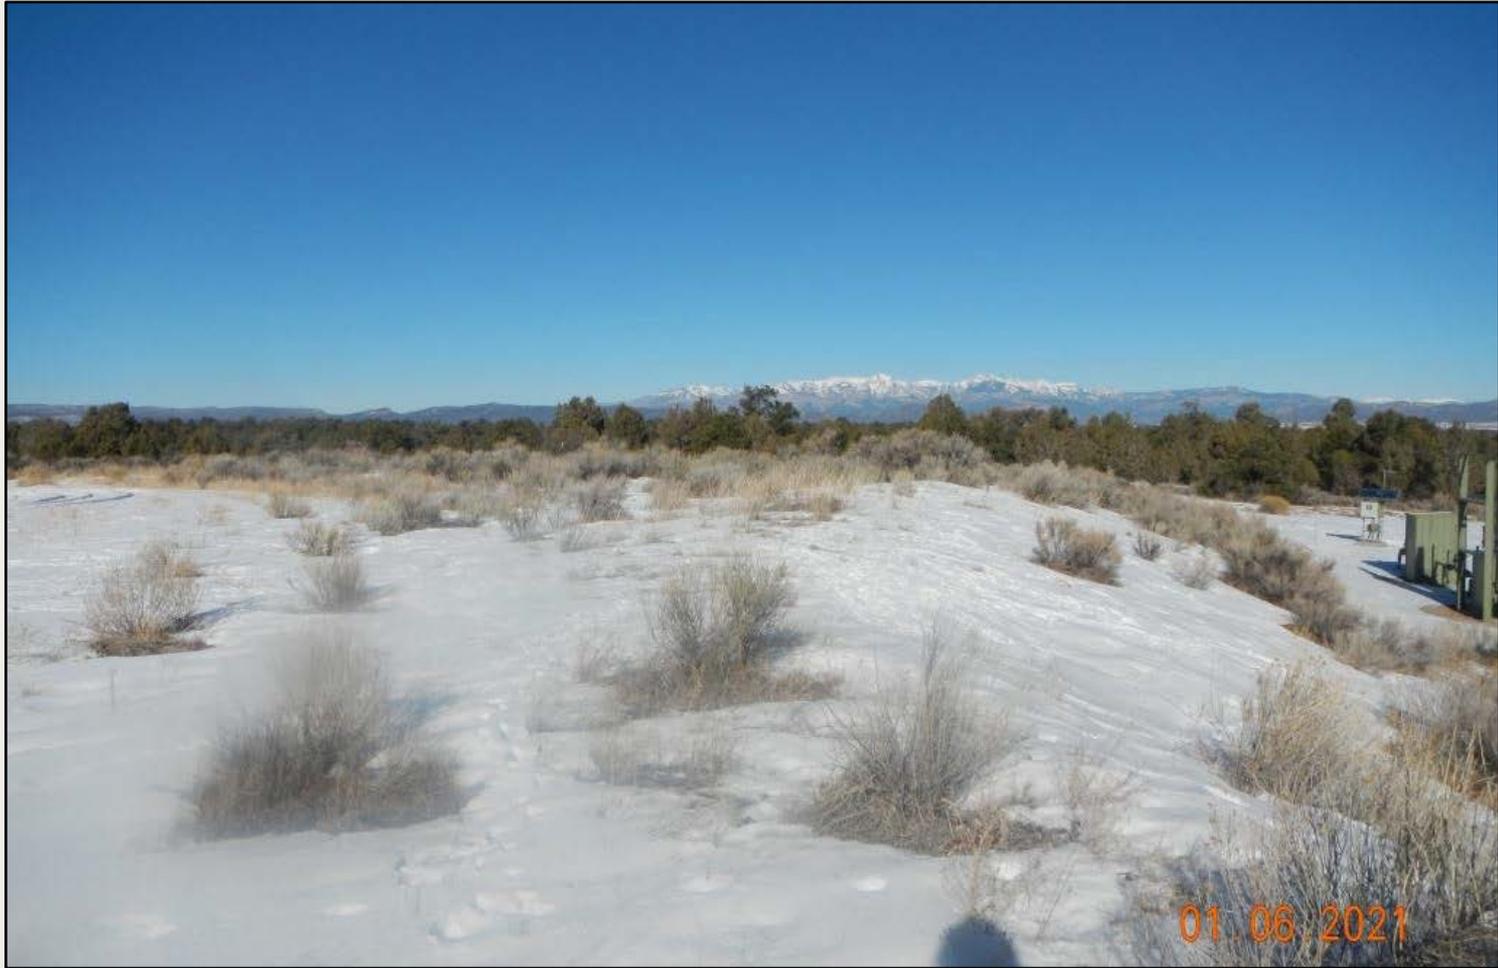
Photo 2. View of the eastern fill slope from the southeastern edge facing northward. Revegetation is progressing with shrubs and grasses such as rubber rabbitbrush, western wheatgrass, smooth brome, and crested wheatgrass.

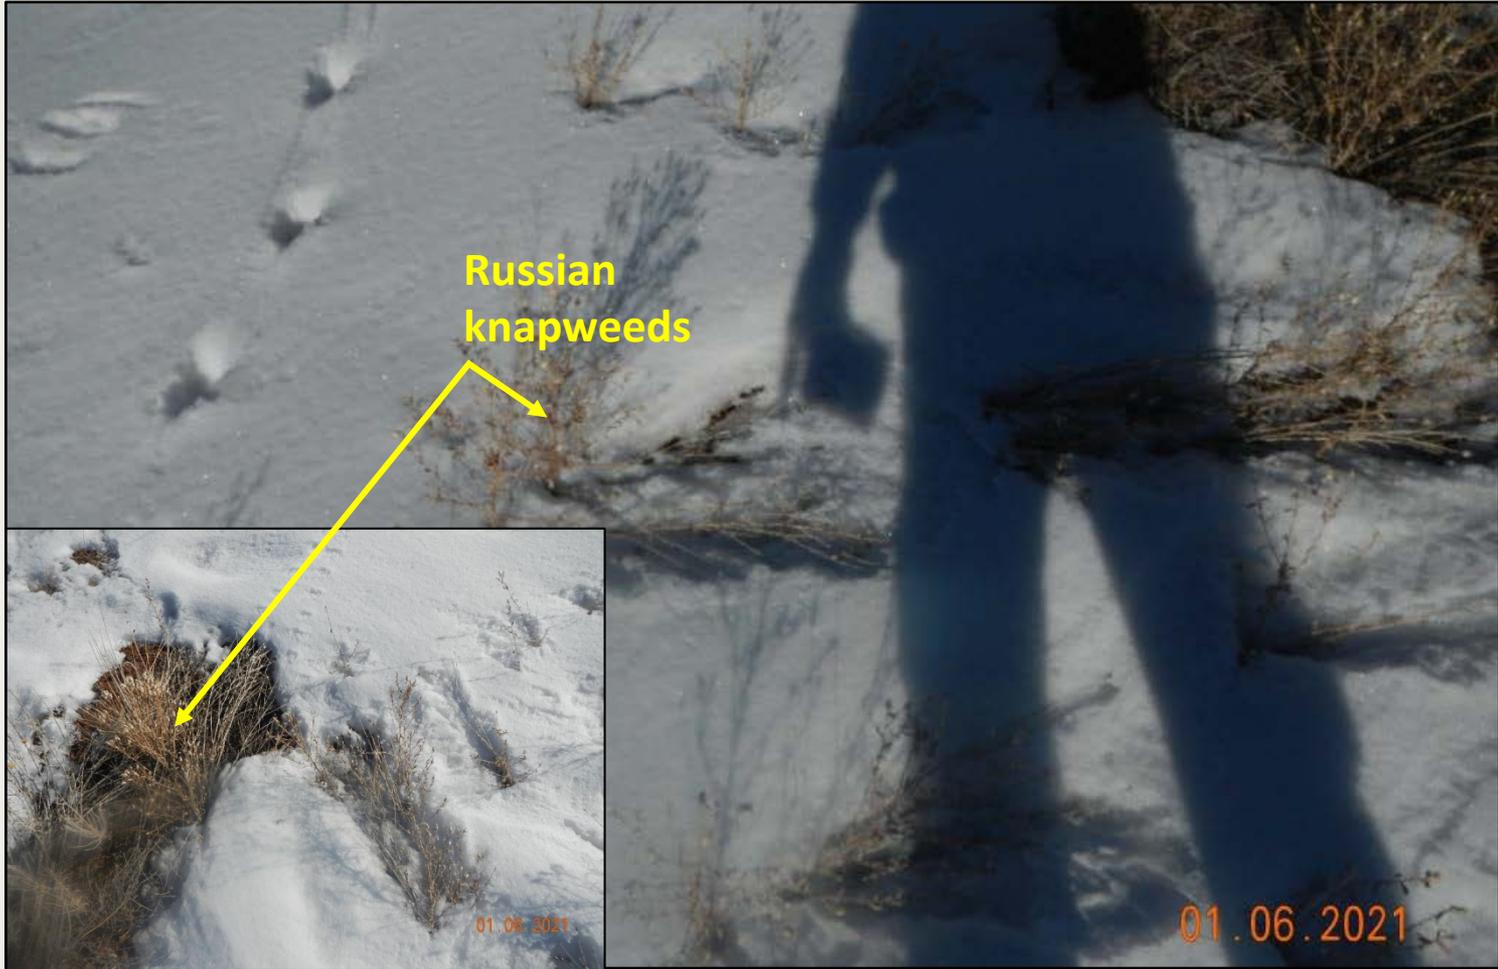
Photo 3. View of Russian knapweeds within the eastern project area. Approximately 300 dormant individuals observed.
