Inspection Photos

1/04/2021

Operator: TEP ROCKY MOUNTAIN LLC - 96850

Location ID: 324155

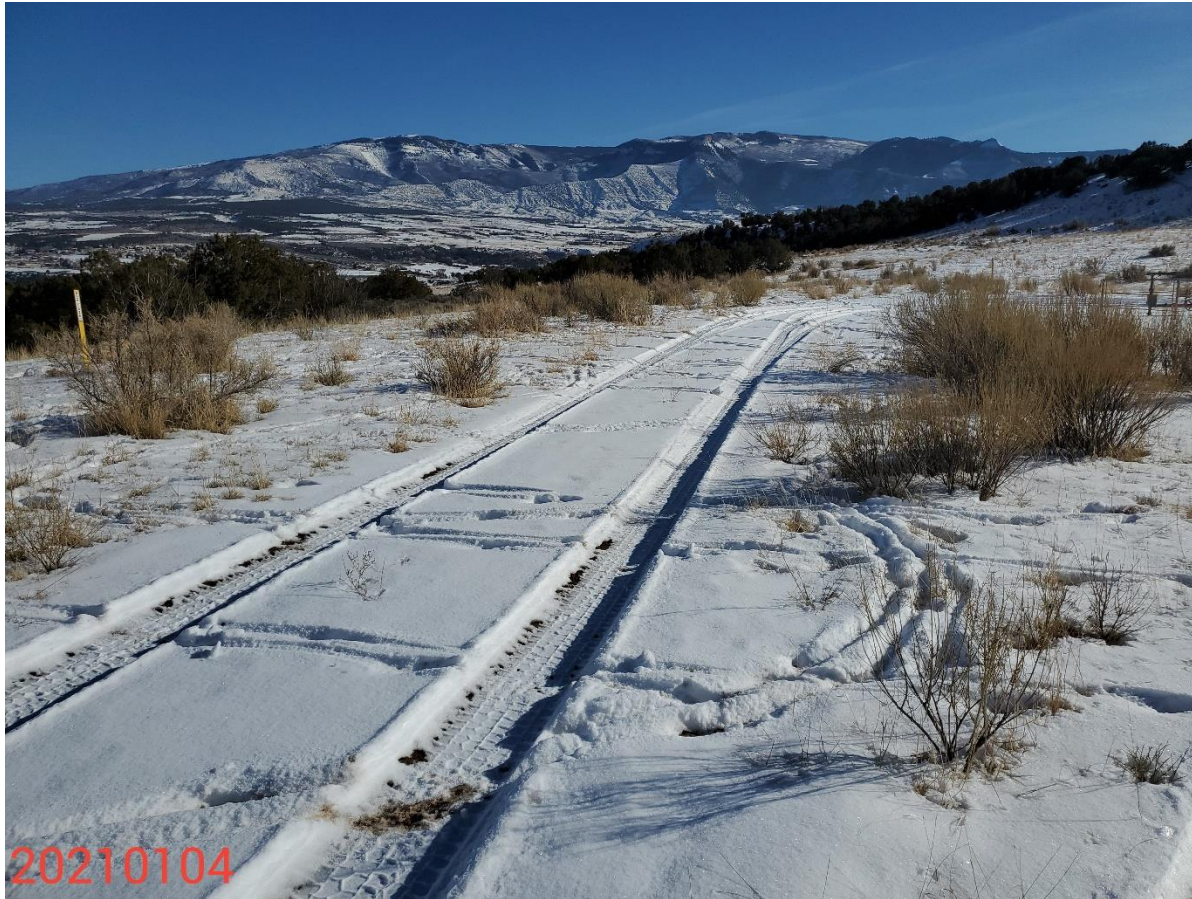
Photo 1: Photo taken from the north end of the Location, facing southeast. Photos 1-2 provide an overview of the Location.

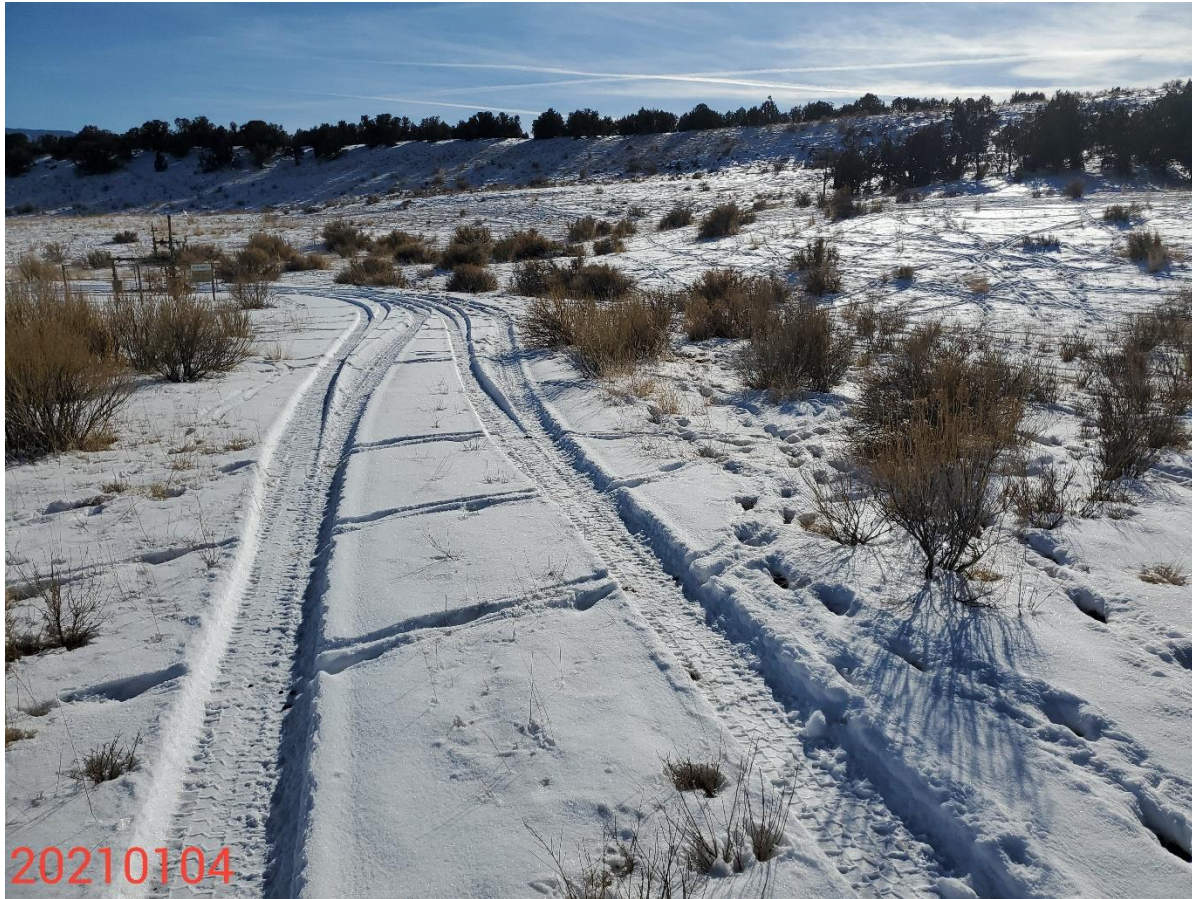
Photo 2: Photo taken from the north end of the Location, facing southwest. Photos 1-2 provide an overview of the Location.

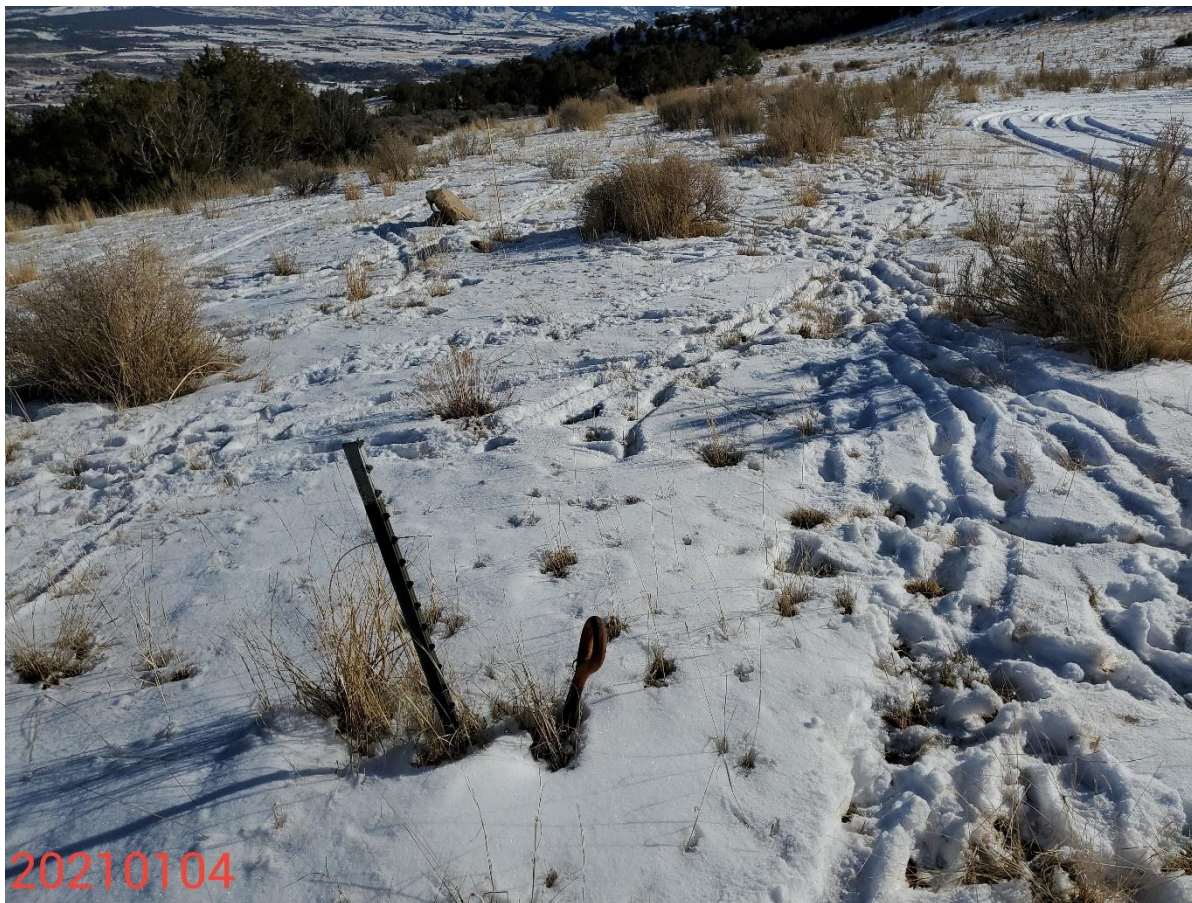
Photo 3: Photo taken from the east end of the Location, facing south. Photo shows example of marked anchors observed on the Location. Marker is not bright in color and at least 4 feet in height pursuant to Rule 1003.a

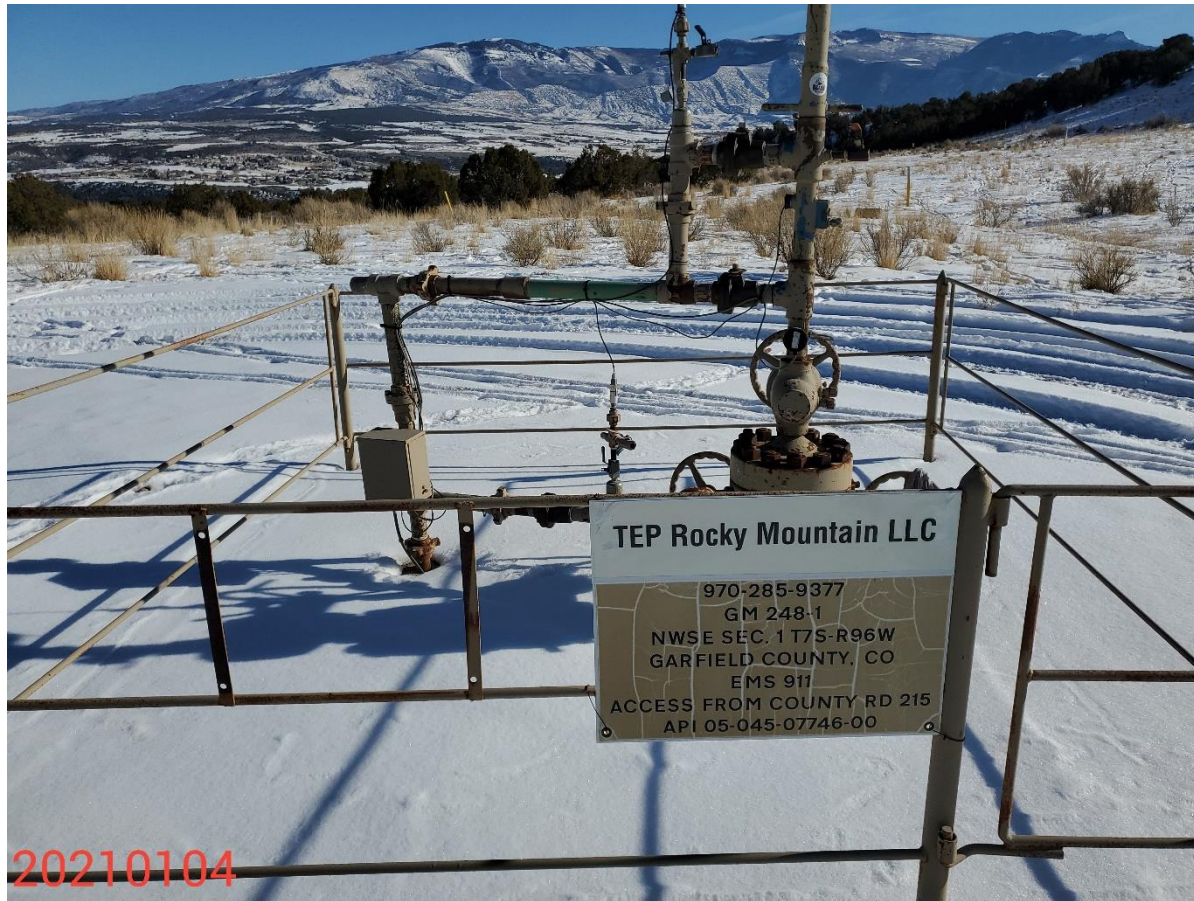
Photo 4: Photo of well.

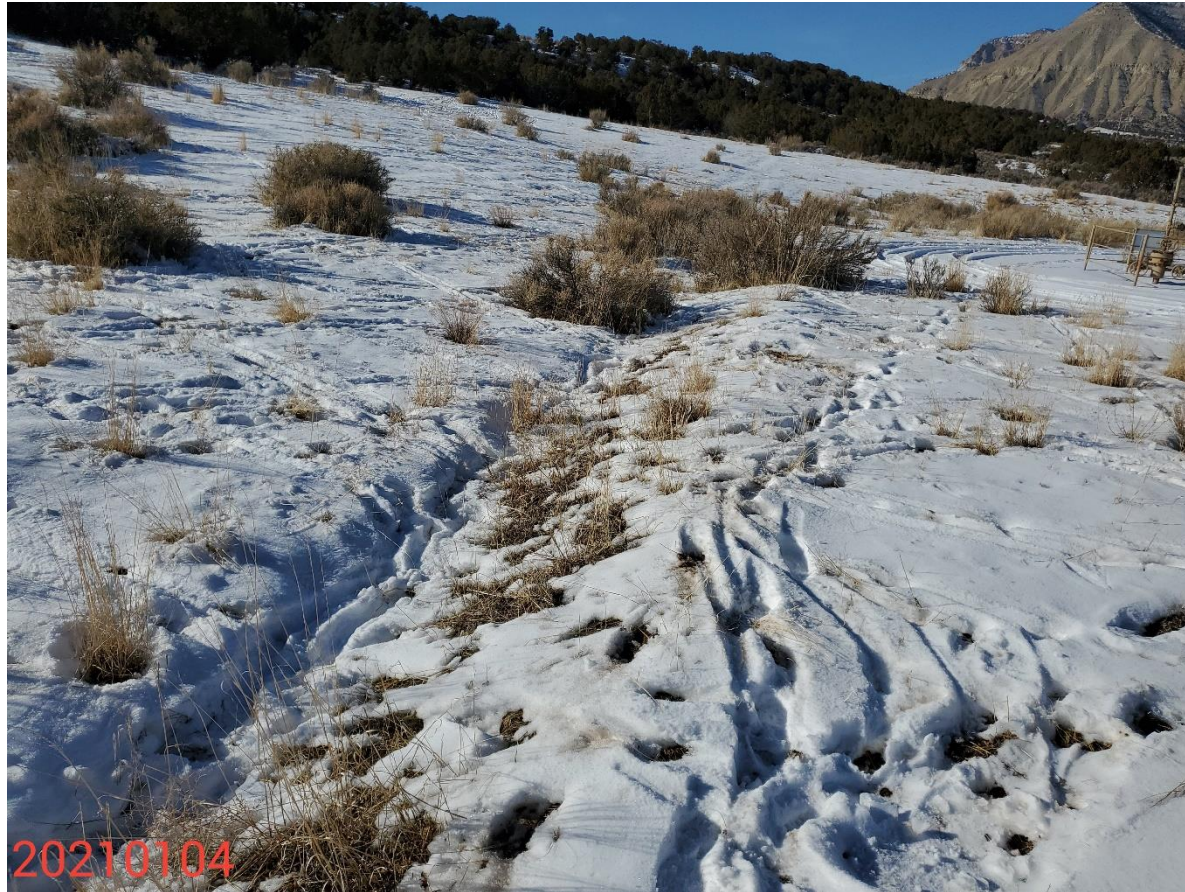
Photo 5: Photo taken from the west end of the Location, facing north. Photo shows perimeter stormwater ditch

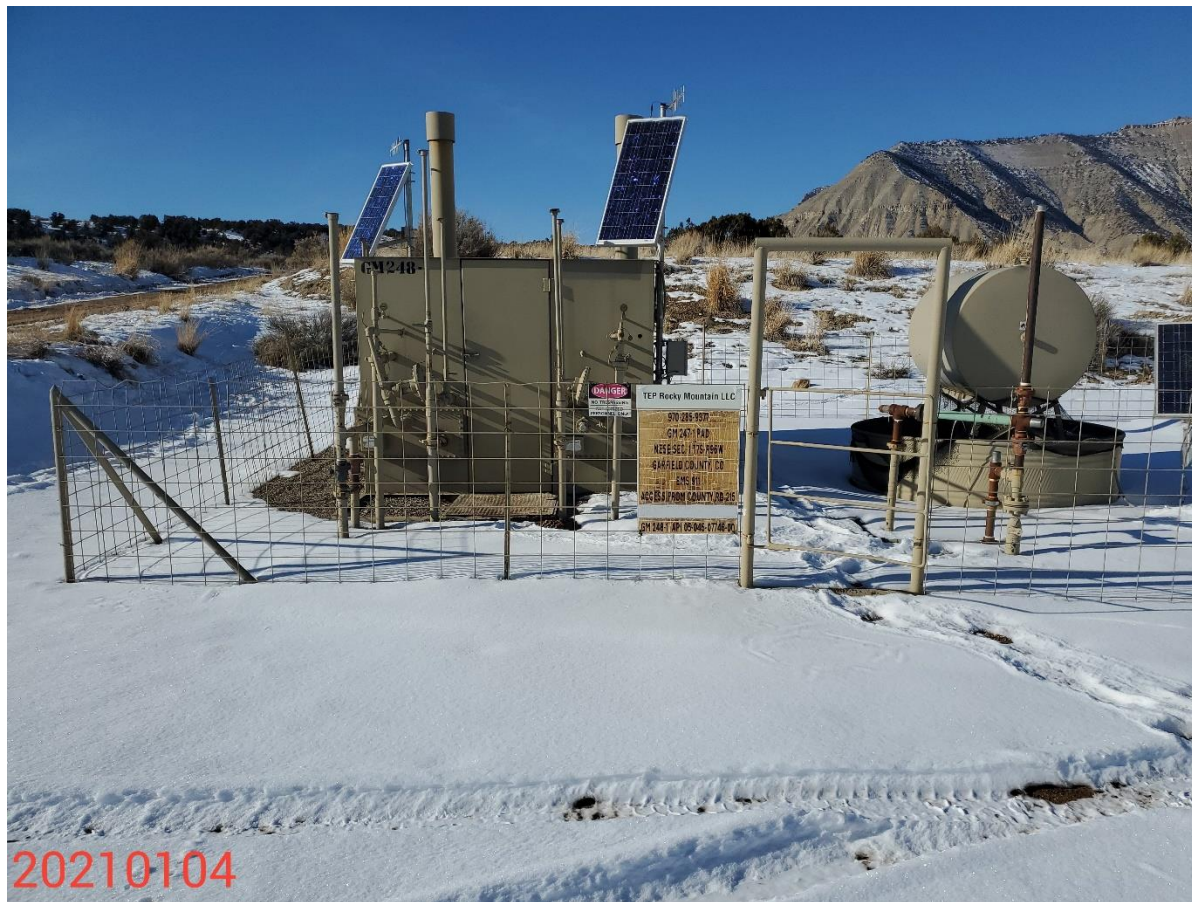
Photo 6: Photo taken from the north end of the 247-1 Location, facing north. Photo shows remote tank battery facility; Separator equipment and Methanol tank.

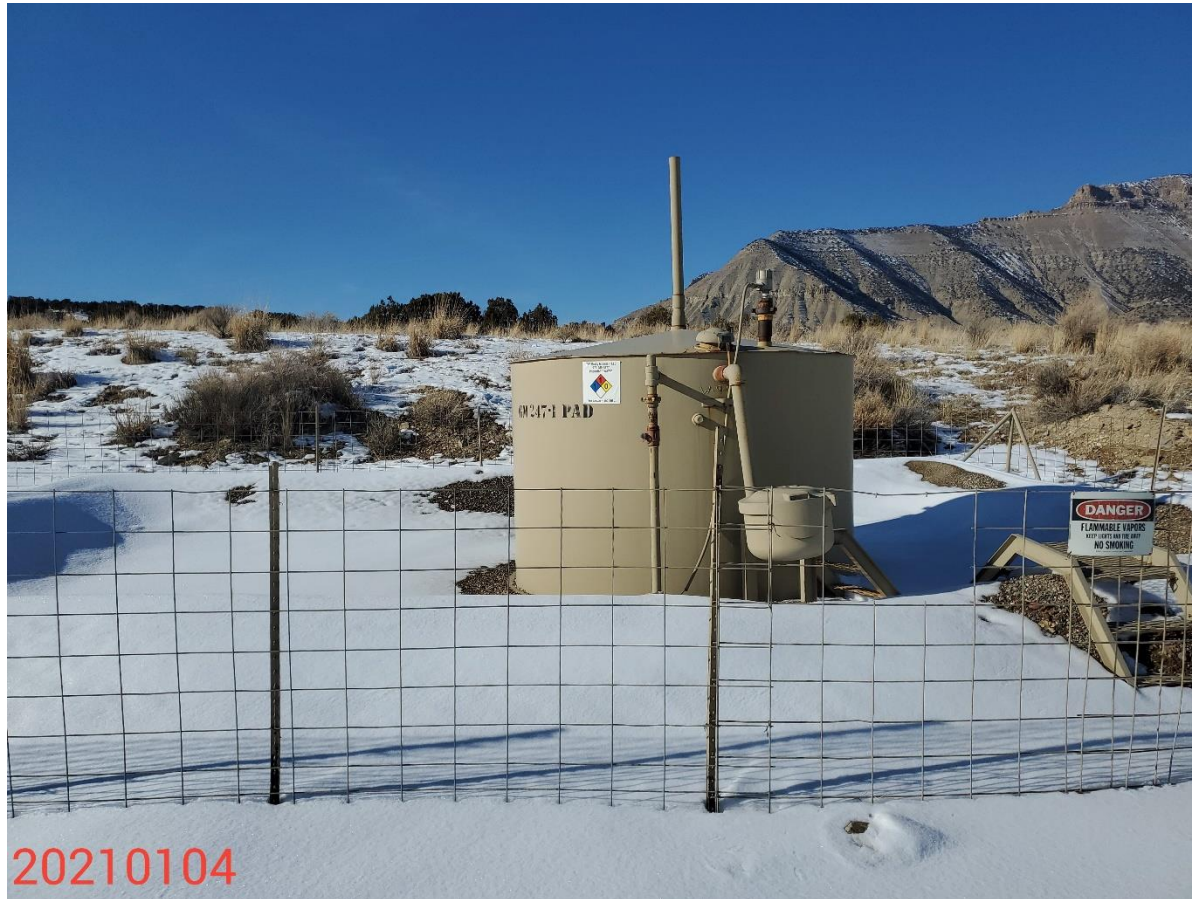
Photo 7: Photo taken from the north end of the 247-1 Location, facing north. Photo shows remote tank battery facility; 80 bbl Produced Water Tank
