Final Reclamation Inspection

Operator: NOBLE ENERGY INC - #100322

Location ID: 422552

Location Name: KUMMER PC LE #23-17

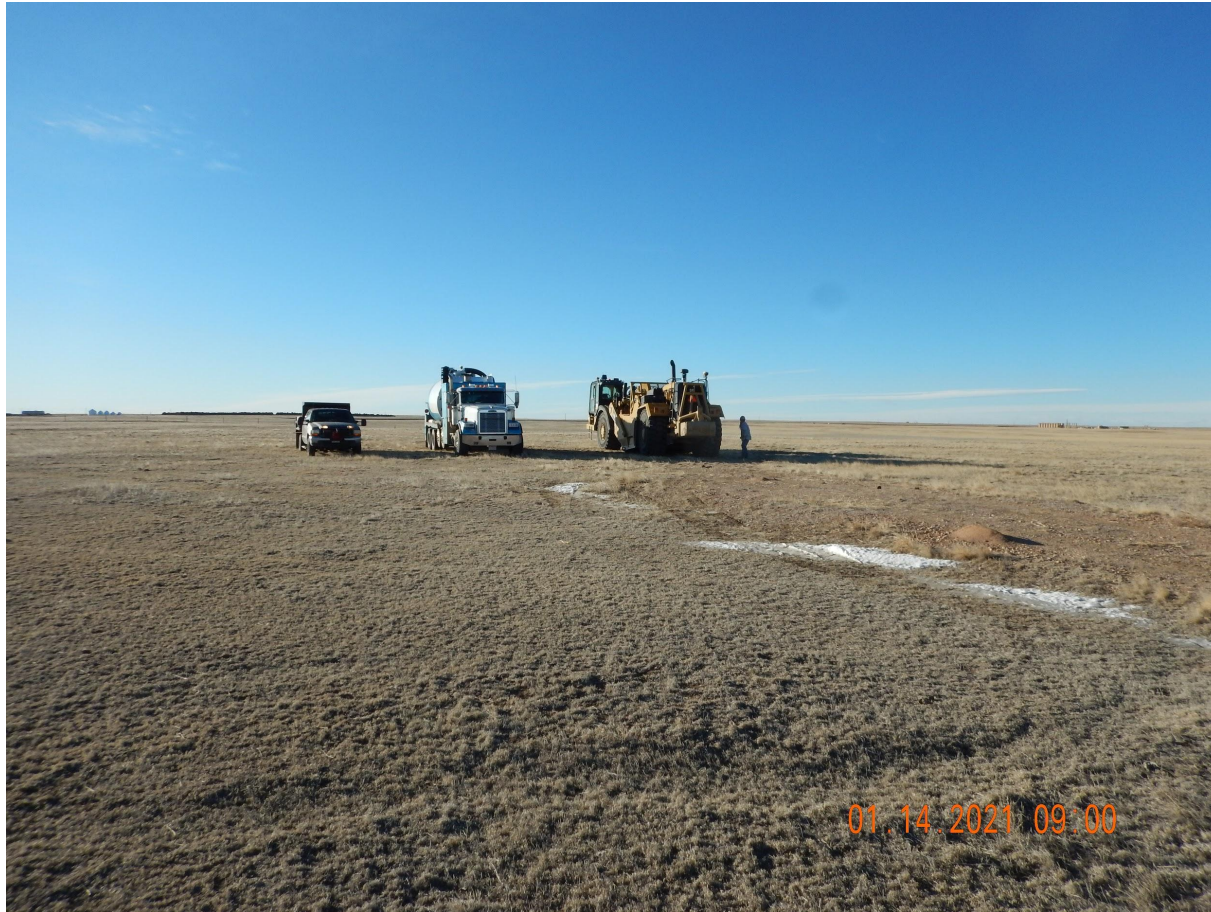
Photo 1. Photo taken from the southern access road, facing South. Photo illustrates Operator field crew commencing final reclamation activities.

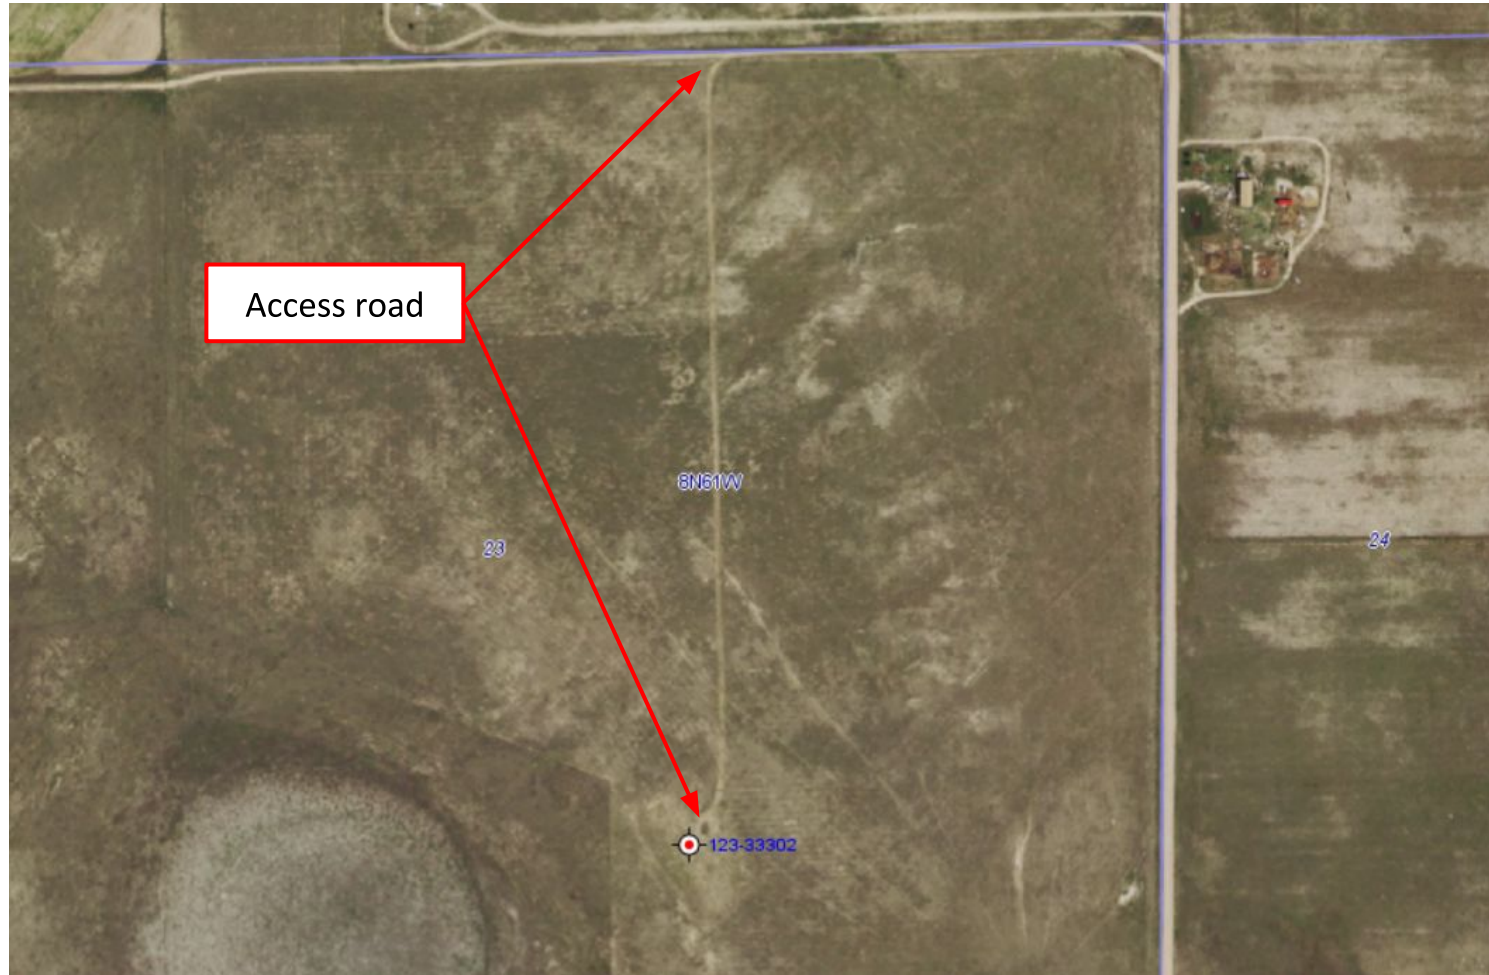
Photo 2. COGCC GISOnline aerial imagery from 2019 illustrates the access road which has not been reclaimed per Rule 1004. On 1/14/2021, Operator was commencing final reclamation activities to reclaim the above access road.

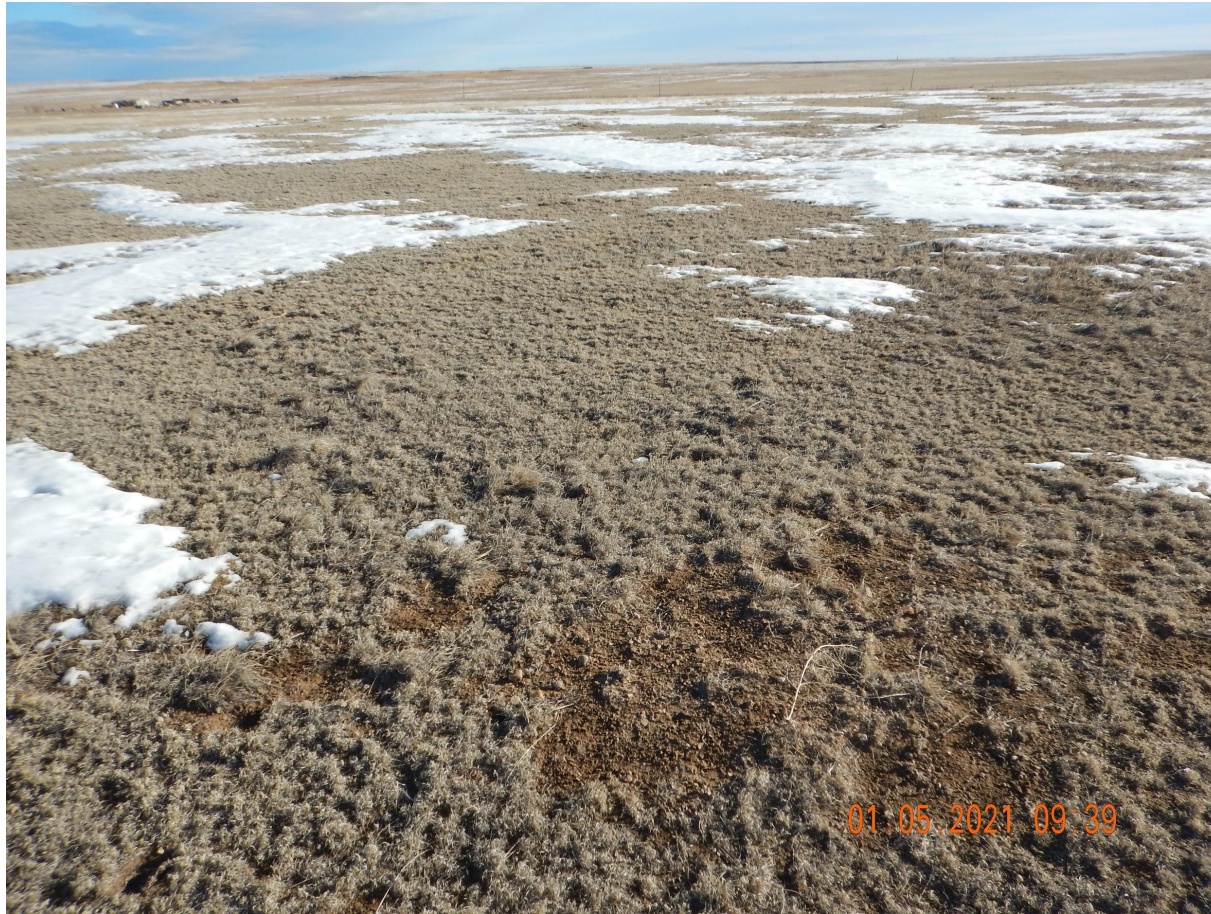
Photo 3. Reference photo taken on 1/5/2021 east of the DA location, facing East. Photo illustrates the reference vegetation is mostly comprised of blue grama with some western wheatgrass, sand dropseed, and purple three-awn.
