Inspection Photos  
Operator: Simcoe  
API: 067-08720  
Date: 1/14/2021

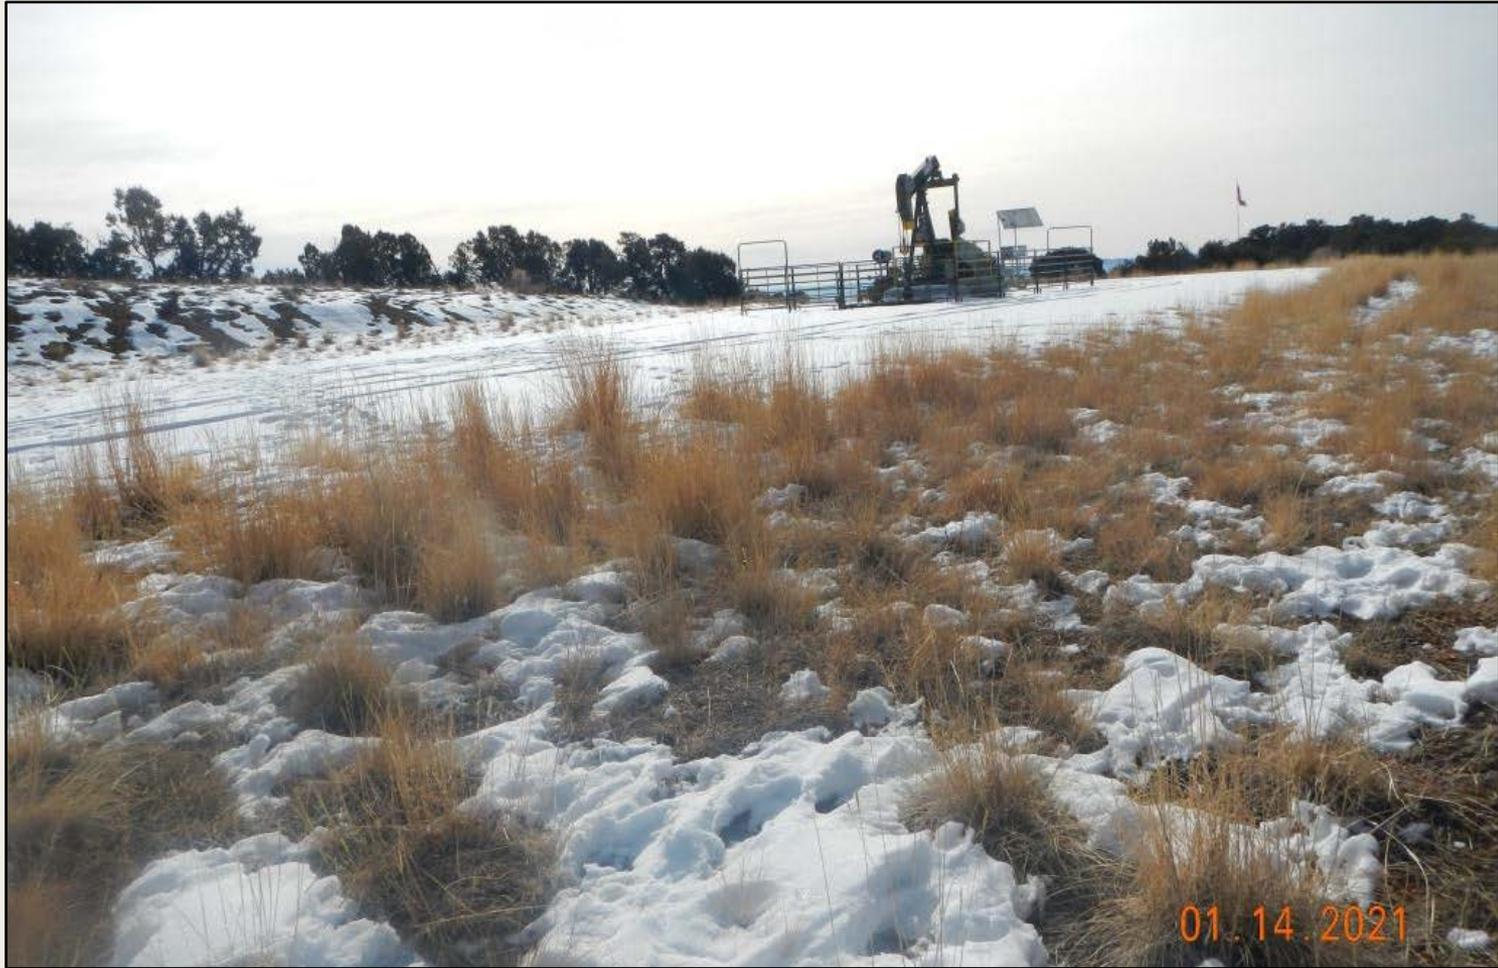
Photo 1. View of the project area from the northwestern corner facing center.

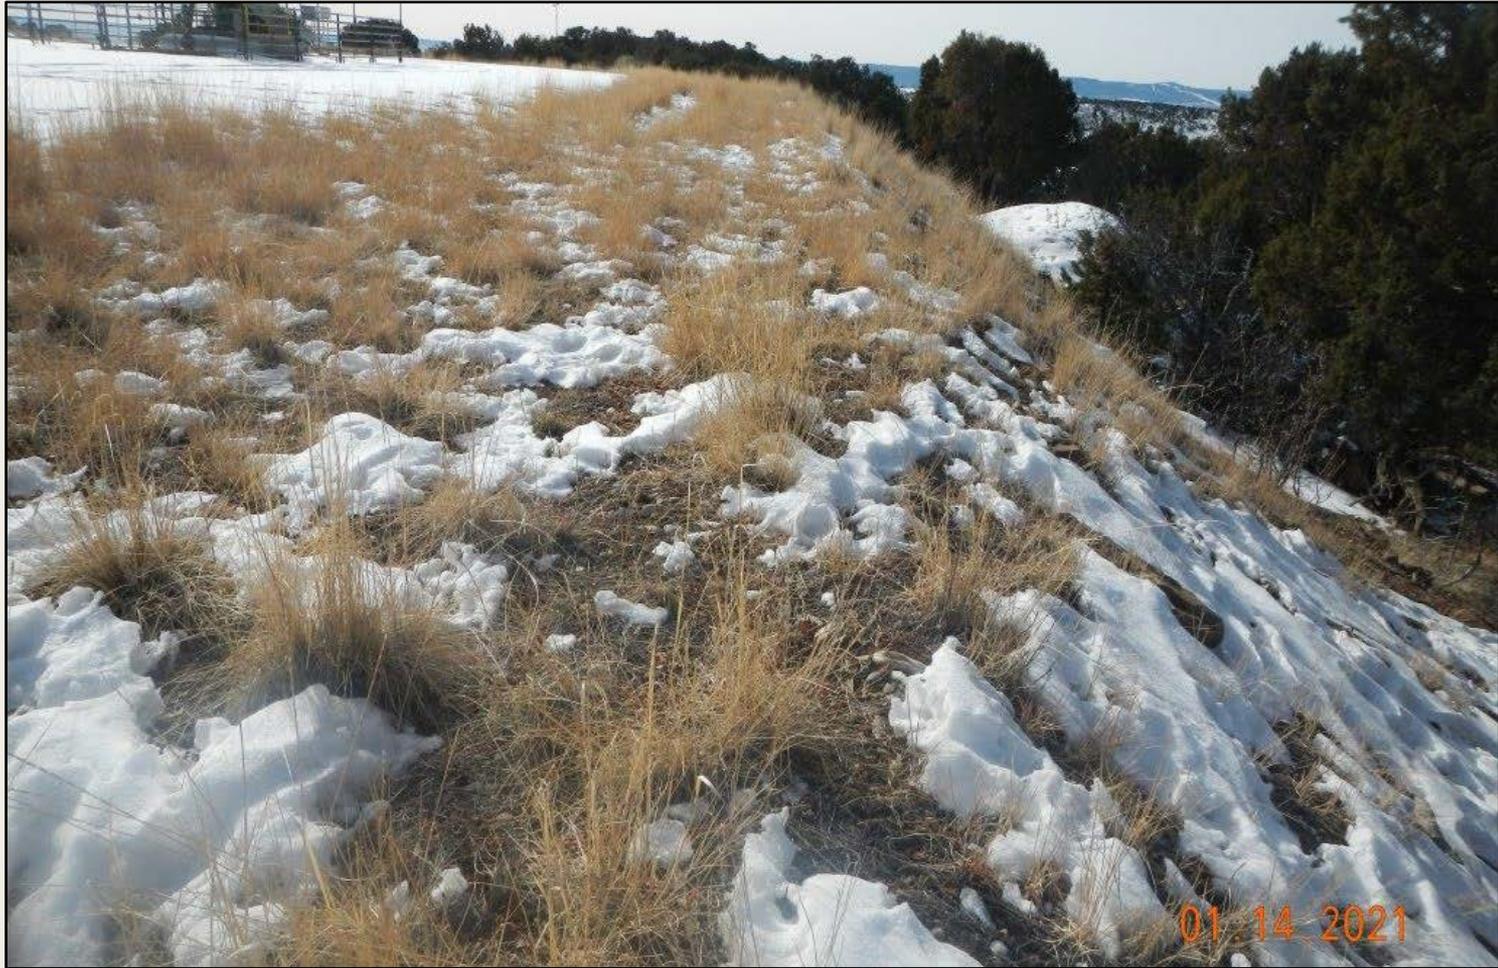
Photo 2. View of the western project area from the northwestern corner facing southward. Revetigation is progressing, largely with grasses such as sand dropseed, western wheatgrass, and smooth brome.

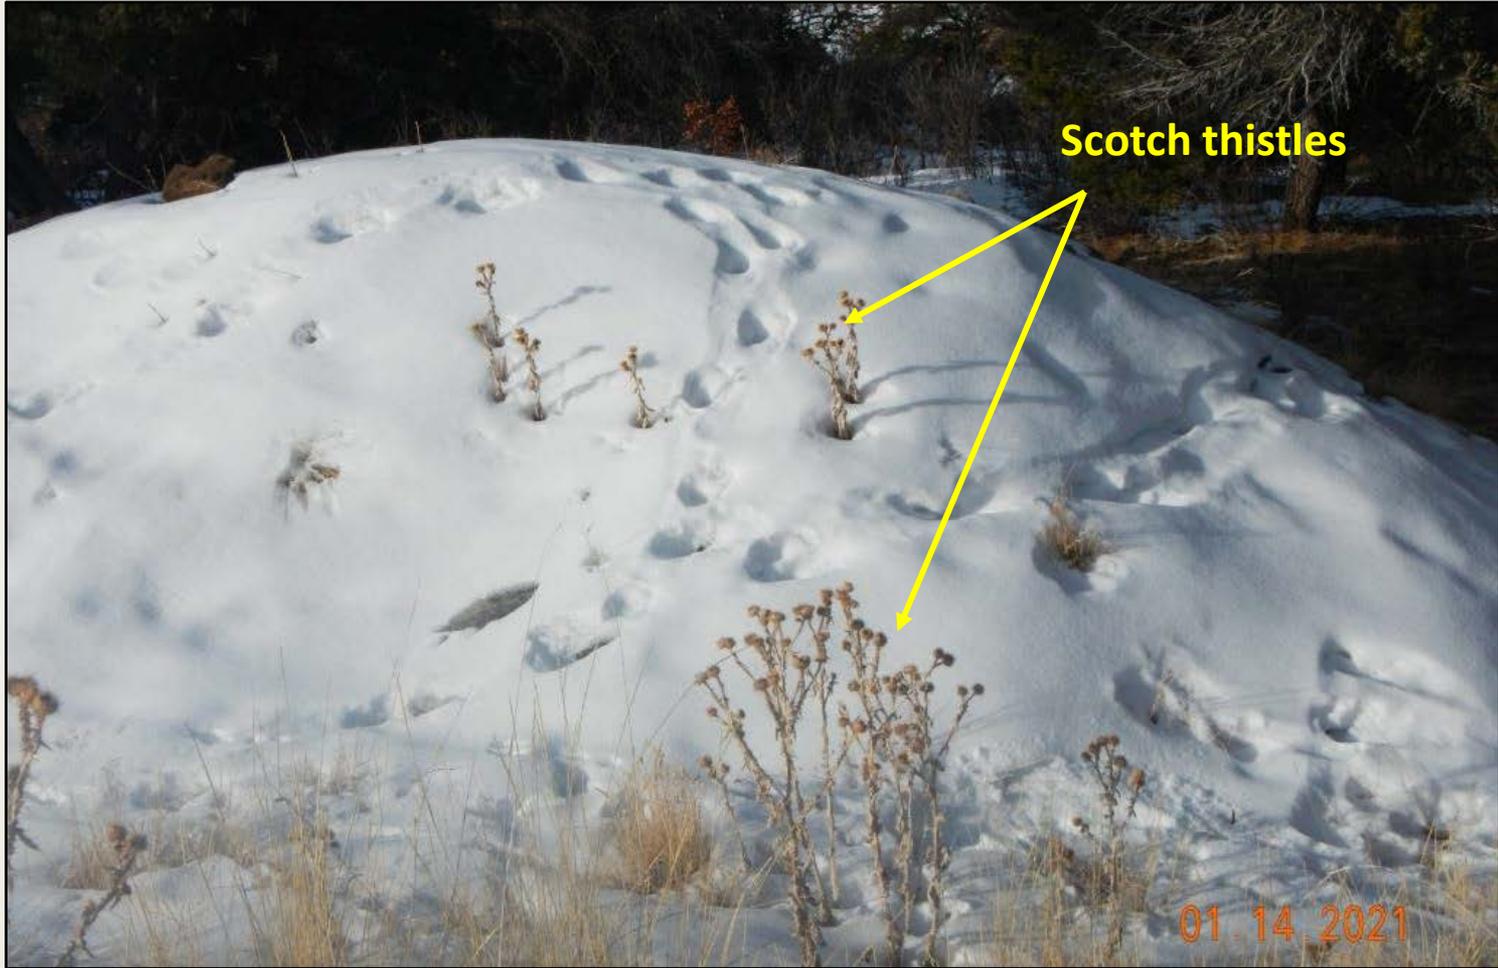
Photo 3. View of Scotch thistles within the project area. Approximately 100 individuals observed.

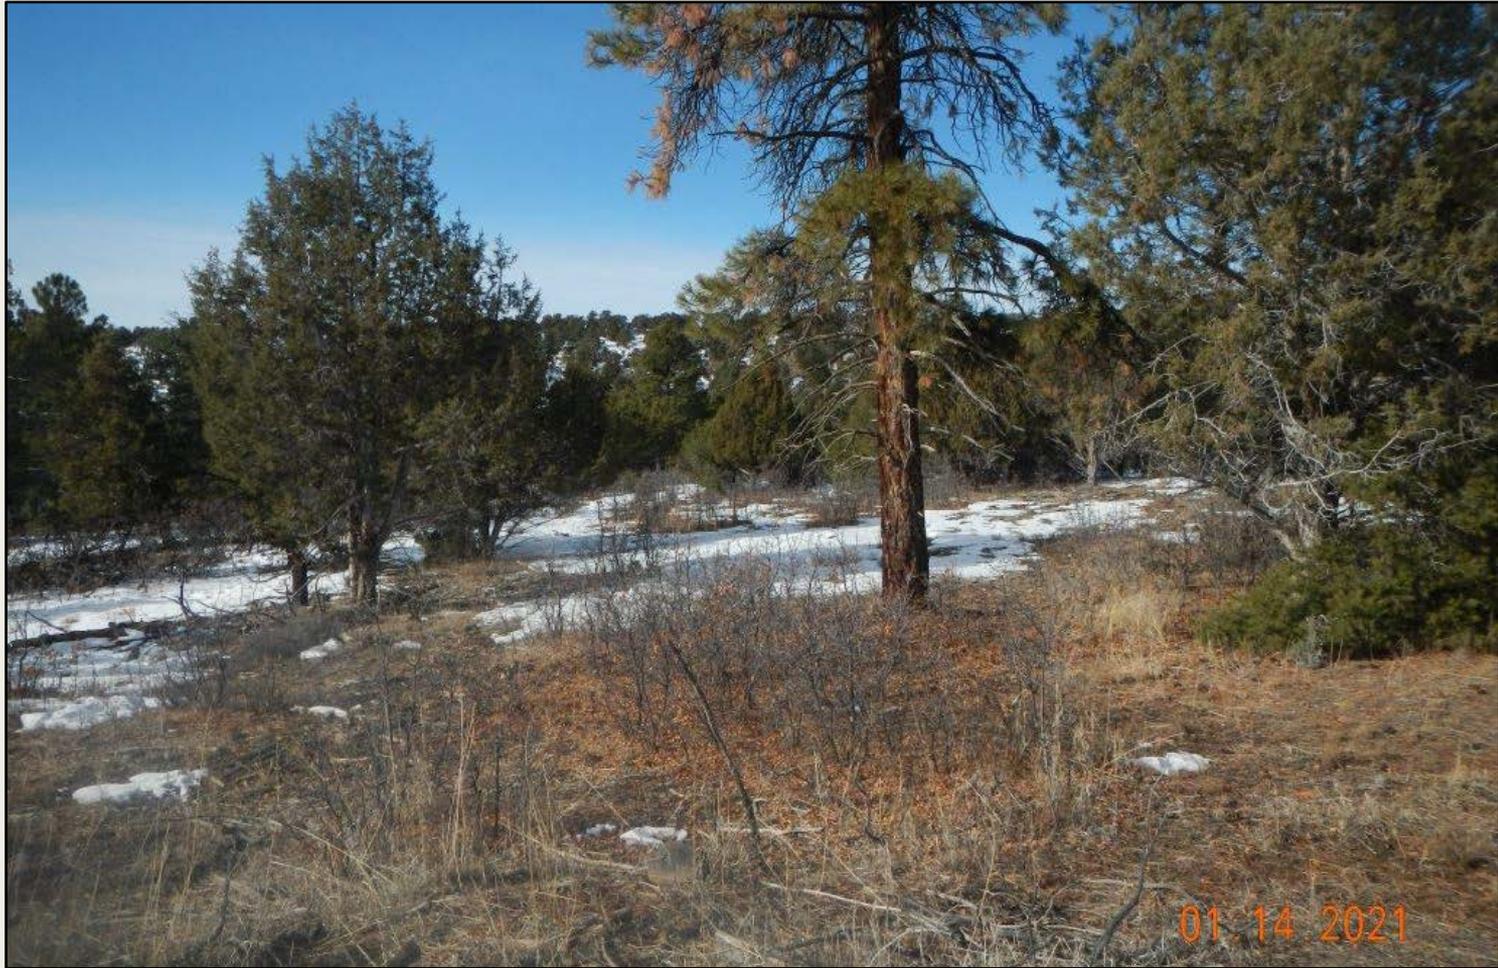
Photo 4. View of the reference area comprised of mixed ponderosa pine and pinyon/juniper woodland with gambel oak and mountain mahogany shrubs, and grasses/forbs such as squirreltail and Colorado rubberplant.
