Construction and Stormwater Inspection

Operator: BISON OIL & GAS II LLC - #10661

Location ID: 472549

Location Name: Big Mountain Viper 8-59 /16

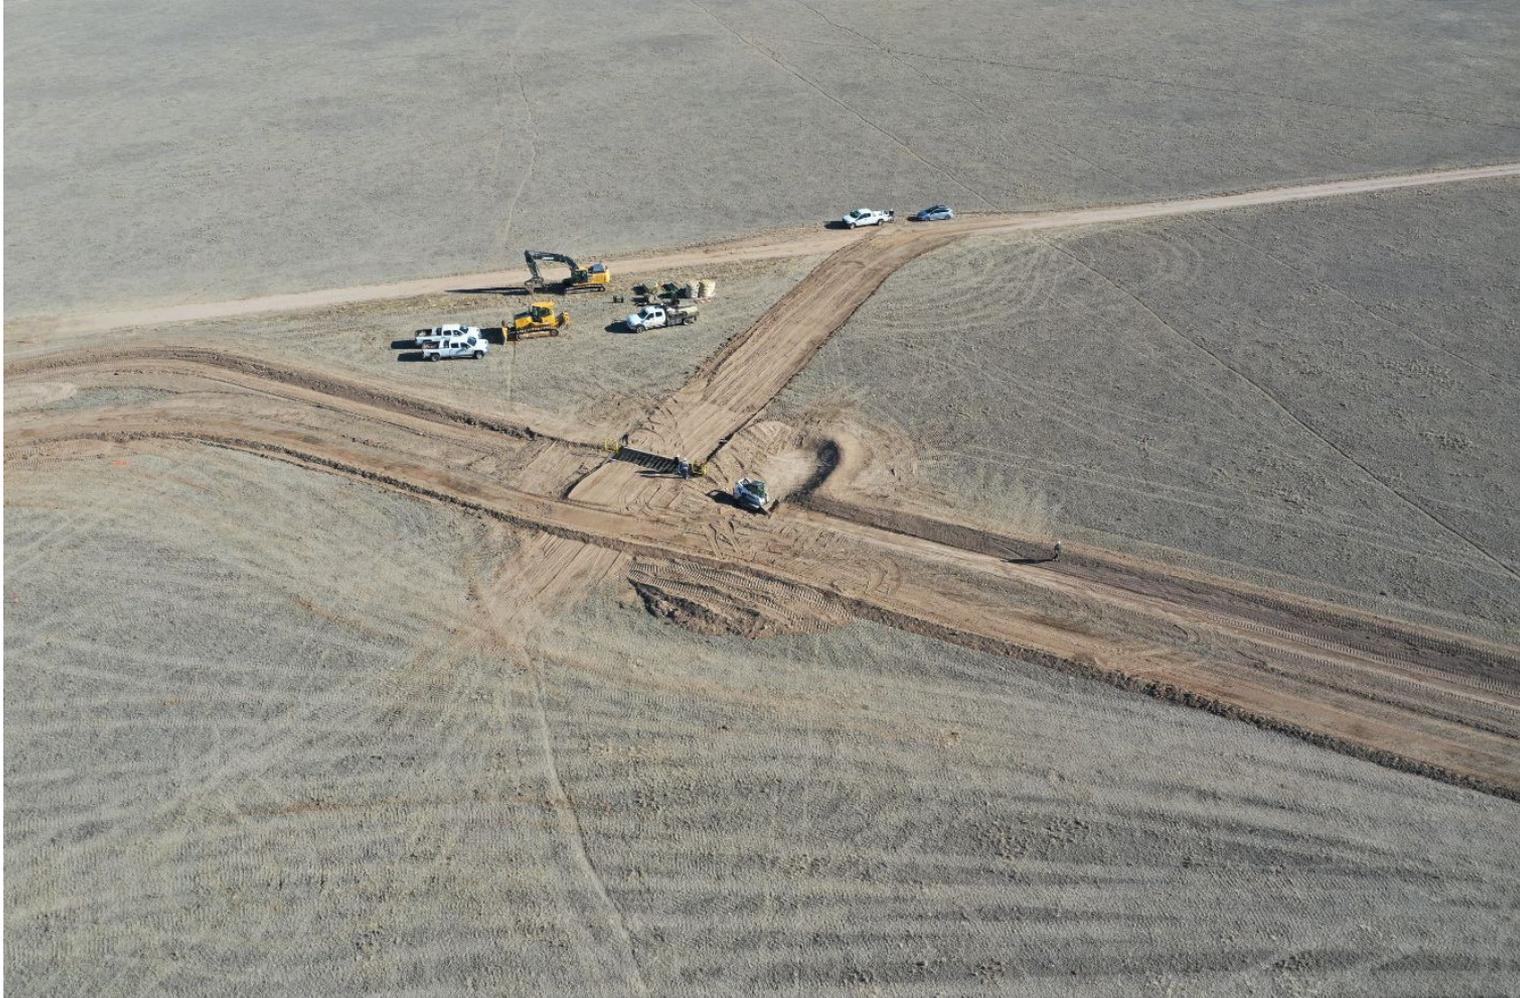
Photo 1. Drone aerial imagery illustrates the eastern location, facing East. Photo illustrates the new access road, ditch and berm BMP, and a sediment trap being completed.

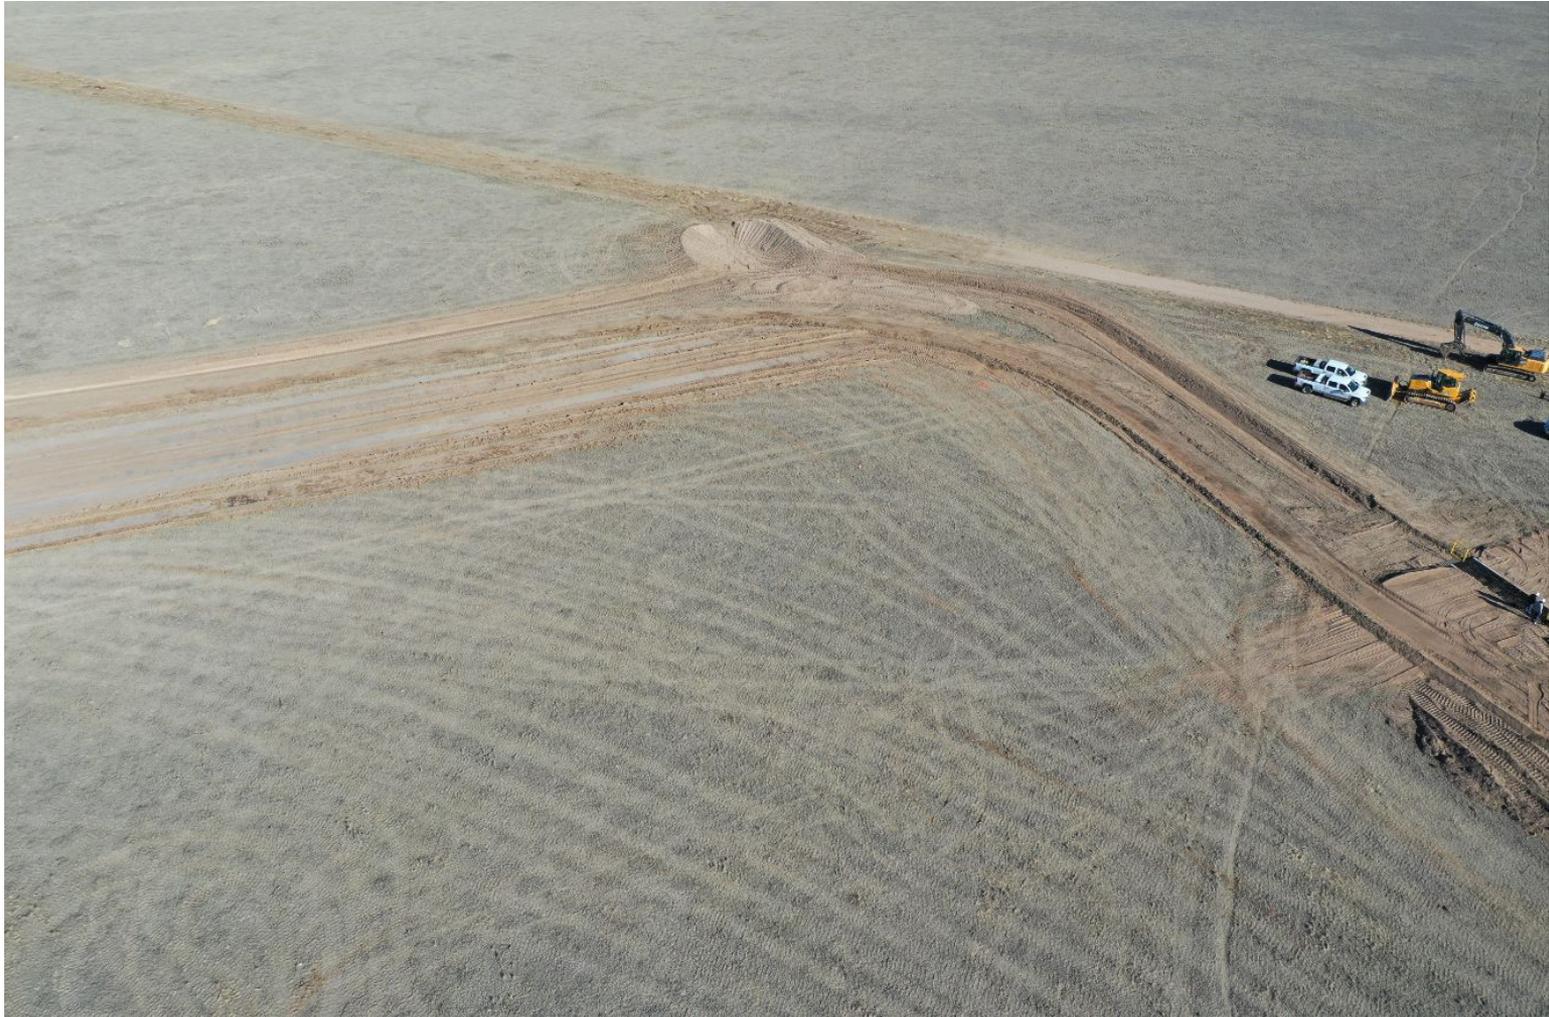
Photo 2. Drone aerial imagery illustrates the northeastern location, facing Northeast. Photo illustrates the ditch and berm BMP, and a sediment trap being completed.

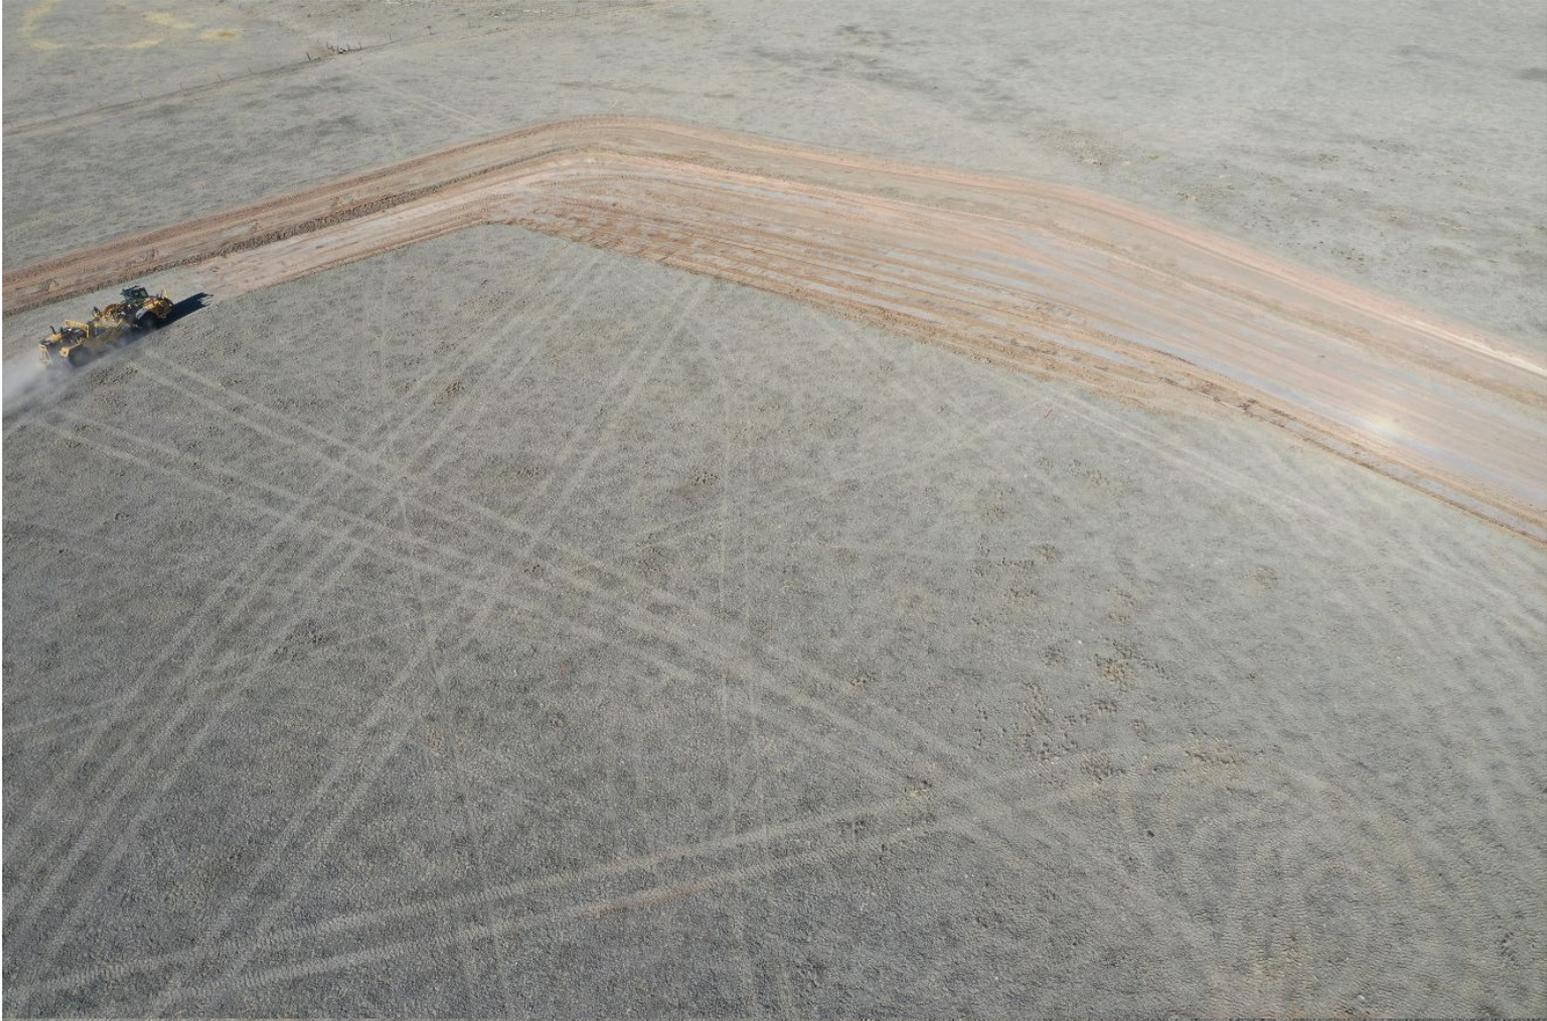
Photo 3. Drone aerial imagery illustrates the northwestern location, facing Northwest. See comments under Photo 1. Topsoil salvage operations were underway at the time of this inspection along the northern location.

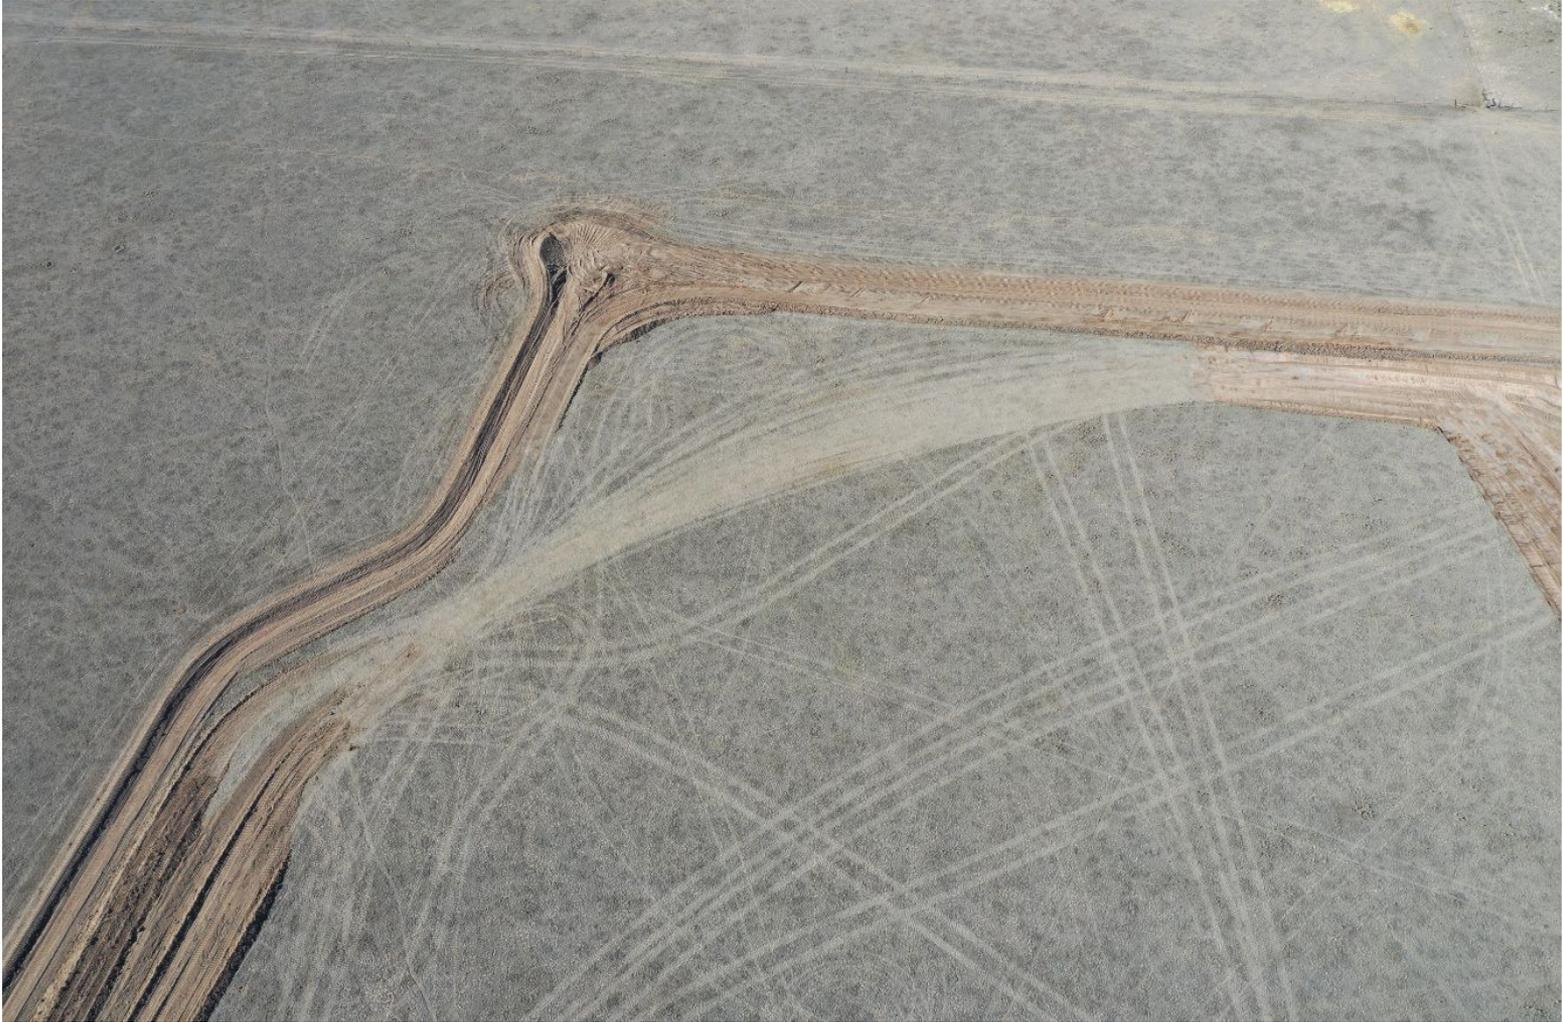
Photo 4. Drone aerial imagery illustrates the southwestern location, facing Southwest. See comments under Photo 1.

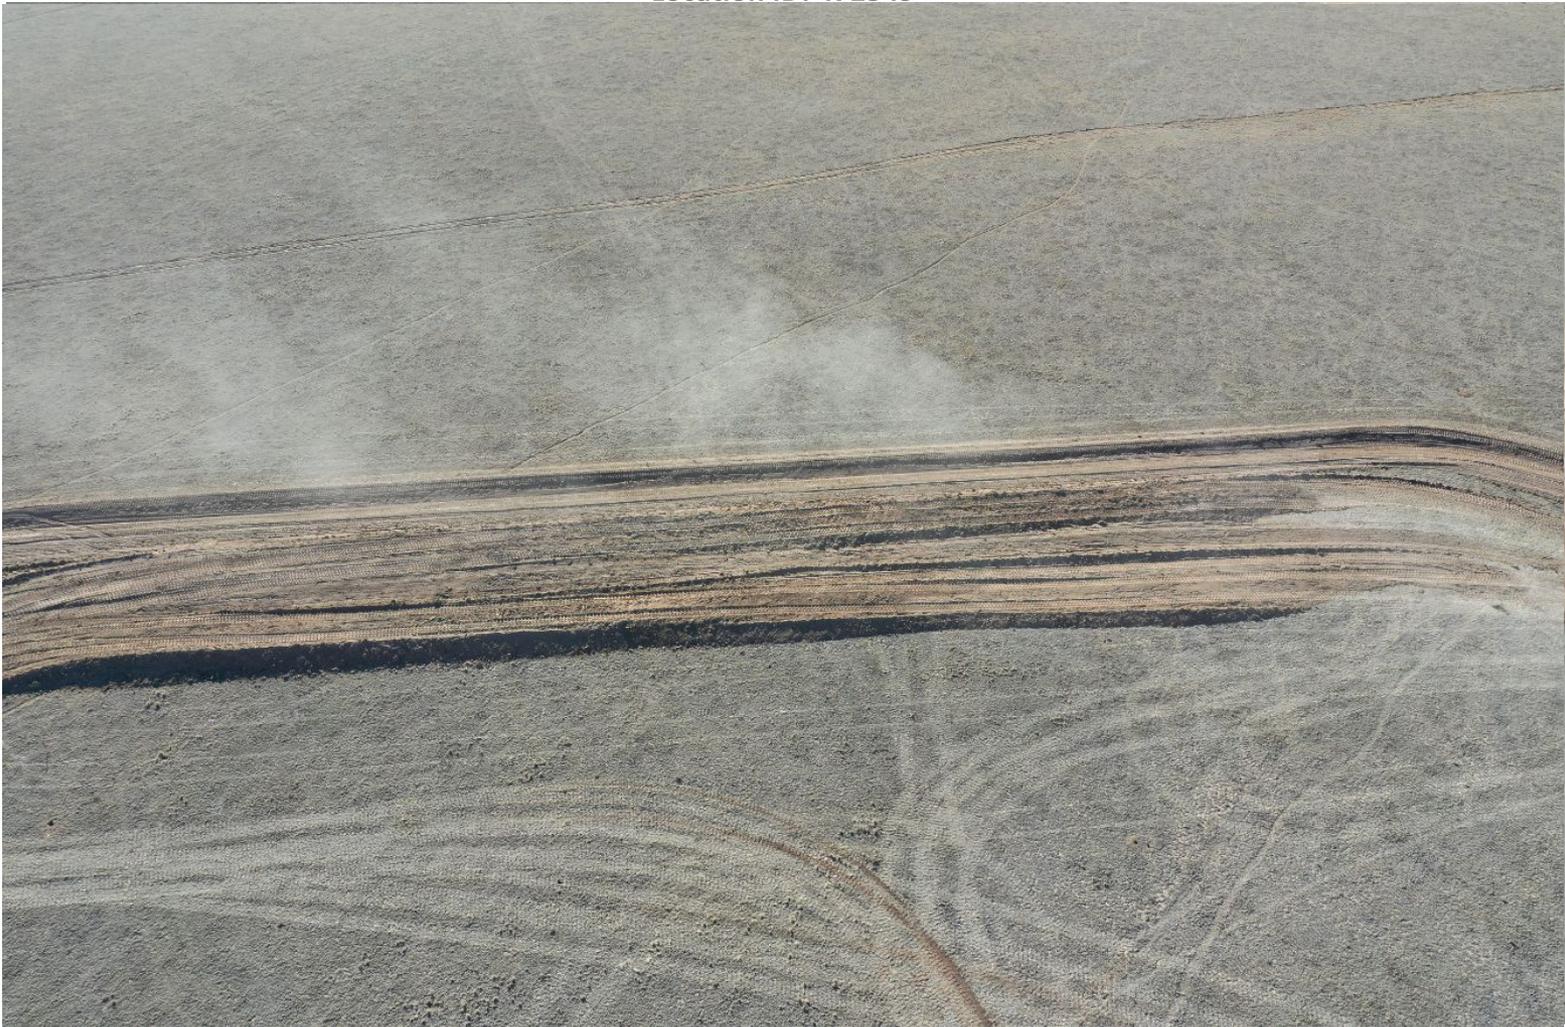
Photo 5. Drone aerial imagery illustrates the southern location, facing South. Photo illustrates the topsoil stockpile.

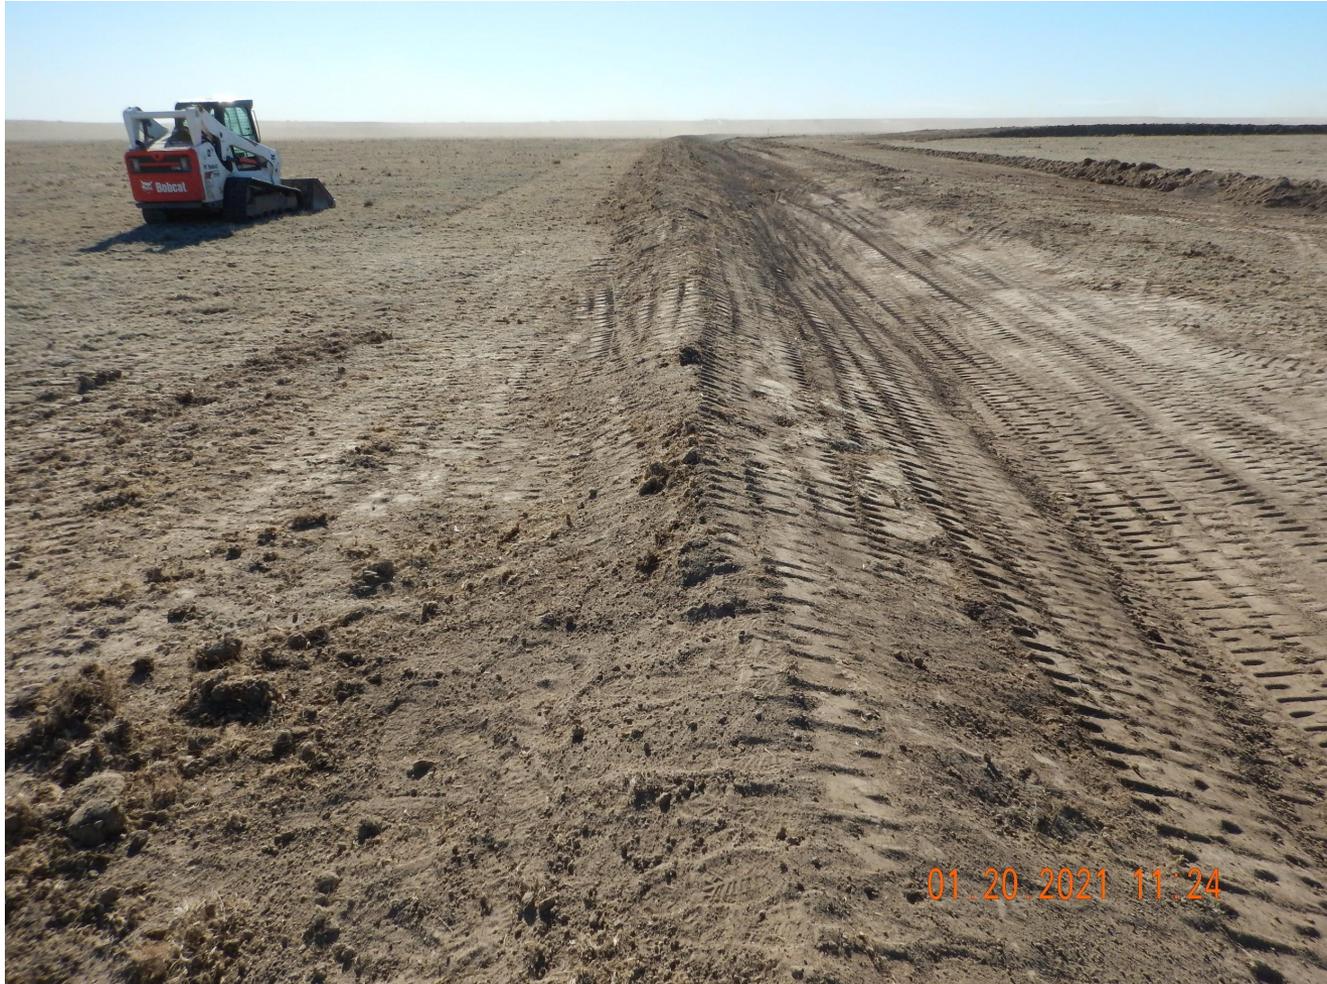
Photo 6. Photo taken from the eastern location, facing South. Photo illustrates the ditch and berm BMP, which has been installed around the entire perimeter of location.

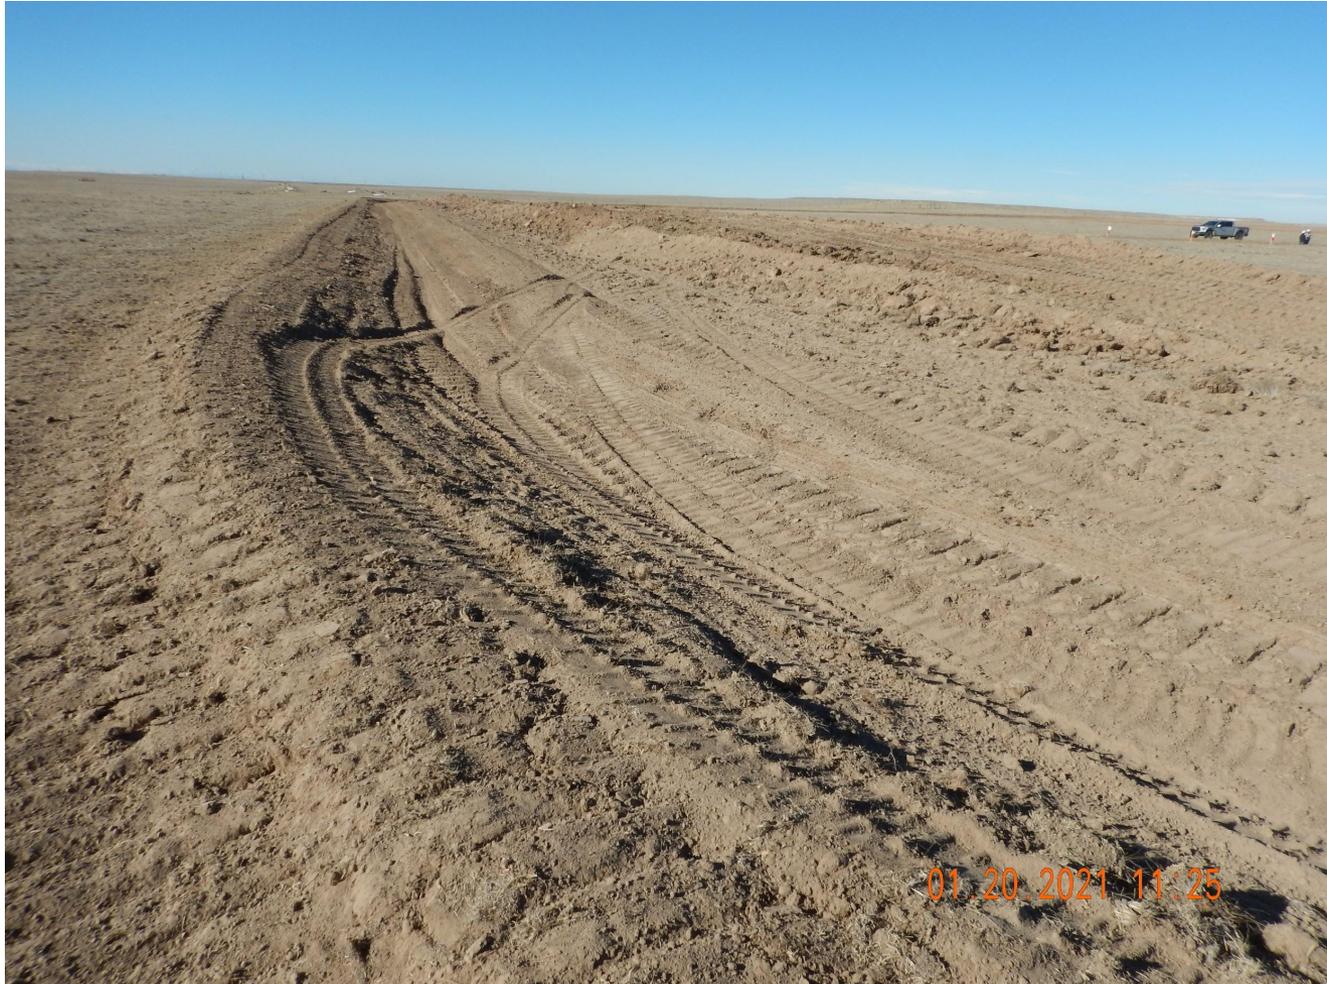
Photo 7. Photo taken from the southern location, facing West. Photo illustrates the ditch and berm BMP and the topsoil stockpile.

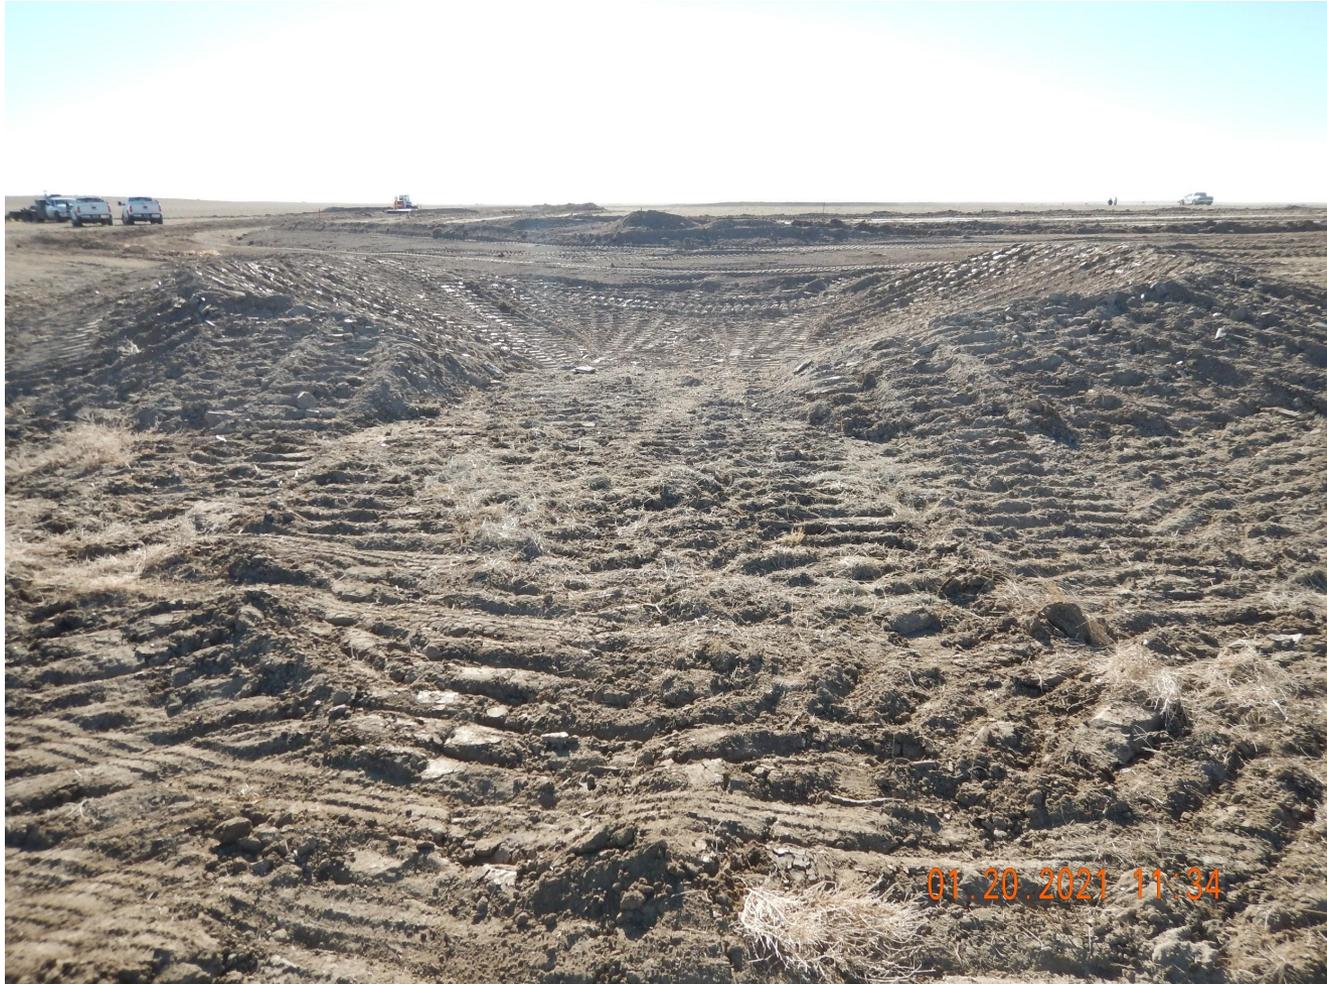
Photo 8. Photo taken from the northeastern location, facing South. Photo illustrates a sediment trap being completed. Rip-rap material was delivered for the tracking pad and sediment trap outlets.
