Construction and Stormwater Inspection

Operator: KERR MCGEE OIL & GAS ONSHORE LP #47120

Location ID: 474765

Inspection Photos
Location Name: S&B /5-11HZ PAD
Location ID: 474765

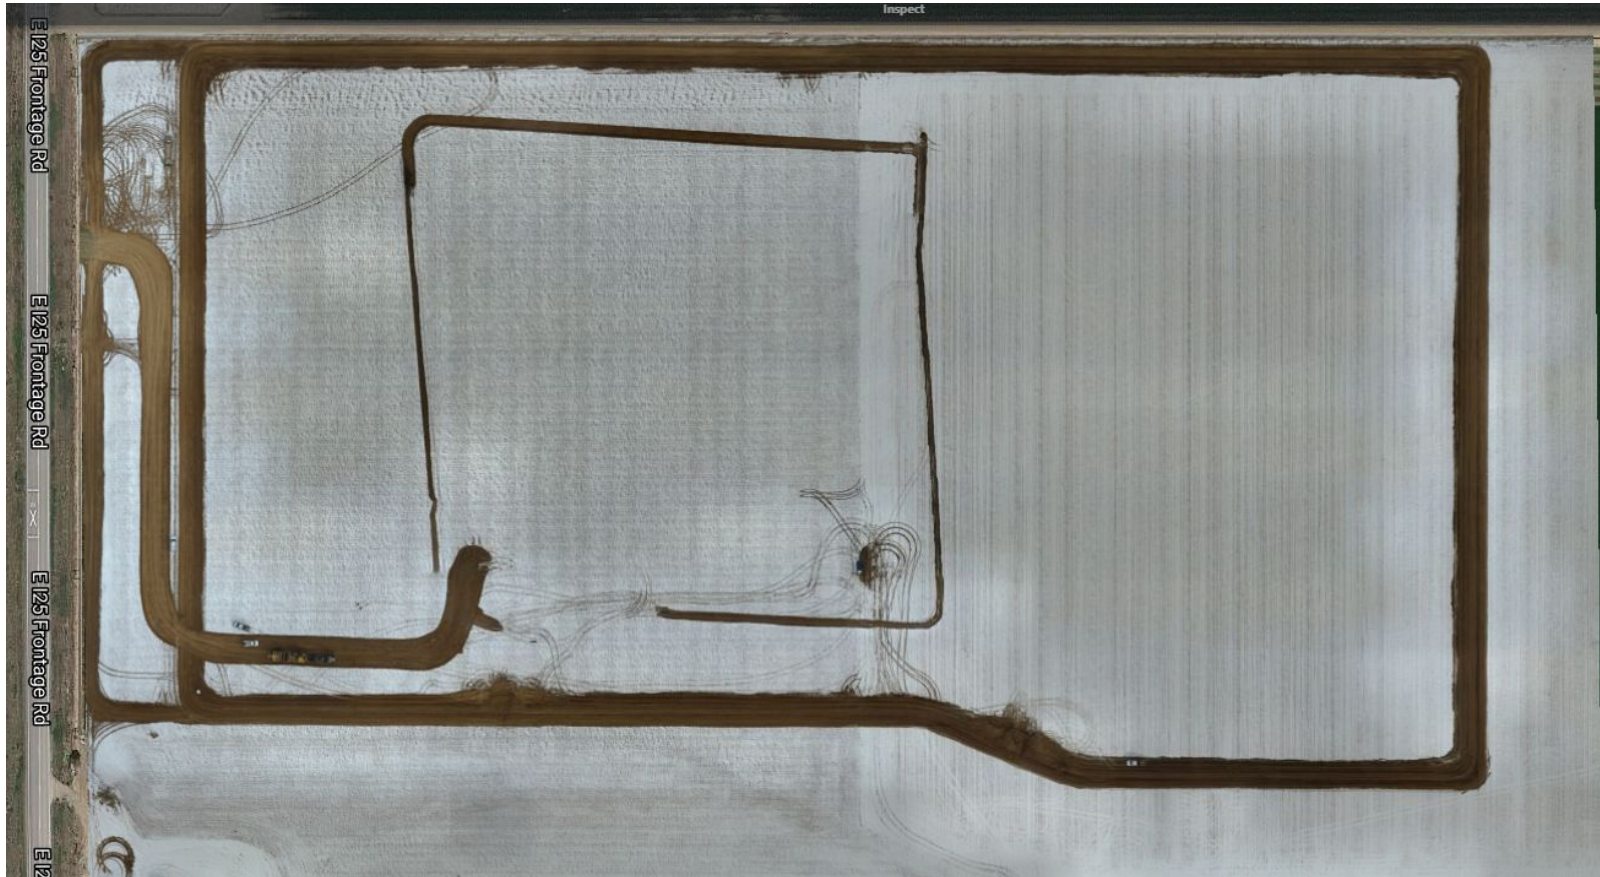
Photo 1. Drone aerial imagery illustrates Operator has commenced construction activities by installing a ditch and berm BMP around the entire perimeter of location. The disturbance area is 33.5 acres.

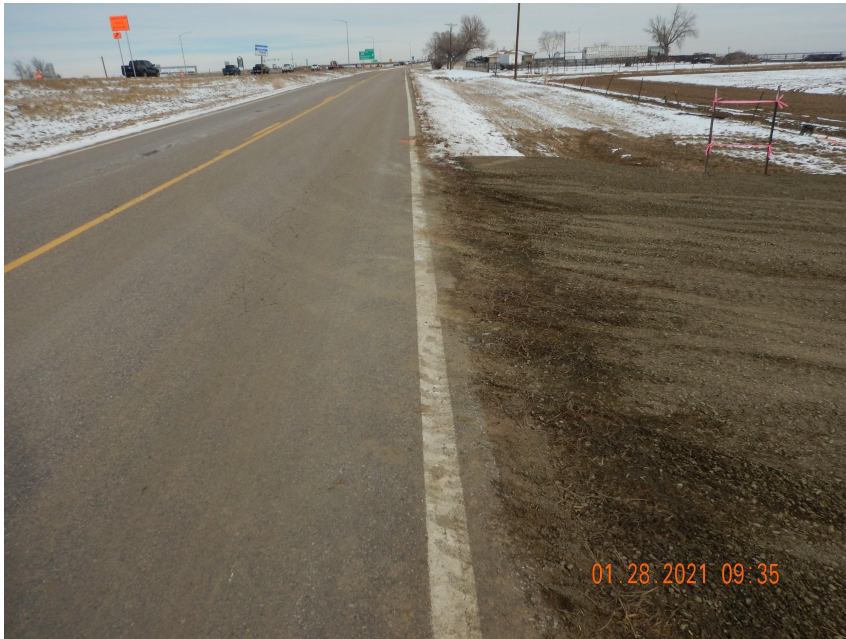
Photo 2. Photo taken from the entrance of location, facing North. Photo illustrates current conditions along the frontage road. At the time of this inspection, no vehicle track out was observed.

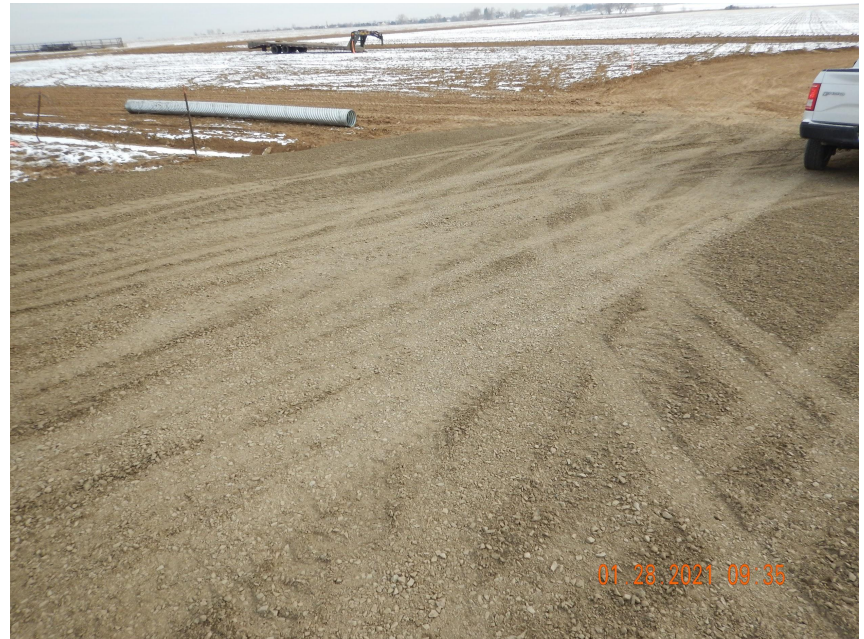
Photo 3. Photo taken from the entrance of location, facing East. See comments under Photo 2.

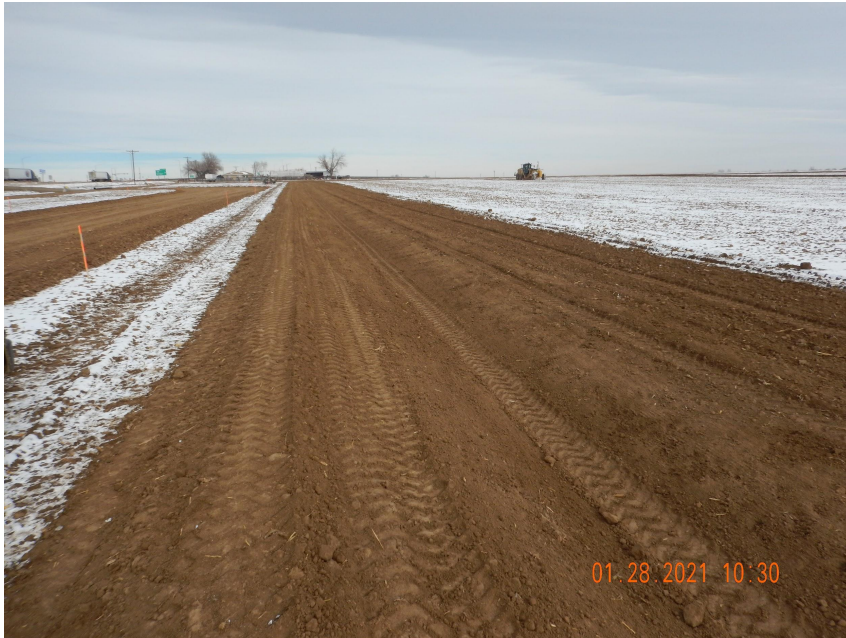
Photo 4. Photo taken from the western location, facing North. Photo illustrates the perimeter stormwater BMP-ditch and berm.

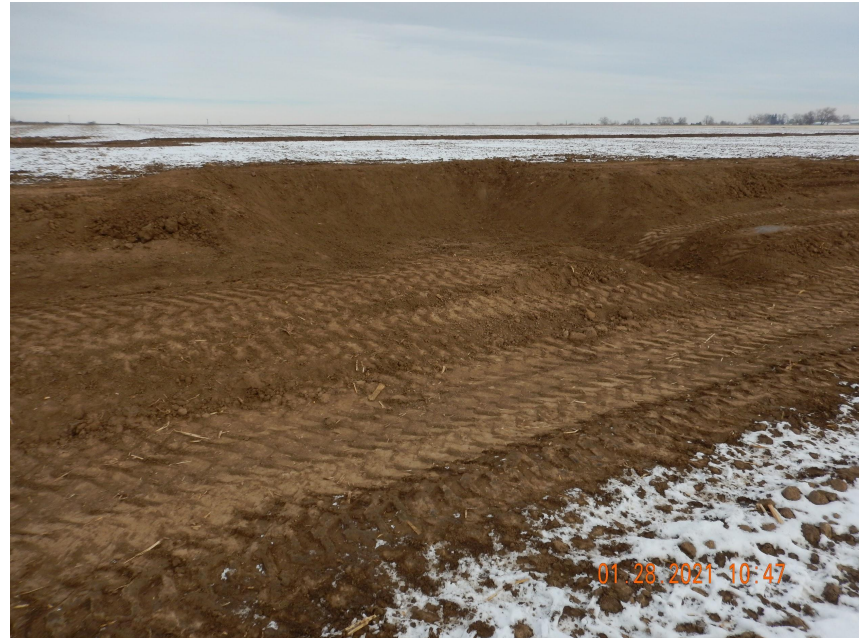
Photo 5. Photo taken from the southern location, facing Northeast. Photo illustrates a sediment trap in-process of being completed.

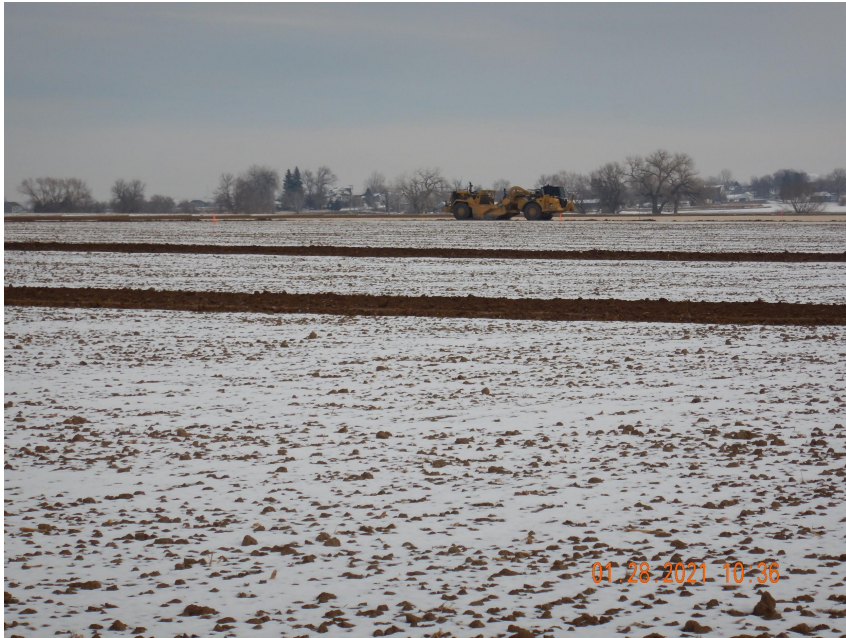
Photo 6. Photo taken from the western location, facing East. Photo illustrates the Operator is commencing topsoil salvage operations.

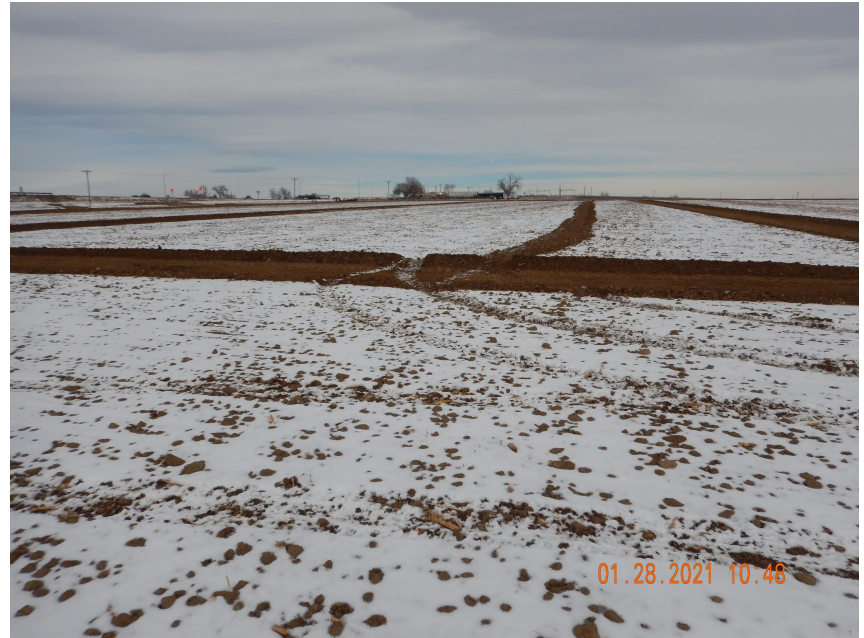
Photo 7. Photo taken from the southwestern location, facing North. Photo illustrates the location of the topsoil stockpile.
