Inspection Photos
Operator: Simcoe
API: 067-07202
Date: 2/22/2021

Photo 1. View of the project area from the well pad entrance facing center.

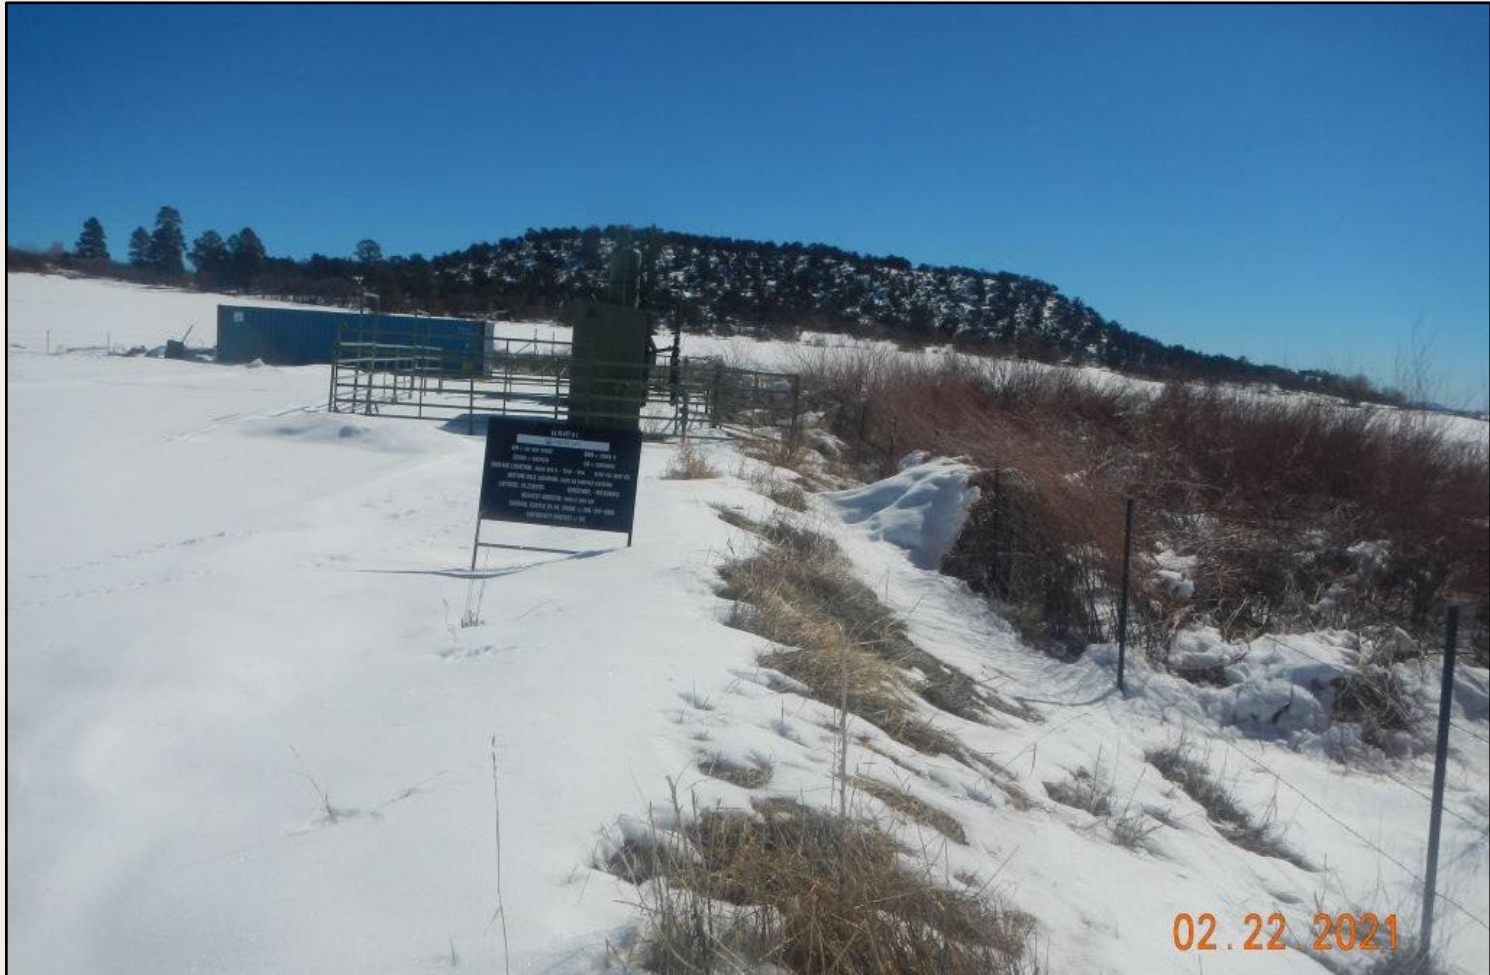
Photo 2. View of the southern fill slope facing eastward. Slope largely snow covered. Perennial vegetation such as western wheatgrass observed in gaps through snow.

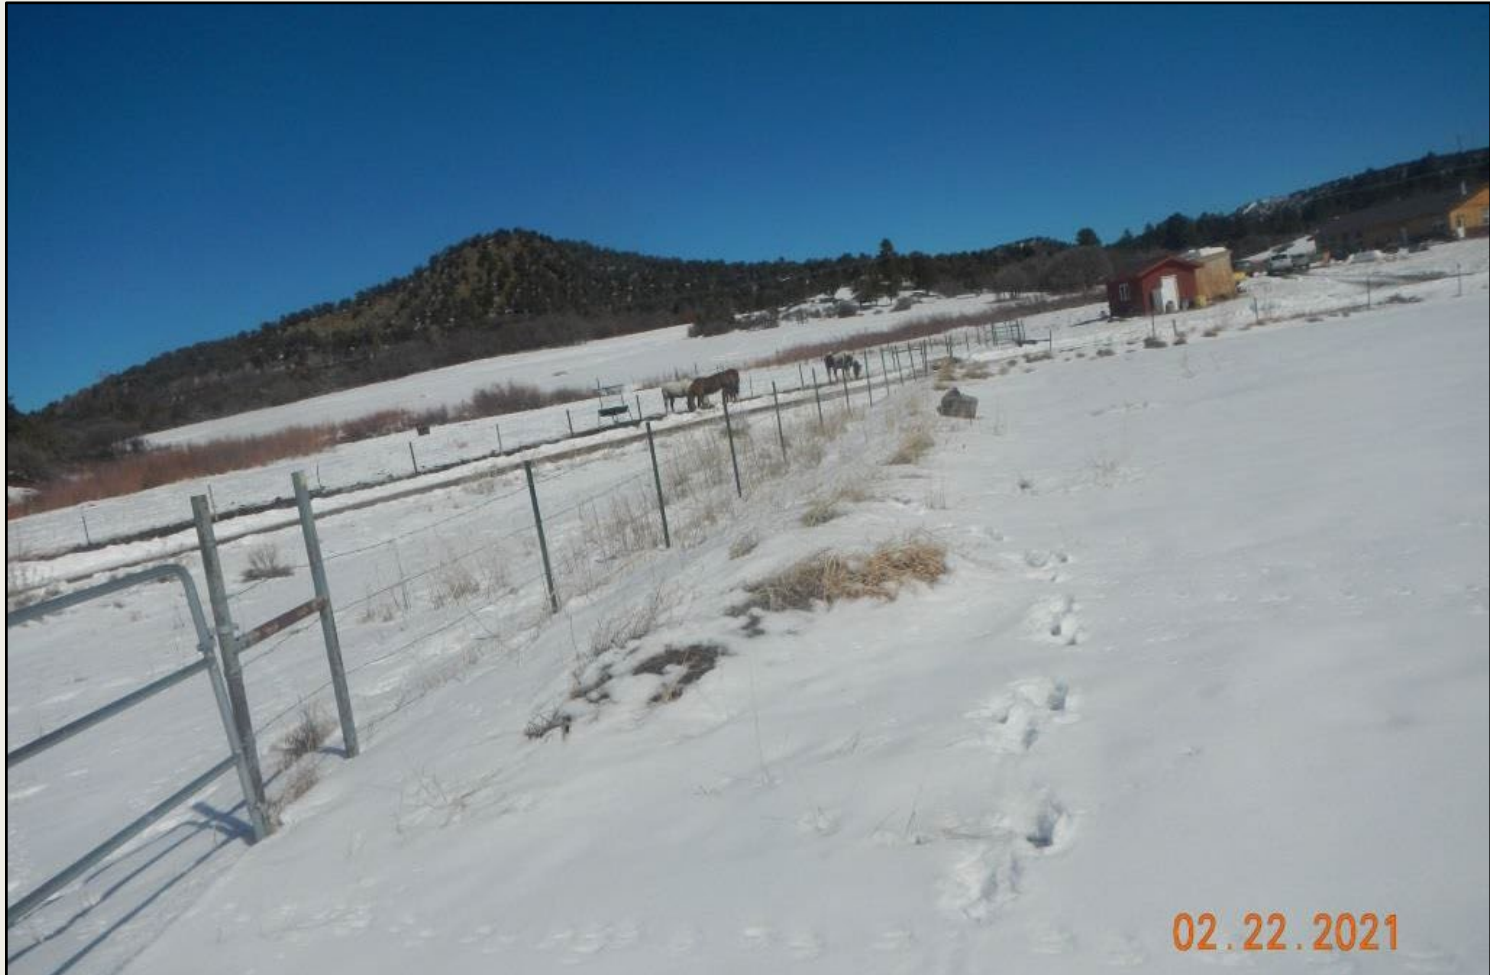
Photo 3. View of the eastern project area facing northward.
