Inspection Photos

Operator: RIO MESA RESOURCES INC - 74740

Location ID: 315713

Rio Blanco County, CO

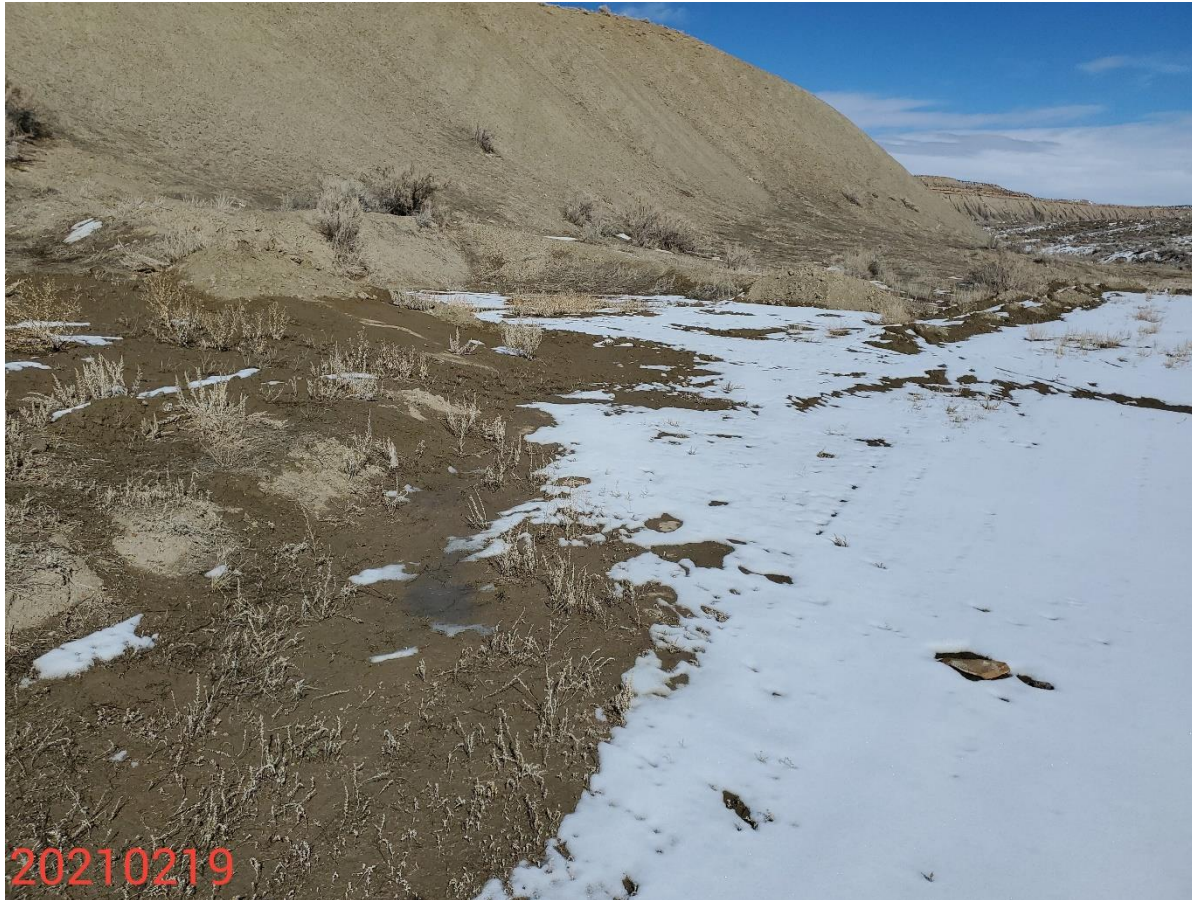
Photo 1: Photo taken from the west end of the Location, facing northeast. Photo shows Location has not been reclaimed in accordance with COGCC 1004 rules.

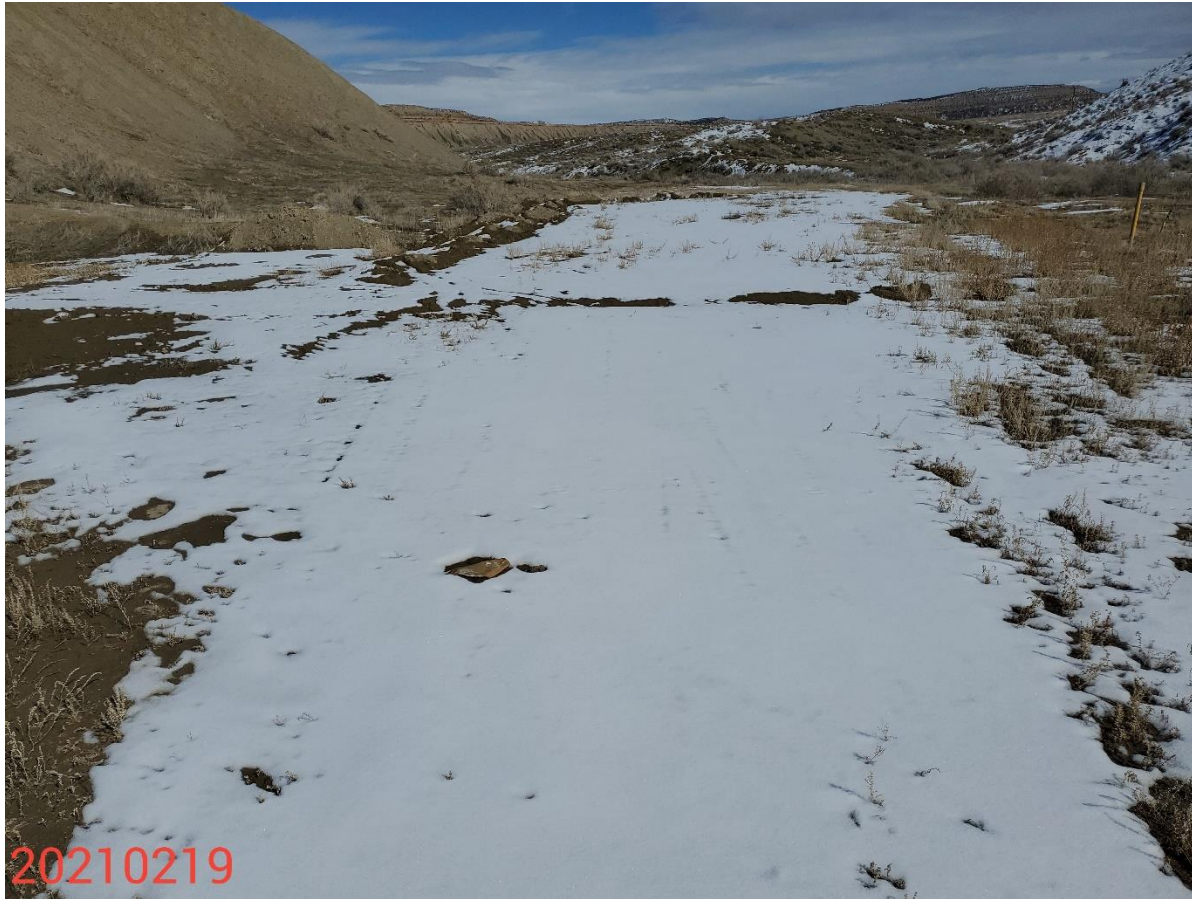
Photo 2: Photo taken from the west end of the Location, facing east. Photo shows Location has not been reclaimed in accordance with COGCC 1004 rules.

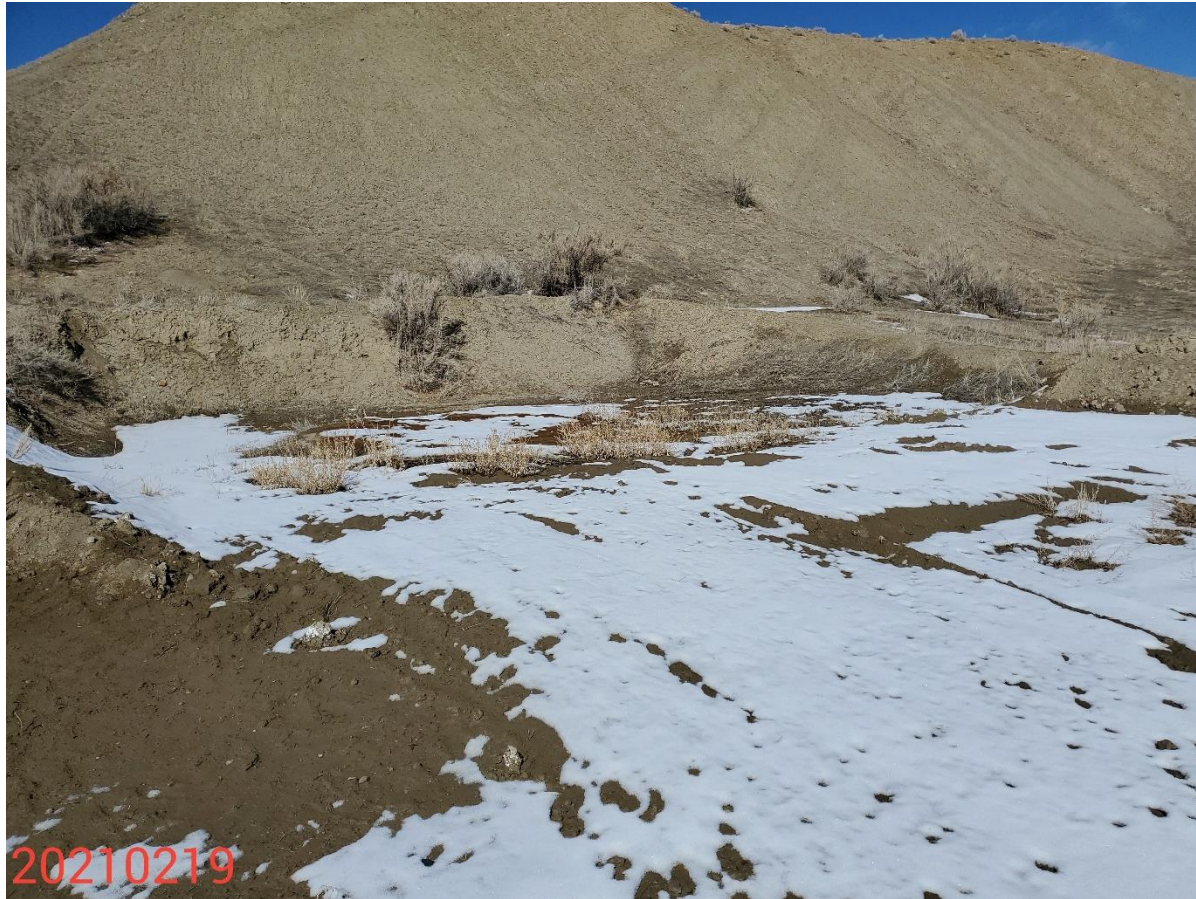
Photo 3: Photo taken from the north end of the Location, facing northeast. Photo shows area where production equipment (tank) was Location. Photo shows areas have not been reclaimed in accordance with COGCC 1004 Rules.

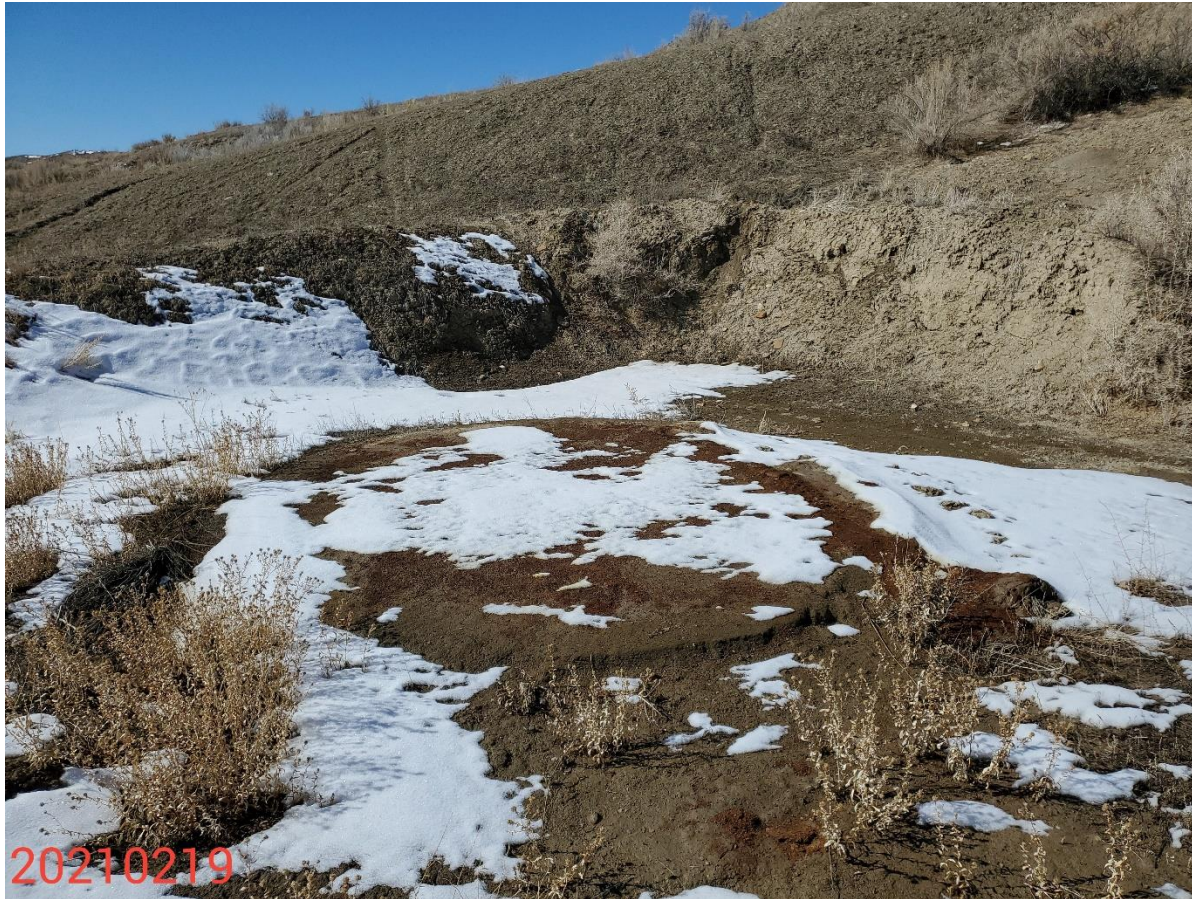
Photo 4: Photo taken from the north end of the Location, facing west. Photo shows area where production equipment (tank) was Location. Photo shows areas have not been reclaimed in accordance with COGCC 1004 Rules.

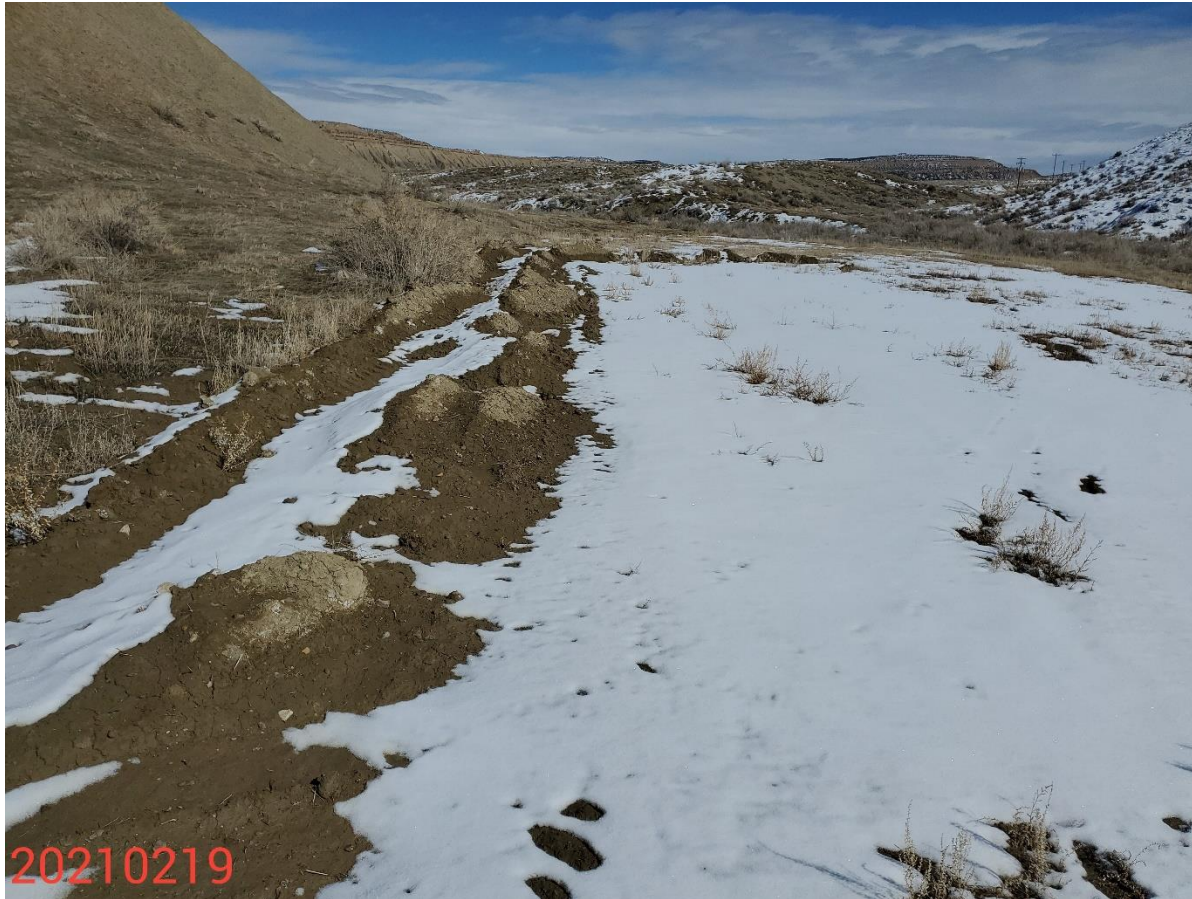
Photo 5: Photo taken from the north end of the Location, facing east. Photo shows Location has not been reclaimed in accordance with COGCC 1004 Rules.

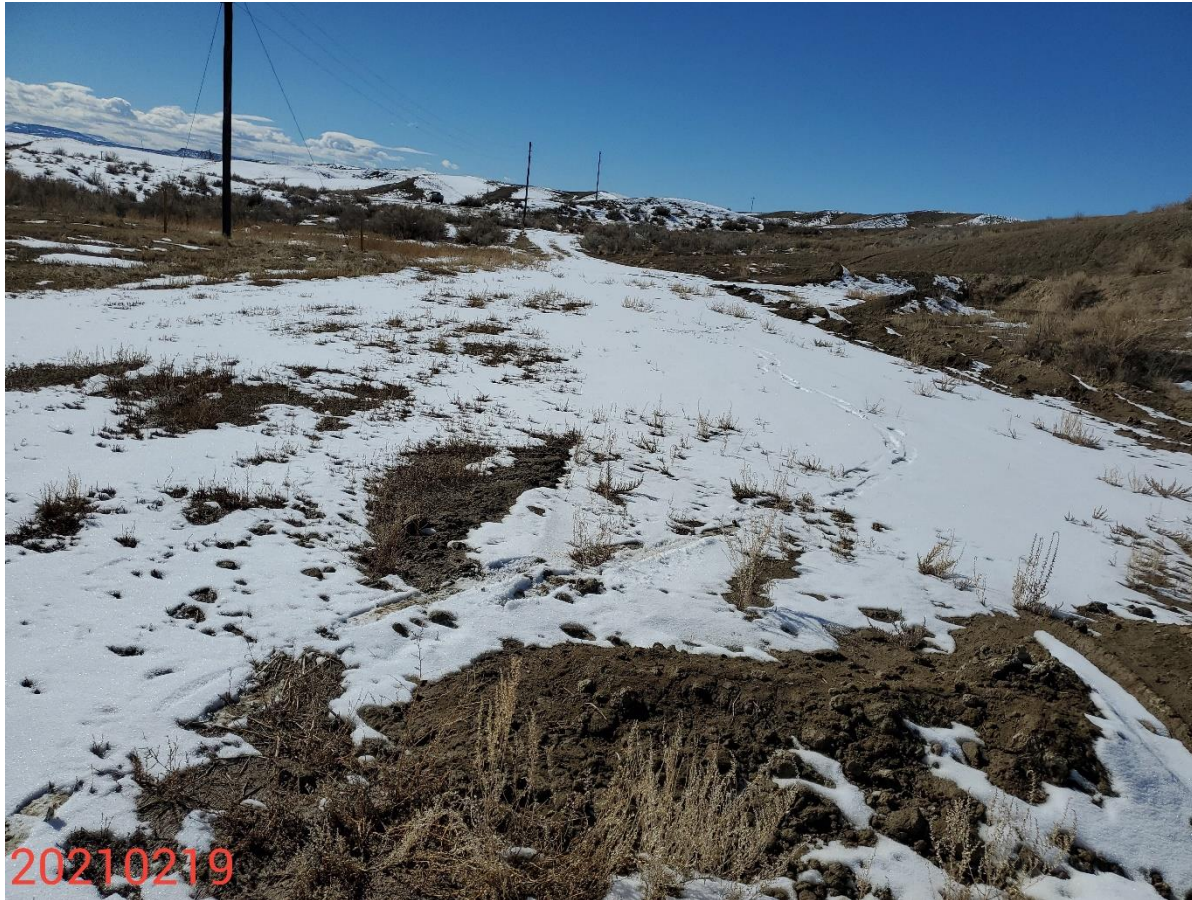
Photo 6: Photo taken from the east end of the Location, facing west. Photo shows Location has not been reclaimed in accordance with COGCC 1004 Rules.

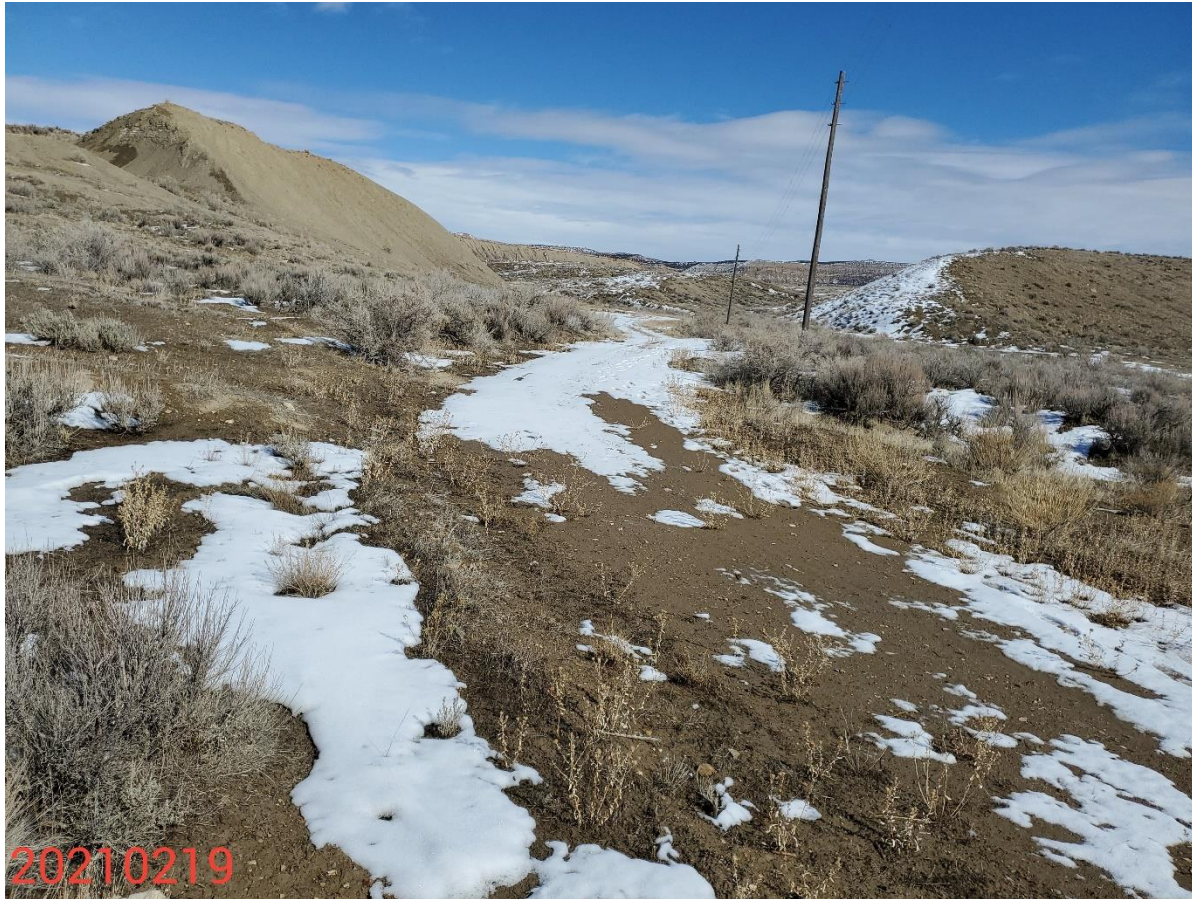
Photo 7: Photo taken from the access road, west of the Location, facing east. Photo shows access road/Location has not been reclaimed in accordance with COGCC 1004 Rules.

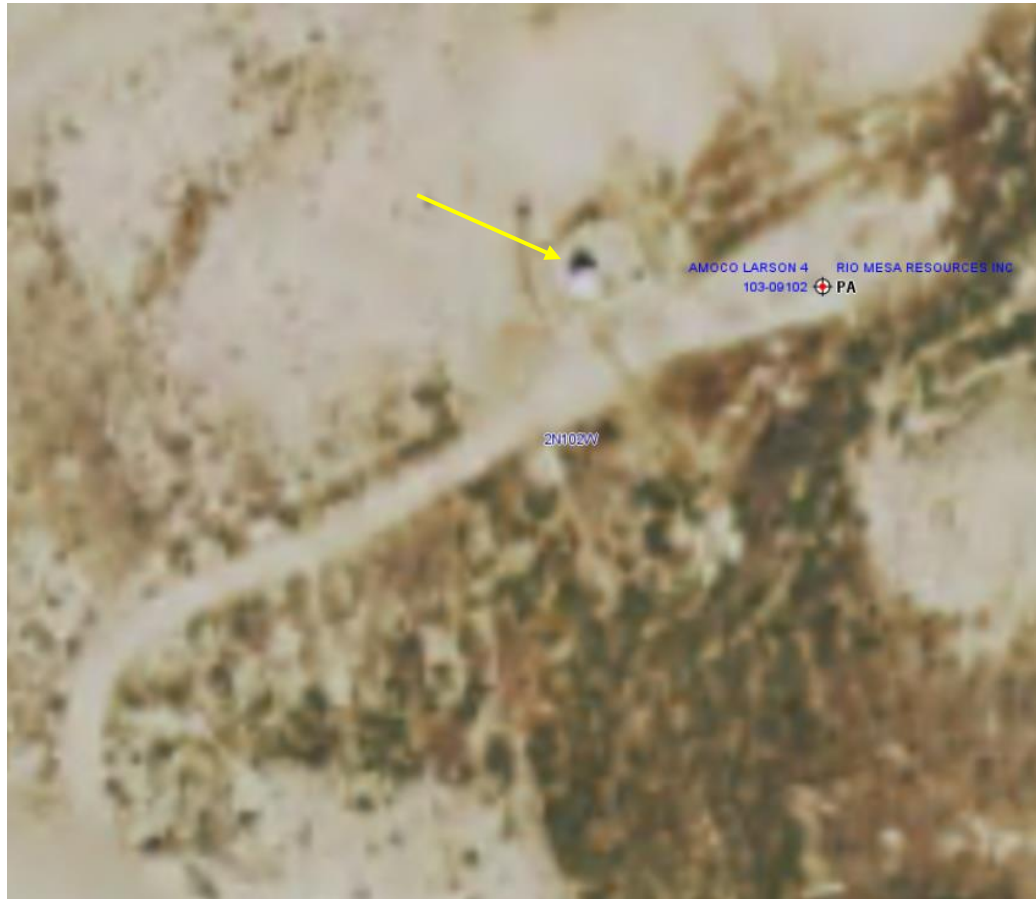
Photo 8: 2019 COGIS aerial image of the Location. Records show well PA 5/27/2014; Pursuant to Rule 1004.a, surface equipment required to be removed by 8/27/2014, and all reclamation work required to be completed by 5/27/2015. Photo shows equipment (tank) remained on the Location in 2019.
