Photographic Log

TASMAN GEOSCIENCES	Tasman Geosciences, Inc. 6855 W 119 th Avenue Broomfield, CO 80020	Noble Energy, Inc. – DJ Basin Werning 7-2 SENW, Section 2, Township 4 North, Range 66 West Weld County, Colorado	Wellhead Closure & Soil Analytical Results Map (02/23/2021)	FIGURE 2
DESIGNED BY: JW					
DRAWN BY: JW

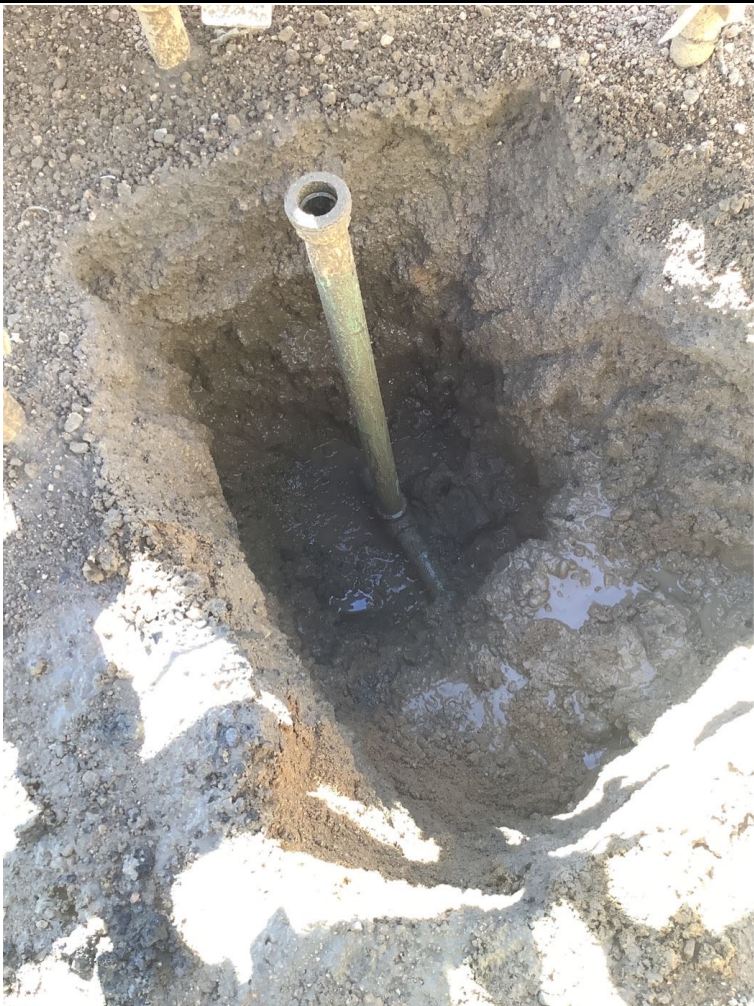
Equipment ID: FL01		Equipment Type: Flowline		Equipment ID:		Equipment Type:					
Material: Steel		Volume: N/A		Contents: Oil/Gas/Water		Material:		Volume:		Contents:	
Notes/Conditions: FL01 @ 4.5' sample location at flowline inlet to separator. Visible water is residual from hydro-excavator.						Notes/Conditions:
