# Inspection Photos

Operator: TEP ROCKY MOUNTAIN LLC - 96850

Location ID: 335924

Garfield County, CO

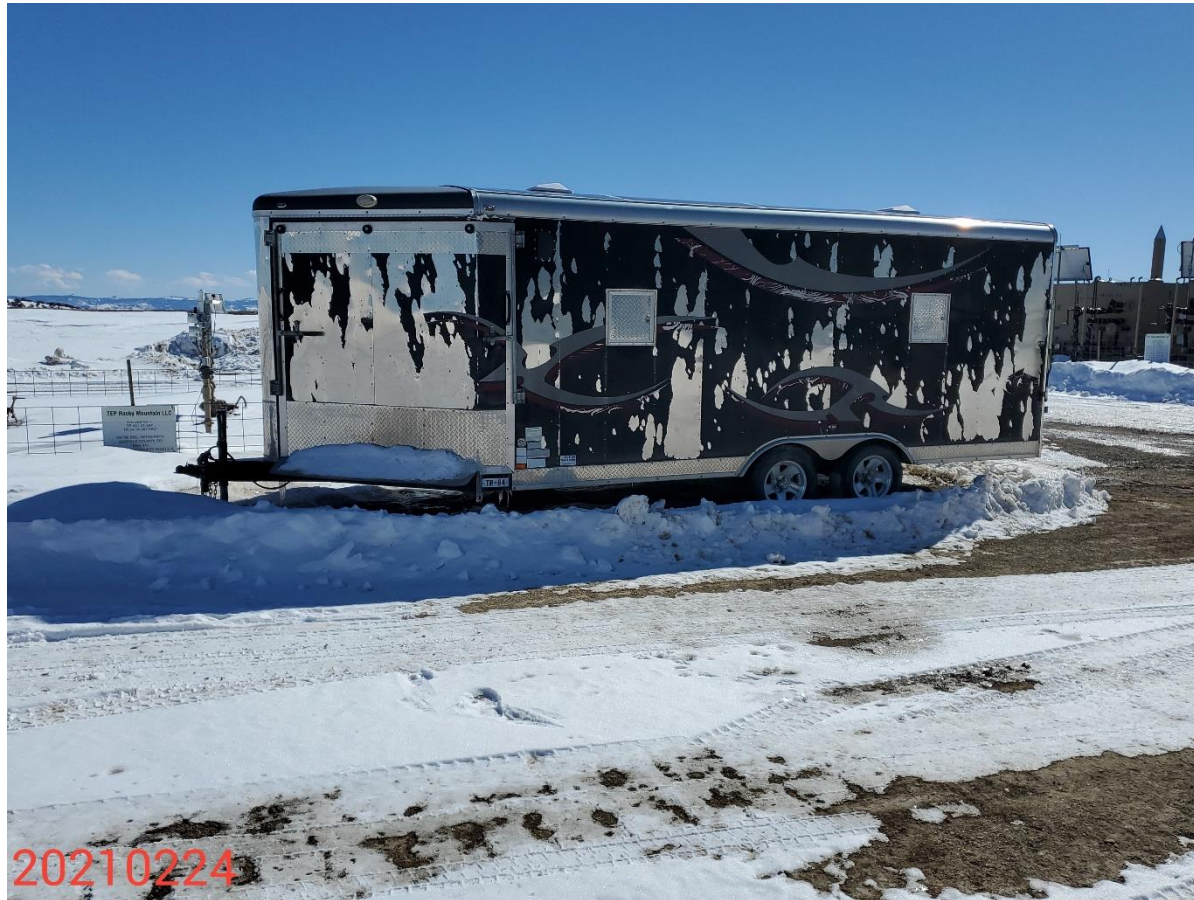
**Photo 1:** Photo shows a trailer stored on the Location next to the wells/production equipment. Trailer not needed for production on the Location and requires removal pursuant to Rule 606.a.

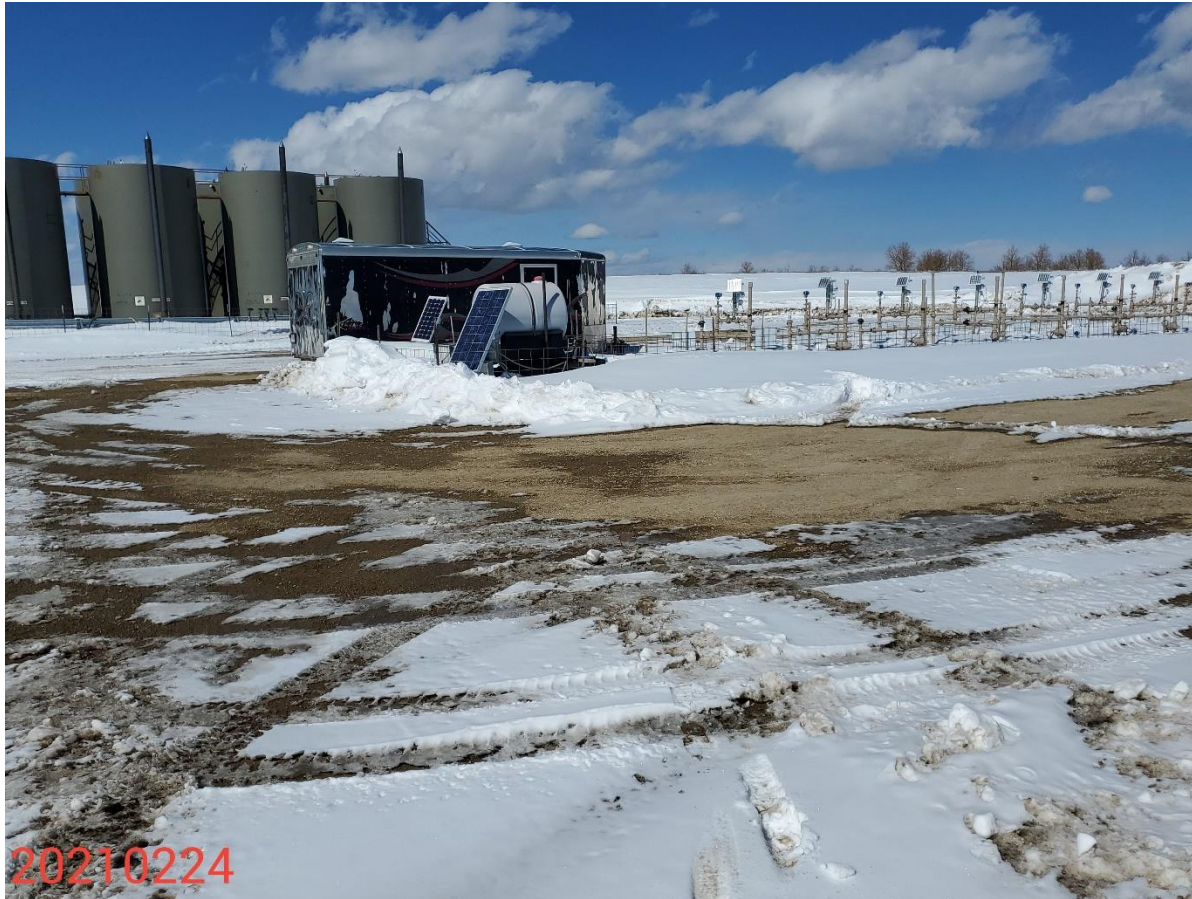
**Photo 2:** Photo shows a trailer stored on the Location next to the wells/production equipment. Trailer not needed for production on the Location and requires removal pursuant to Rule 606.a.

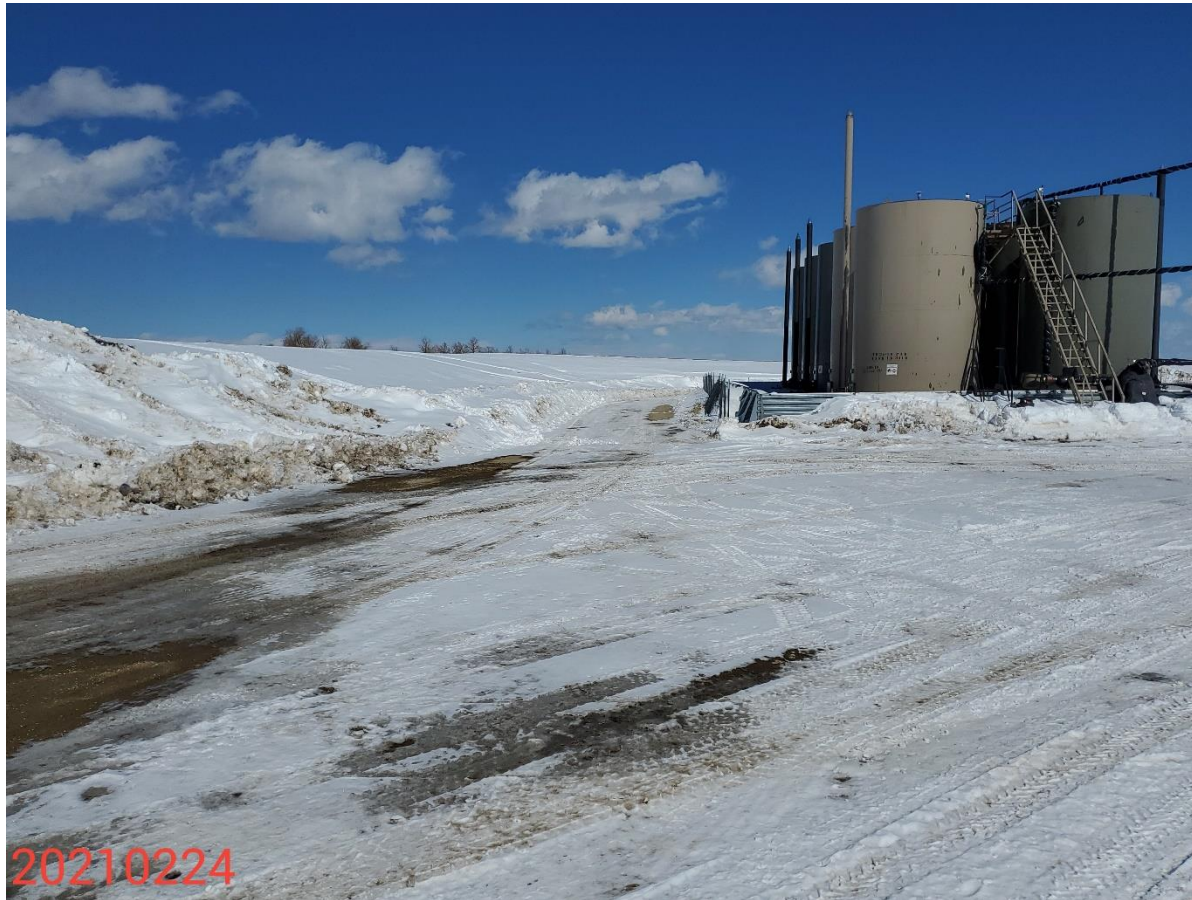
**Photo 3:** Photo taken from the south end of the Location, facing north. Photos 4-5 provide and overview of the Location from north, northeast to east. .

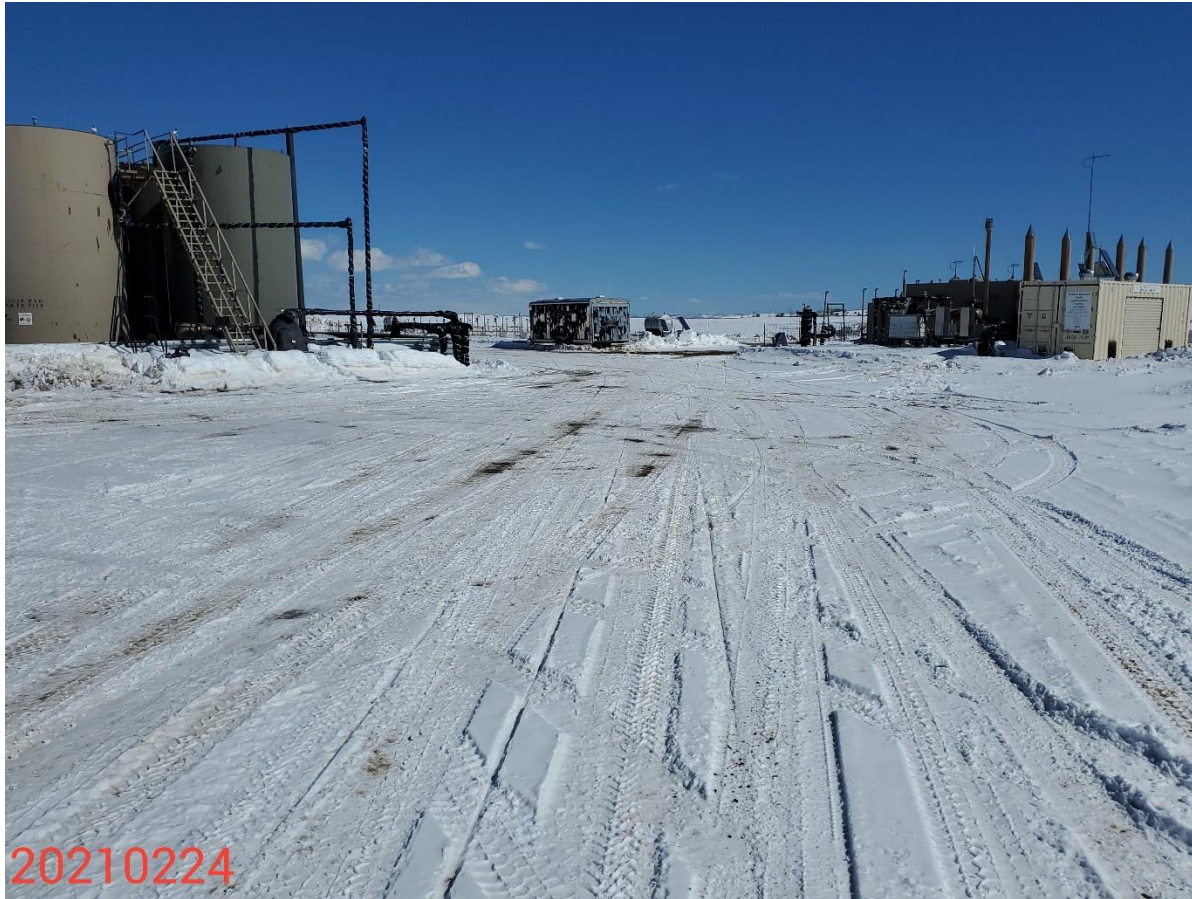
**Photo 4:** See comments under photo 3.

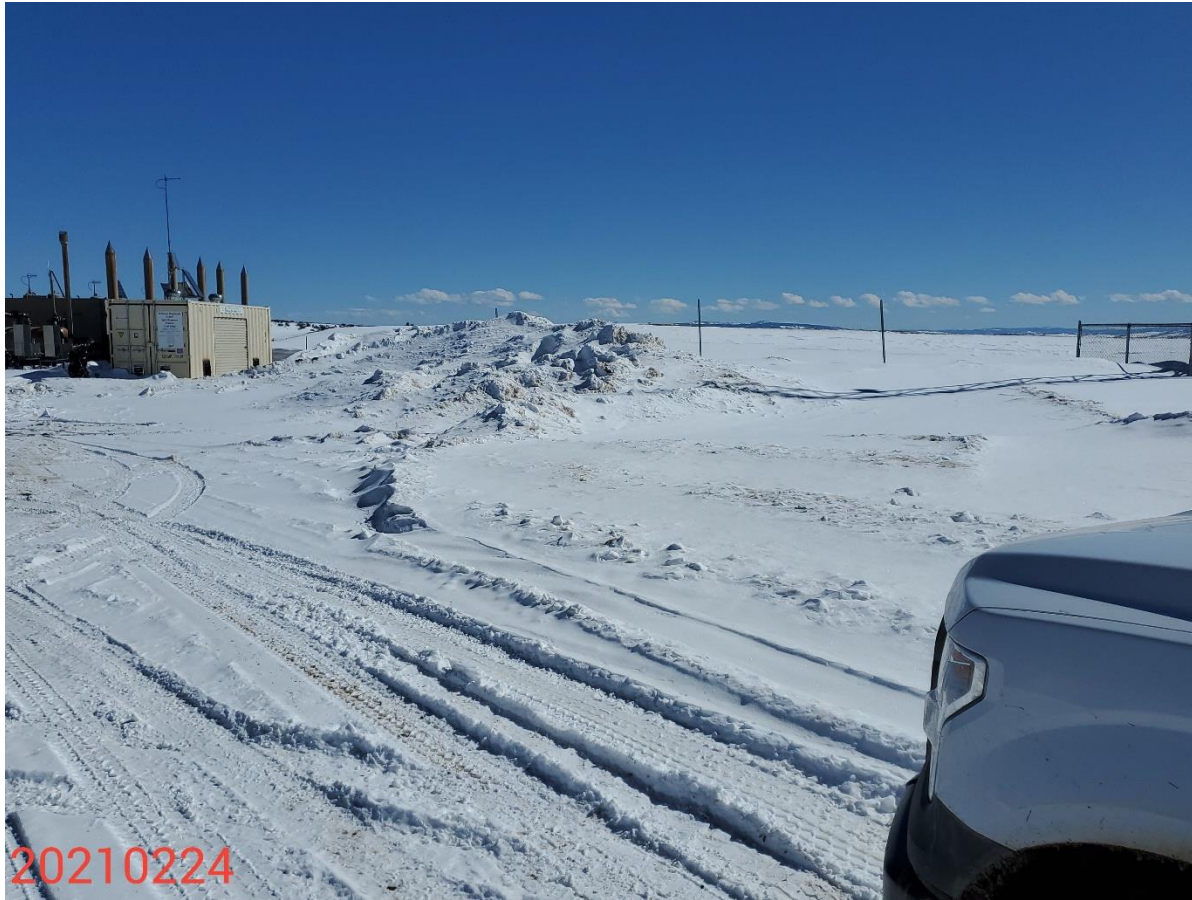
**Photo 5:** See comments under photo 3.
