Inspection Photos

Operator: CAERUS PICEANCE LLC - 10456

Location ID: 335795

Garfield County, CO

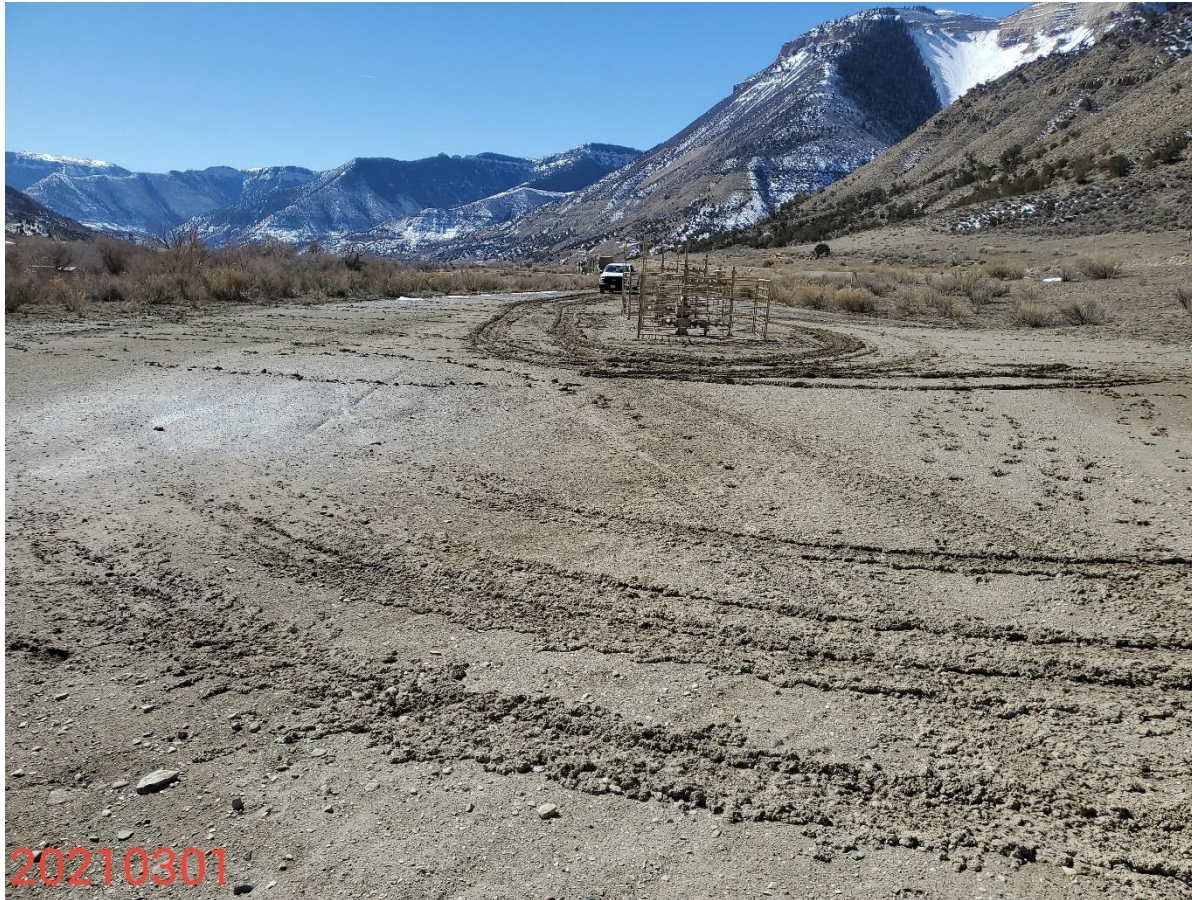
Photo 1: Photo taken from the north end of the Location, facing south. Photo provides an overview of the Location. Photo also shows rutting and tracking issues observed on the Location. Photo also shows areas where stormwater ponding on the Location is evident; Pad does not appear to have been constructed to allow for proper stormwater discharge

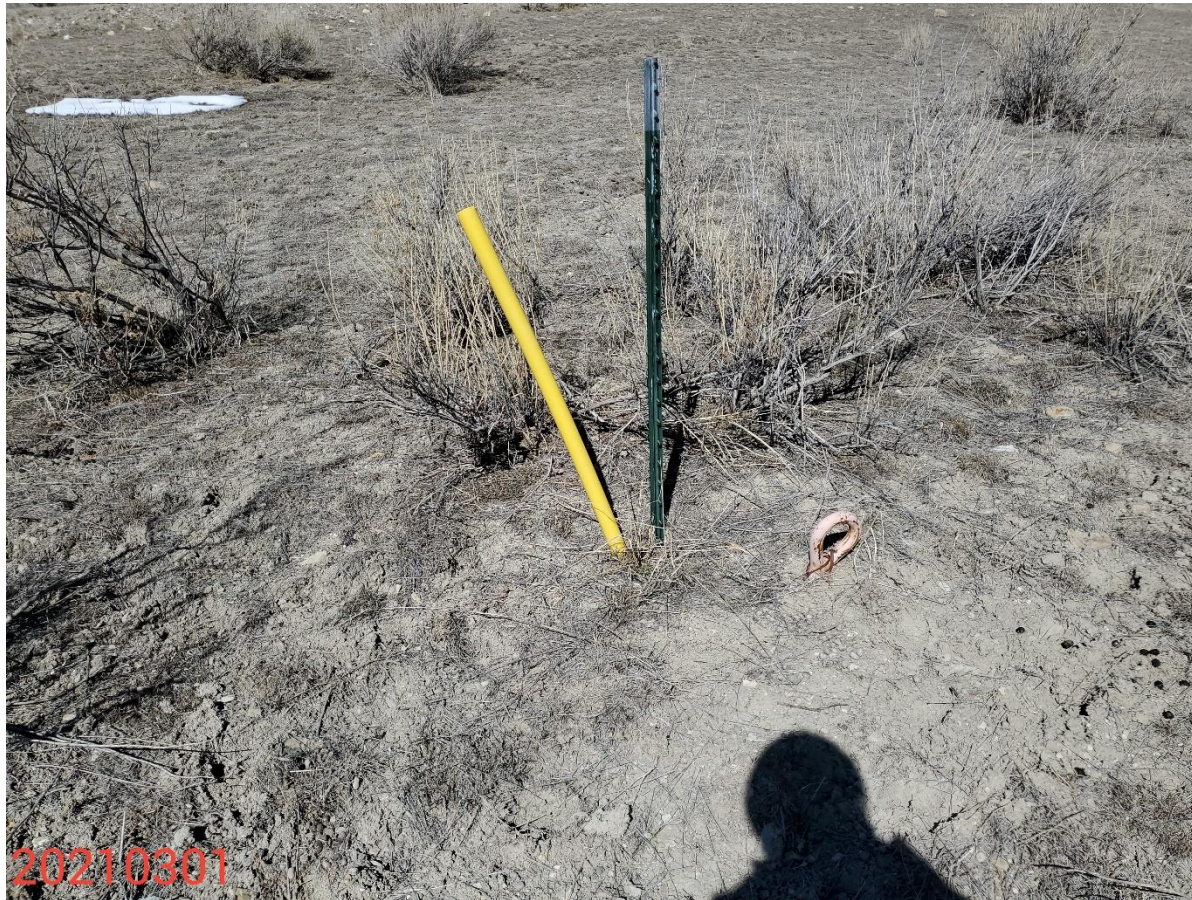
Photo 2: Photo shows example of marked anchors on the Location.

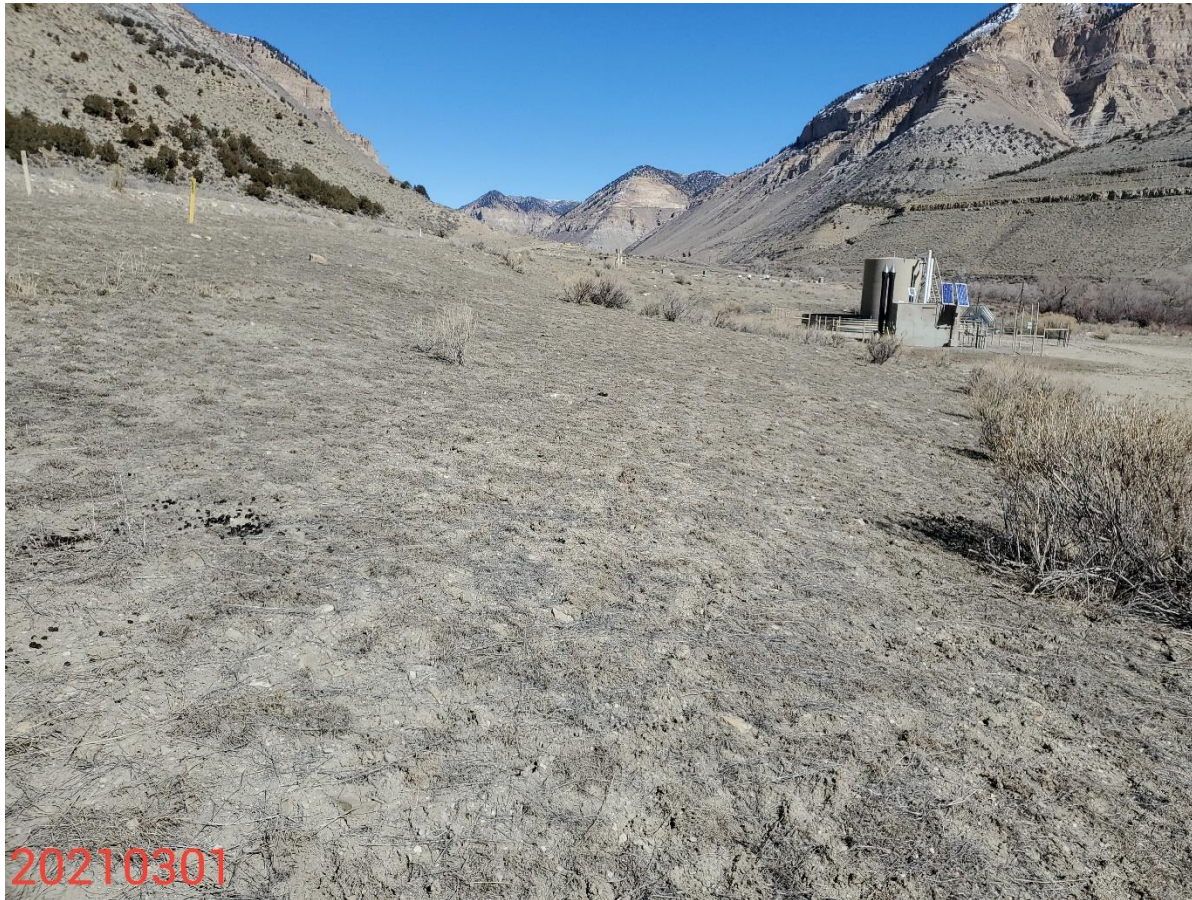
Photo 3: Photo taken from the west end of the Location, facing north. Desirable perennial vegetative establishment observed on slopes.

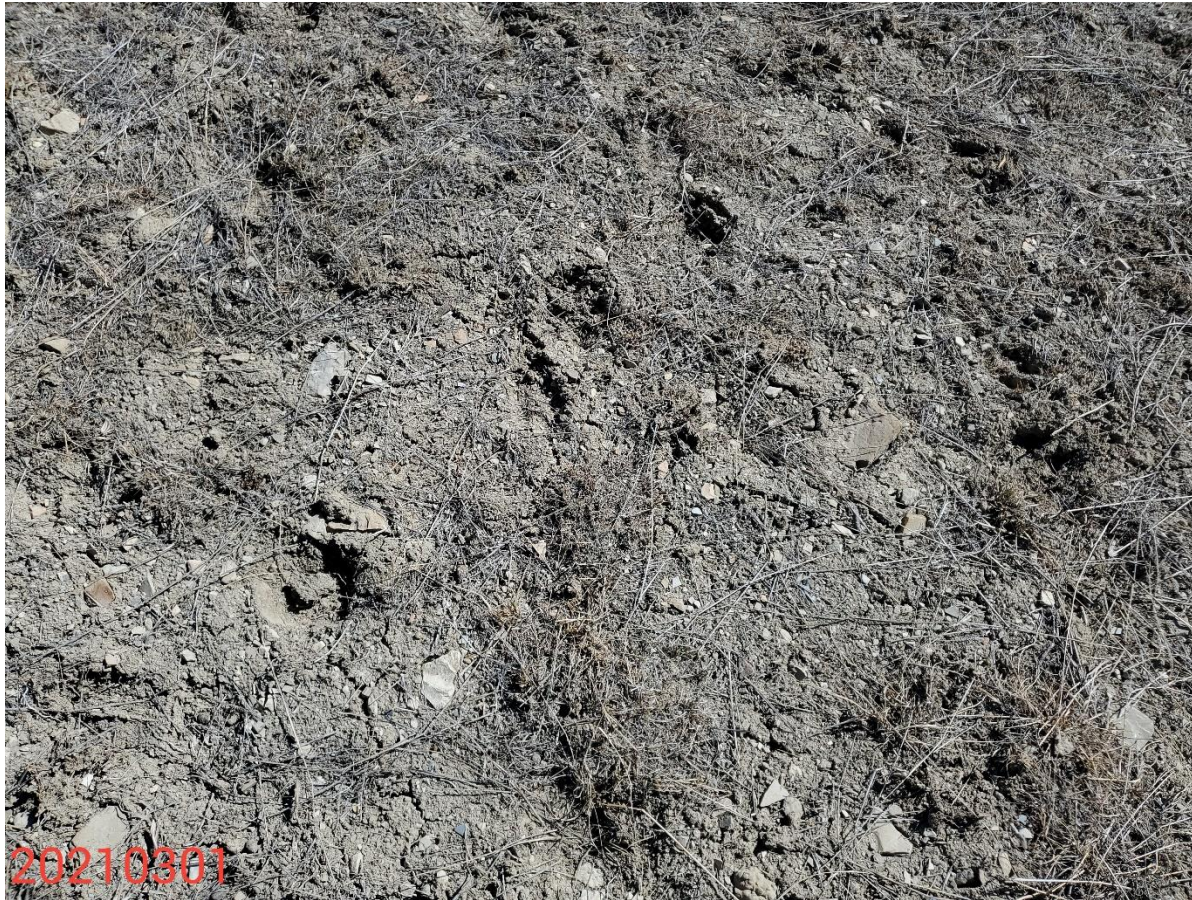
Photo 4: Photo taken from the interim areas. Photo shows desirable perennial vegetative establishment is evident. Cheat grass and heavy grazing pressure also evident throughout interim areas.

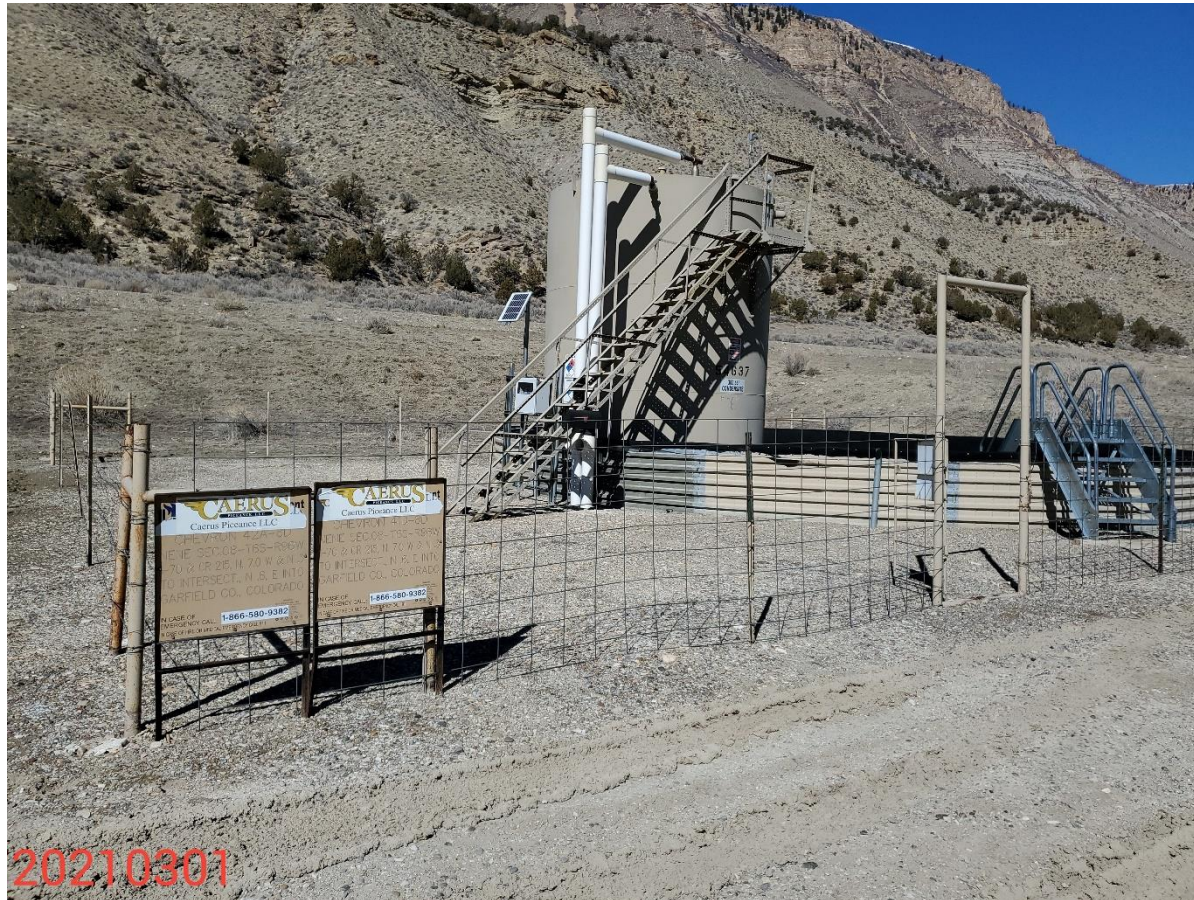
Photo 5: Photo of tanks battery and signage.

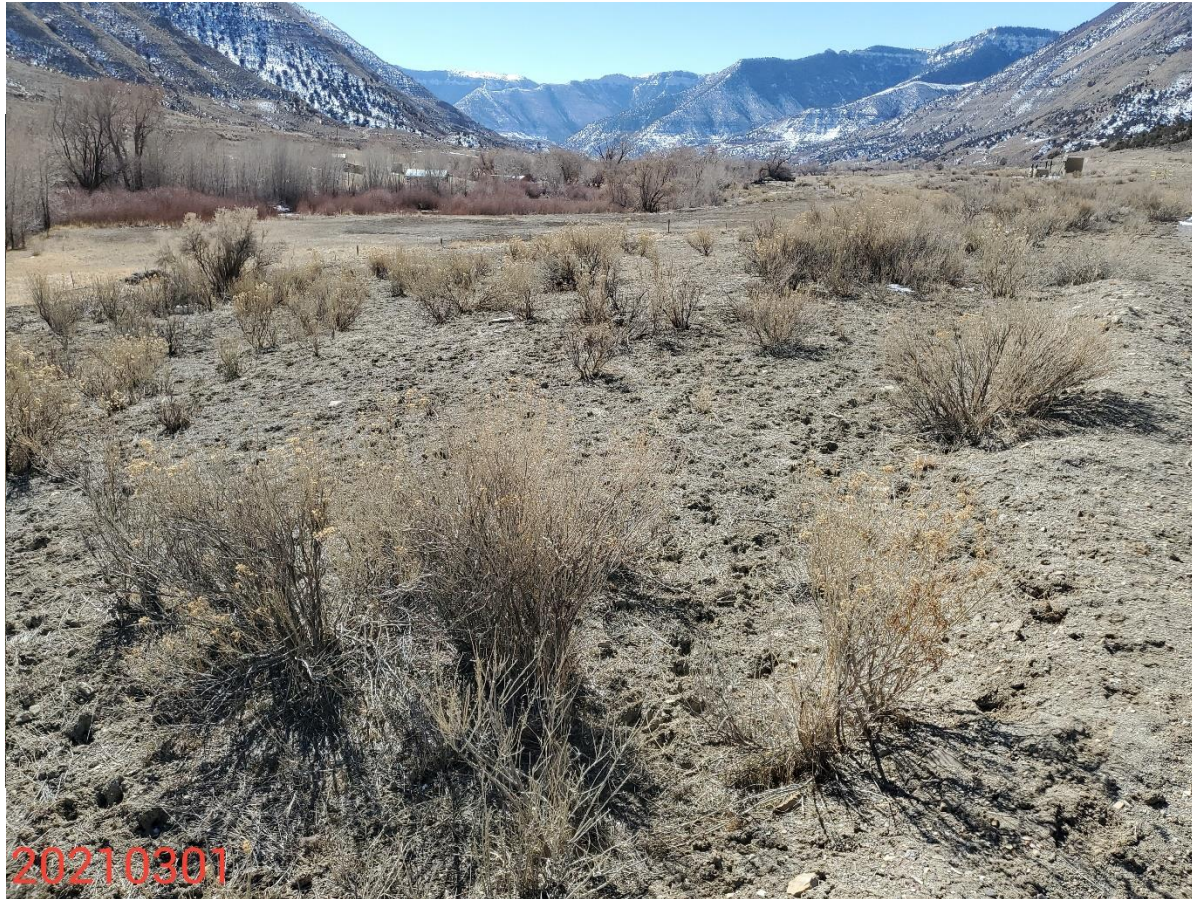
Photo 6: Photo taken from the eastern interim areas of the Location, facing south. See comments under photo 5
