Inspection Photos

Operator: CAERUS PICEANCE LLC - 10456

Location ID: 324198

Garfield County, CO

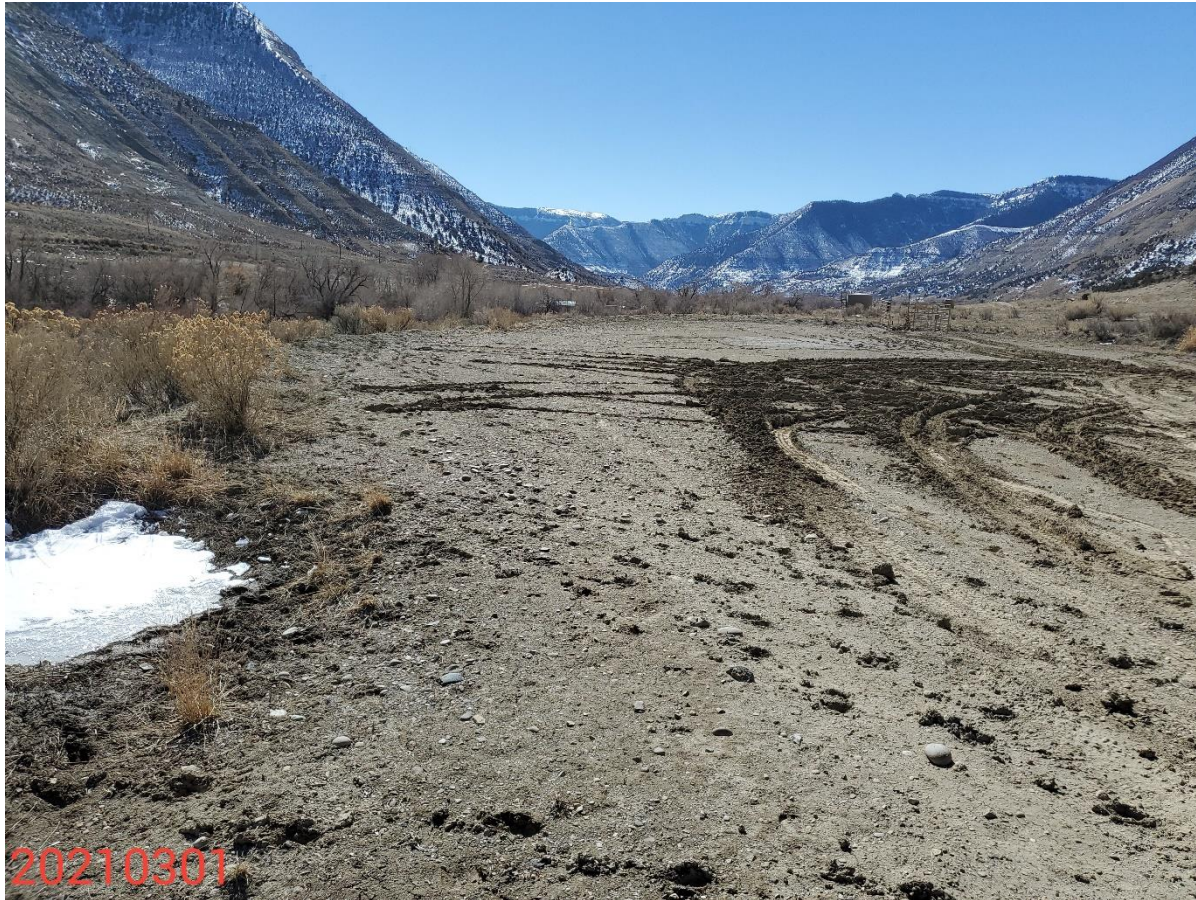
Photo 1: Photo taken from the north end of the Location, facing south. Photo provides an overview of the Location. Photo also shows pad stabilization, rutting and tracking issues observed on the Location.

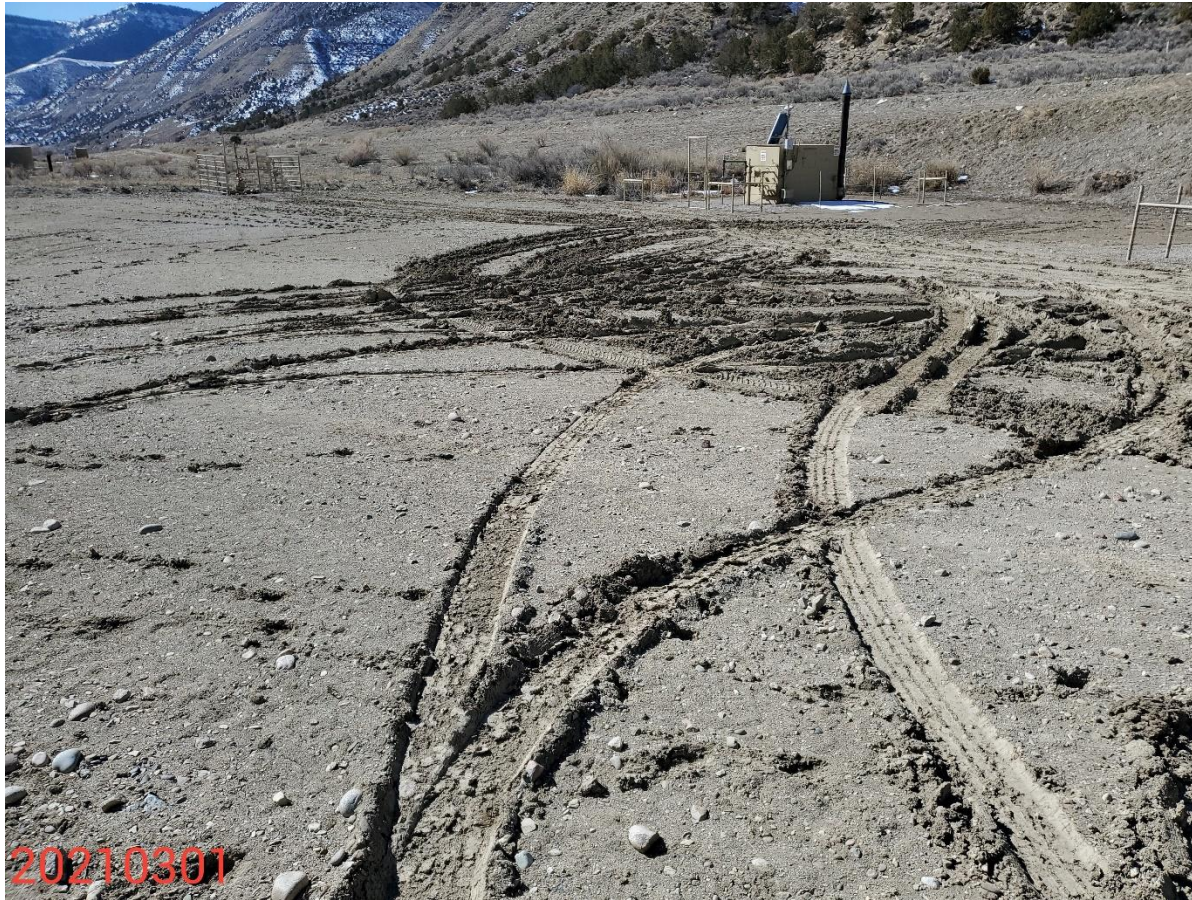
Photo 2: Photo taken from the northeast end of the Location, facing west. Photo shows pad stabilization, rutting and tracking issues observed on the Location.

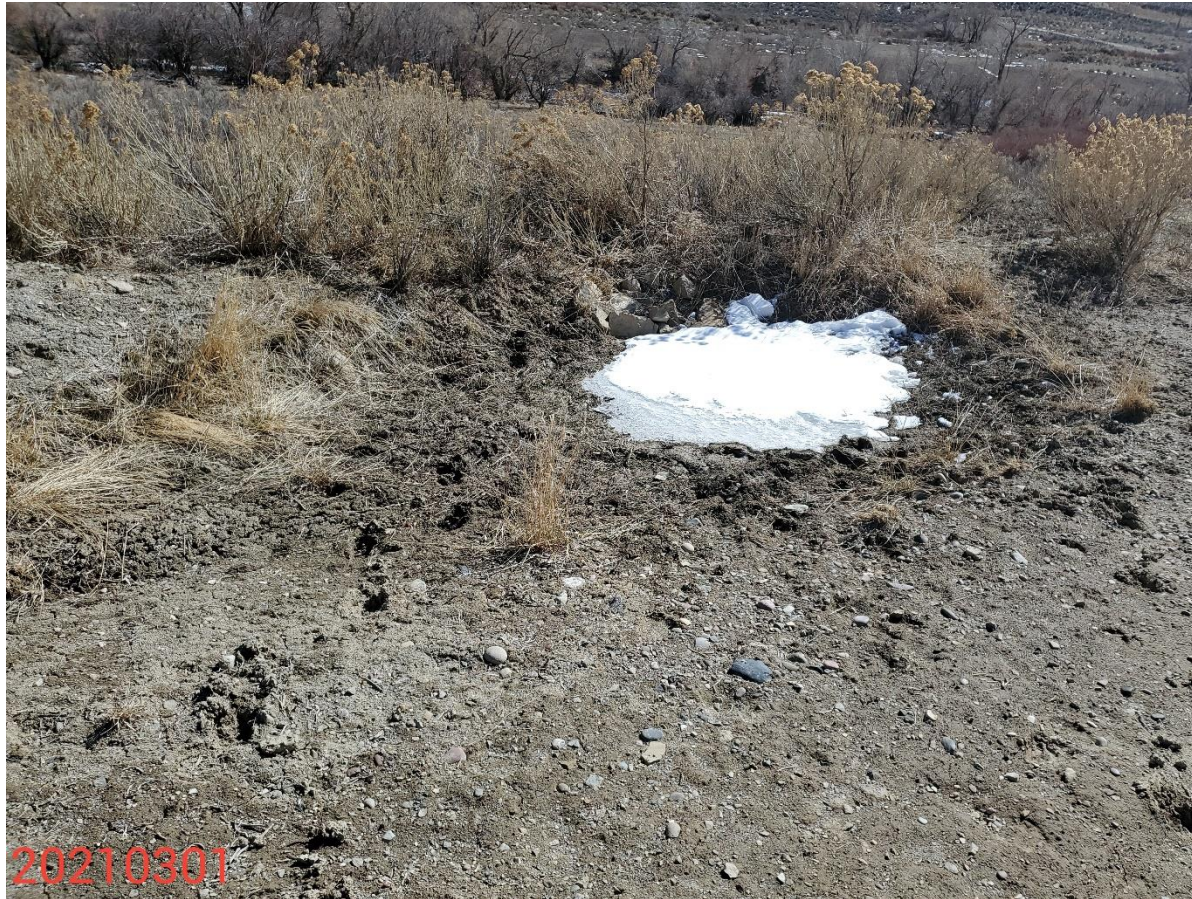
Photo 3: Photo taken from the east end of the Location, facing east. Photo shows sediment trap with armored outlet.

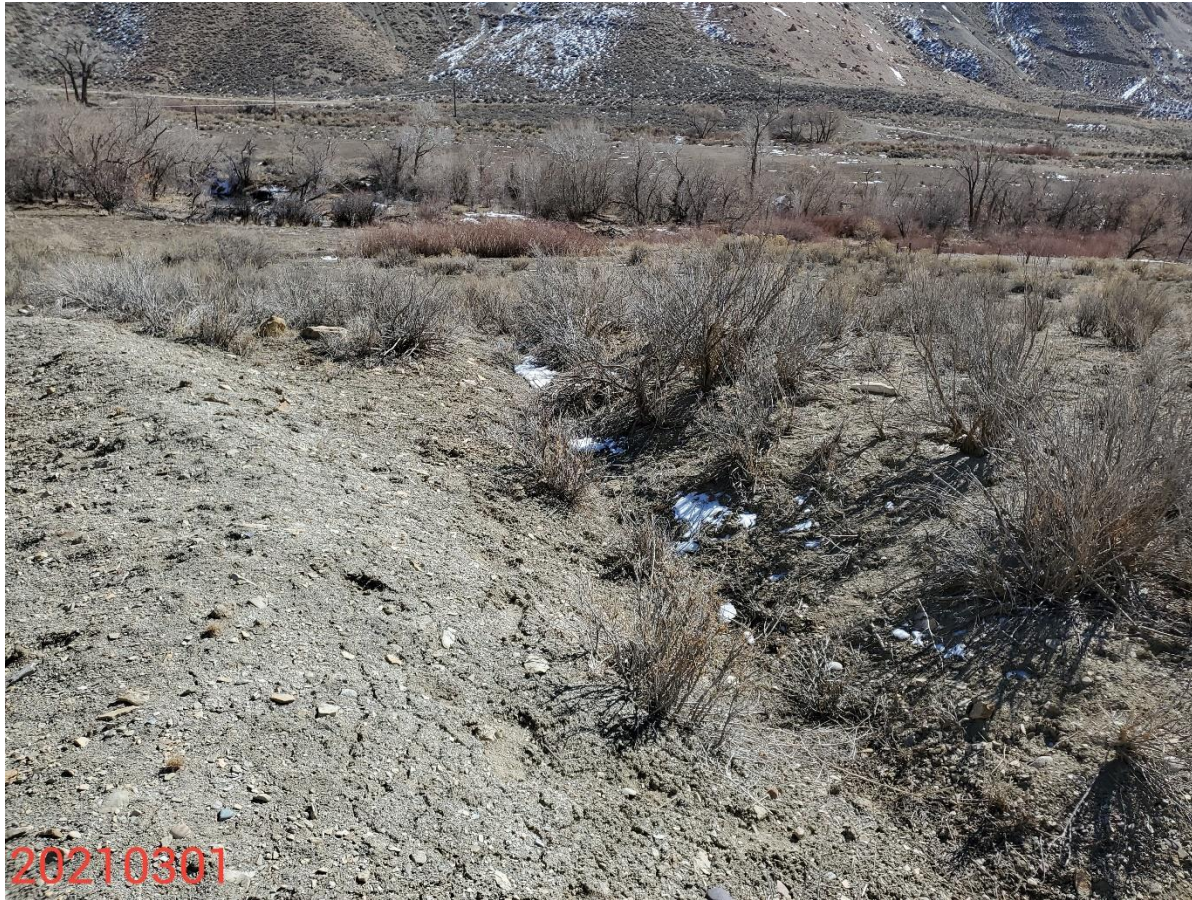
Photo 4: Photo taken from the south end of the Location, facing east. Photo shows perimeter stormwater ditch. Ditch currently discharges directly from pad onto the adjacent interim areas/lands; Ditch has not been constructed with an outlet to allow for sediment laden-free stormwater discharge

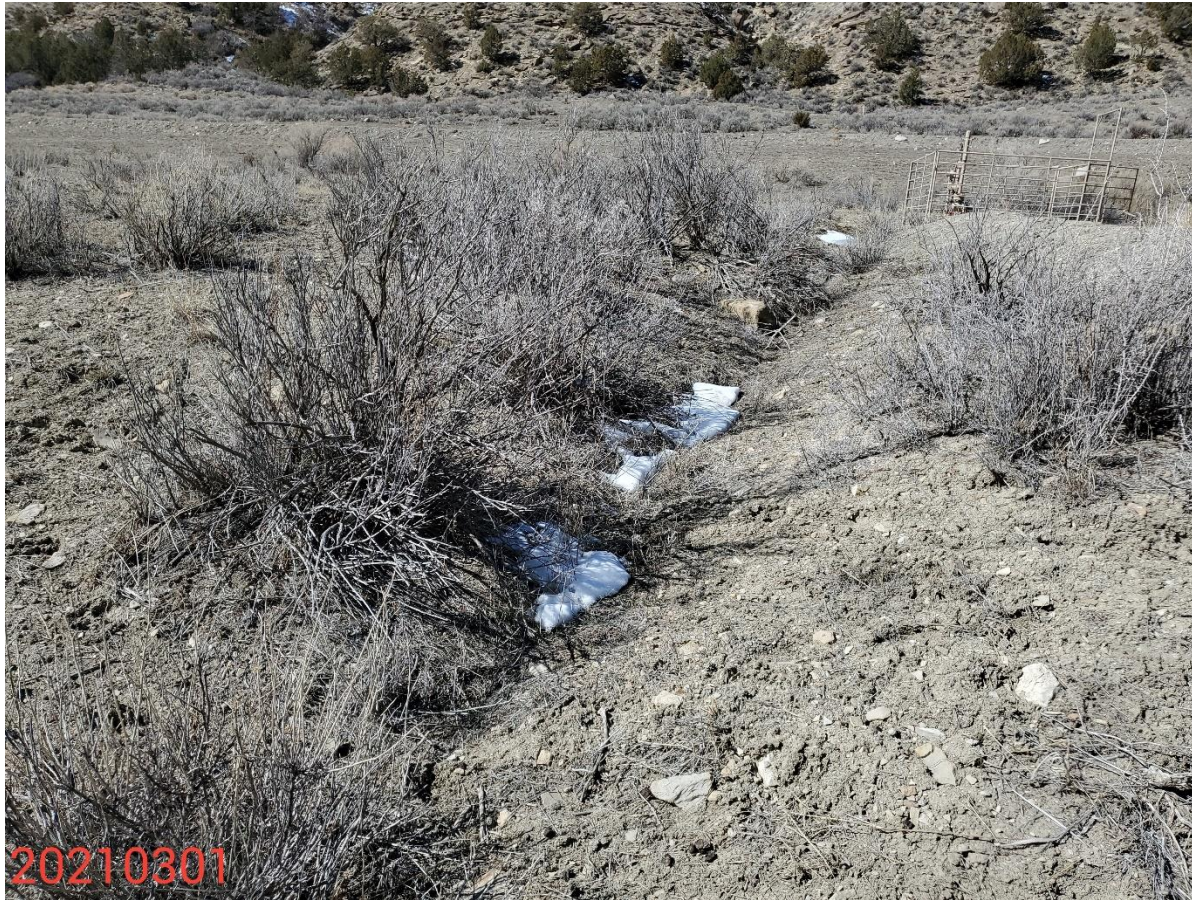
Photo 5: Continued from photo 4. Ditch currently discharges directly from pad onto the adjacent interim areas/lands; Ditch has not been constructed with an outlet to allow for sediment laden-free stormwater discharge

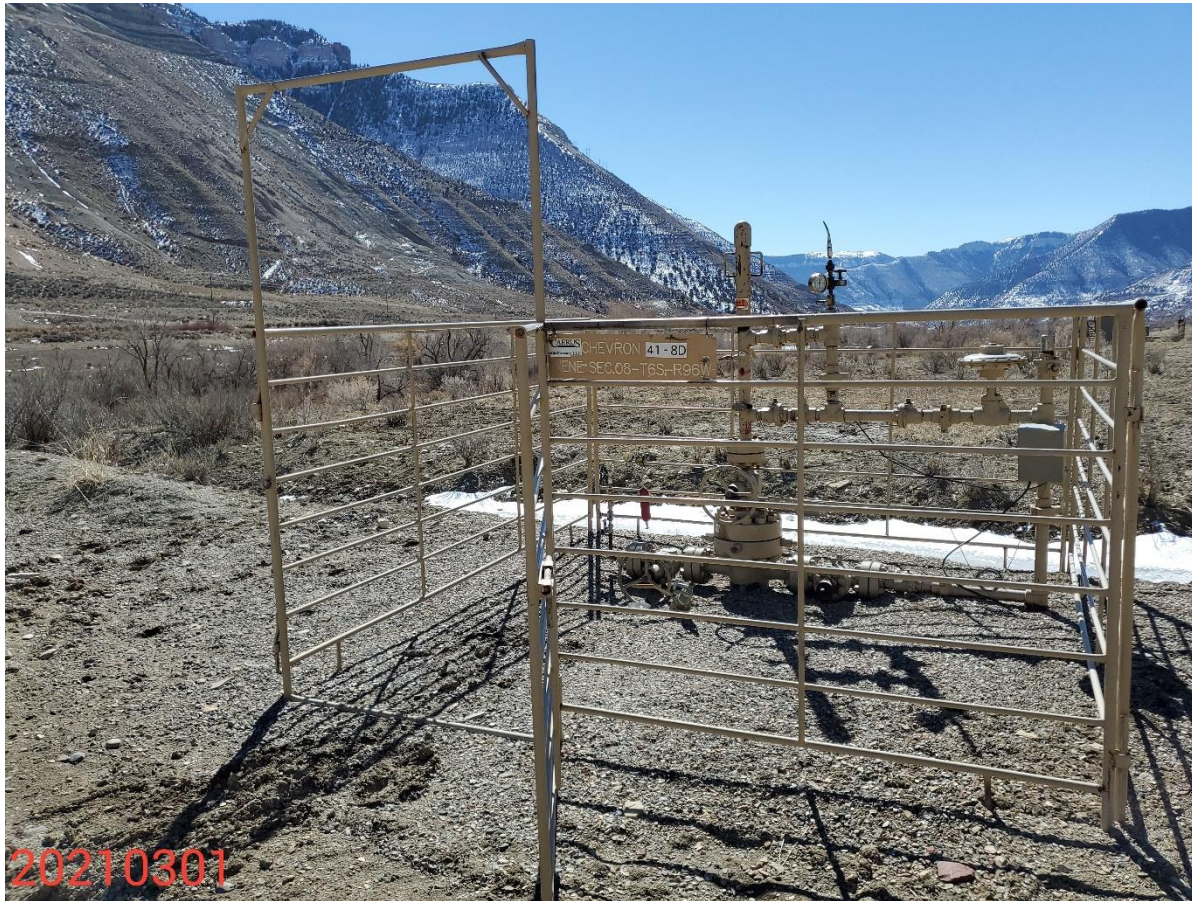
Photo 6: Photo of well and signage.

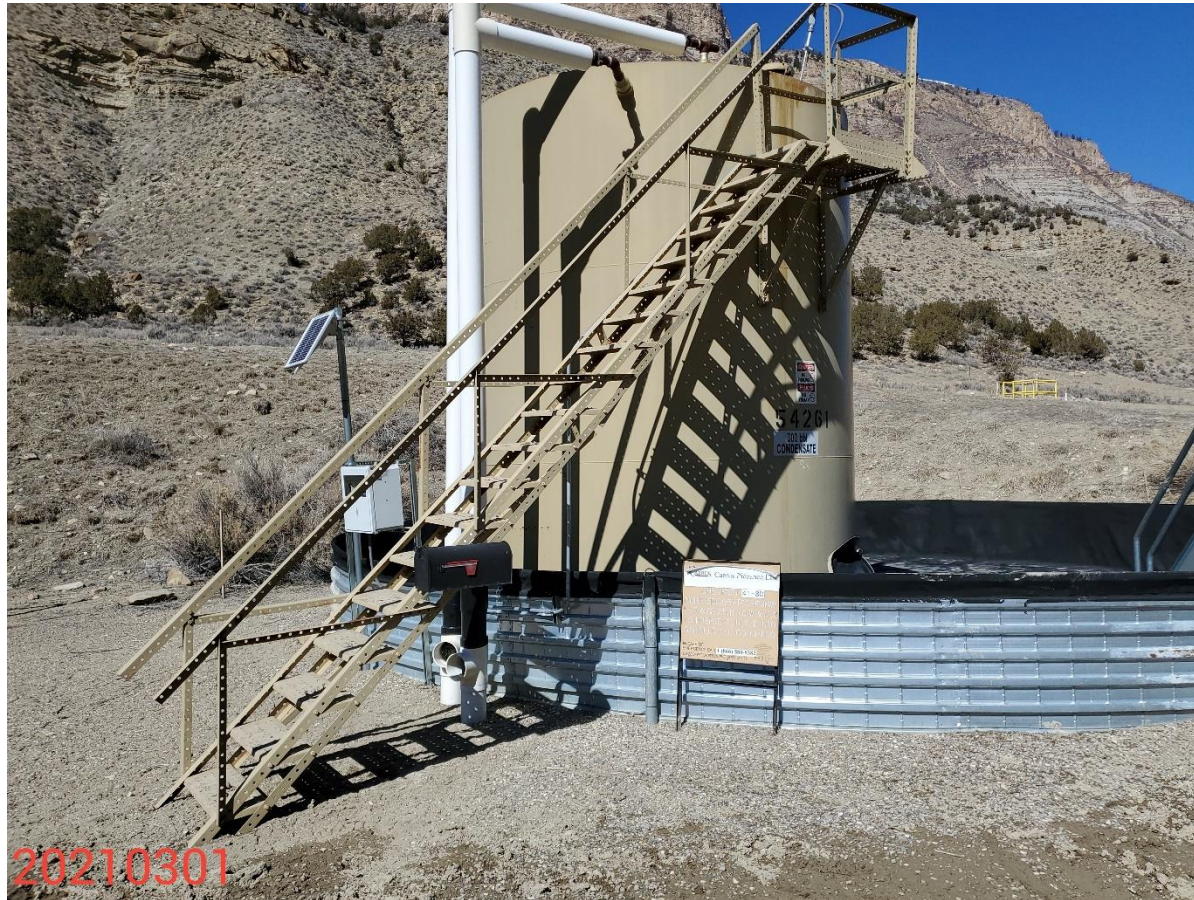
Photo 7: Photo of tank battery and signage.
