# Inspection Photos

Operator: Fritz & Digman  
API: 067-06141  
Date: 3/3/2021

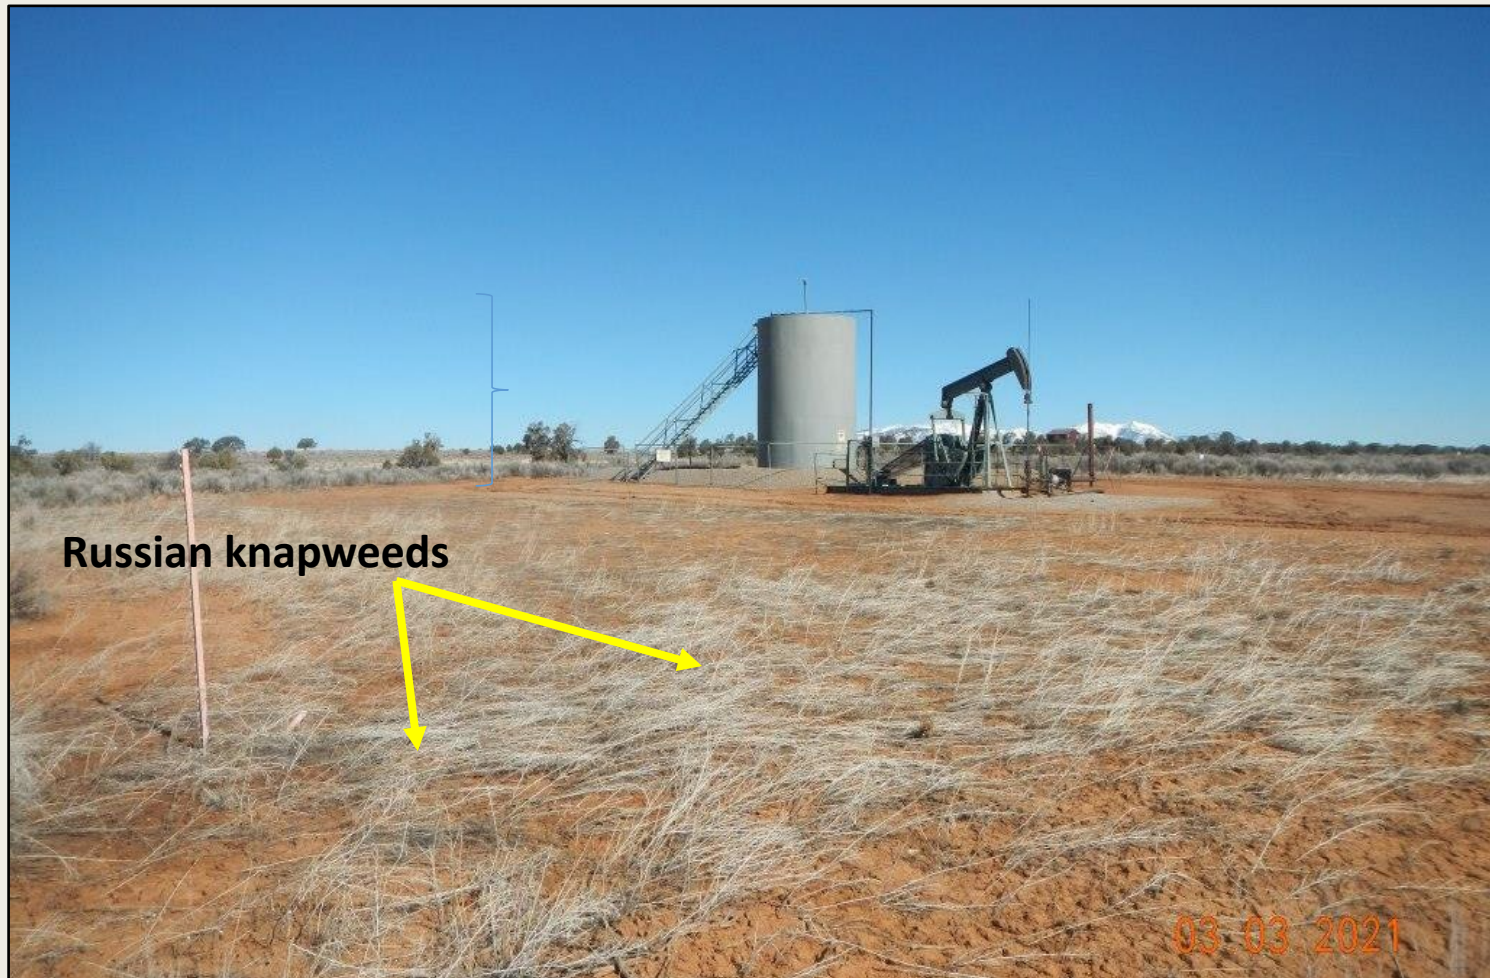
Photo 1. View of the project area from the southwestern corner facing center. Russian knapweeds appear to be treated, but need to be assessed during the active growing season.

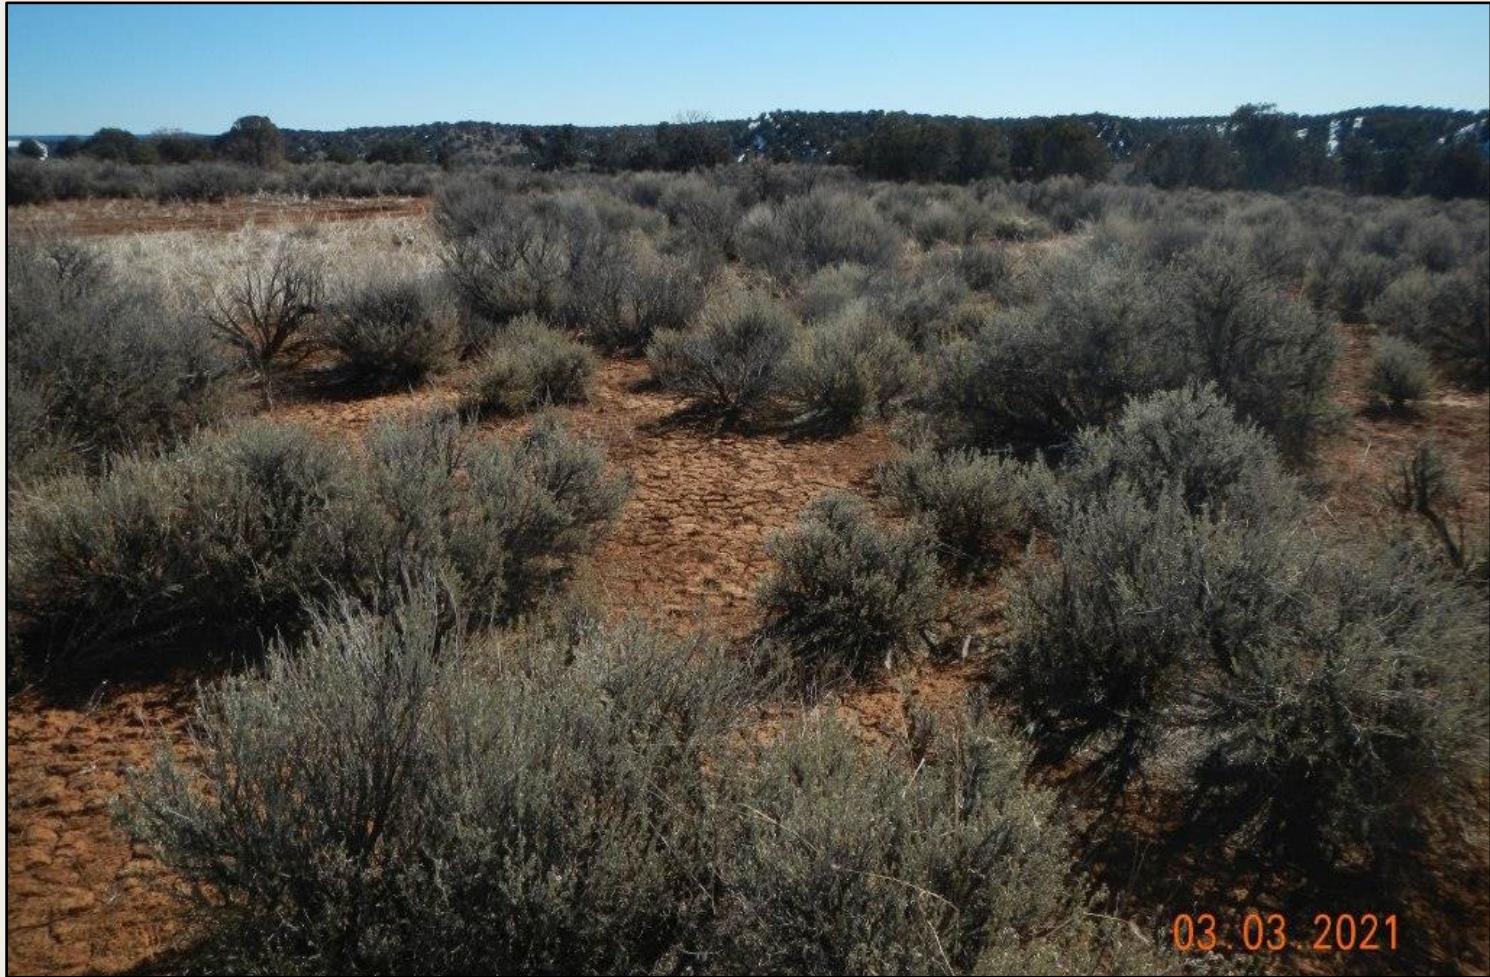
Photo 2. View of the southern project area from the southeastern corner facing northward. Vegetation is largely comprised of sagebrush, which is largely continuous with the surrounding sagebrush shrubland.

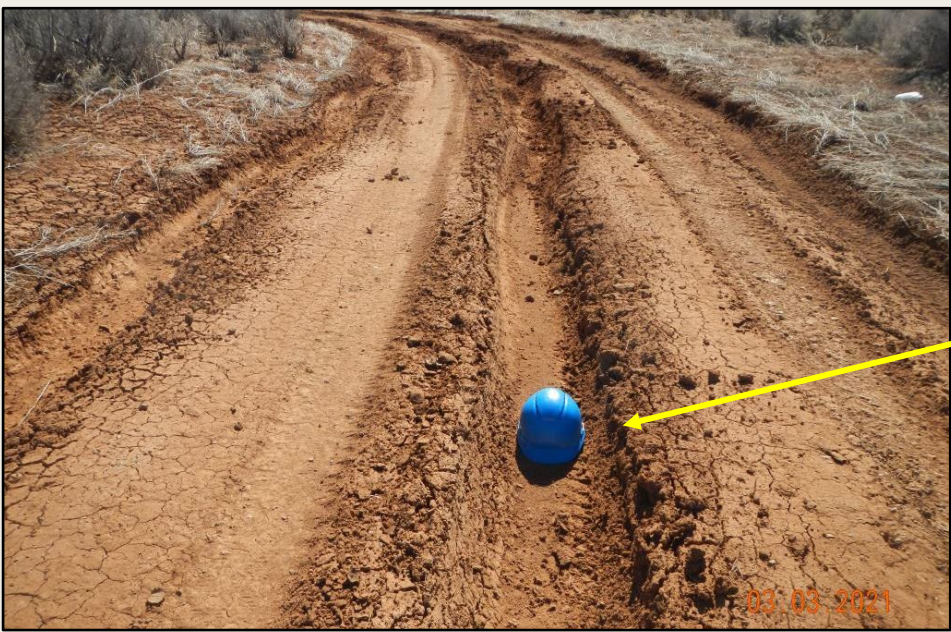
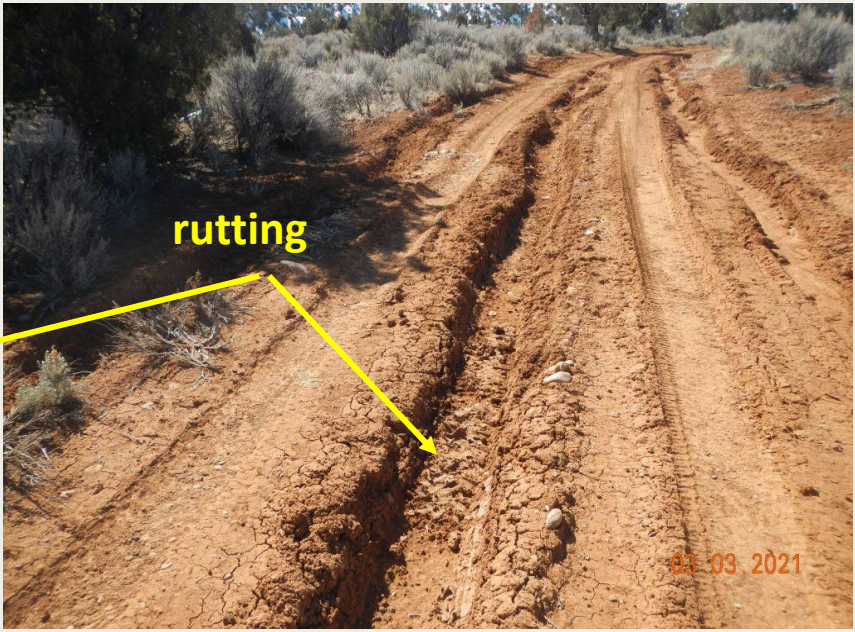
Photos 3/4. View of rutting and tracking up to 15 inches deep and wide observed along the access road.
