Inspection Photos

3/9/2021

Operator: CAERUS PICEANCE LLC #10456

Location ID: 335657

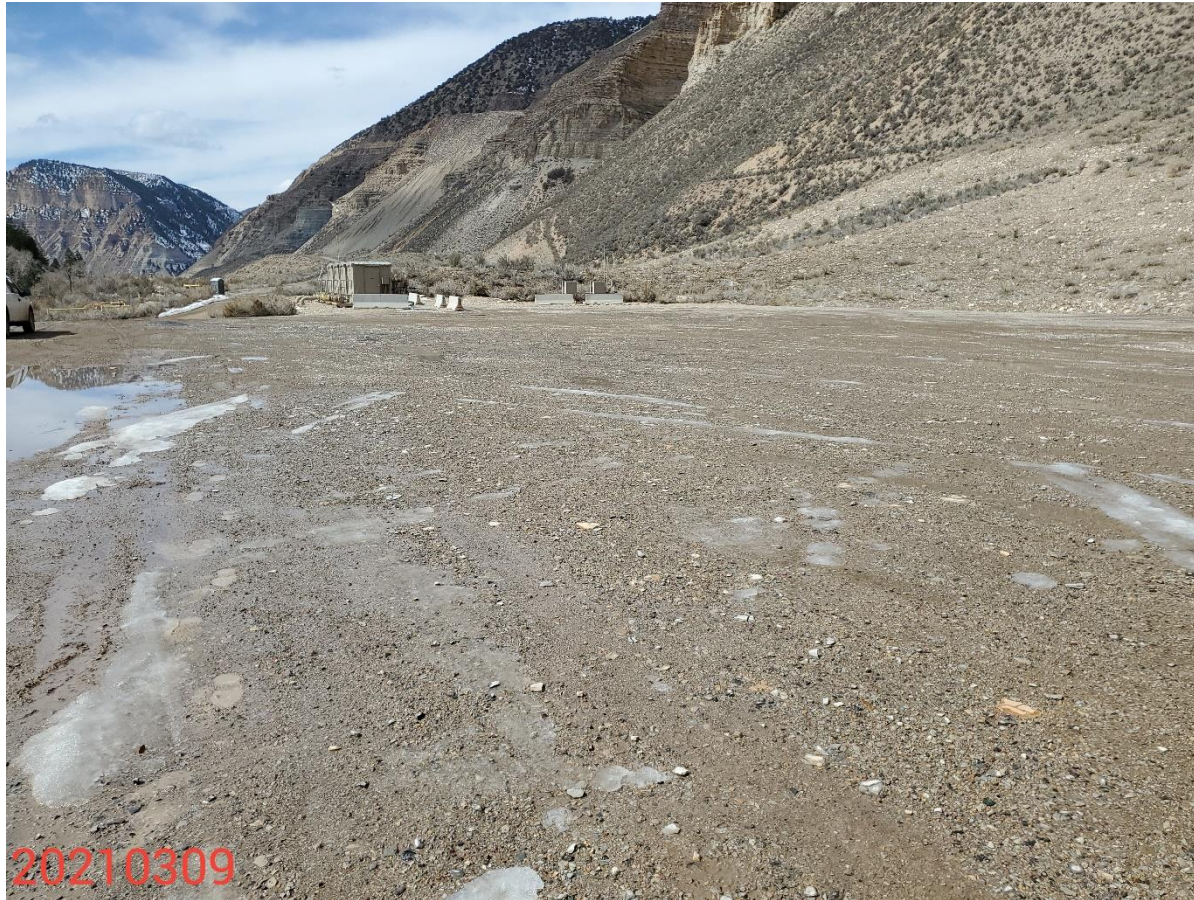
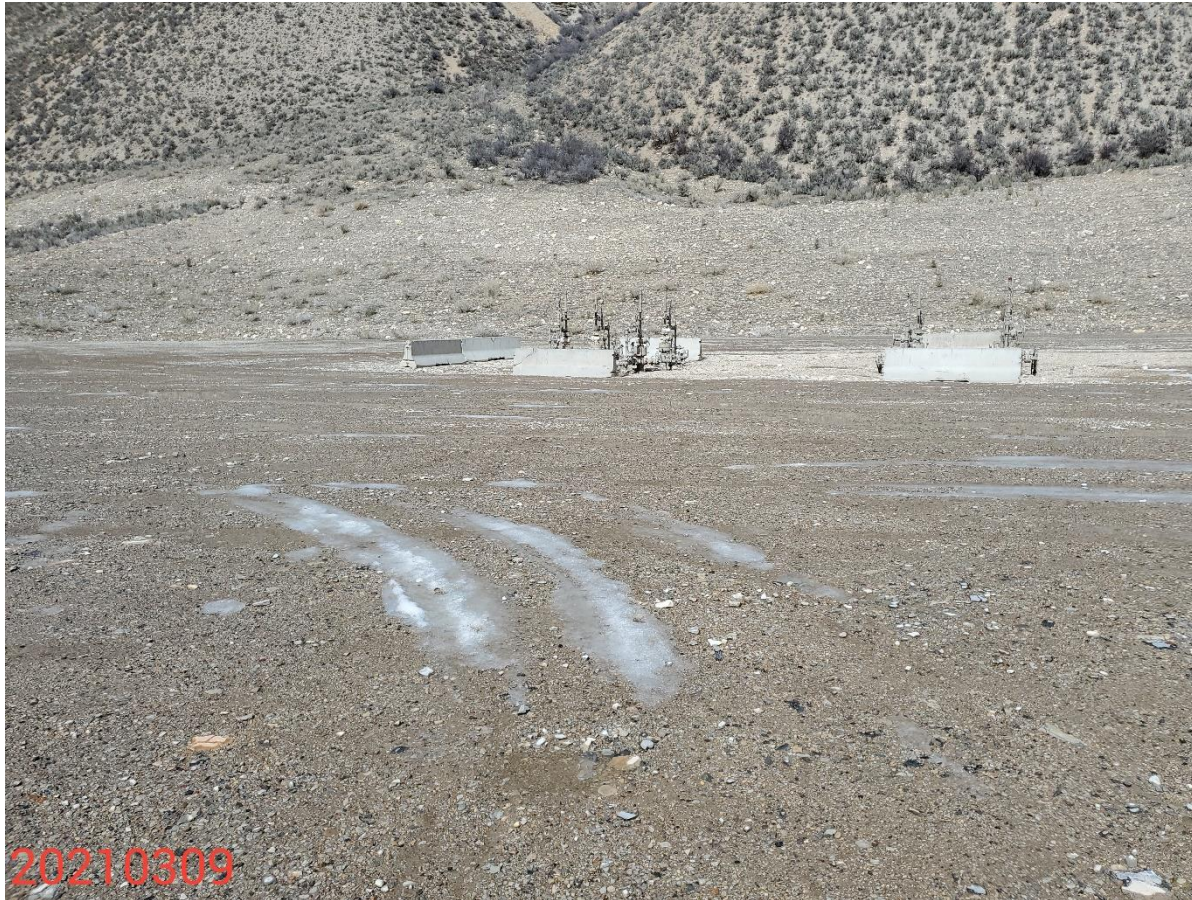
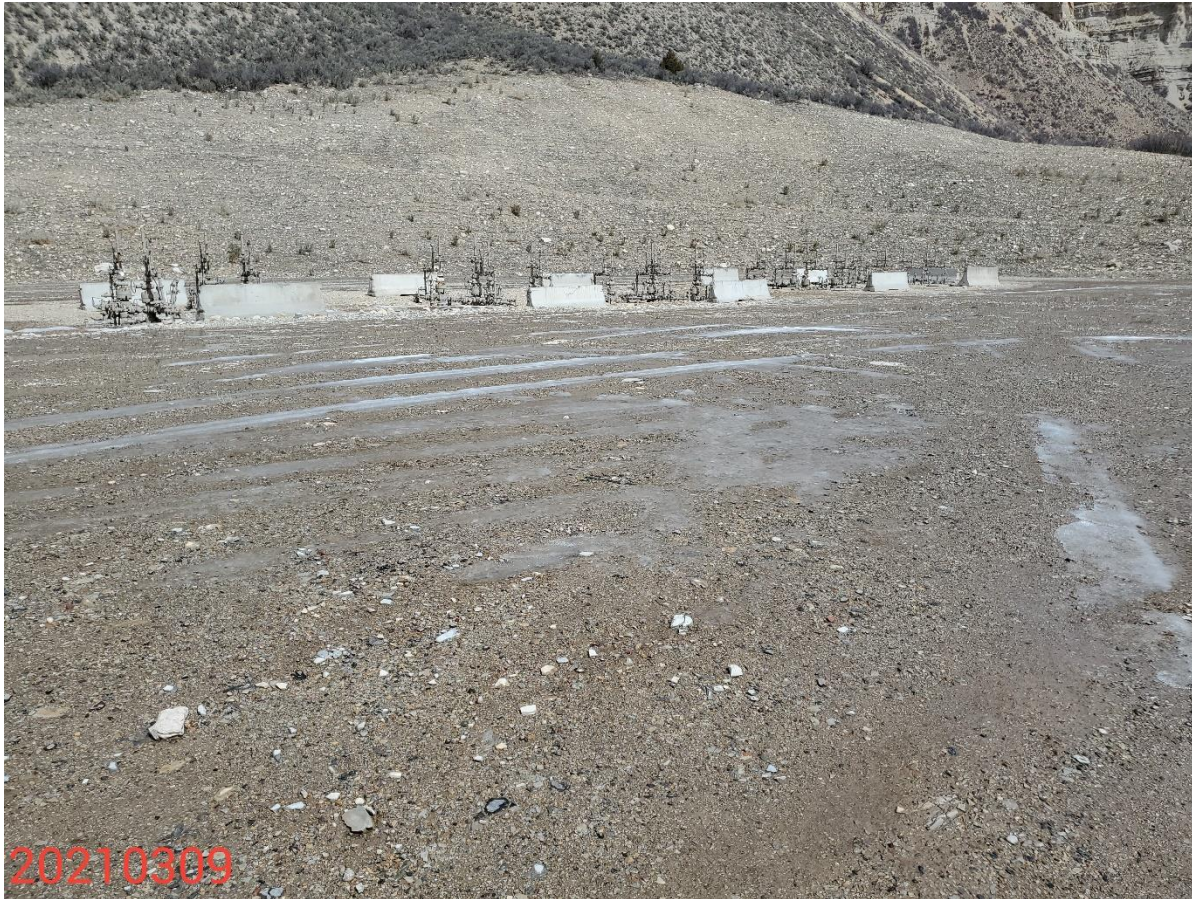
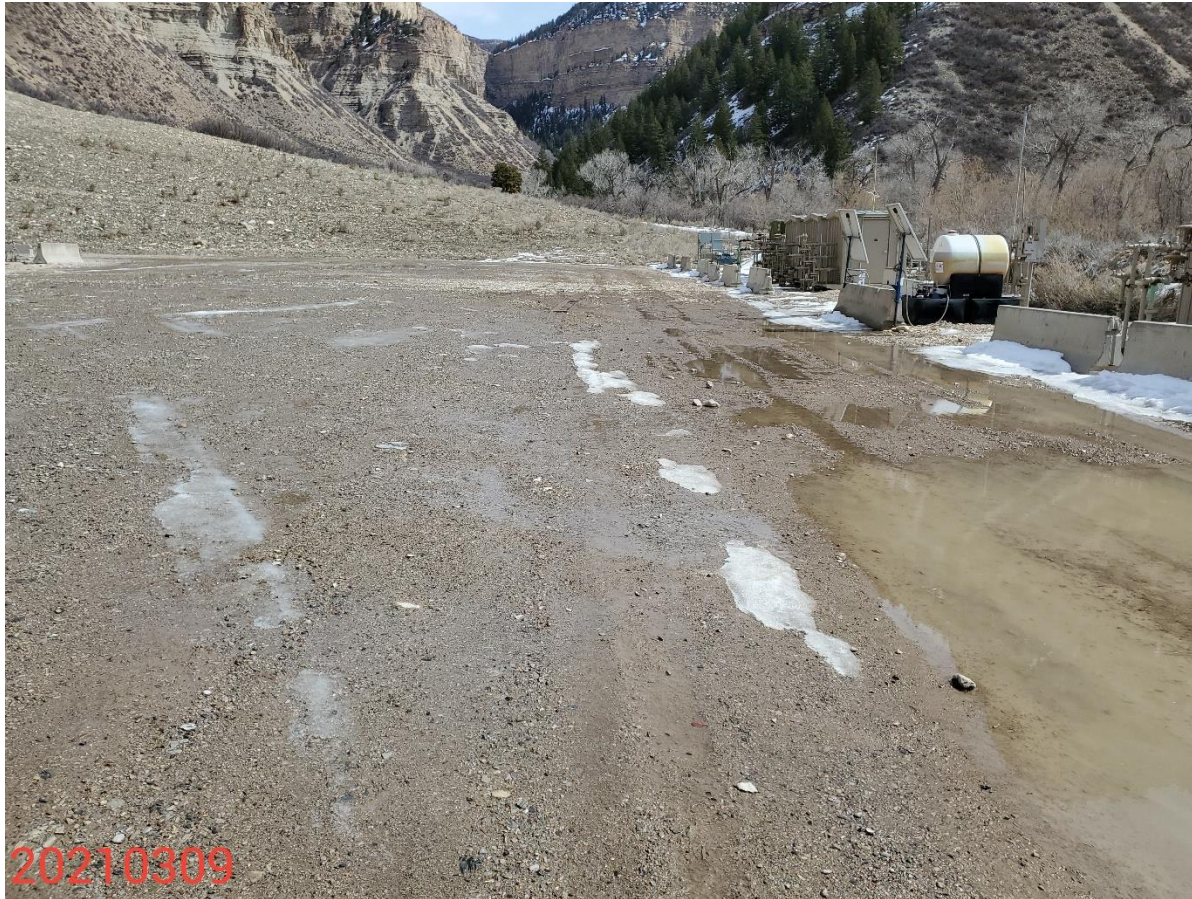
Photo 1: Photo taken from the south end of the Location, facing west. Photos 1-4 provide an overview of the Location from west, northwest, northeast to east.

Photo 2: See comments under photo 1.

Photo 3: See comments under photo 1.

Photo 4: See comments under photo 1.

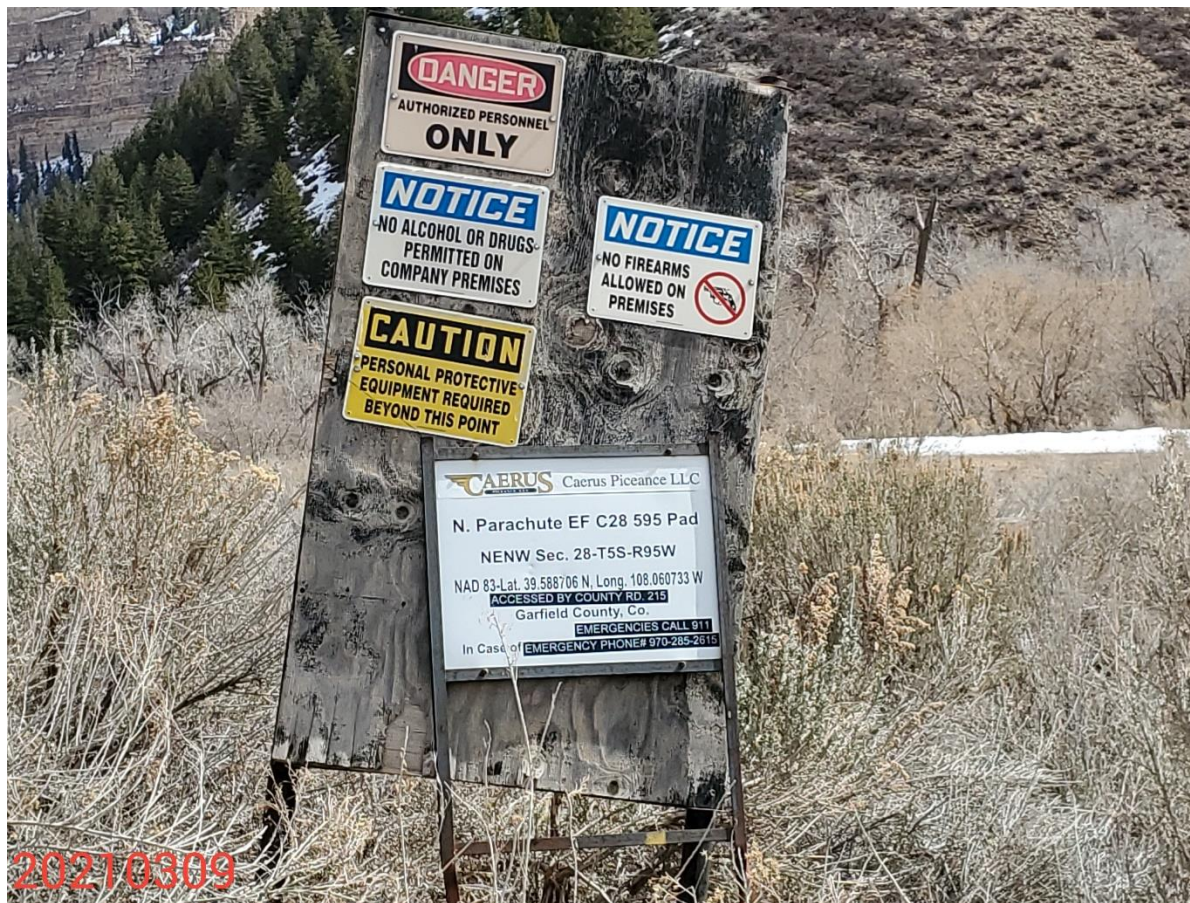
Photo 5: Photo of signs at location entrance.

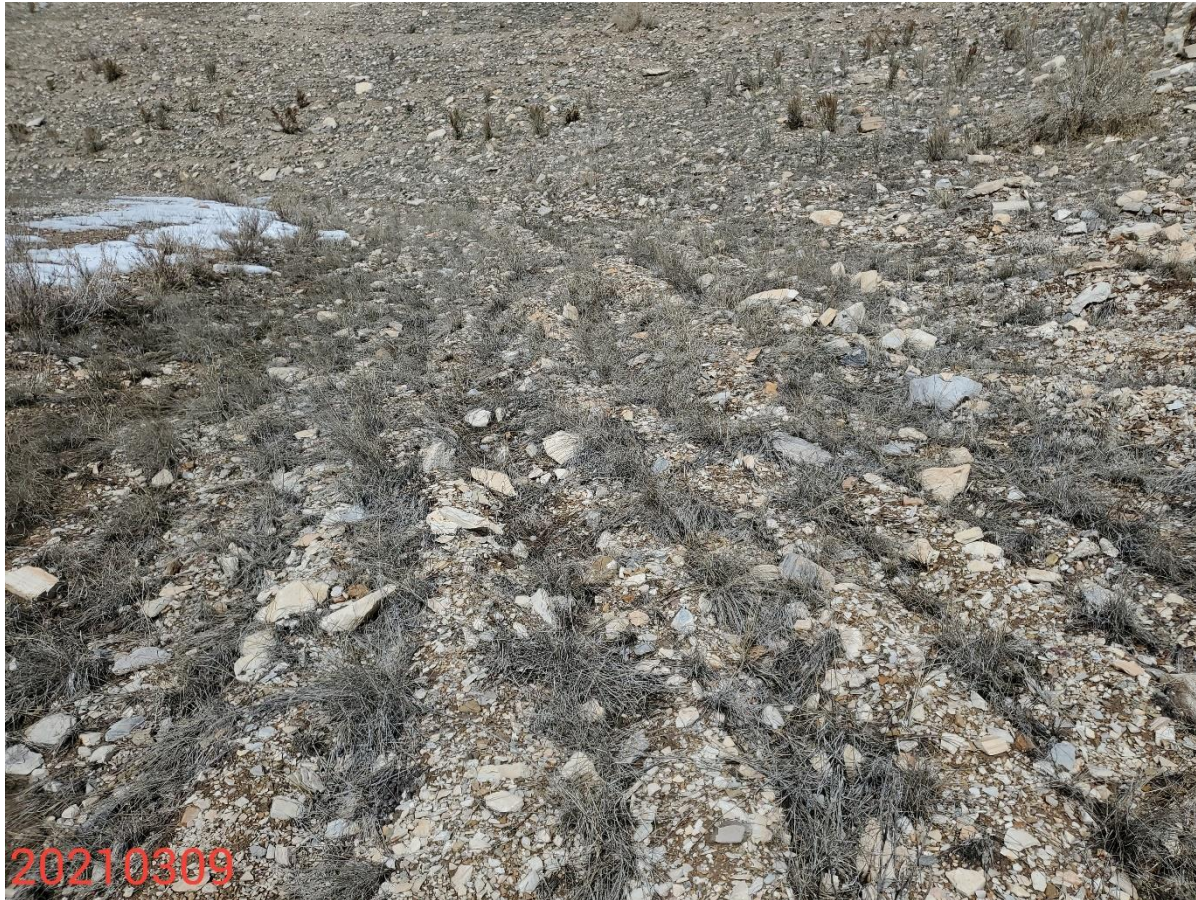
Photo 6: Photo taken from the northern interim areas. Interim areas appear to be progressing towards COGCC 1003 Standards.

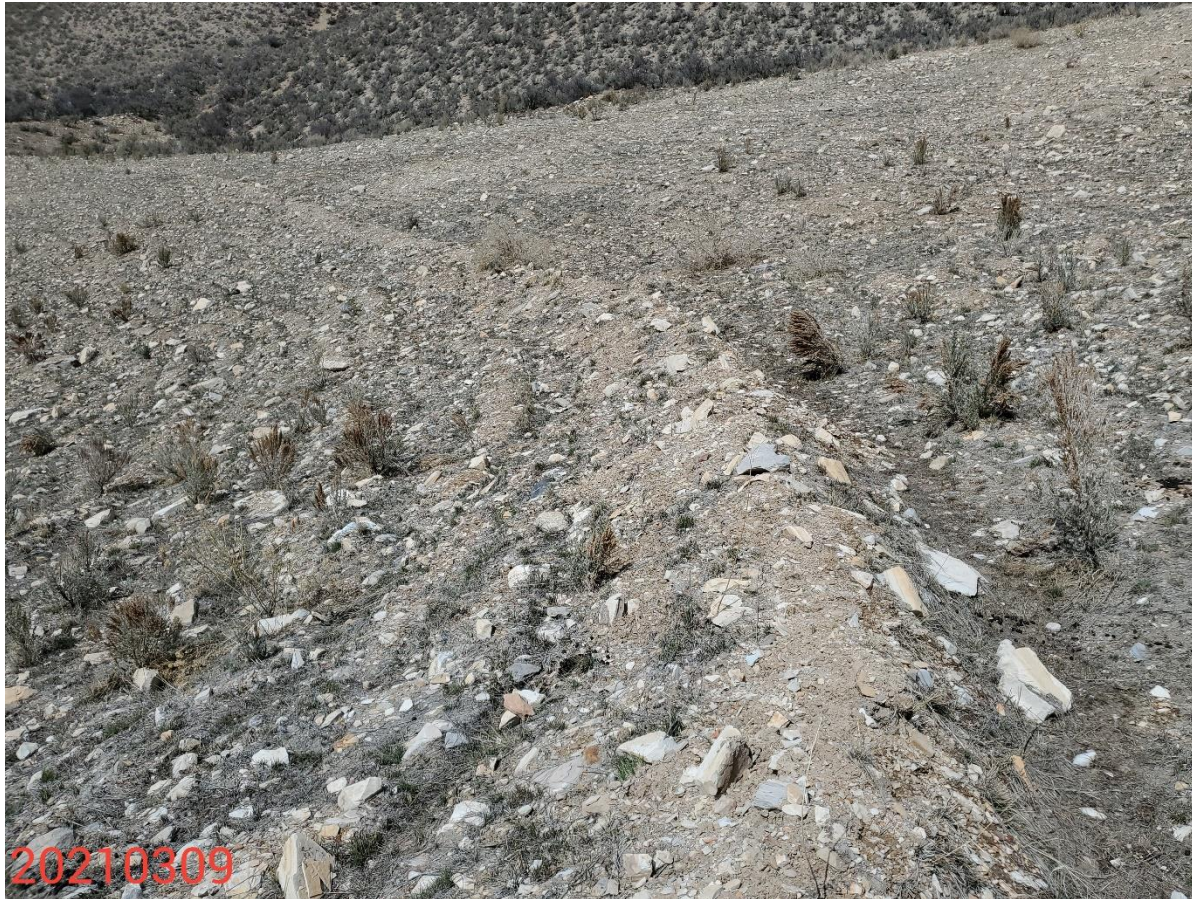
Photo 7: Photo taken from the northeastern interim areas. Interim areas appear to be progressing towards COGCC 1003 Standards. Photo also shows stormwater run-on ditch and berm installed at interim areas.

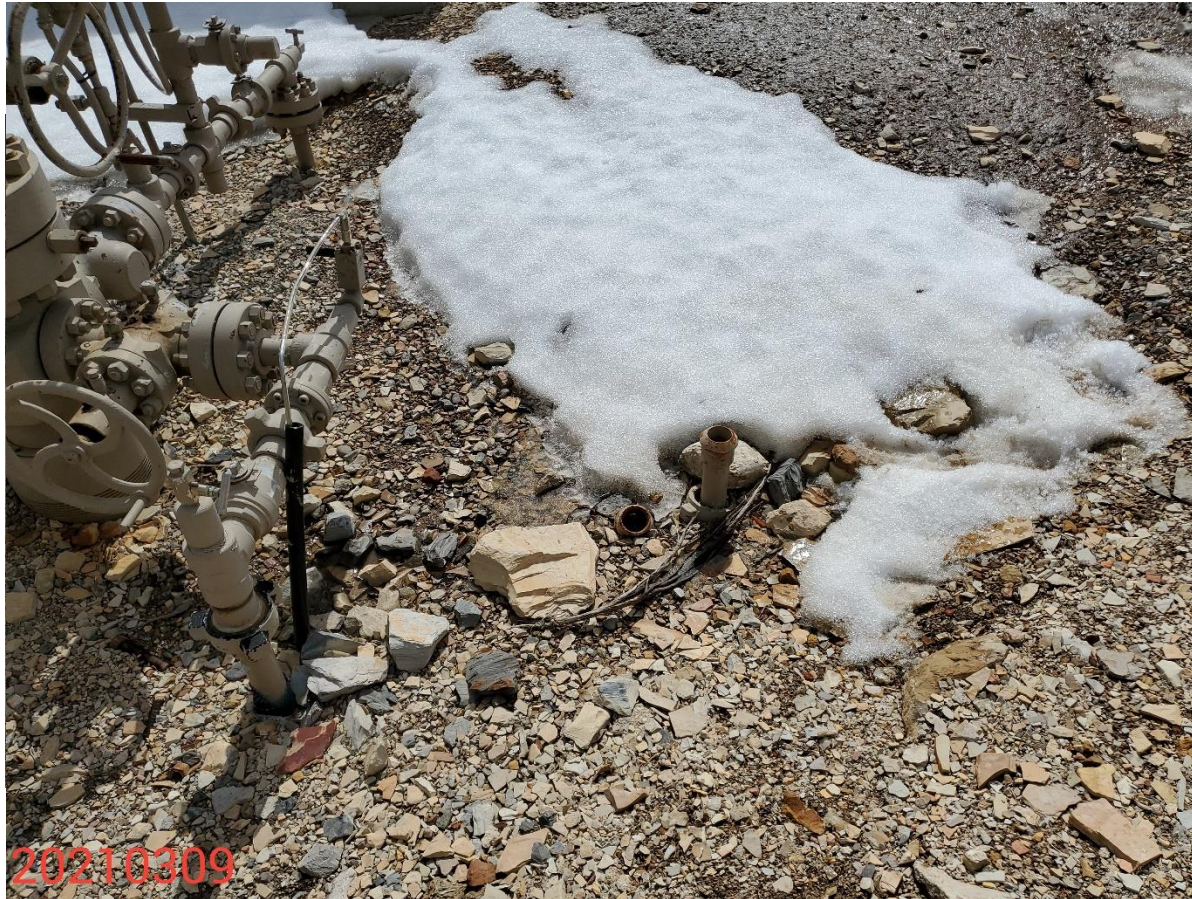
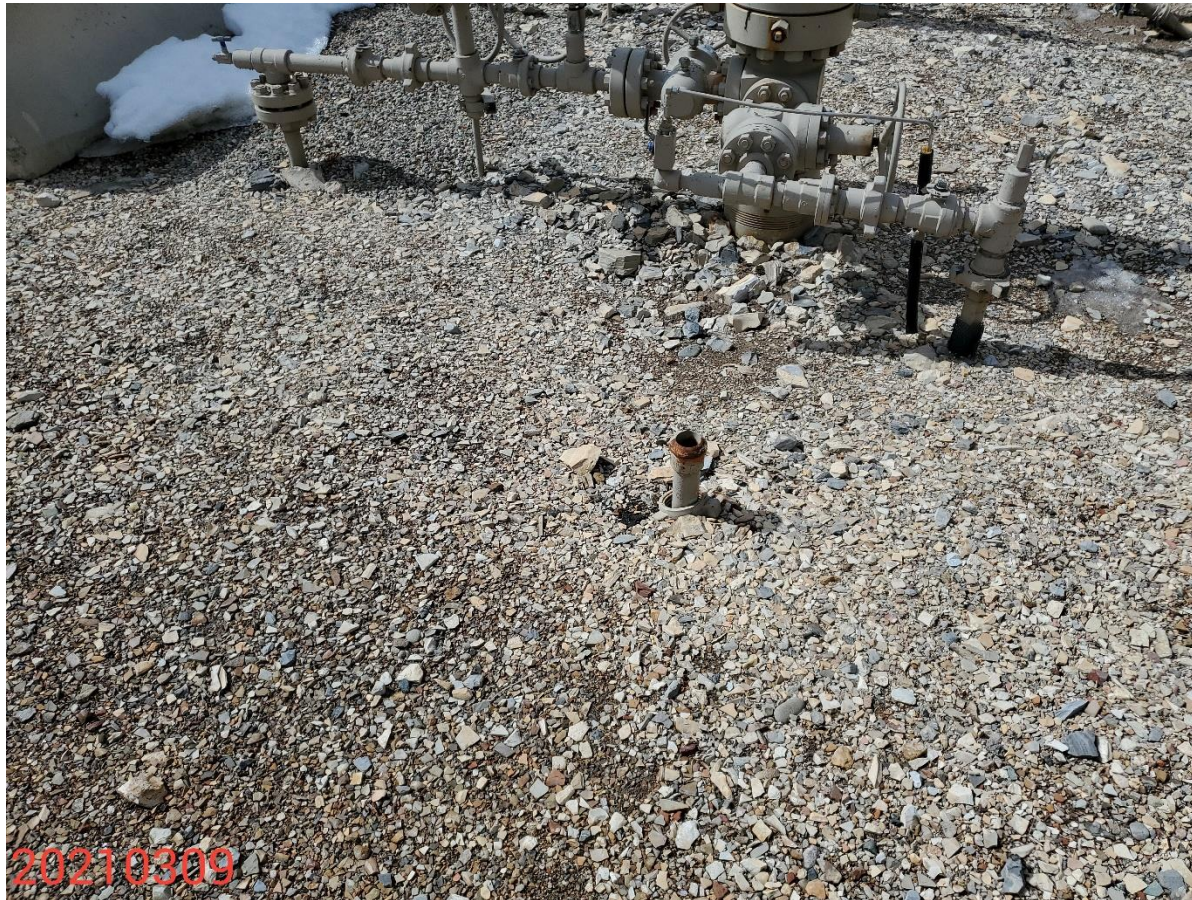
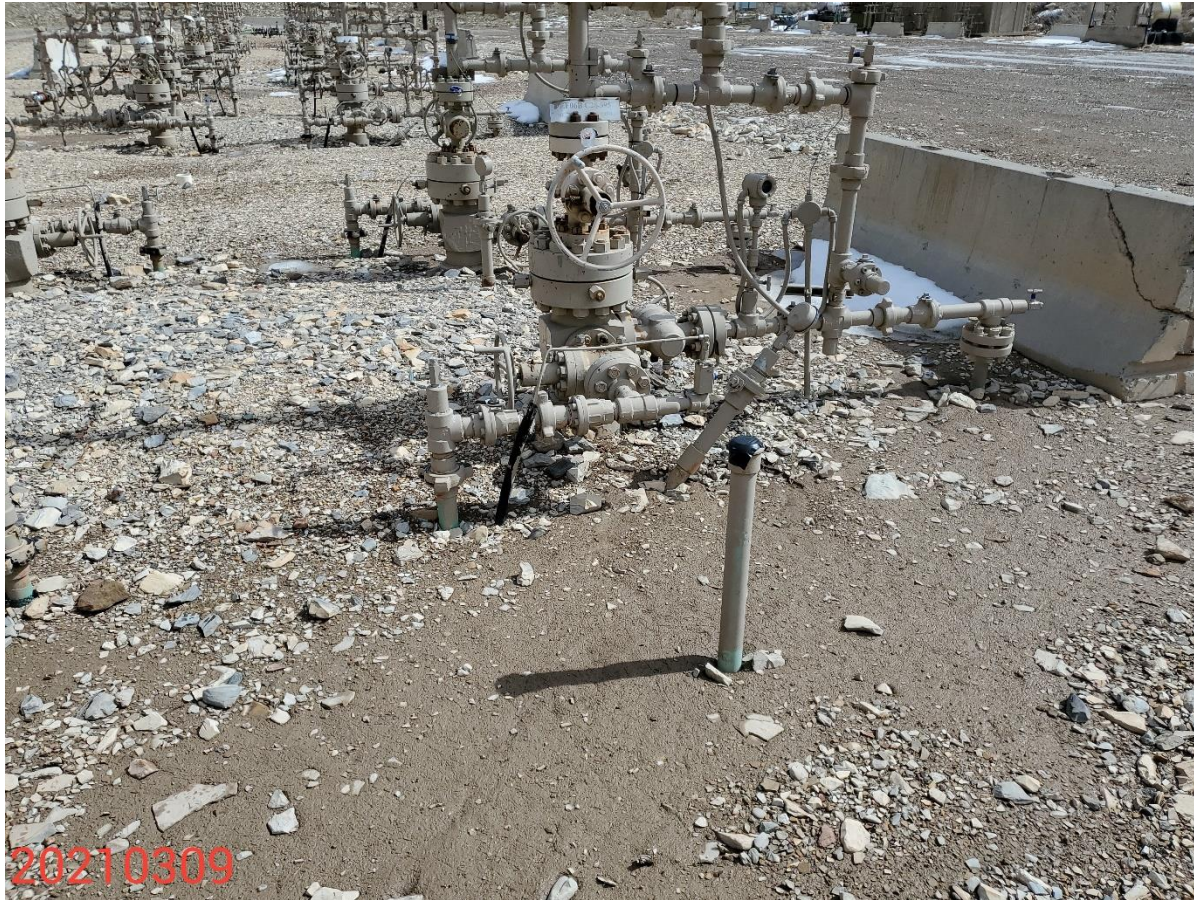
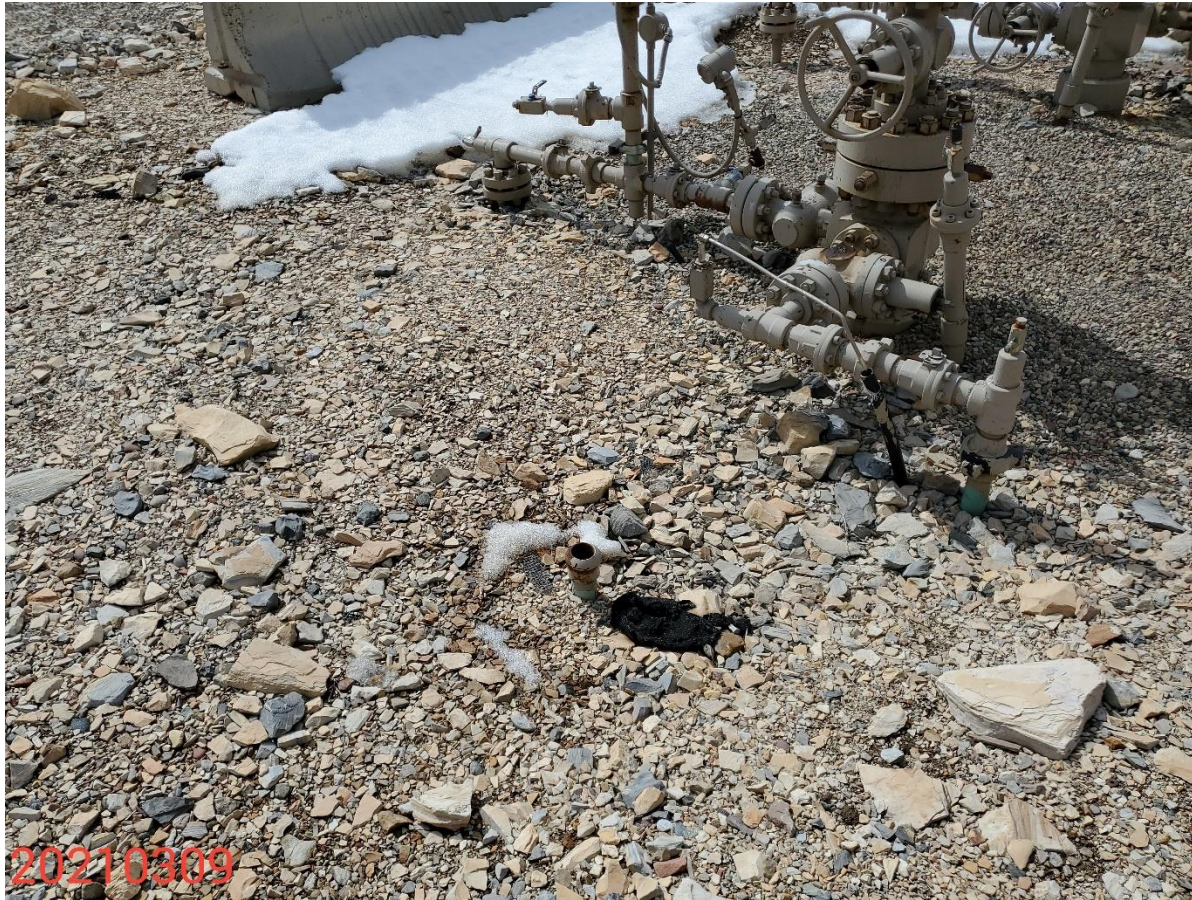
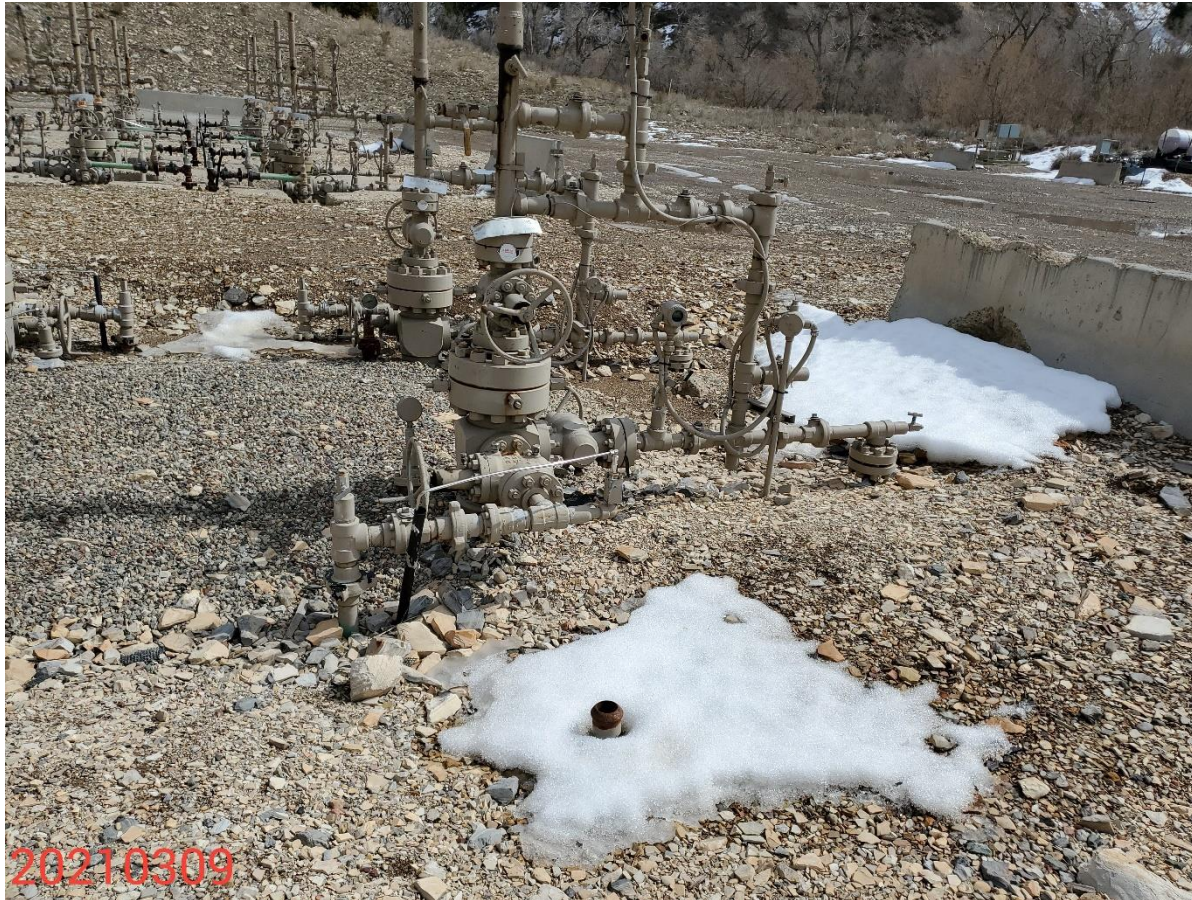
Photo 8: Photo taken from the wells. Photos 8-12 show unused equipment (risers) observed along the wells.

Photo 9: See comments under photo 8.

Photo 10: See comments under photo 8.

Photo 11: See comments under photo 8.

Photo 12: See comments under photo 8.
