# Inspection Photos

3/9/2021

Operator: CAERUS PICEANCE LLC #10456

Location ID: 335822

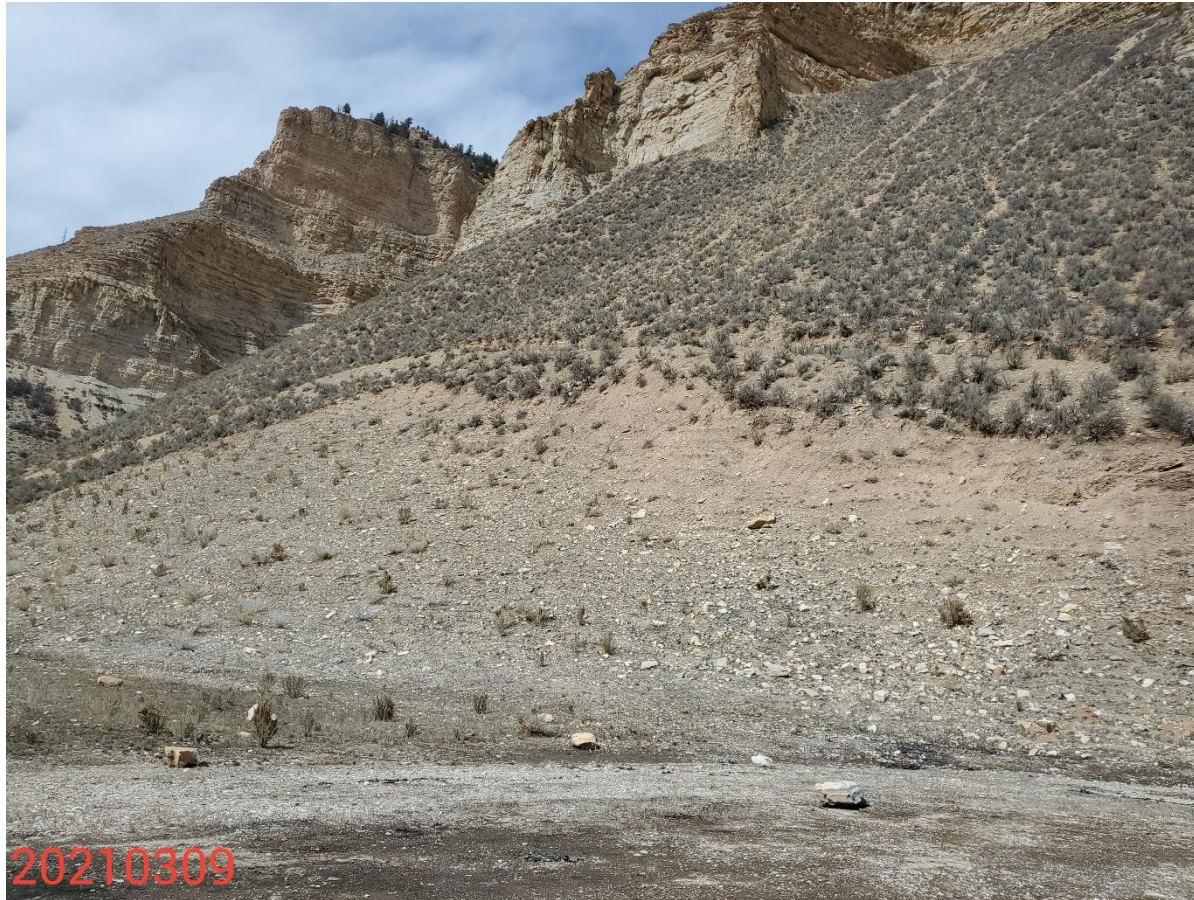
**Photo 1:** Photo taken from the north end of the Location, facing northwest. Photo shows interim areas where control measures to stabilize the slopes and ditch are missing or insufficient. Photo also show reclamation in these areas are not progressing towards 1003 reclamation standards.

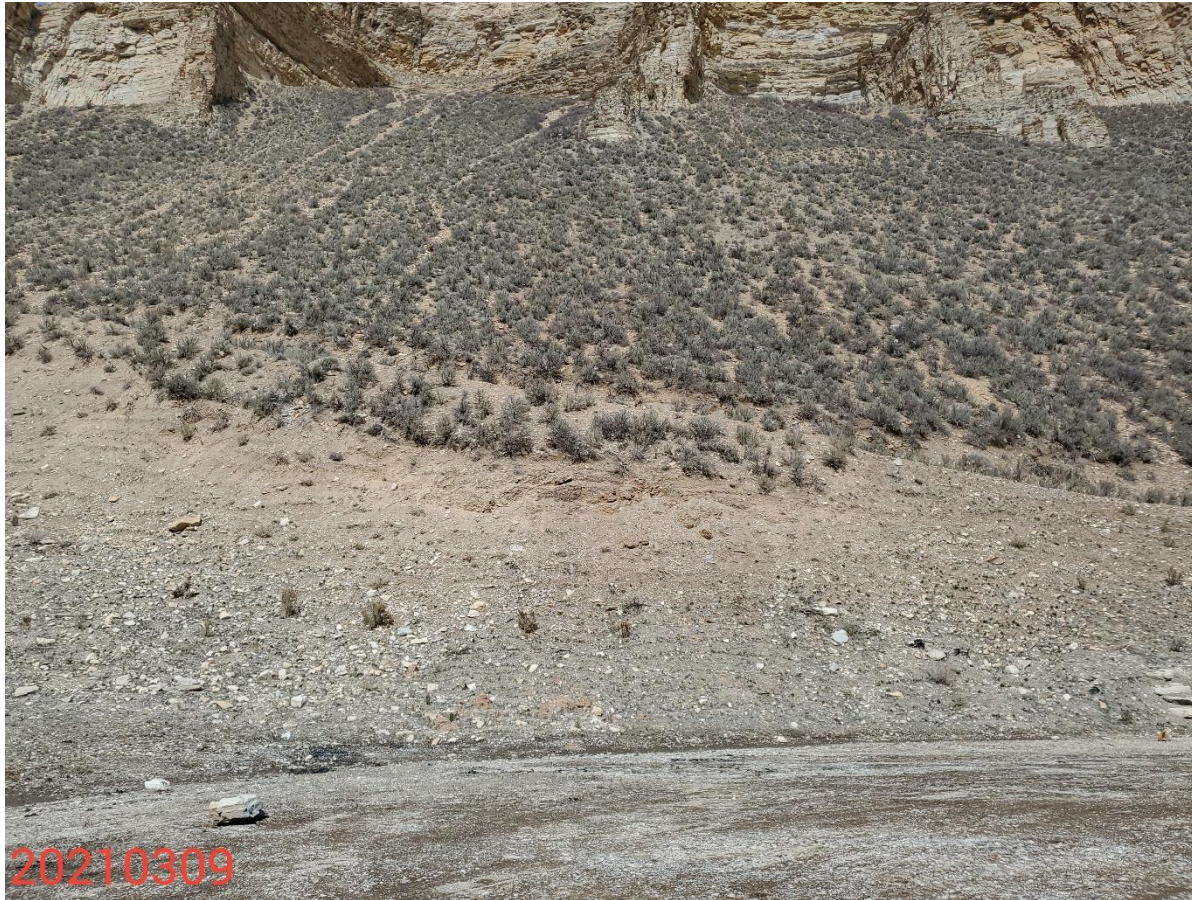
**Photo 2:** See comments under photo 1.

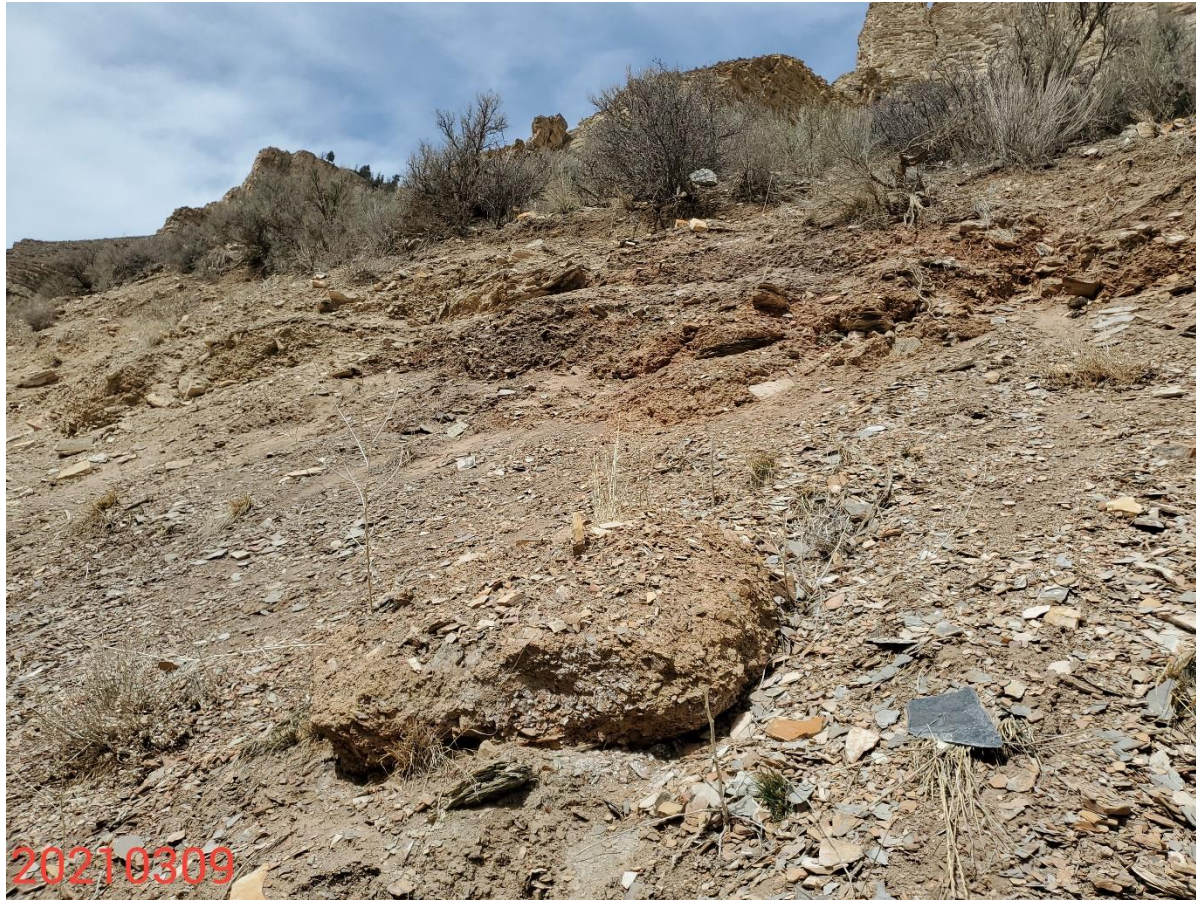
**Photo 3:** Photo taken from the interim areas on the north end of the Location. Photo shows that control measures to stabilize and protect the slopes are missing or insufficient. Uniform vegetative establishment on interim areas is not progressing towards 1003 standards.

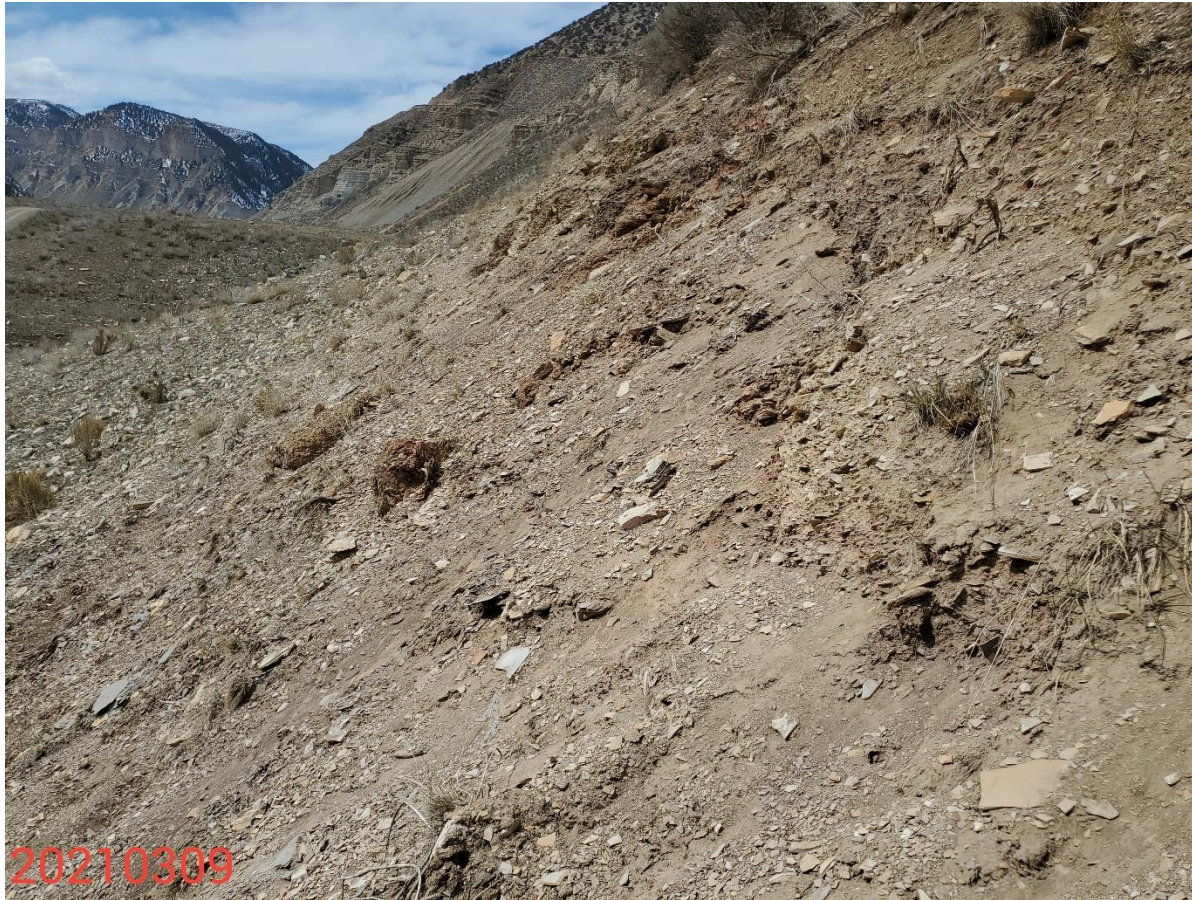
**Photo 4:** Photo taken from the interim areas on the north end of the Location, facing west. Photo shows that control measures to stabilize and protect the slopes are missing or insufficient. Uniform vegetative establishment on interim areas is not progressing towards 1003 standards.

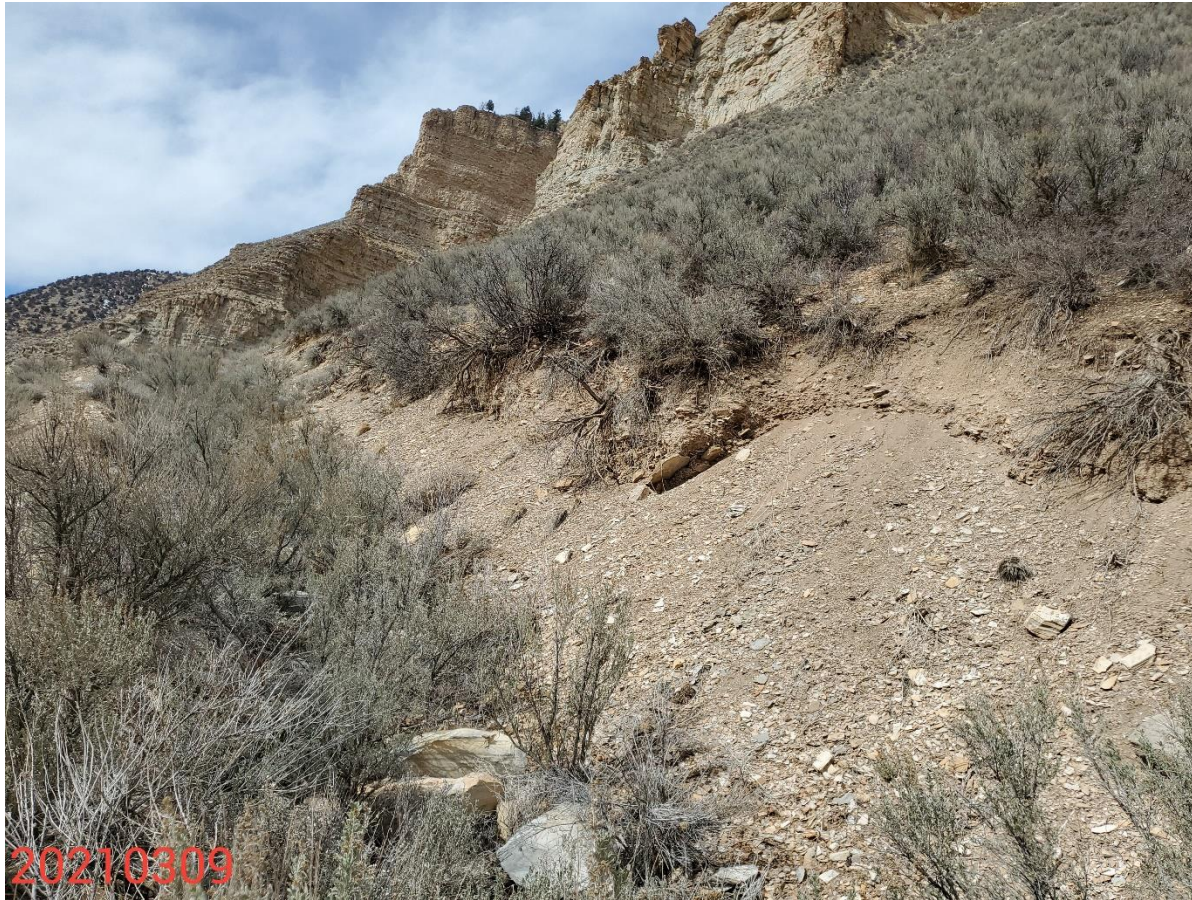
**Photo 5:** Photo taken from the stormwater ditch along the northern interim areas, facing west. Photo shows BMP is not in proper functioning condition; slopes along ditch have not been sufficiently stabilized; erosion degradation evident.

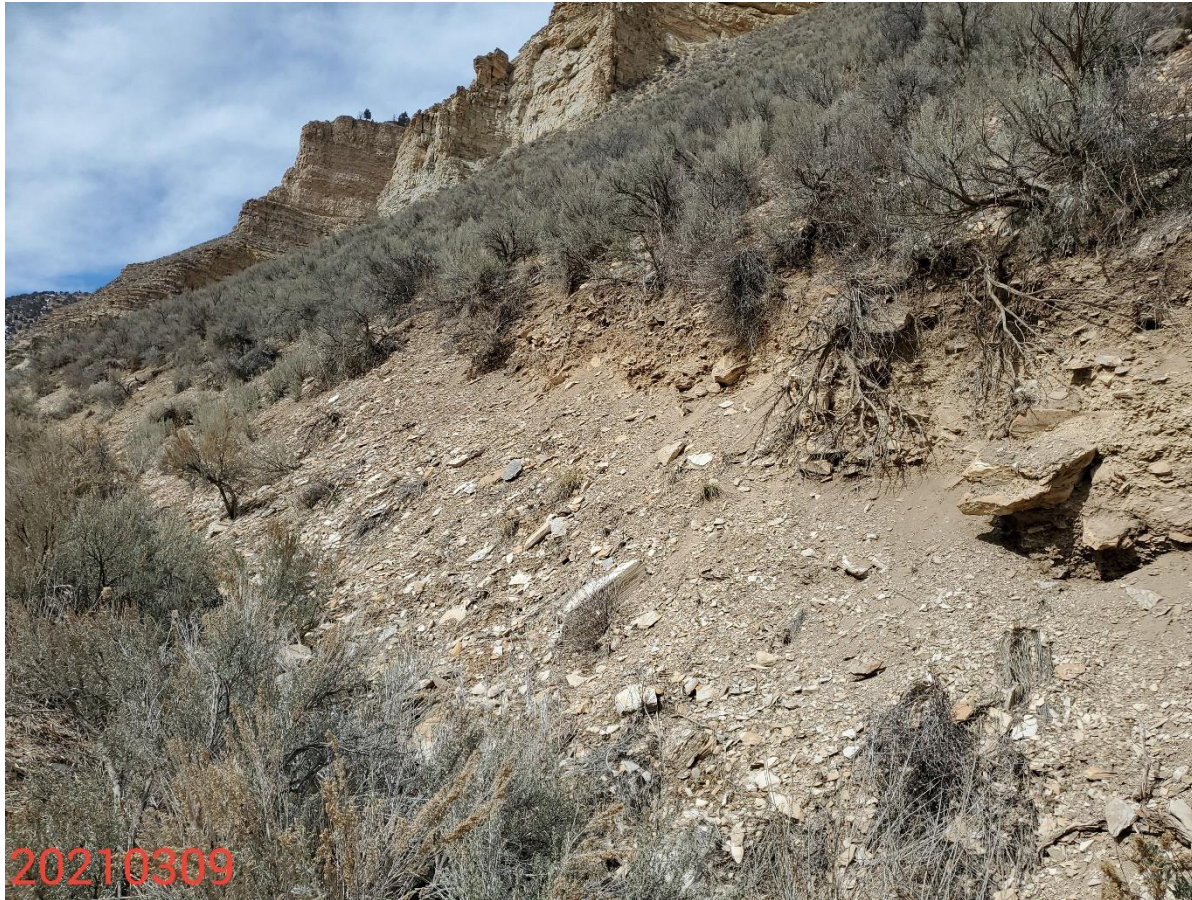
**Photo 6:** Photo taken from the stormwater ditch along the northern interim areas, facing west. Photo shows BMP is not in proper functioning condition; slopes along ditch have not been sufficiently stabilized; erosion degradation evident.
