TANK BATTERY DECOMMISSIONING FORM

| SITE NAME: Owl Creek 7, 7-5 Tank Battery | | | | | | | DATE: 2/16/2021 | REM. PROJECT #: | WEATHER: Sunny ~ 5 degrees | | |

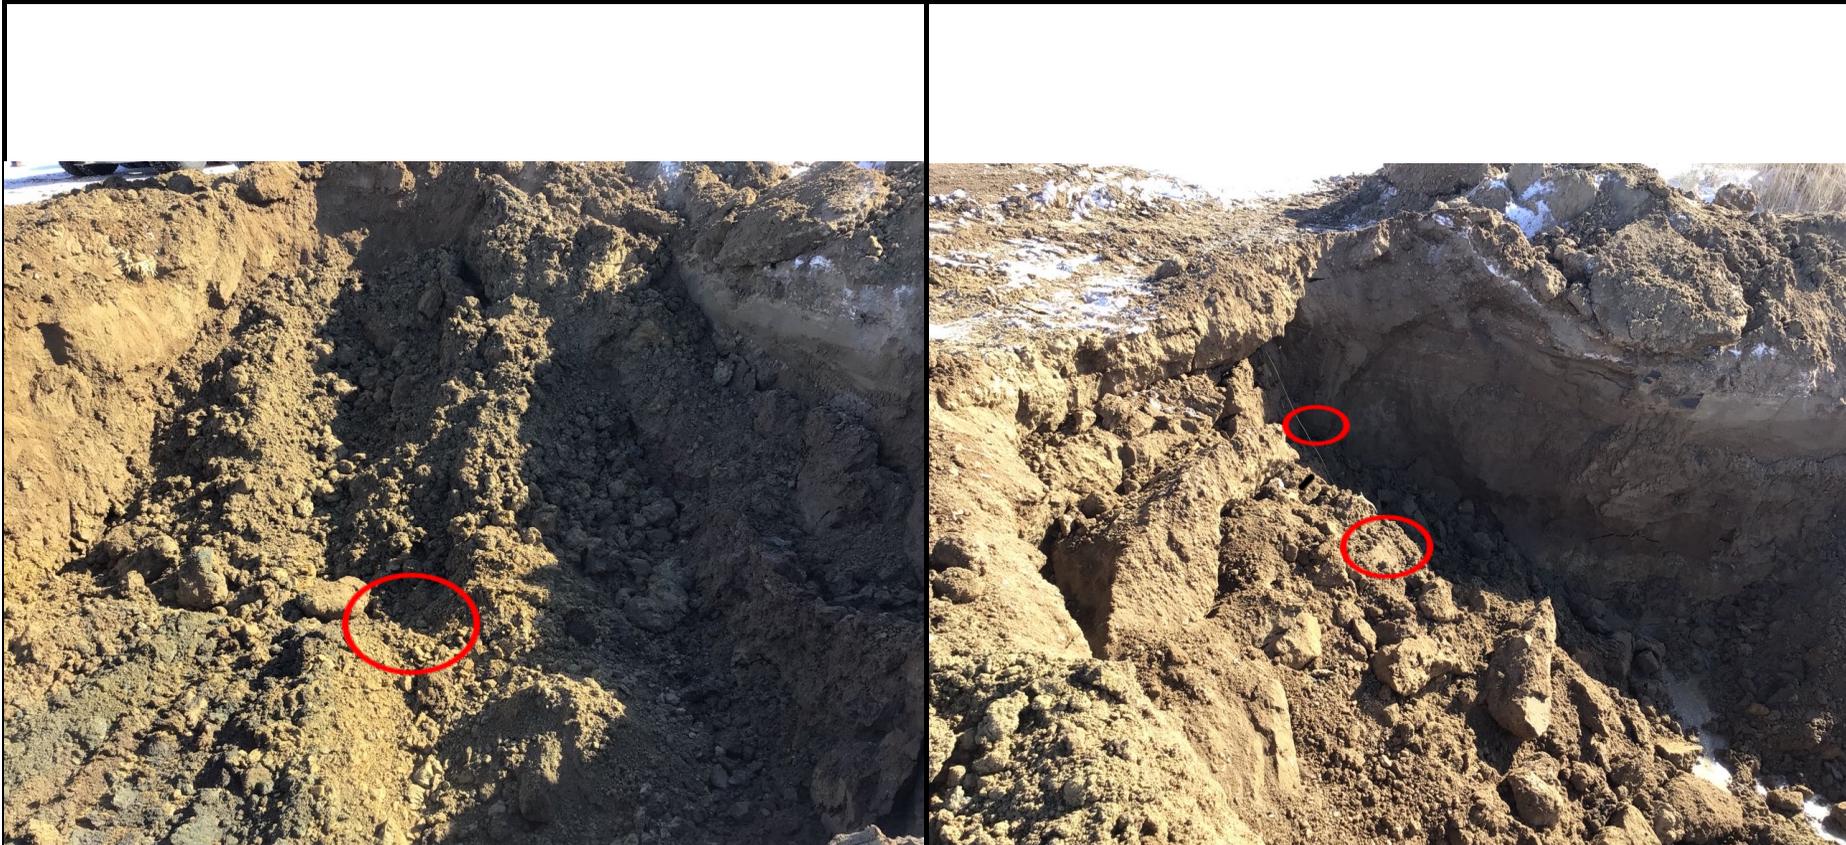
| Equipment ID: Base 1 | | Equipment Type: | | Equipment ID: East | | Equipment Type: | |

| Notes/Conditions: | | | | Notes/Conditions: East wall caved in after sample collection. Area beneath former dump line exposed to show absence of contamination. | | | |

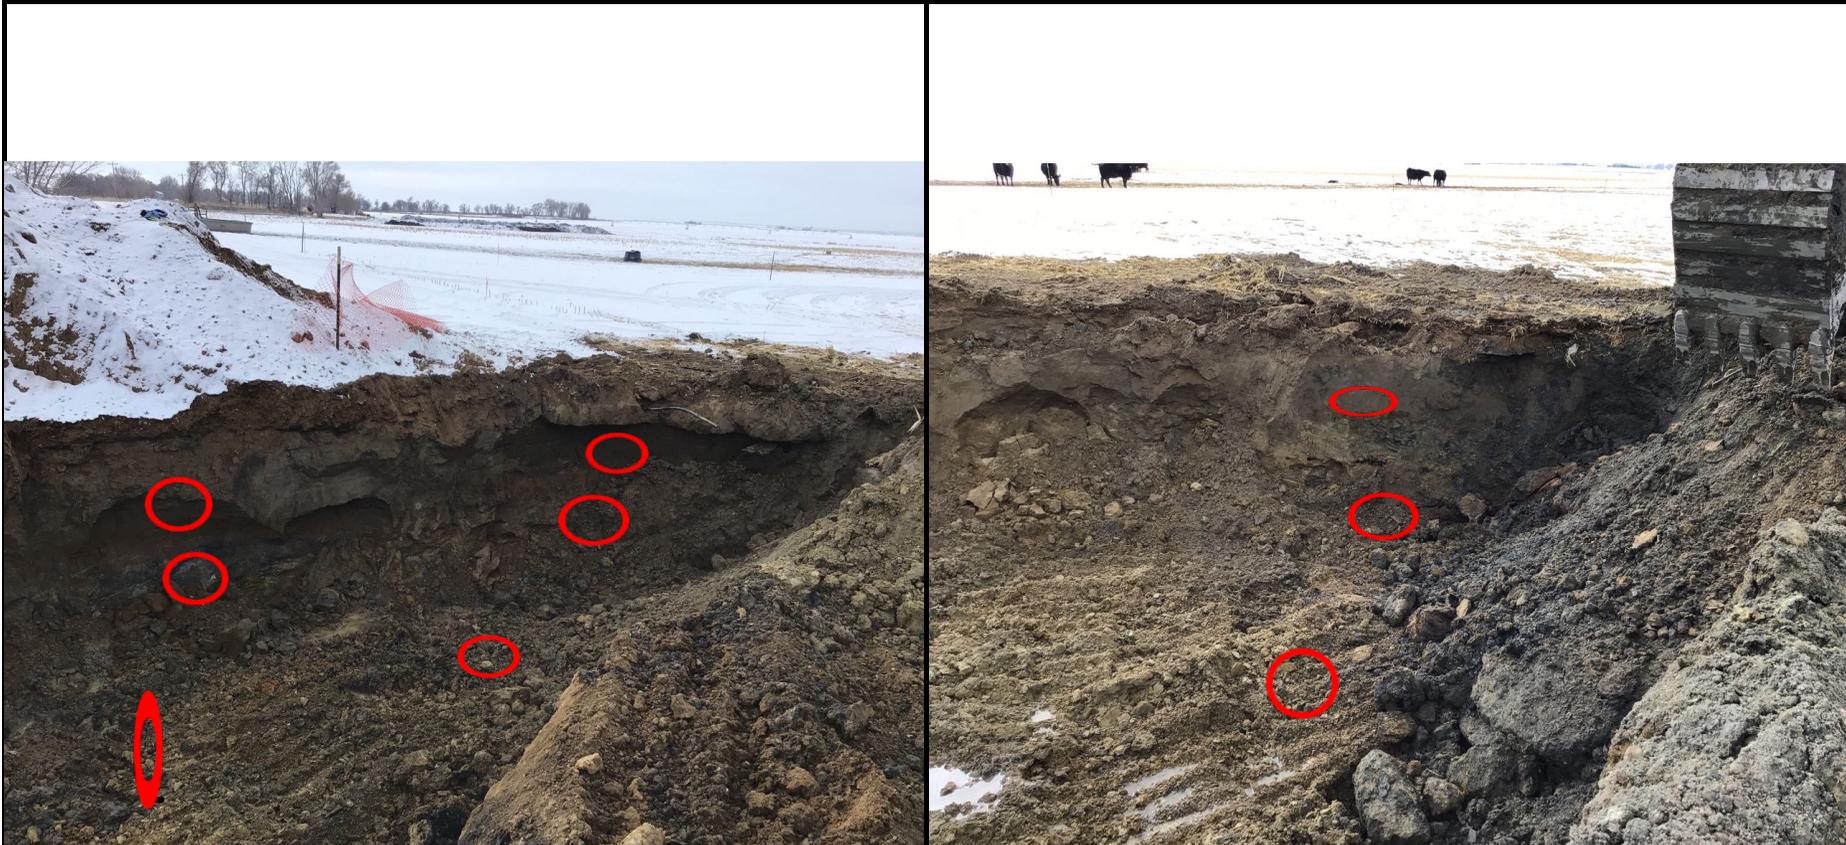
| Equipment ID: S1, S2, AND BASES | | Equipment Type: | | Equipment ID: SW AND BASE 3 | | Equipment Type: | |

| Notes/Conditions: 2/17/21 SAMPLES | | | | Notes/Conditions: | | | |

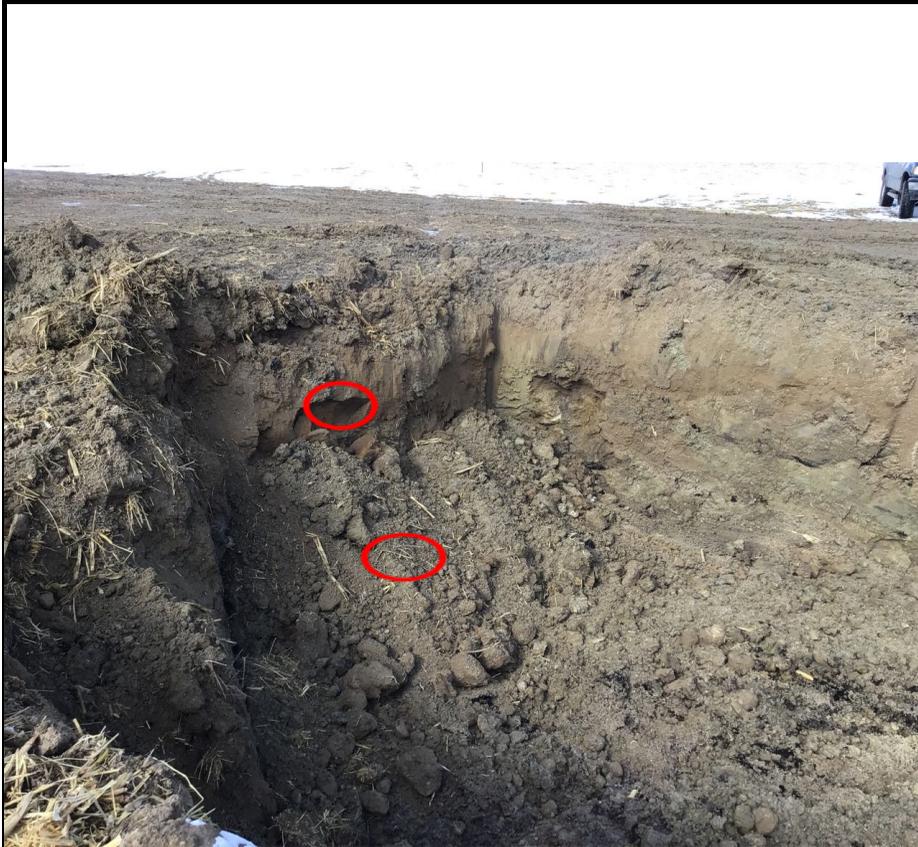
| Equipment ID: West | | Equipment Type: | |

| Notes/Conditions: Slight cave in on wall following sample collection | | | |

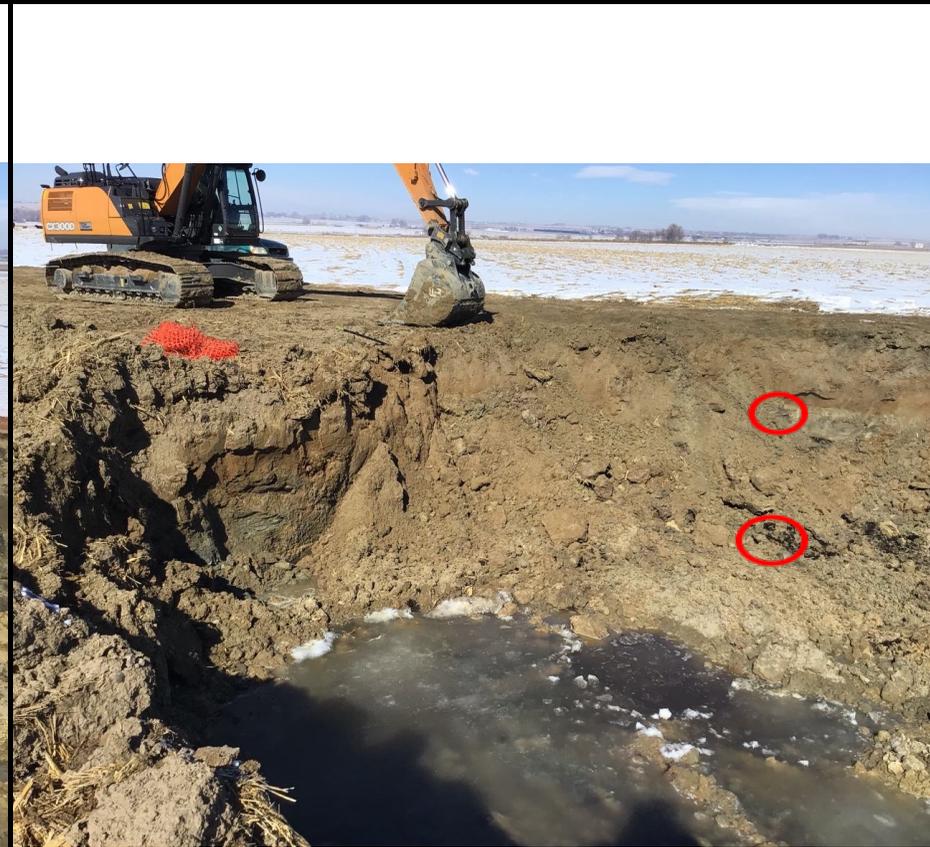
Equipment ID:West wall

Notes/Conditions: Excess material was hauled out following collection of final, clean west wall samples. Remaining piled material was screened to ensure absence of contamination. General depth and material types are circled to represent final west samples.

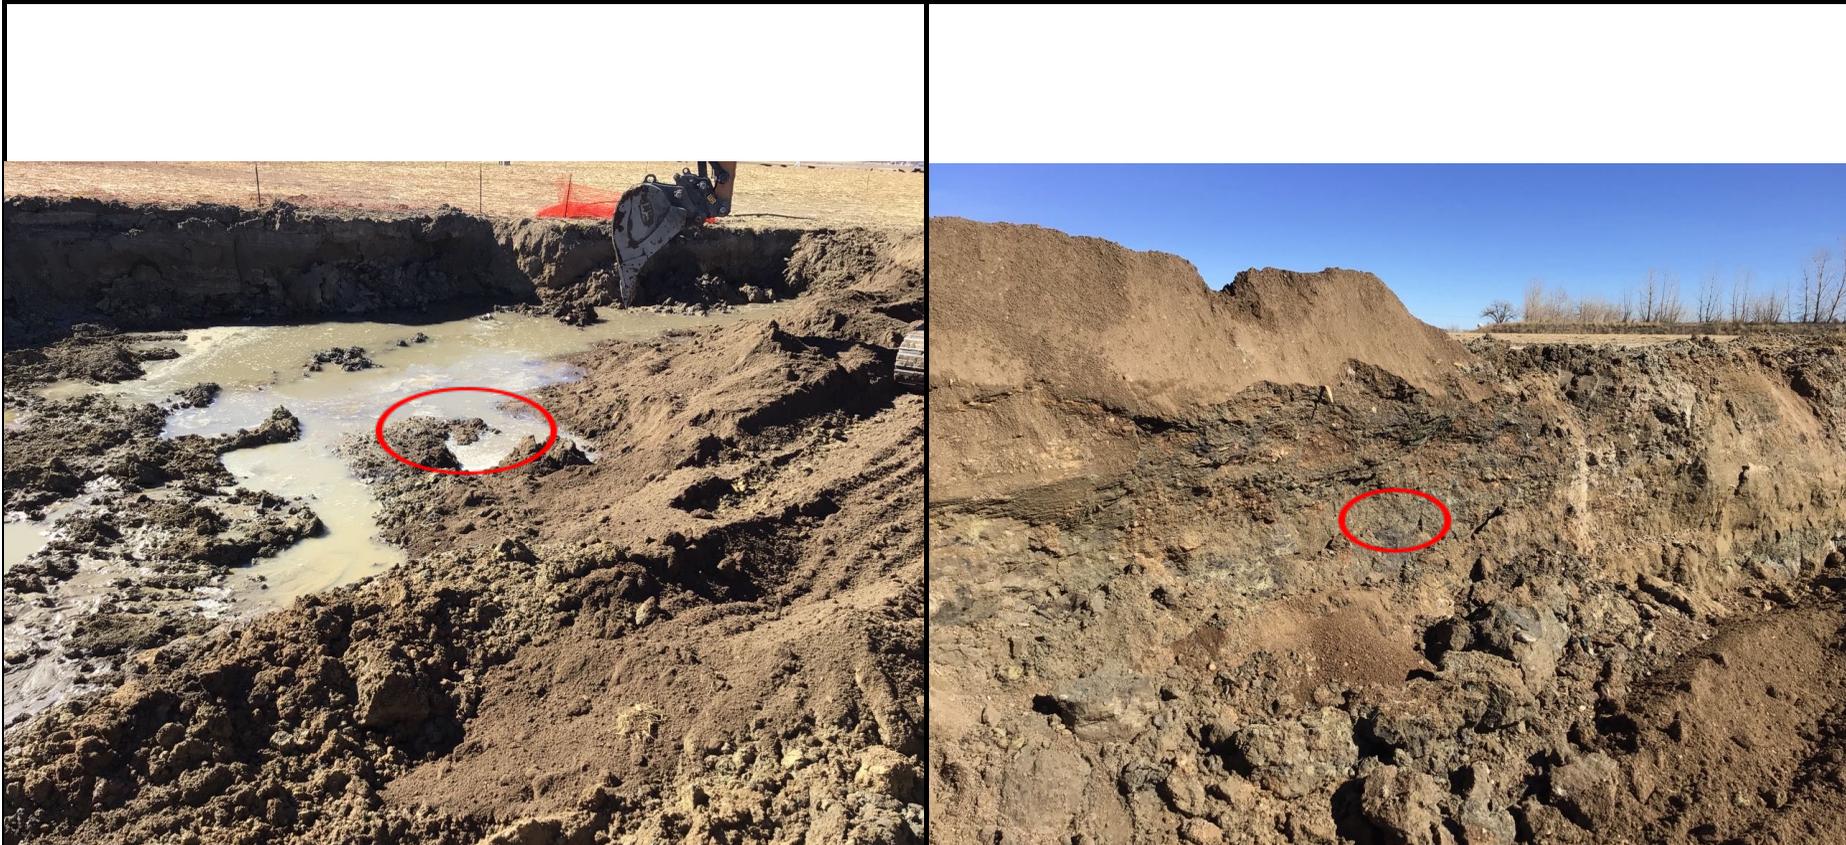
Equipment ID:SS50 BASE

Equipment Type:
Material:
Volume:
Contents:
Notes/Conditions:BASE SAMPLE COLLECTED UNDER FORMER FAILED SAMPLE. MATERIAL ON RIGHT SIDE OF PICTURE IS BACKFILL USED TO REACH THE FAILED SAMPLE AREA.

Equipment Type:
Material:
Volume:
Contents:
Notes/Conditions:SOIL SUITABILITY SAMPLE COLLECTED FROM FINAL EXTENT.
