WELLHEAD ABANDONMENT FORM

SITE NAME: Leafgren 1-17 Wellhead							DATE: 3/3/2021	REM. PROJECT #:	WEATHER: 40's Sunny
SITE DIRECTIONS: HWY 85 / 392 0.2 mi e, 0.1 mi n, ne into							CLIENT: PDC		
LEGALS AND LAT/LONG: 40.482670 -104.694920							TASMAN PERSONNEL: Jesse Marcus		
SOIL TYPES: Clayey Sand - SC							SURFACE GRADIENT: Southwest		
SOIL SAMPLING							FACILITY INFRASTRUCTURE		
Date/Time	Soil Sample ID	PID (ppm)	Visual	Olfactory	Photo?	Grab or Lab Sample?	EQUIPMENT	Quantity	
							Above Ground Storage Tank (AST)		
3/3/2021 12:51	FLR01@4'	400.2	HC Staining	HC Odor	No	Grab	Buried or Partially Buried Vessel		
3/3/2021 13:14	WH01@5'	800.6	HC Staining	HC Odor	Yes	Lab	Separator		
3/3/2021 13:15	FLR01@4'	393.1	HC Staining	HC Odor	Yes	Lab	Emission Control Device (ECD)		
3/3/2021 13:16	WH01-W@4'	90.2	HC Staining	HC Odor	Yes	Grab	Dump Line		
3/3/2021 13:17	WH01-S@4'	16.7	HC Staining	HC Odor	Yes	Grab	Wellhead	1	
3/3/2021 13:18	WH01-E@4'	5.0	HC Staining	HC Odor	Yes	Grab	Flowline	1

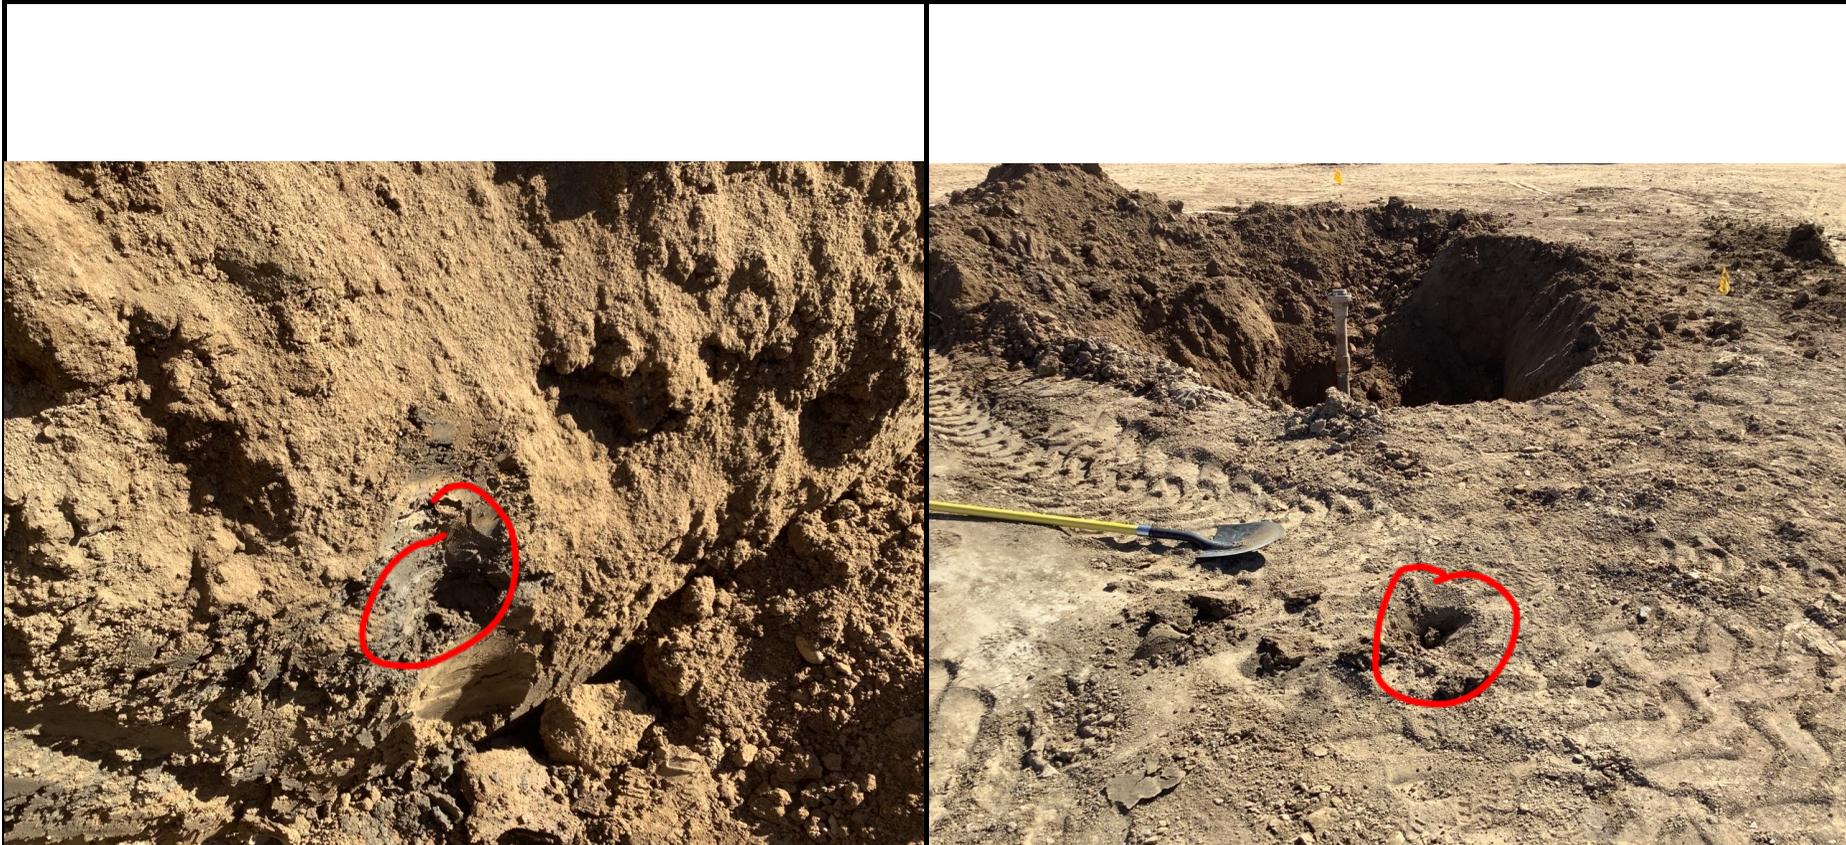
Equipment ID: WH01-E@4'

Equipment Type: Wellhead

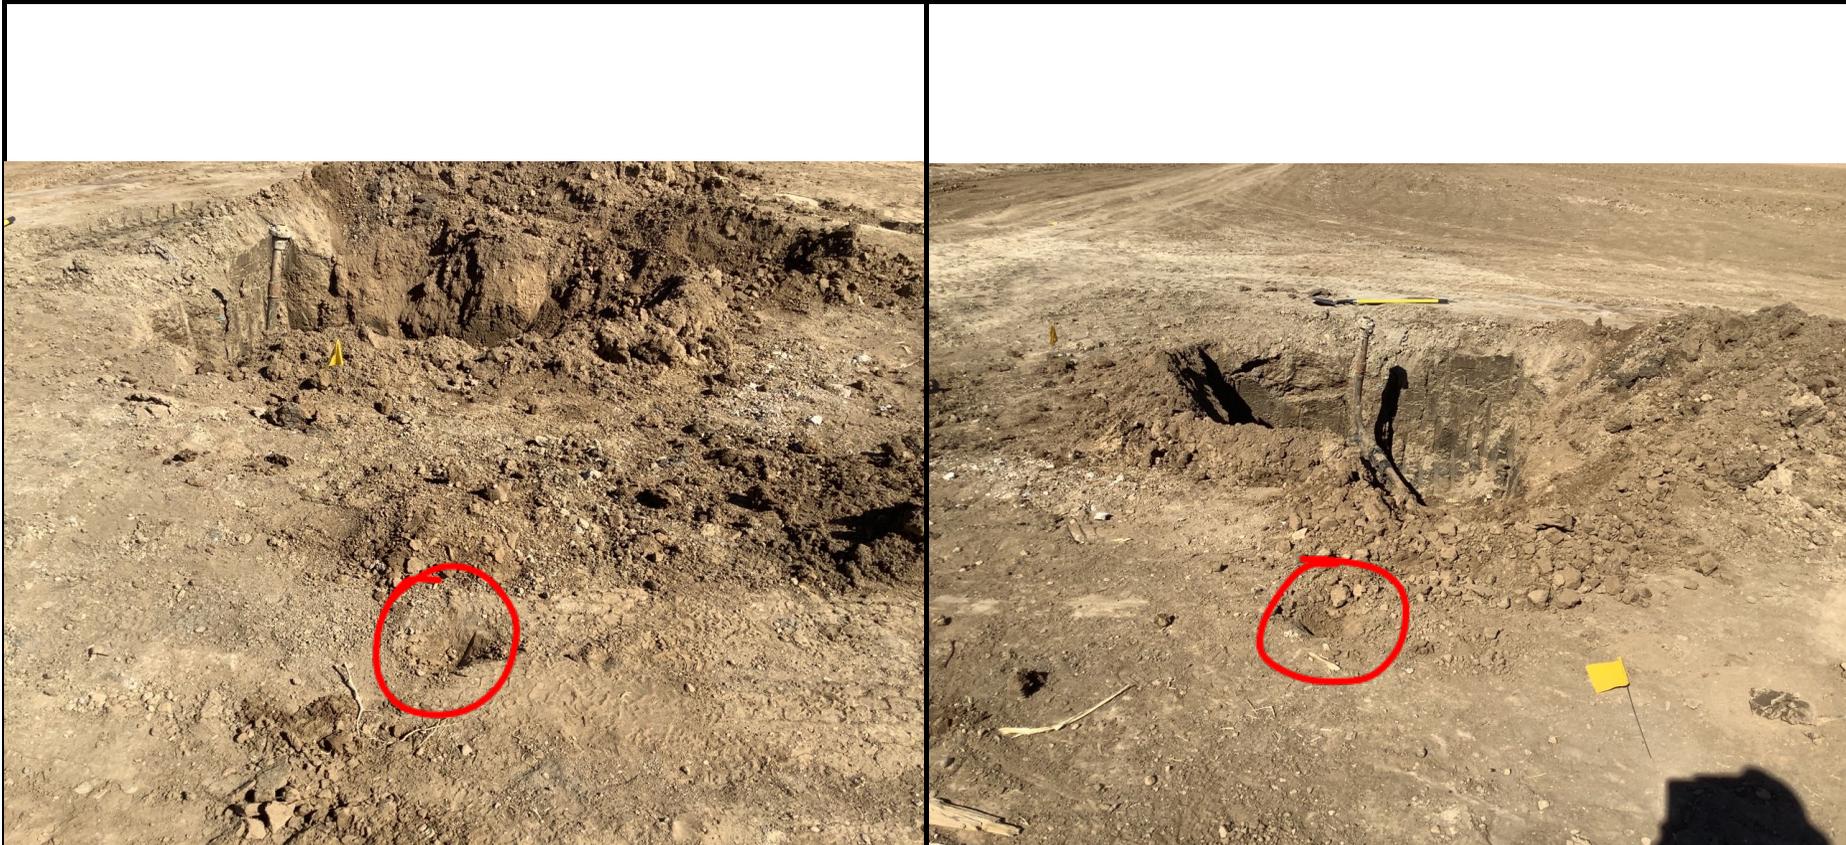
Equipment ID: WHS		Equipment Type: Wellhead	
Material:	Volume:	Contents:	
Notes/Conditions: WHS01-W@0-6"

Equipment ID: WHS		Equipment Type: Wellhead	
Material:	Volume:	Contents:	
Notes/Conditions: WHS01-S@0-6"

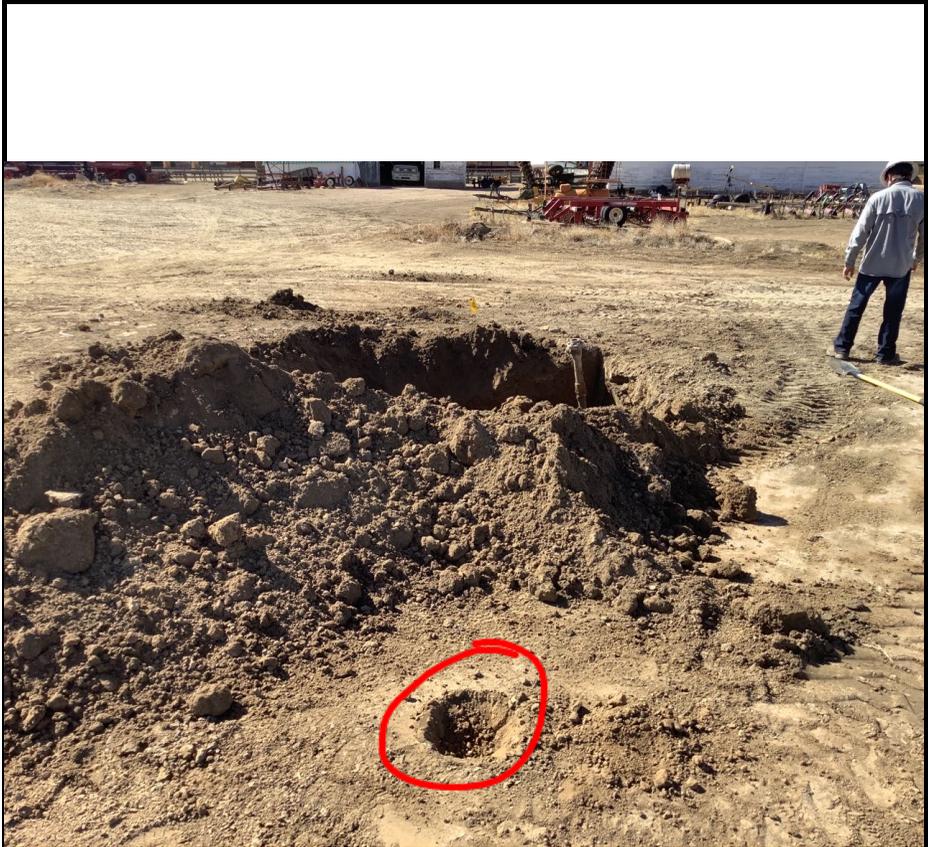
Equipment ID: WHS		Equipment Type: Wellhead		Equipment ID:		Equipment Type:	
Material:		Volume:		Material:		Volume:	
Contents:				Contents:			
Notes/Conditions: WHS01-E@0-6"				Notes/Conditions:

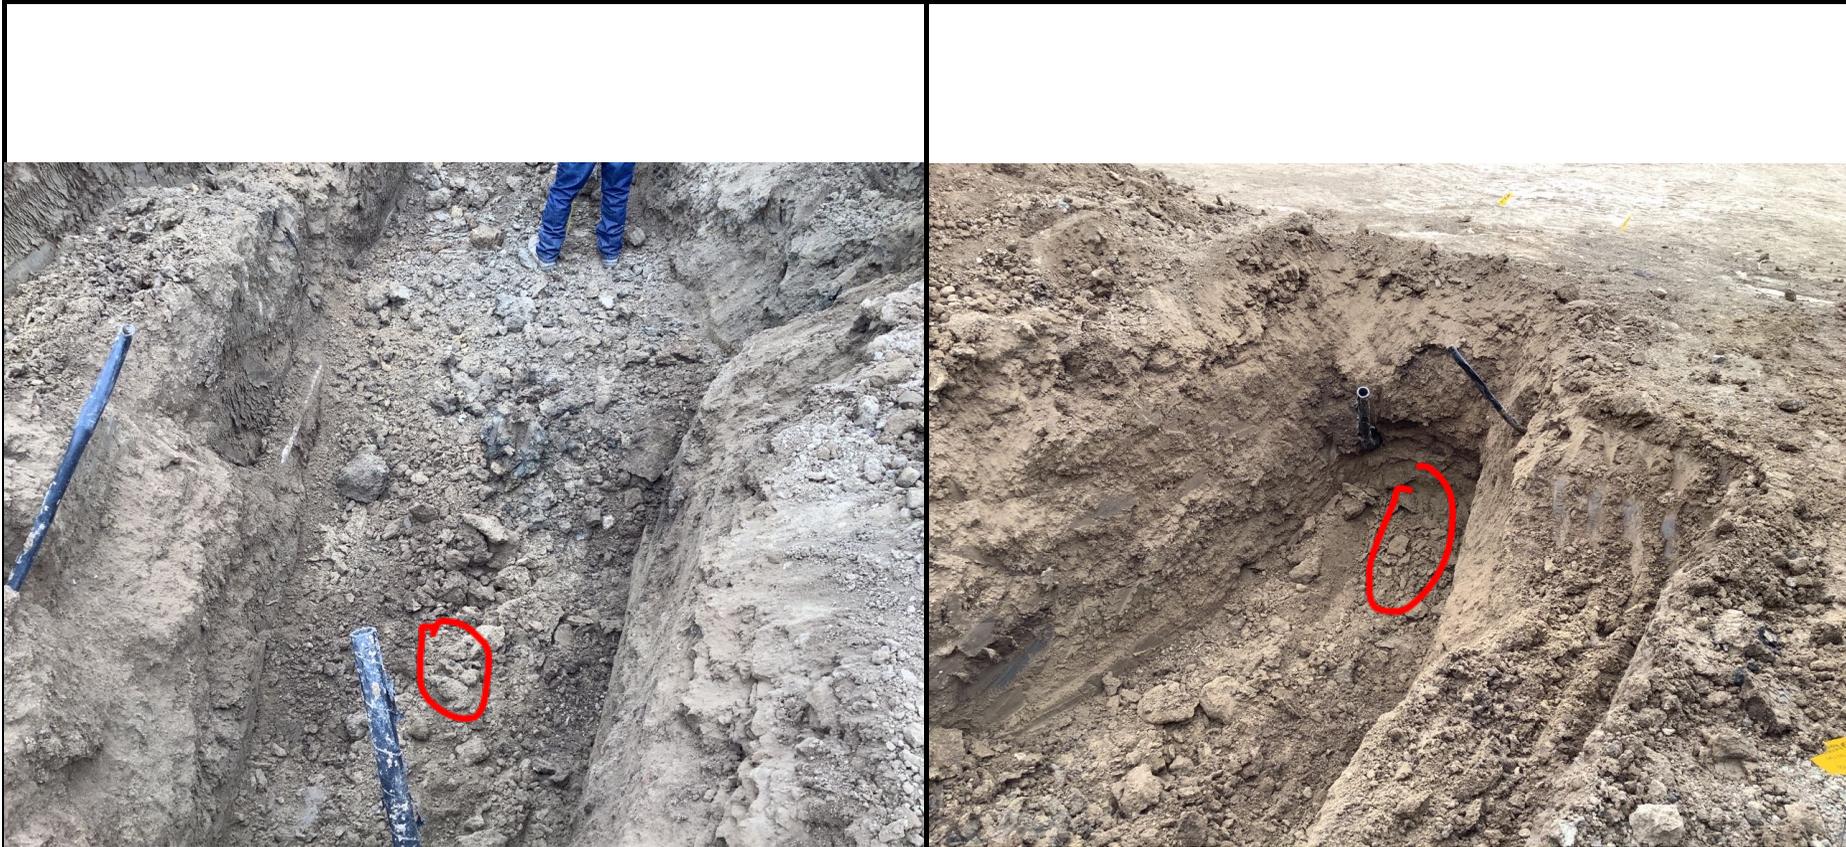
Equipment ID:		Equipment Type:		Equipment ID:		Equipment Type:	
Material:	Volume:	Contents:		Material:	Volume:	Contents:	
Notes/Conditions: B@6', SS01@6'				Notes/Conditions: S@5', SS02@5'

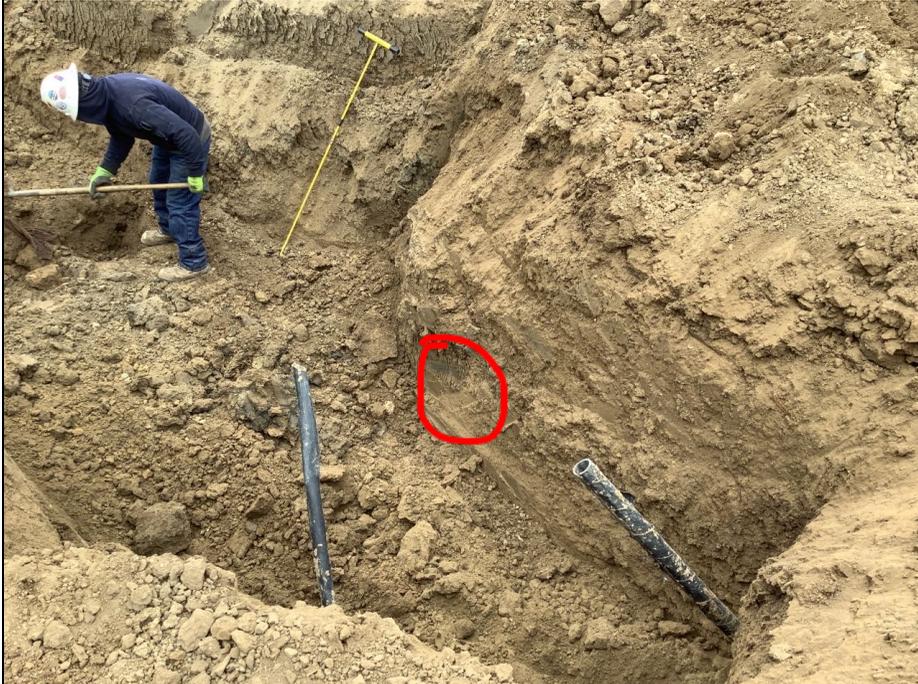
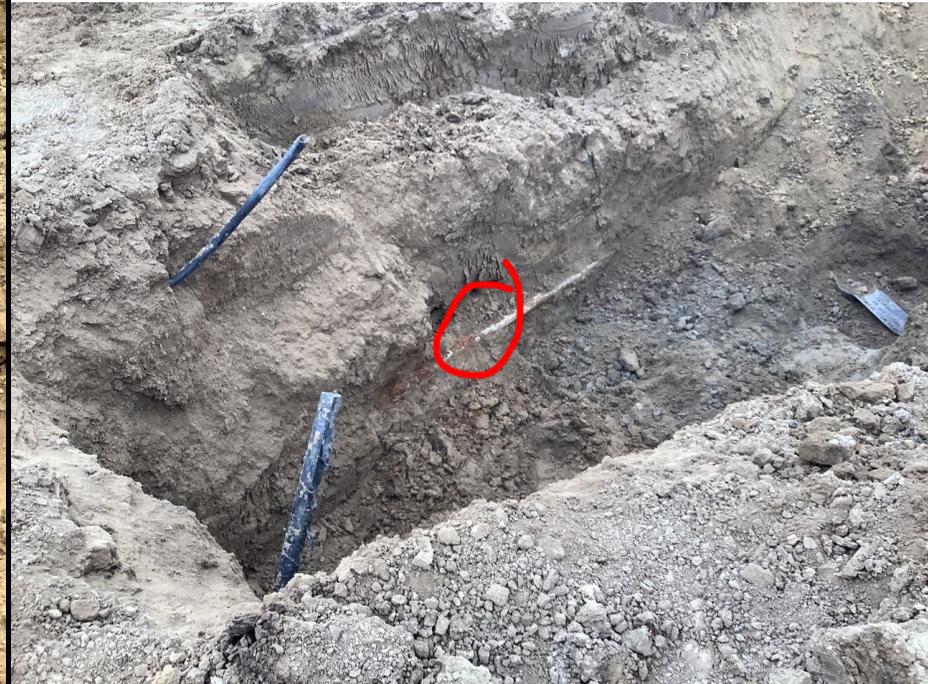
Material:	Volume:	Contents:	Material:	Volume:	Contents:
Notes/Conditions: E@5', SS03@5'			Notes/Conditions: W@5', SS04@5'

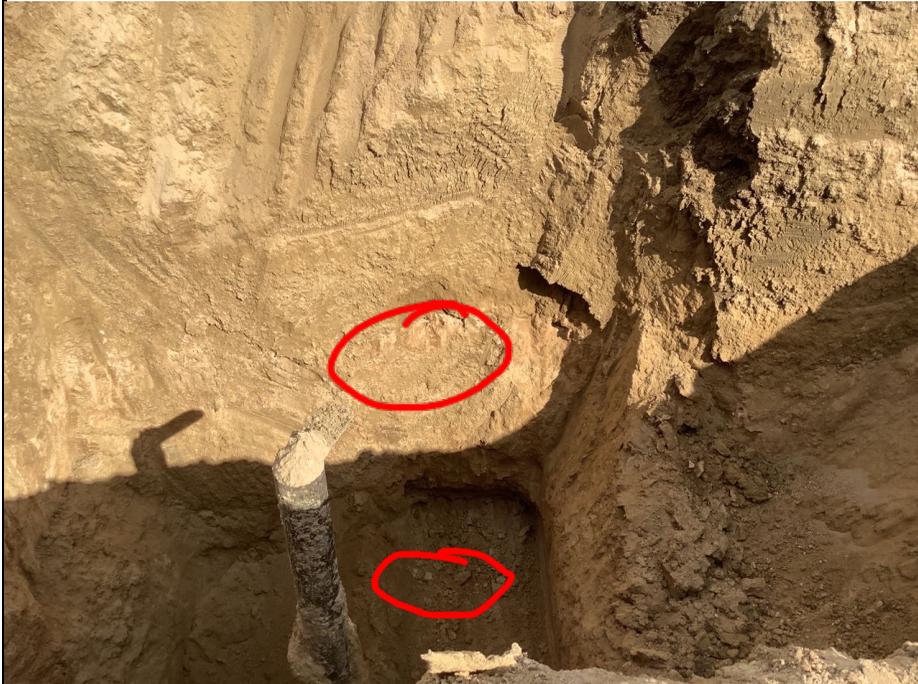
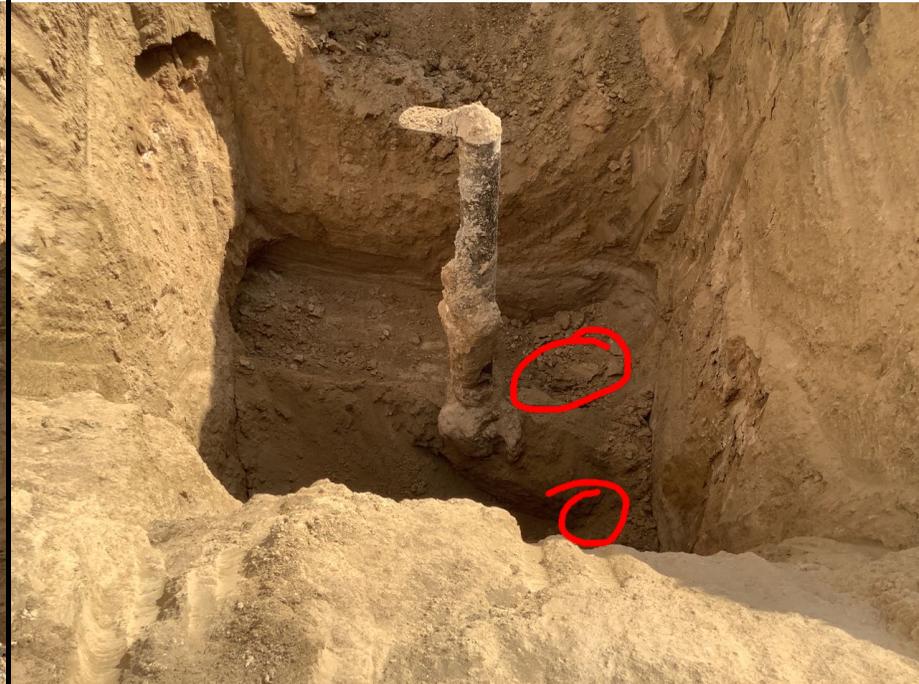
Material:	Volume:	Contents:	Material:	Volume:	Contents:
Notes/Conditions: East Wall, SS05@12', SS06@20'			Notes/Conditions: South Wall, SS011@12', SS12@20'

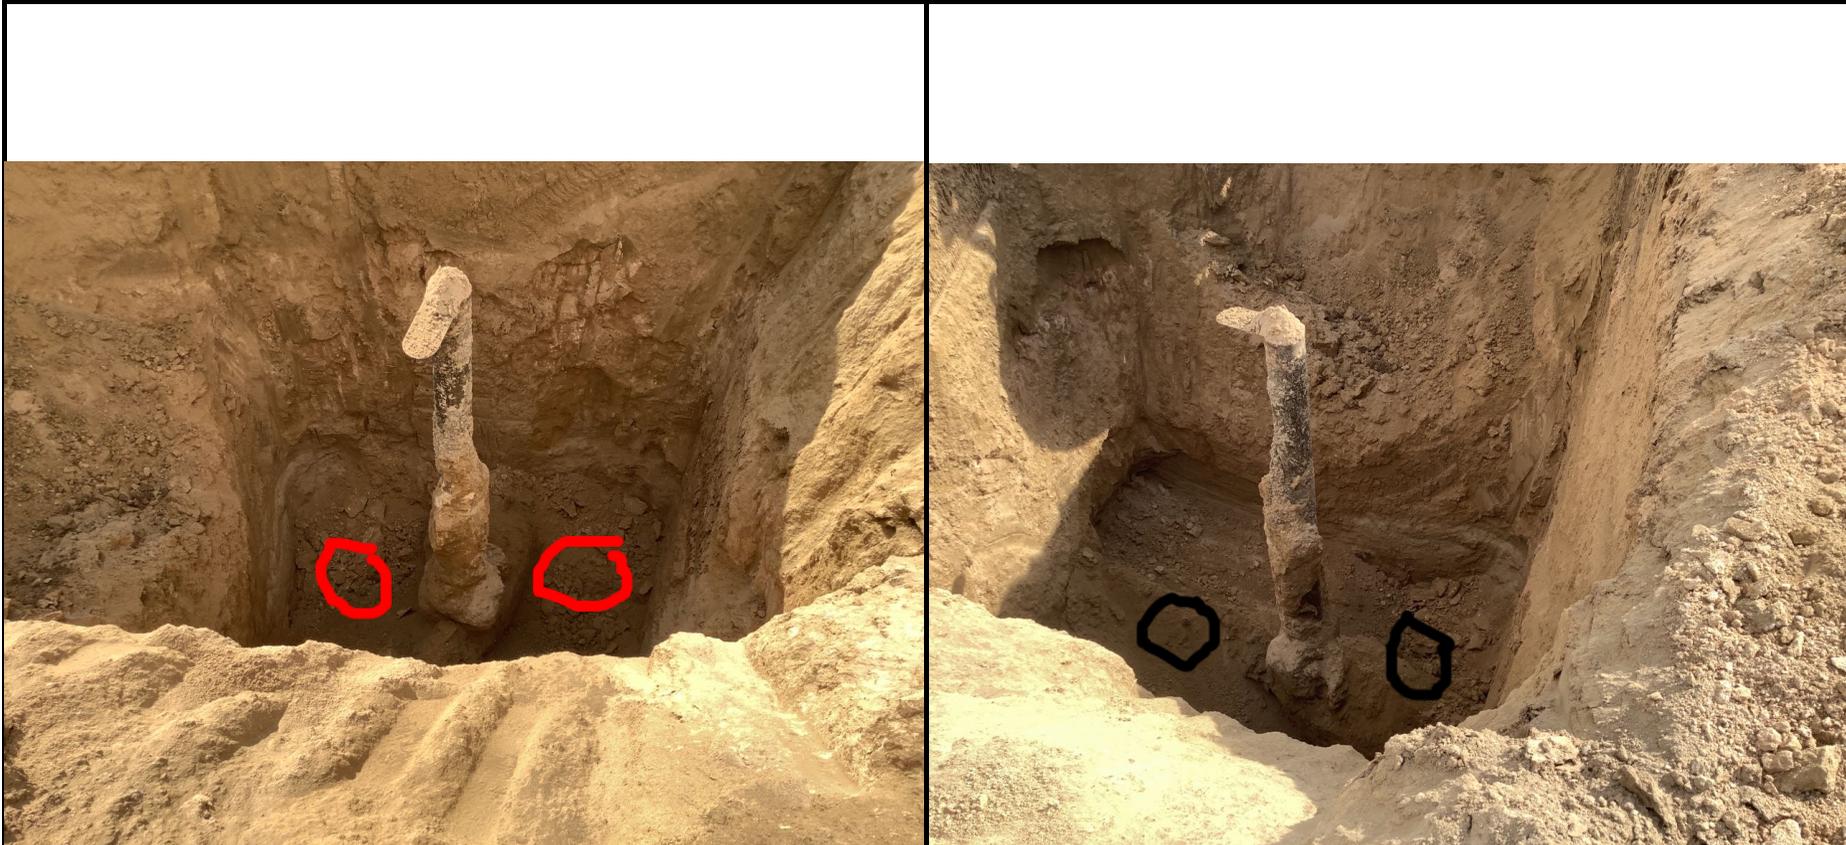
Notes/Conditions: Base, SS01 @20', SS02 @20'

Notes/Conditions: Base, SS03 @20, SS04 @20'

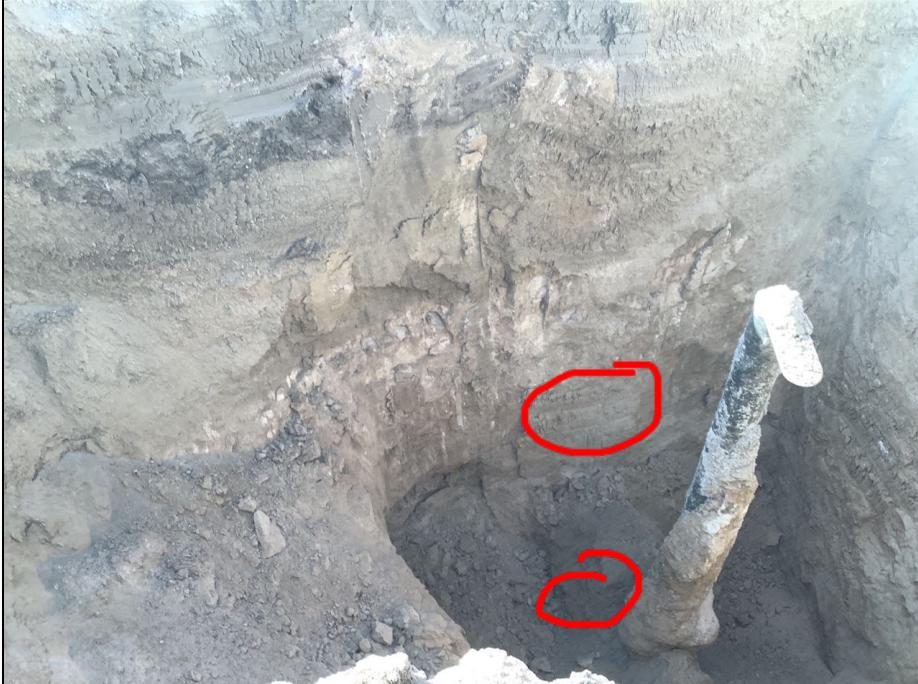
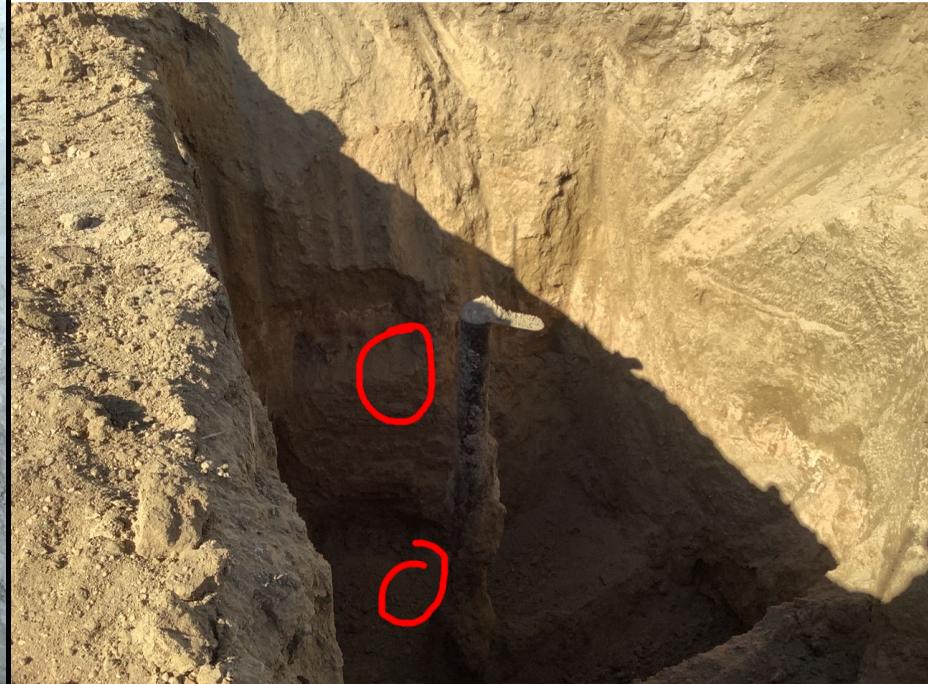
Material:	Volume:	Contents:	Material:	Volume:	Contents:
Notes/Conditions: West Wall, SS09@12', SS10@20'			Notes/Conditions: North Wall, SS07@12', SS08@20'

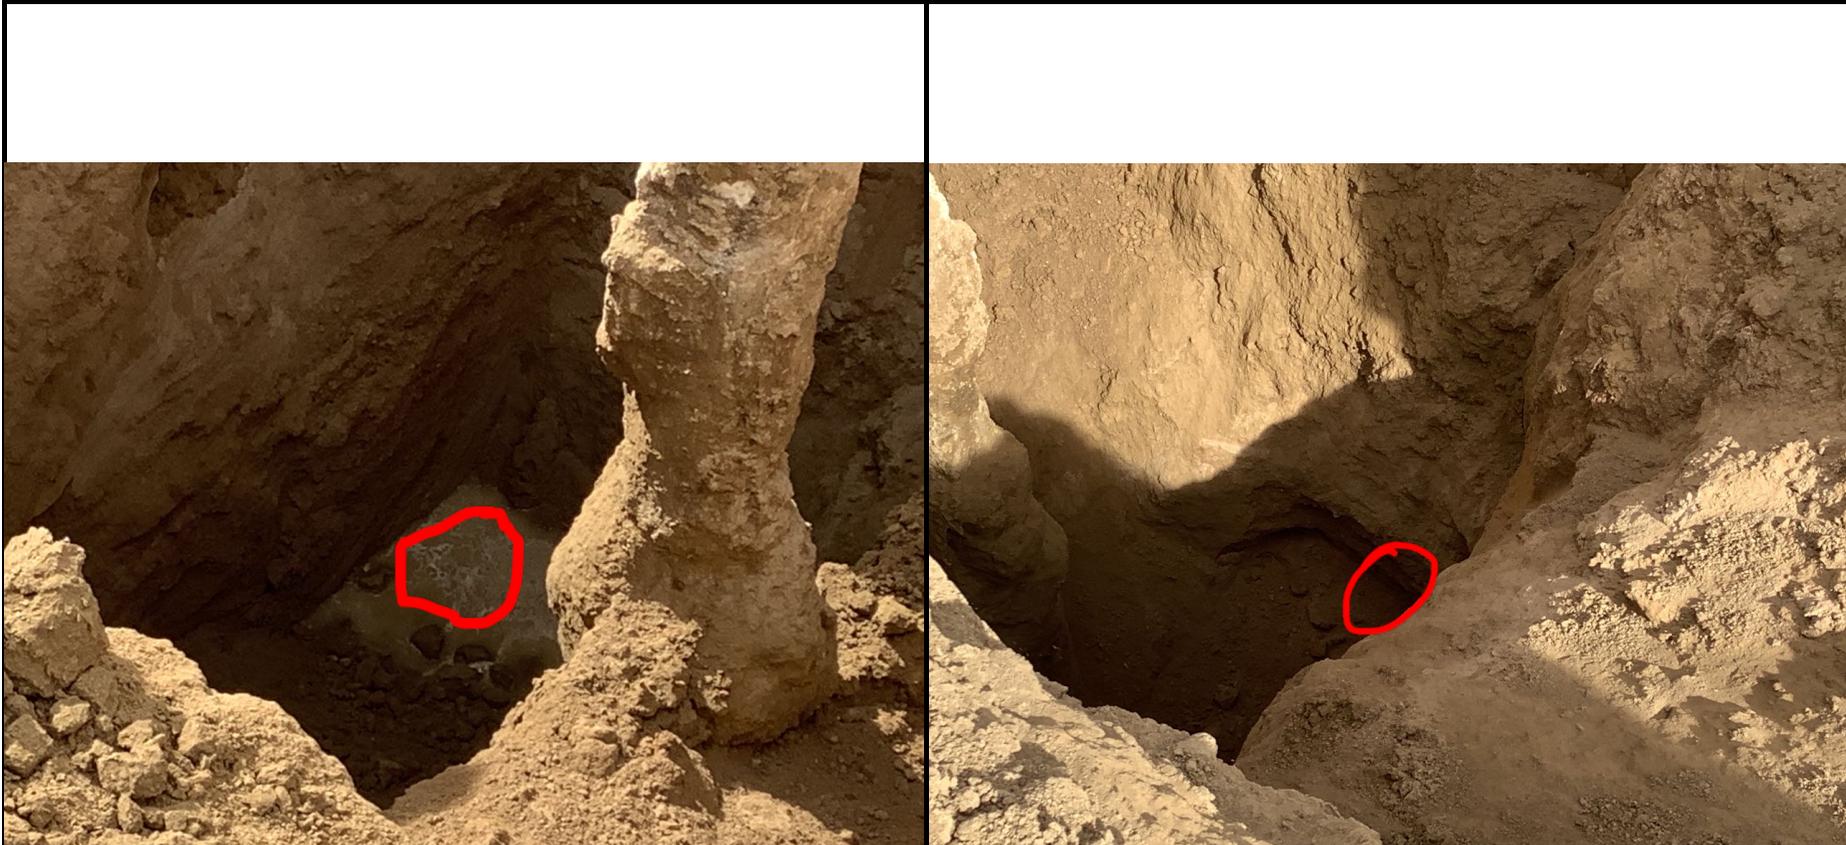
Notes/Conditions: Groundwater @ 23', B-S@24', SS13@24'

Notes/Conditions: SS14@24', E@24'

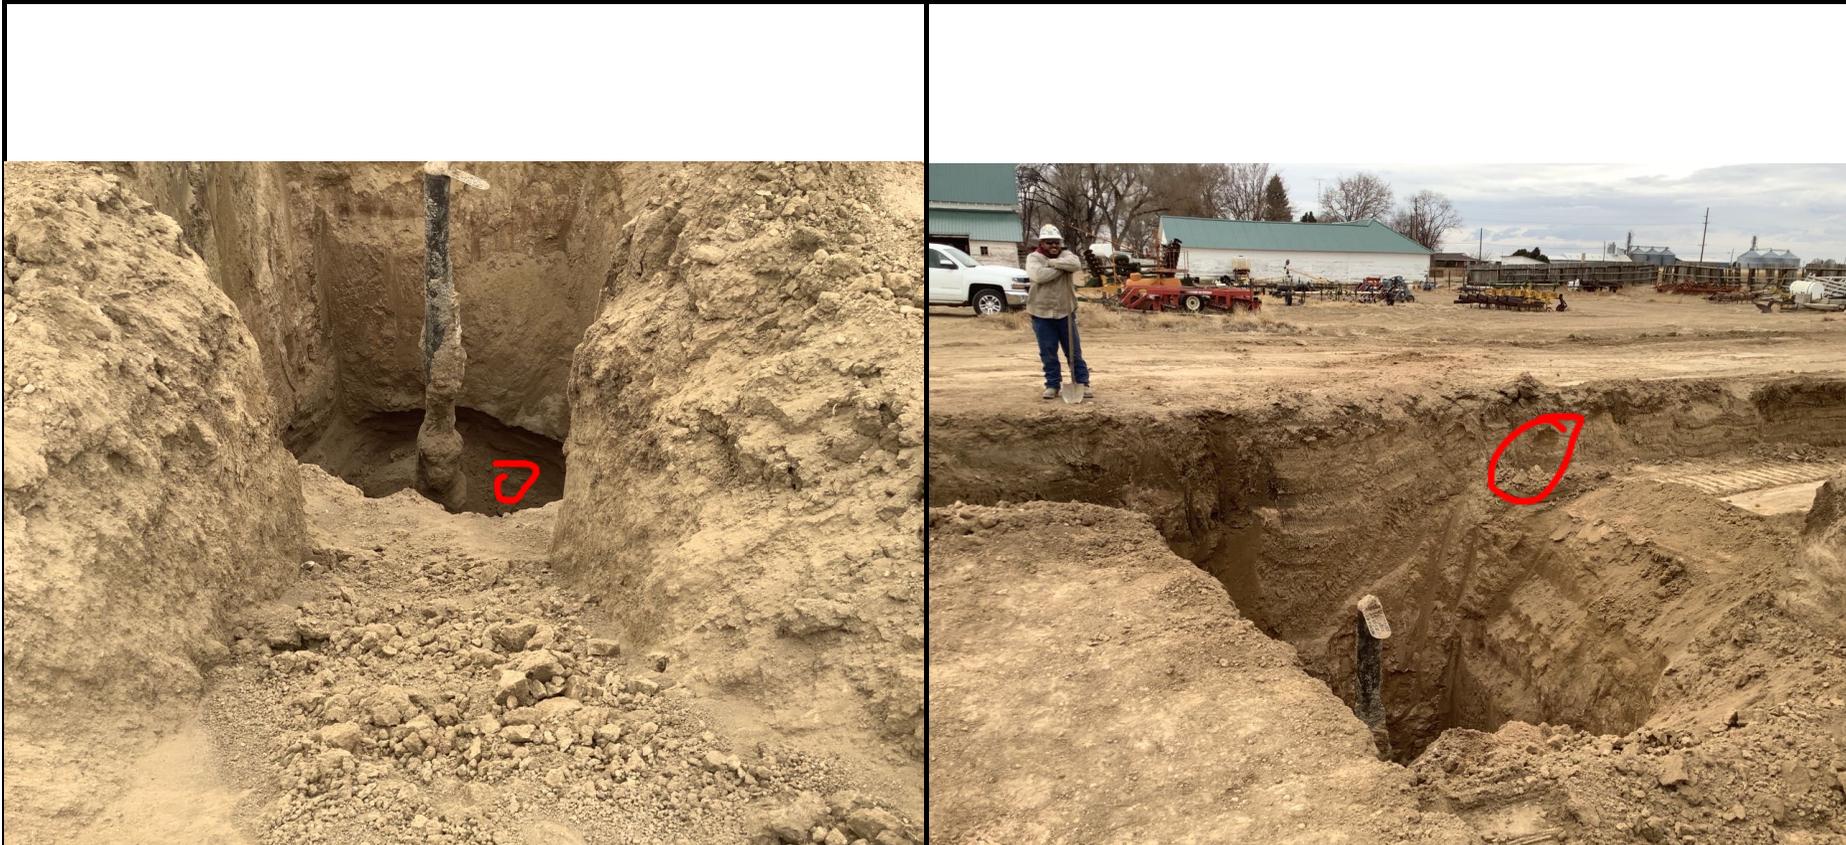
Equipment ID:		Equipment Type:	
Material:	Volume:	Contents:	
Notes/Conditions: SS17@24', N@24'

Equipment ID:		Equipment Type:	
Material:	Volume:	Contents:	
Notes/Conditions: SS18@2.5'
