Inspection Photos

Operator: TEP ROCKY MOUNTAIN LLC - 96850

Location ID: 324079

Garfield County, CO

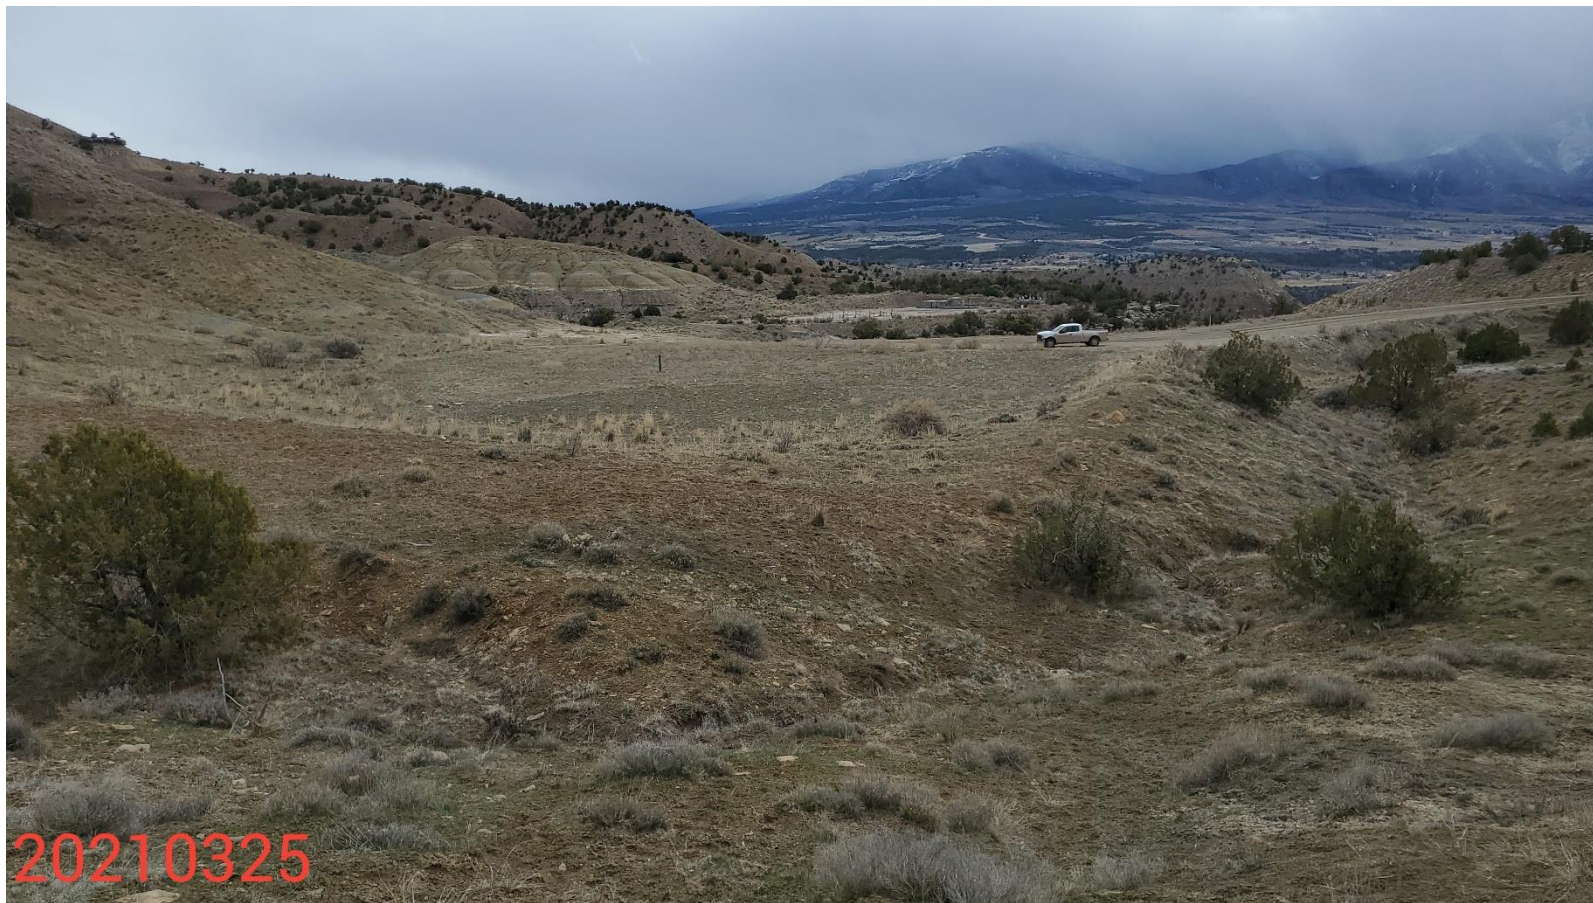
Photo 1: Photo taken from the northwest end of the Location, facing southeast. Photo provides an overview of the Location. Photo also shows that Location has not been recontoured and regraded in accordance with Rule 1004.a

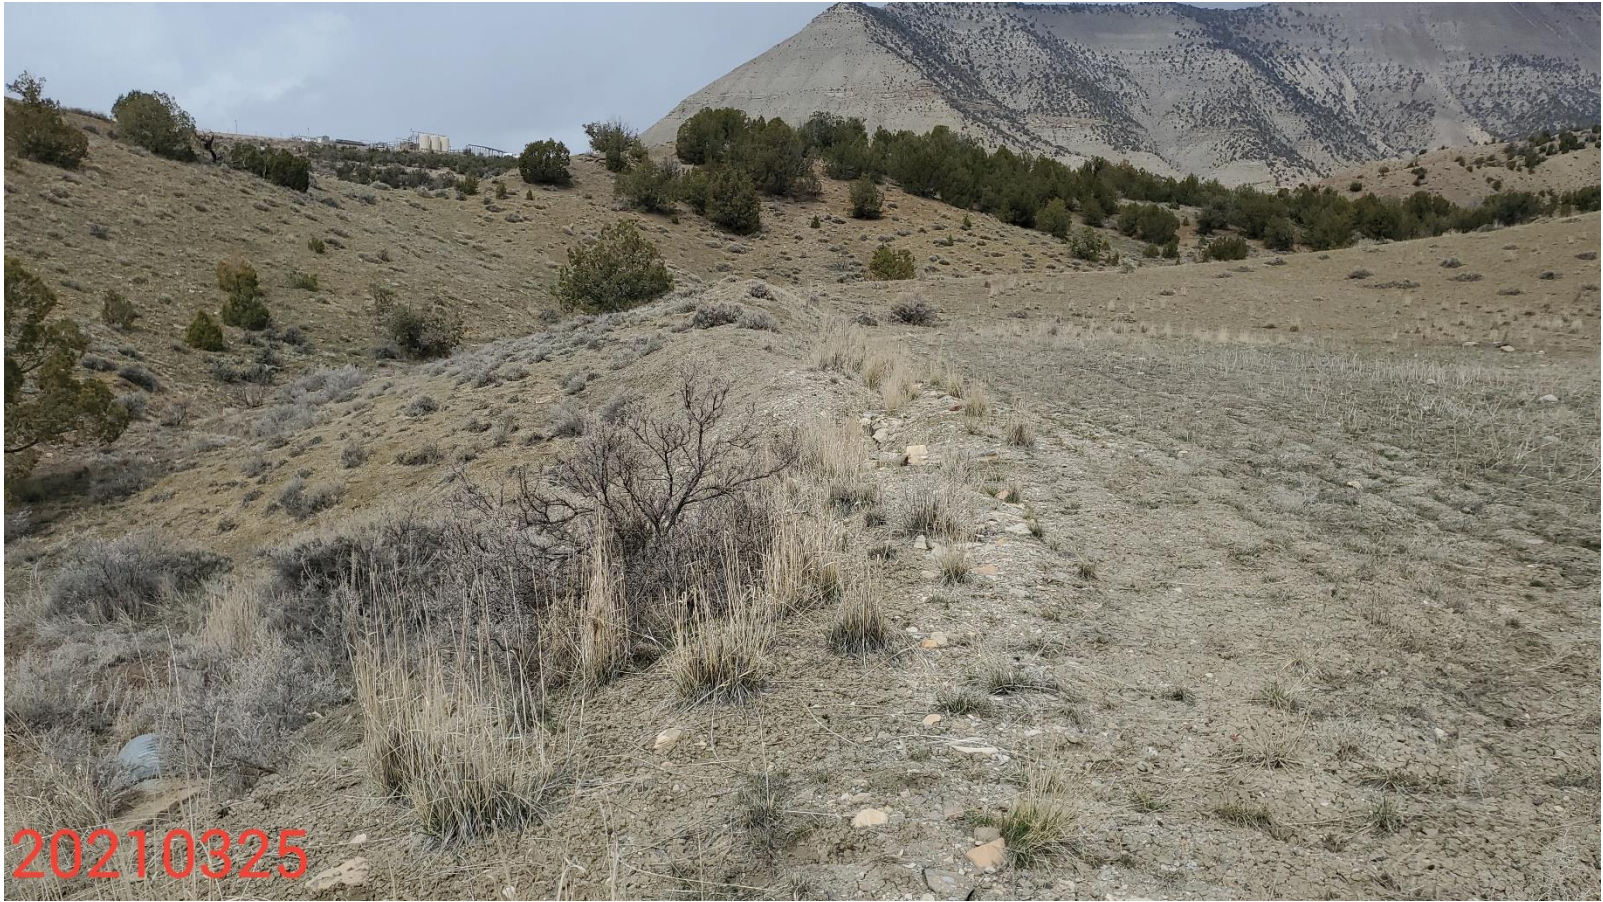
Photo 2: Photo taken from the south end of the Location, facing northwest. Photos 2-4 provide an overview of the Location from northwest, north to northeast. Photos show that Location has not been recontoured and regraded in accordance with Rule 1004.a

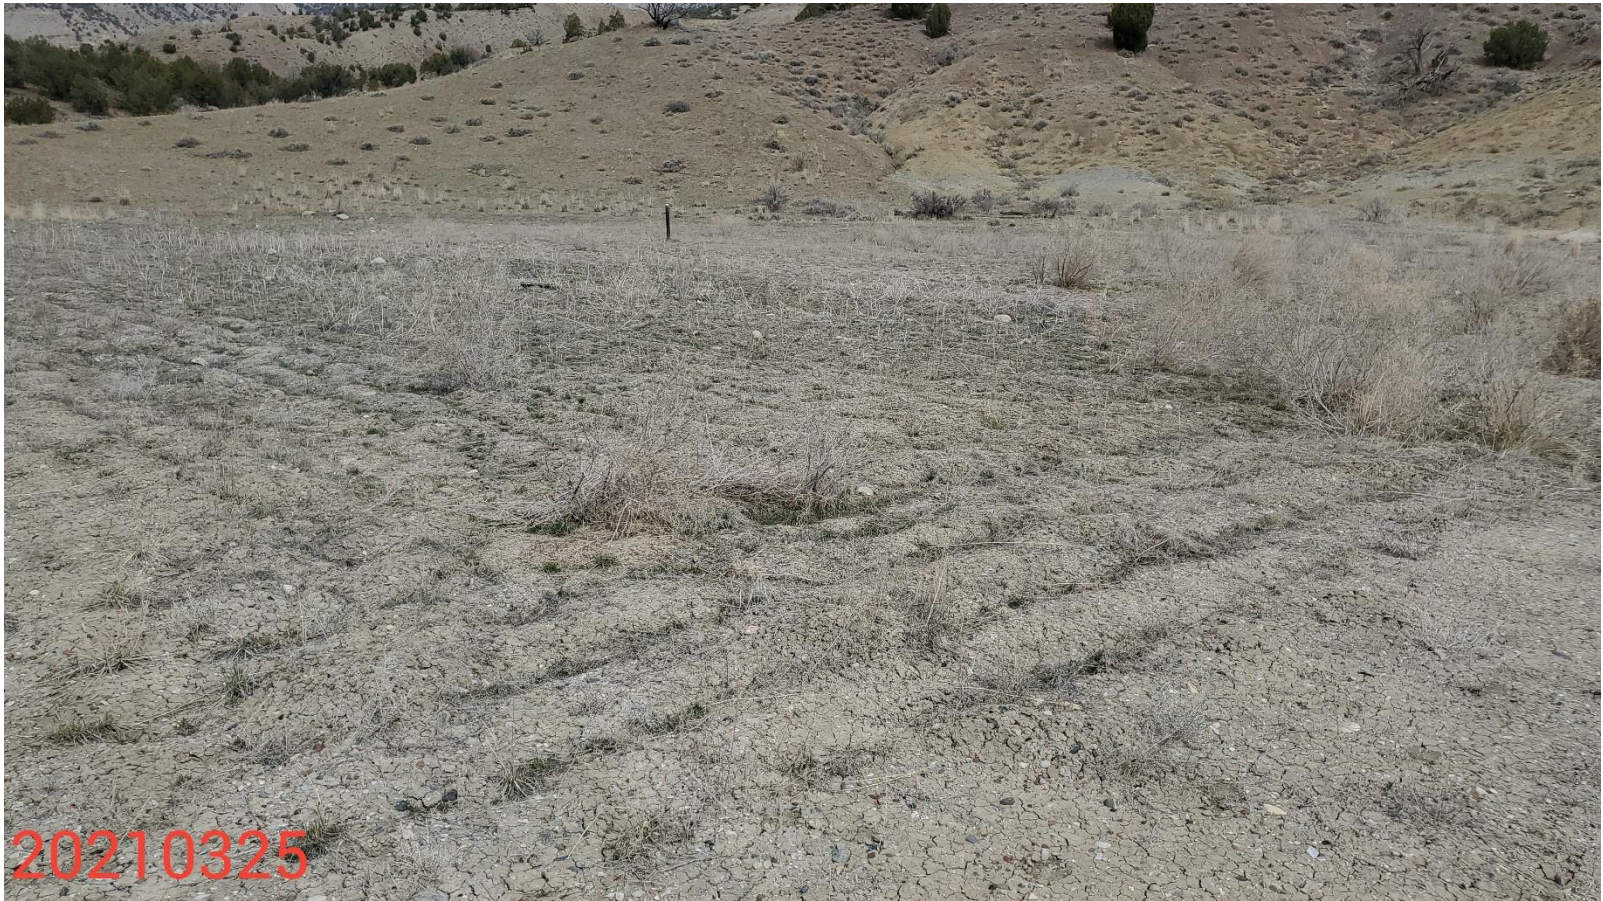
Photo 3: See comments under photo 2.

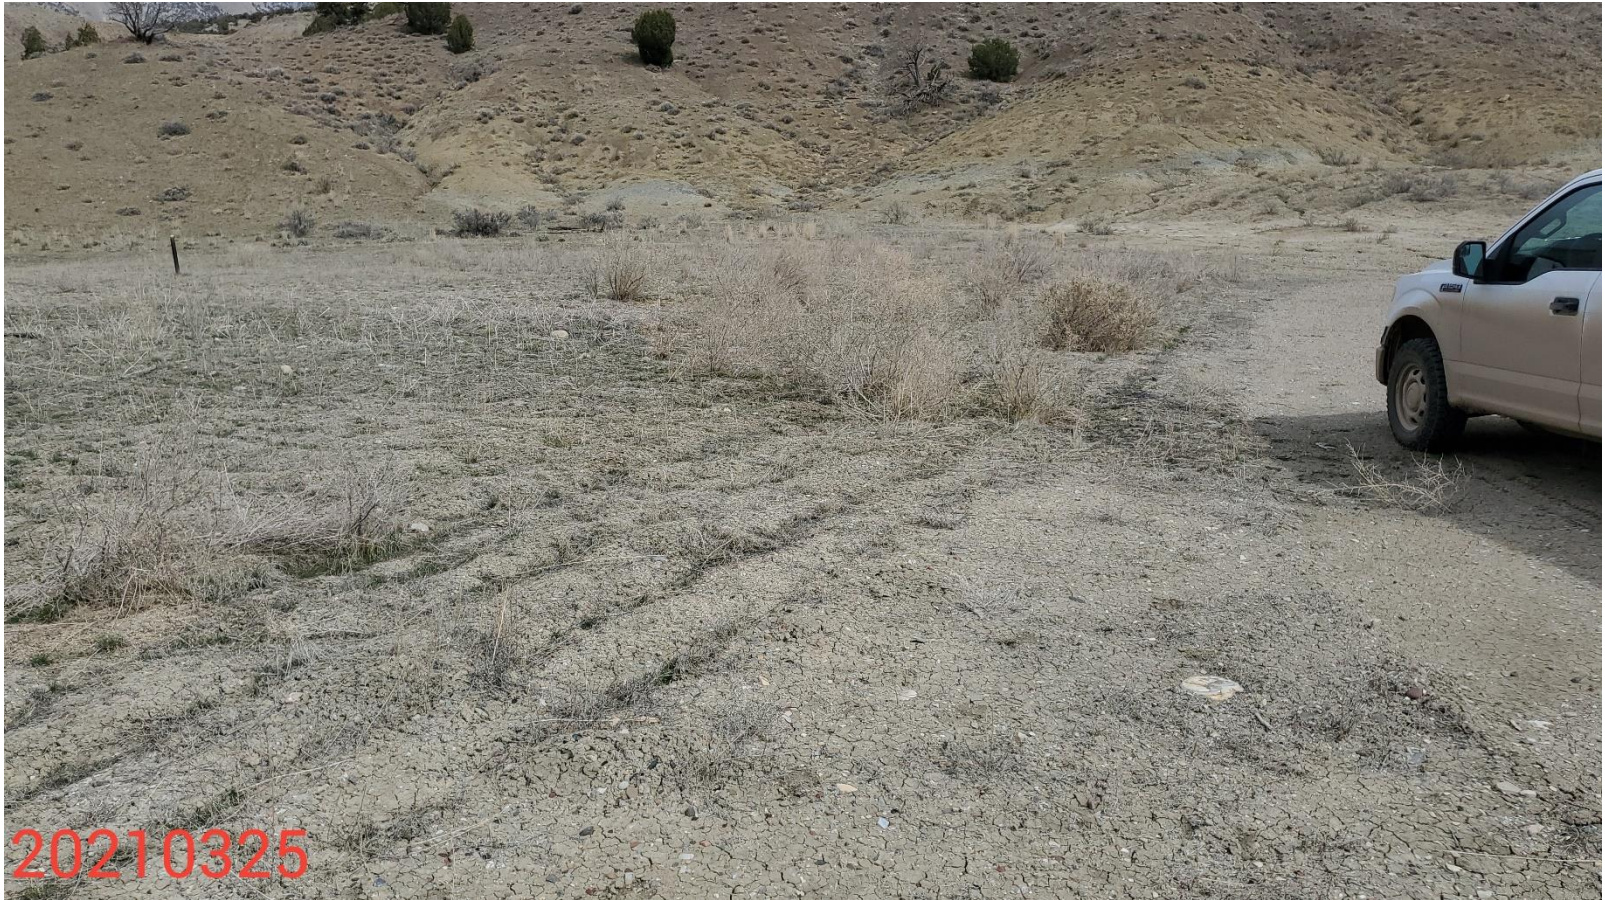
Photo 4: See comments under photo 2.

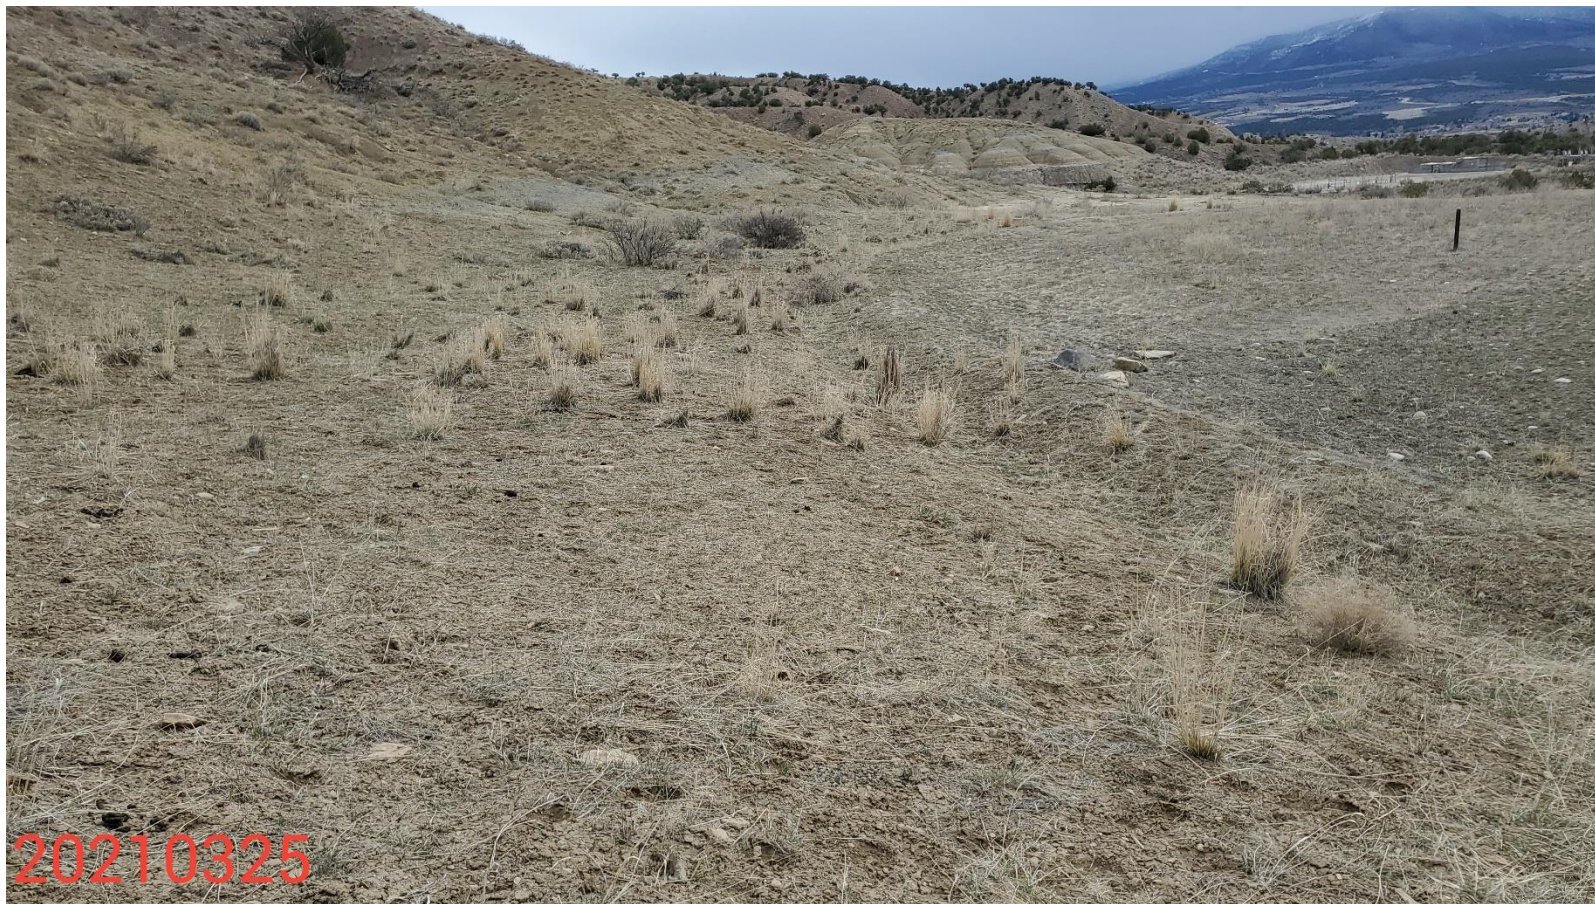
Photo 5: Photo taken from the north end of the Location, facing east. Photos 5-6 provide an overview of the Location from east to south. Photos show that Location has not been recontoured and regraded in accordance with Rule 1004.a.

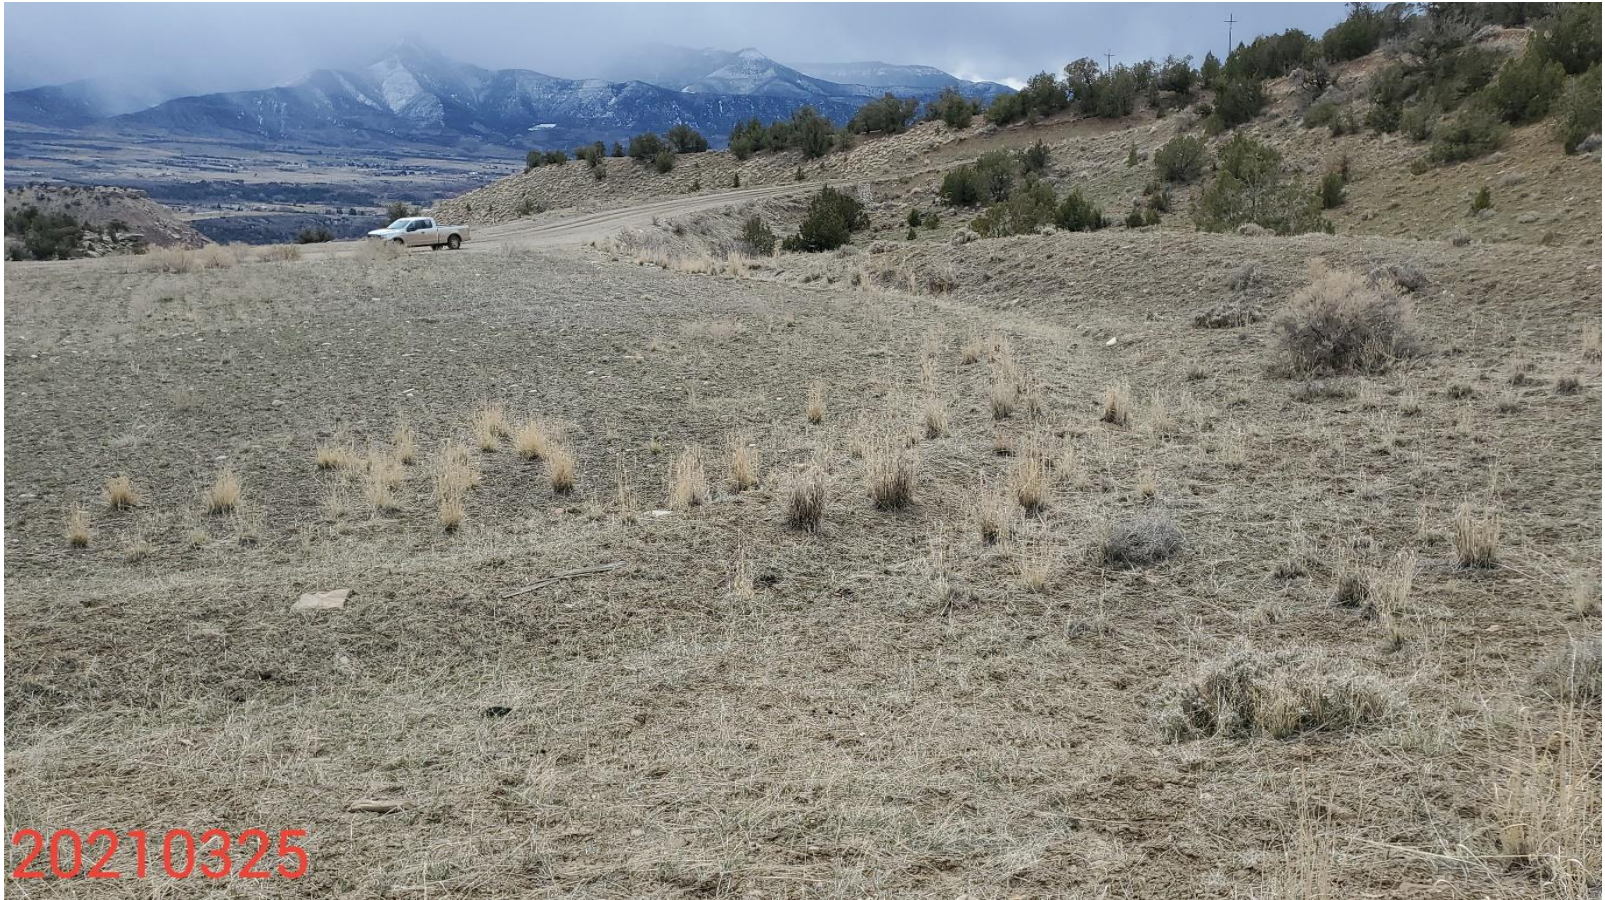
Photo 6: See comments under photo 5.
