Inspection Photos

3/25/2021

Operator: TEP ROCKY MOUNTAIN LLC - 96850

Location ID: 335145

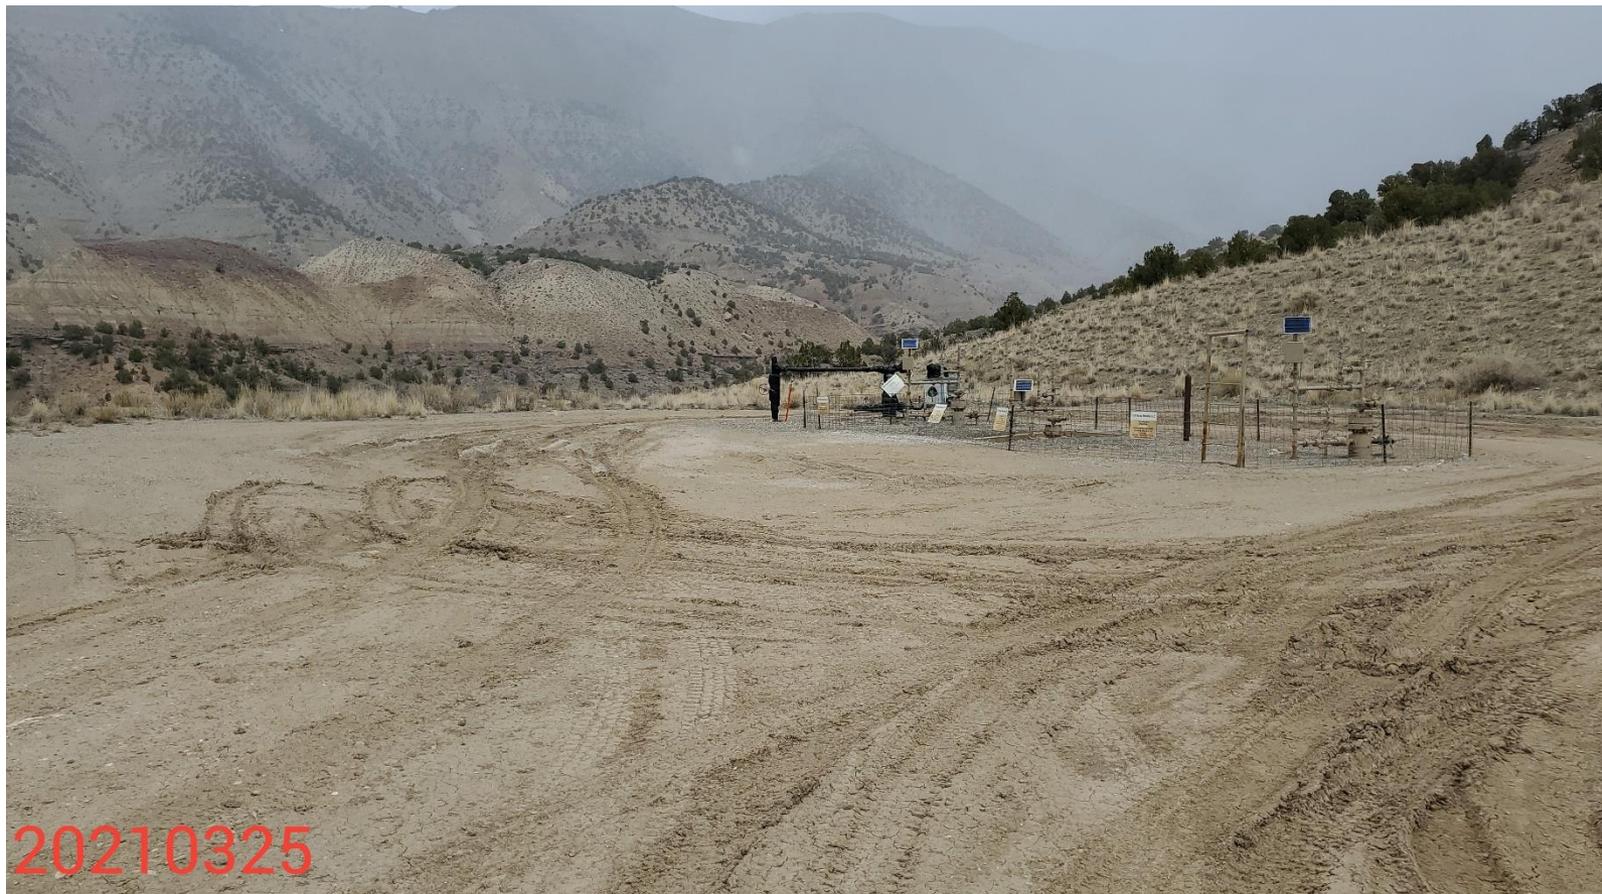
Photo 1: Photo taken from the south end of the Location, facing north. Photo shows that control measures to stabilize/protect unpaved areas of the Location are missing or insufficient.

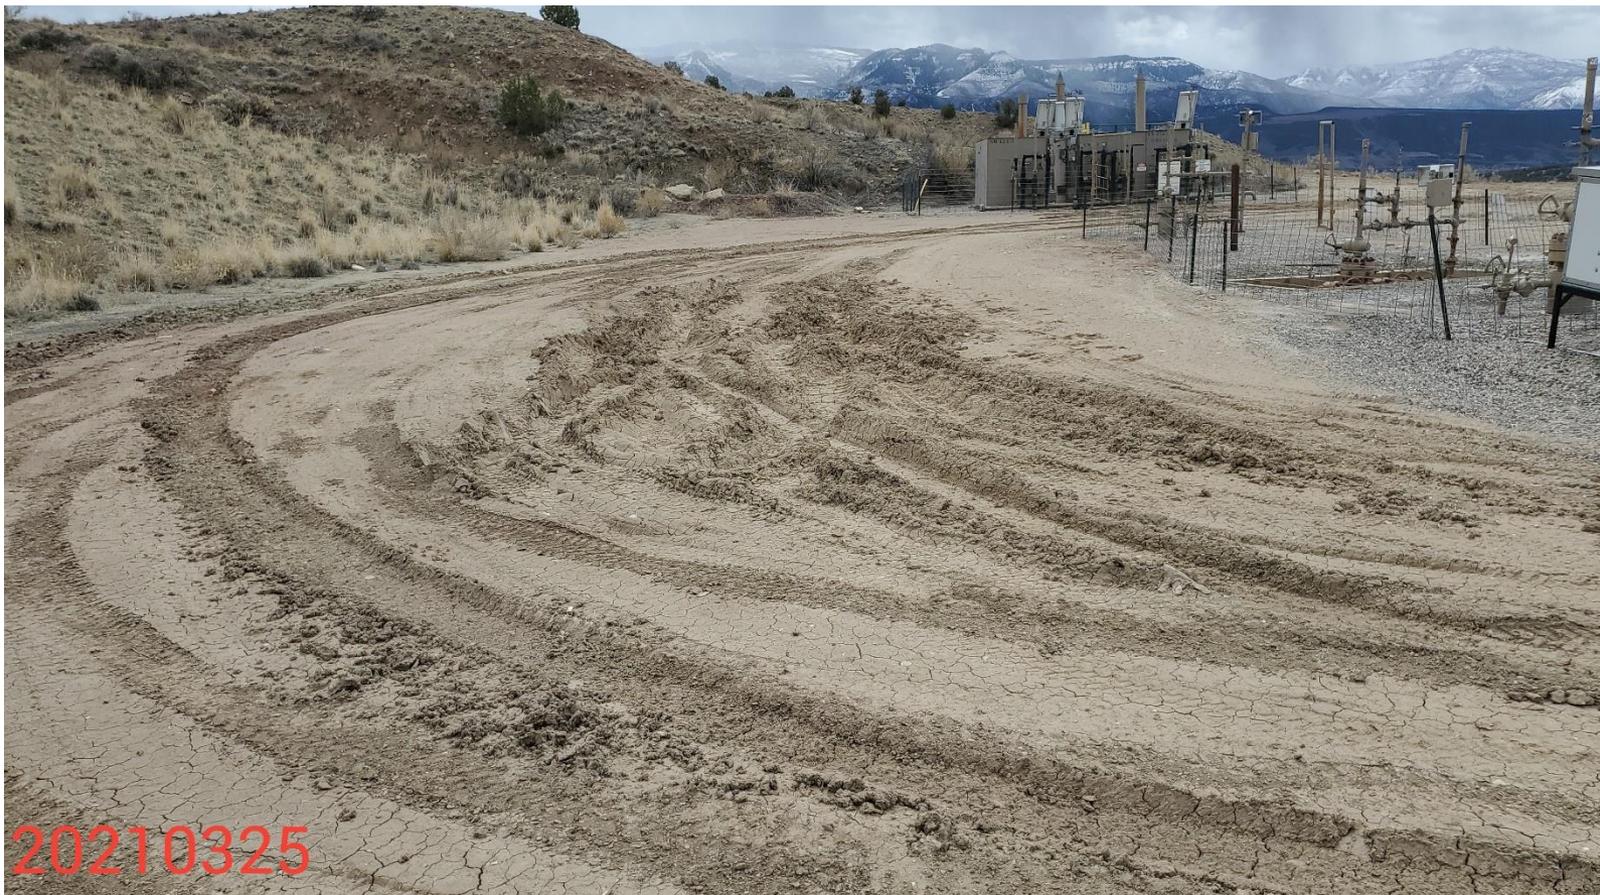
Photo 2: Photo taken from the north end of the Location, facing southeast. Photo shows that control measures to stabilize/protect unpaved areas of the Location are missing or insufficient.

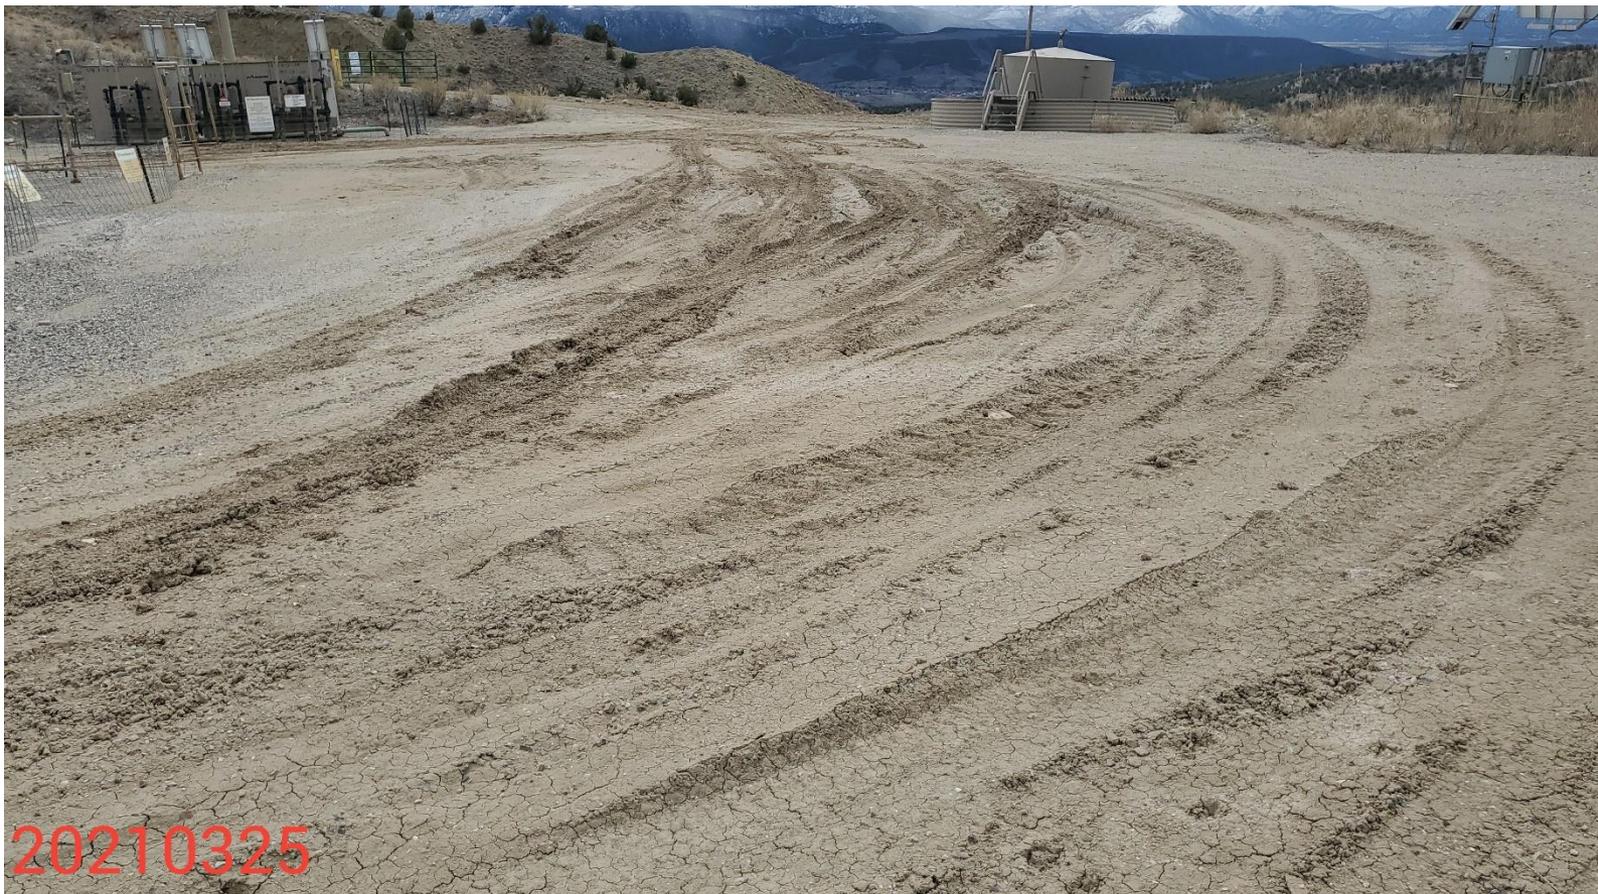
Photo 3: Photo taken from the north end of the Location, facing southeast. Photo shows that control measures to stabilize/protect unpaved areas of the Location are missing or insufficient.

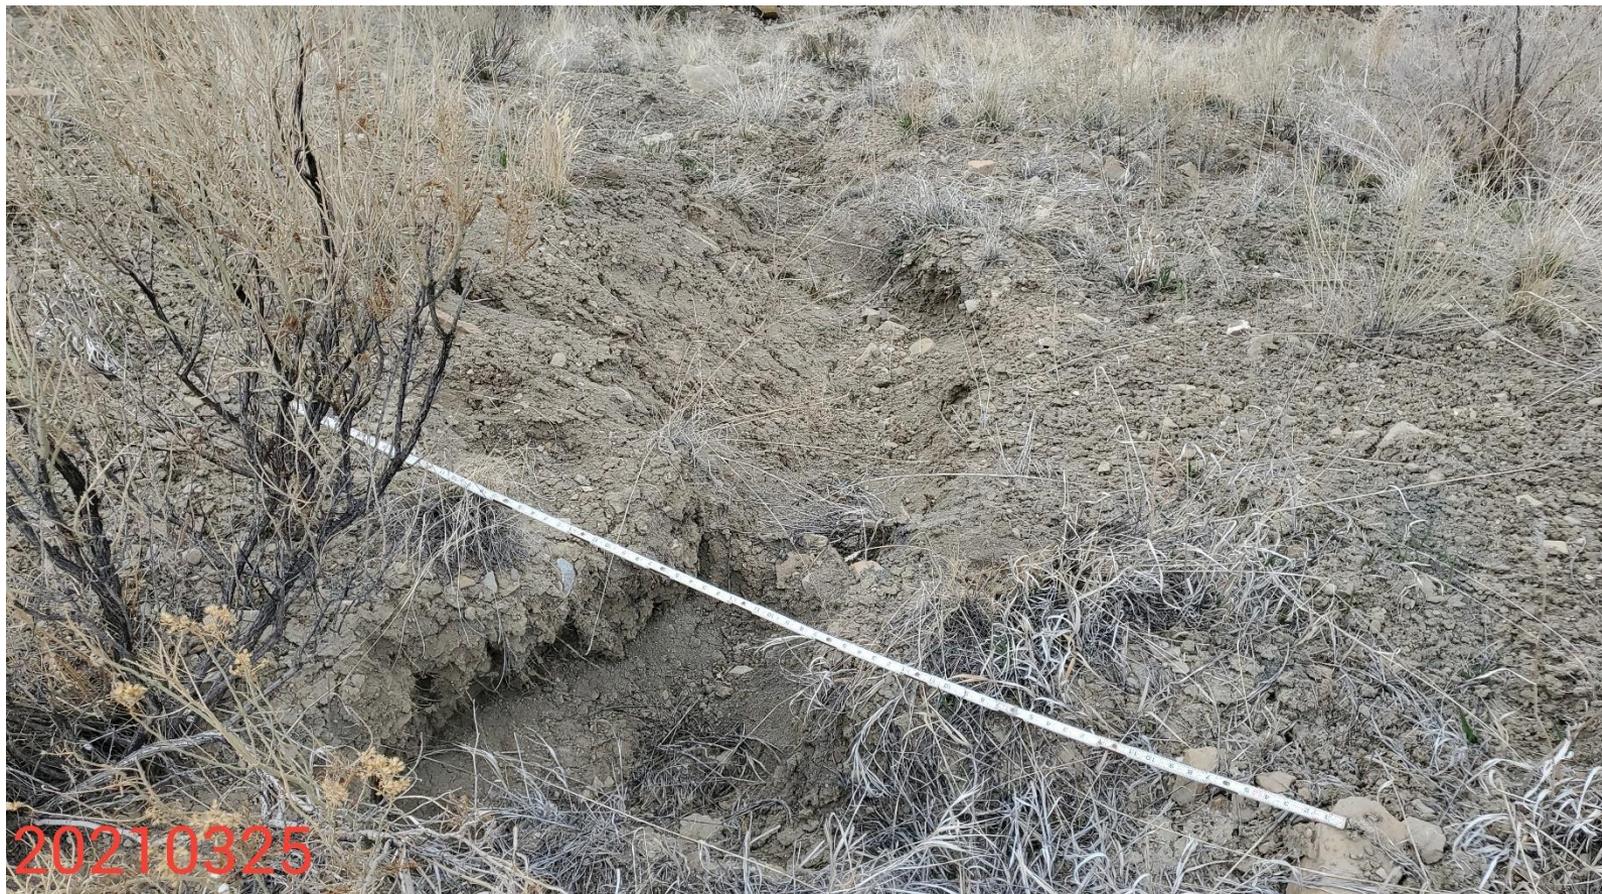
Photo 4: Photo taken from the slopes on the west end of the Location. Photo shows that control measures to stabilize/protect the cut/fill slopes of the Location are missing or insufficient; Gully erosion evident; crack forming within slope. 6 foot measuring stick used for reference.

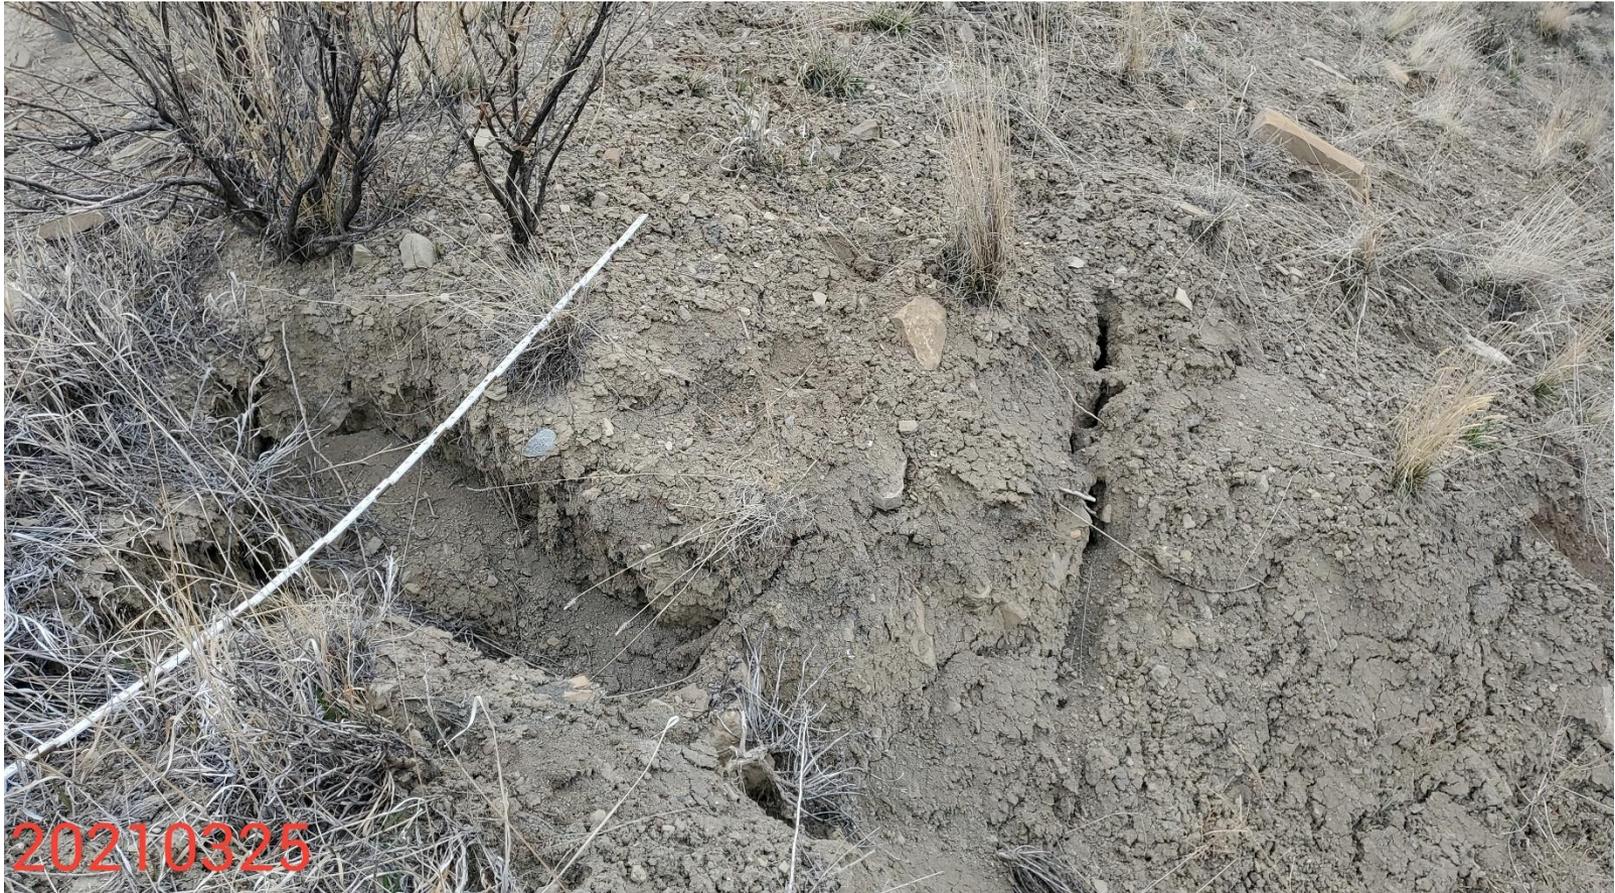
Photo 5: Photo taken from the slopes on the west end of the Location. Photo shows that control measures to stabilize/protect the cut/fill slopes of the Location are missing or insufficient; Gully erosion evident; crack forming within slope. 6 foot measuring stick used for reference.

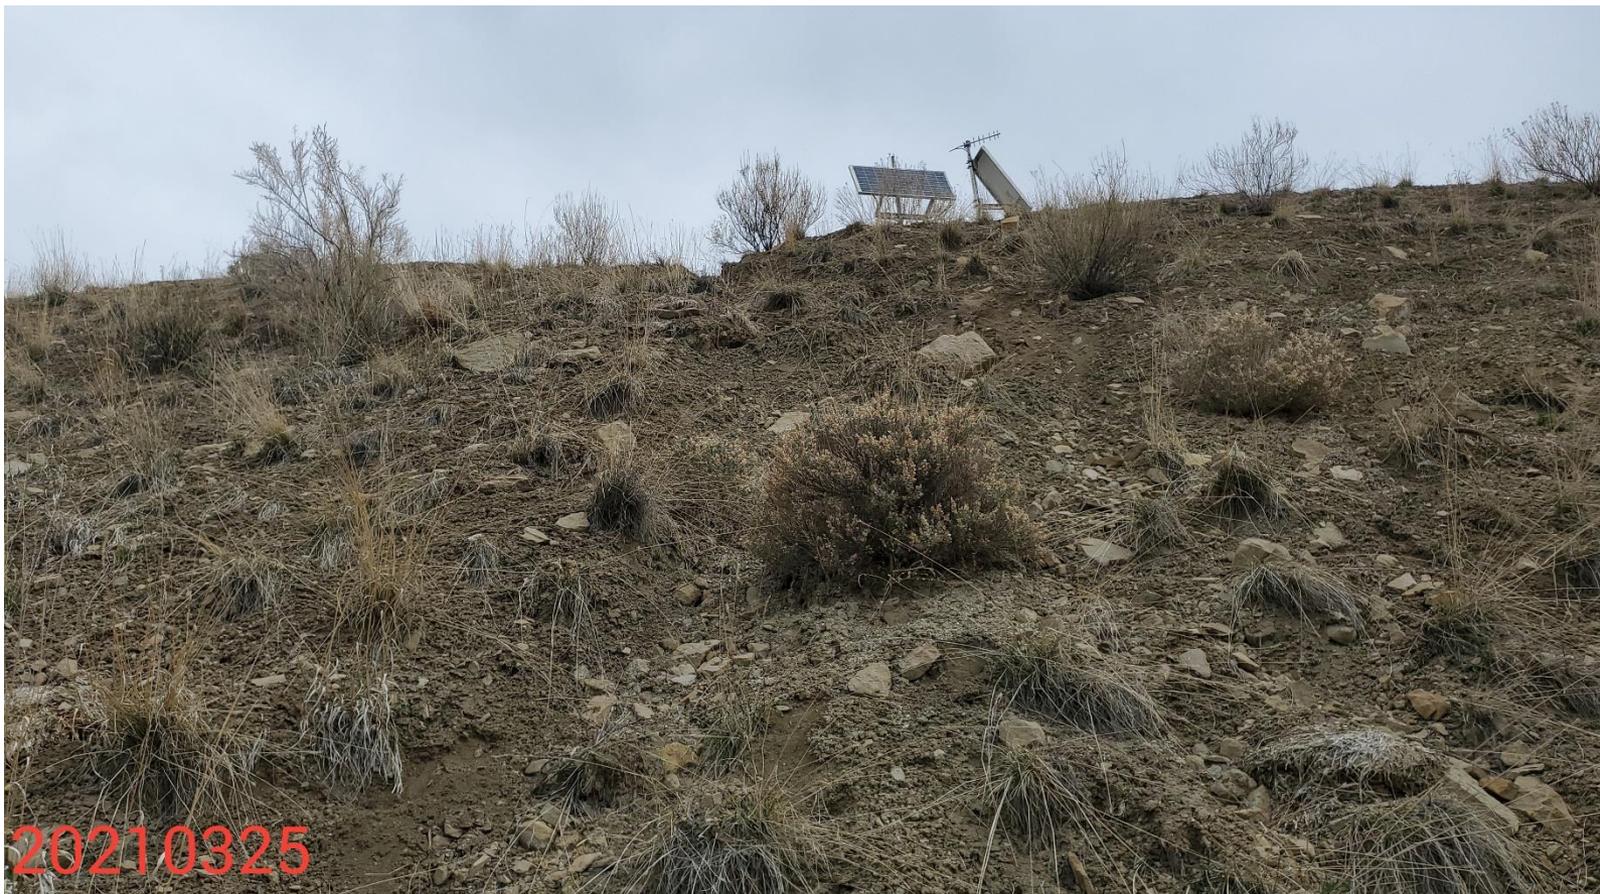
Photo 6: Photo taken from the slopes on the west end of the Location. Photo shows that control measures to stabilize/protect the cut/fill slopes of the Location are missing or insufficient; Gully erosion evident; crack forming within slope.
