August 30, 2007

RE: Limited Subsurface Site Assessment Report and Work Plan to Conduct Spill Cleanup Excavation and Remediation Activities at the Divide Creek Unit #35 (B1) Well Pad Mesa County, Colorado - Cordilleran Project #E07137

FIGURE 1
 TOPO LOCATION MAP
 ENCANA OIL & GAS
 DC35 (B1-DCU)
 COLORADO

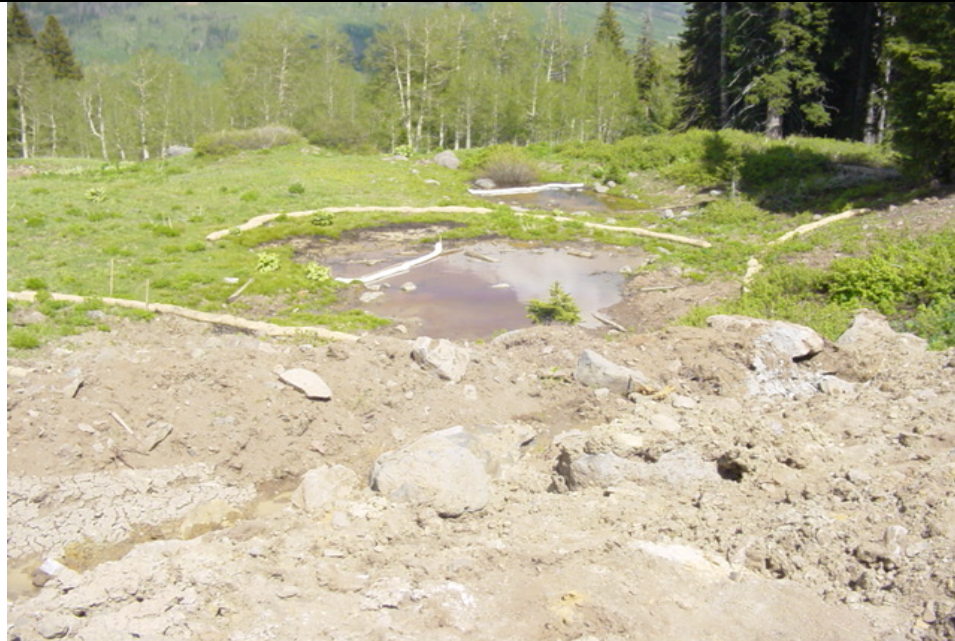
Subject: A sensitive area with standing water was identified at the base of the DCU #35 (B1) well pad. Snow melt caused the drill cuttings pit onsite to over flow resulting in impacts to the sensitive area during the spring of 2007.

Date: June 14, 2007

View: East

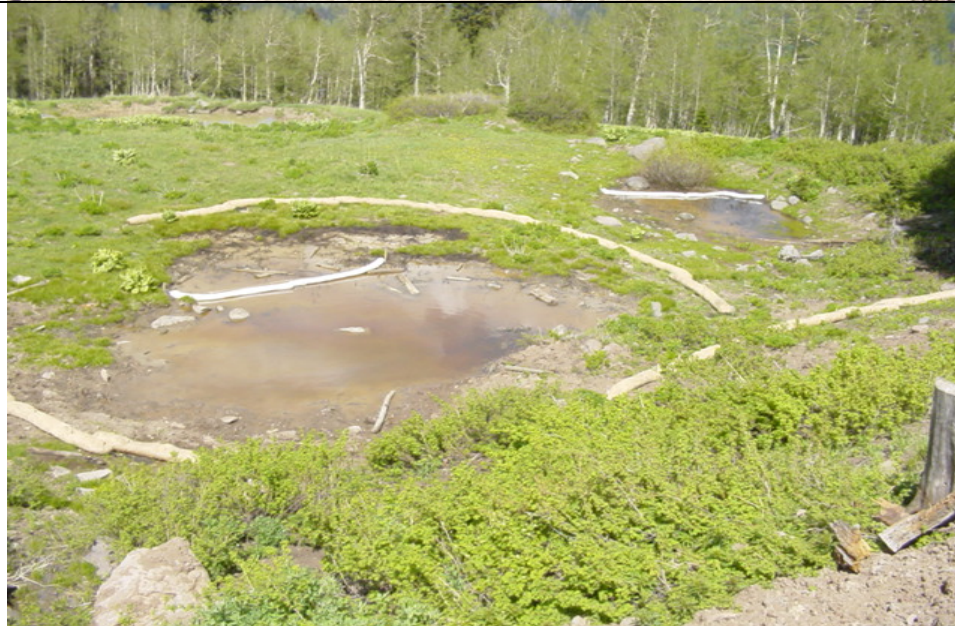
Subject: The sensitive area had standing water at the base of the DCU #35 (B1) well pad in the spring-early summer of 2007. Straw wattles were in place for storm water control to retain sediment in run off from the well pad. Absorbent booms were placed to skim petroleum hydrocarbon sheens on the water surface. The pond is located in the upper left hand corner of the picture and is separated by a hummock.

Date: June 14, 2007

View: East-northeast

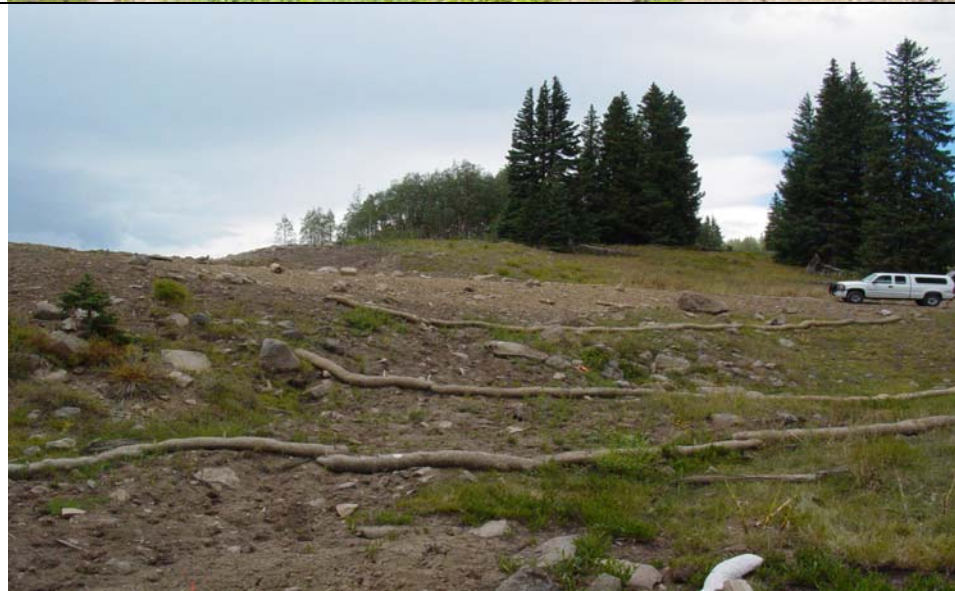
Subject: Straw wattles were placed on the slope of the well pad up to the access road to control sediment in storm water run off from the well pad. The picture shows one of the slopes from the pad where drilling fluids are suspected of running off into the sensitive area.

Date: August 14, 2007

View: Northwest

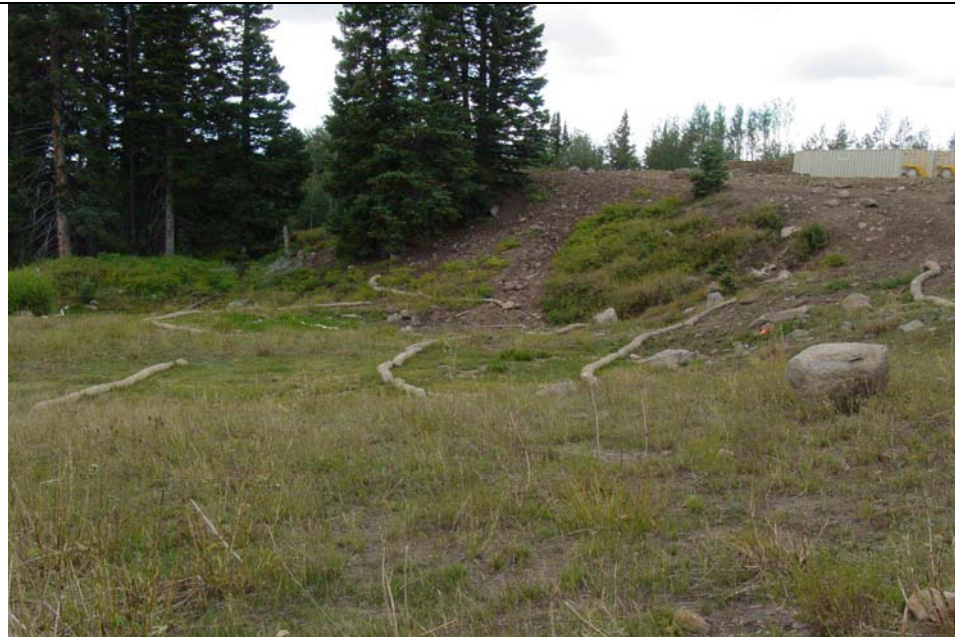
Subject: Photograph shows how the sensitive are looked in August 2007 and the well pad shown in the background. The areas that had water in June were dry. Vegetation did not appear to be chemically stressed from the release. A hummock separating the impacted area is shown in the foreground.

Date: August 14, 2007

View: South

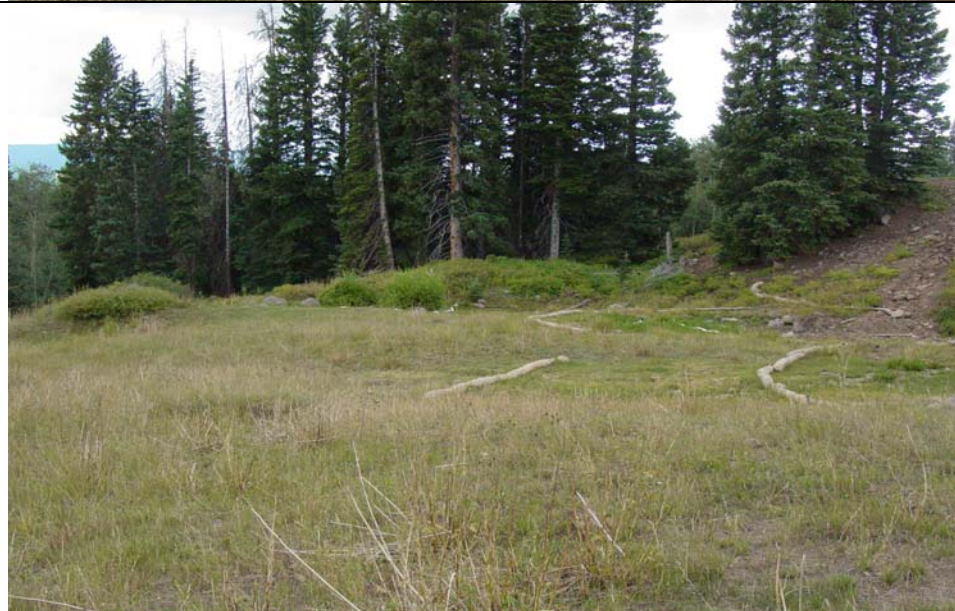
Subject: The sensitive area is within a swale located on a bench to the east-northeast of the well pad. A hummock shown in the foreground separates it from the drainage to a pond located northeast of the area of impact. Straw wattles were placed in the swale to control sediment entrained in the runoff.

Date: August 14, 2007

View: Southeast

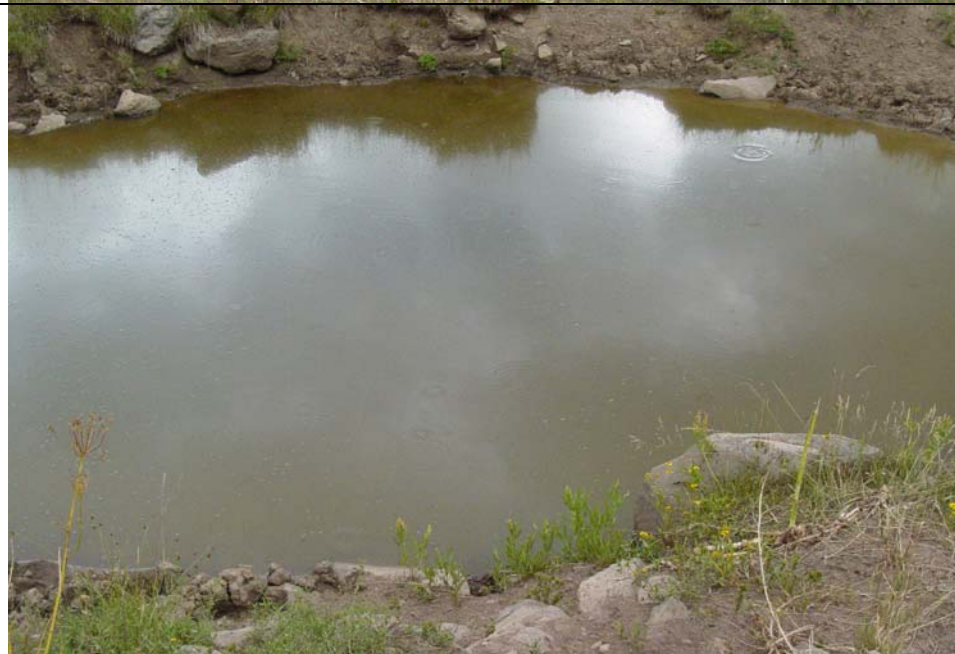
Subject: The pond was observed to contain aquatic life, possibly either tadpoles or salamanders. A bio-film was observed on the water surface but it did not exhibit an iridescent sheen suggesting petroleum hydrocarbons. A water sample was analyzed by the Chemsolutions mobile laboratory and petroleum hydrocarbons were not detected.

Date: August 14, 2007

View: East

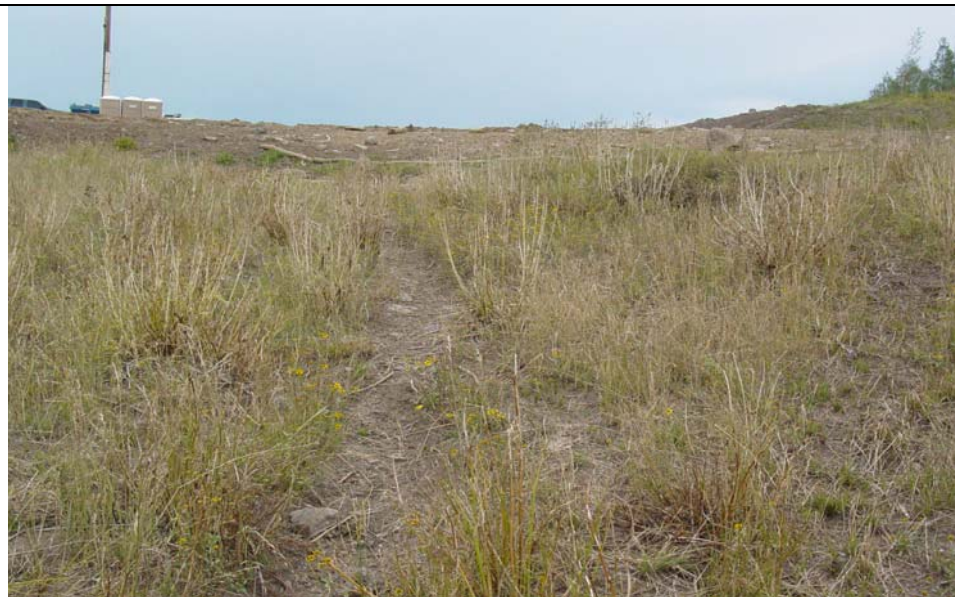
Subject: The photograph shows the drainage down to the pond and the ridge or hummock separating this drainage from the impacted area. One of the straw wattles on the slope of the well pad indicates the direction of flow from the pad.

Date: August 14, 2007

View: West

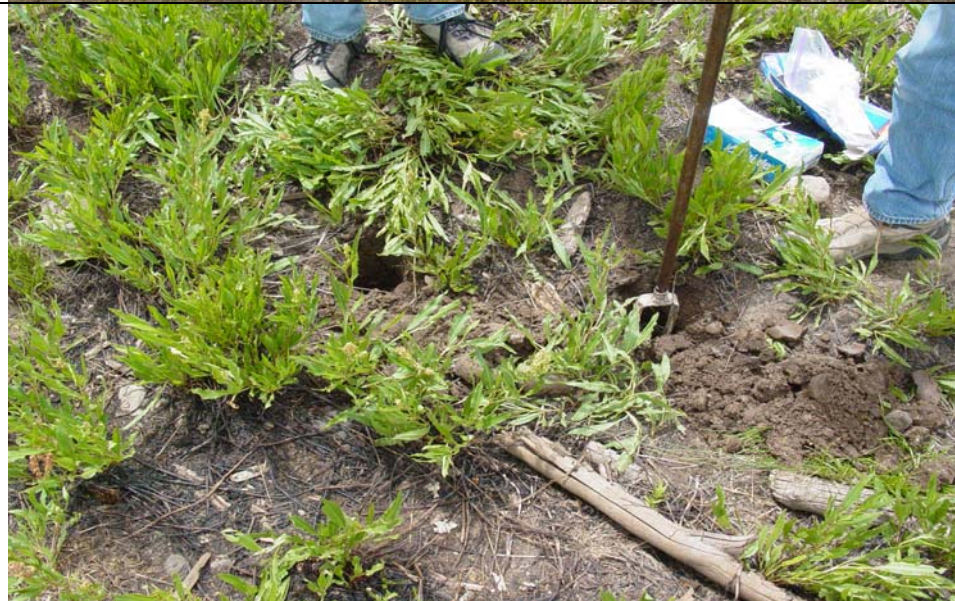
Subject: Surface soils in the impacted area immediately downgradient of the well pad exhibited some staining; however, site vegetation did not appear to be chemically stressed. Downward migration of petroleum hydrocarbons in the drill cuttings generally appears to have been limited by the clay soils and/or the ground being frozen at the time of the release.

Date: August 14, 2007

View: N/A - South

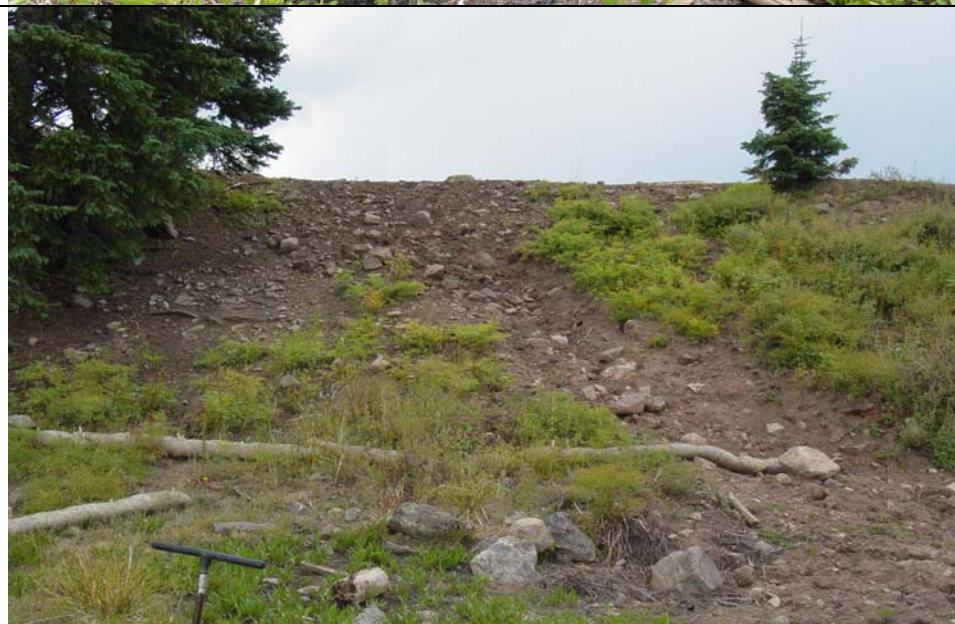
Subject: Photograph shows the well pad slope to the south of the sensitive area and storm water controls. There were reportedly two areas where the drilling liquids entered the sensitive area.

Date: August 14, 2007

View: South

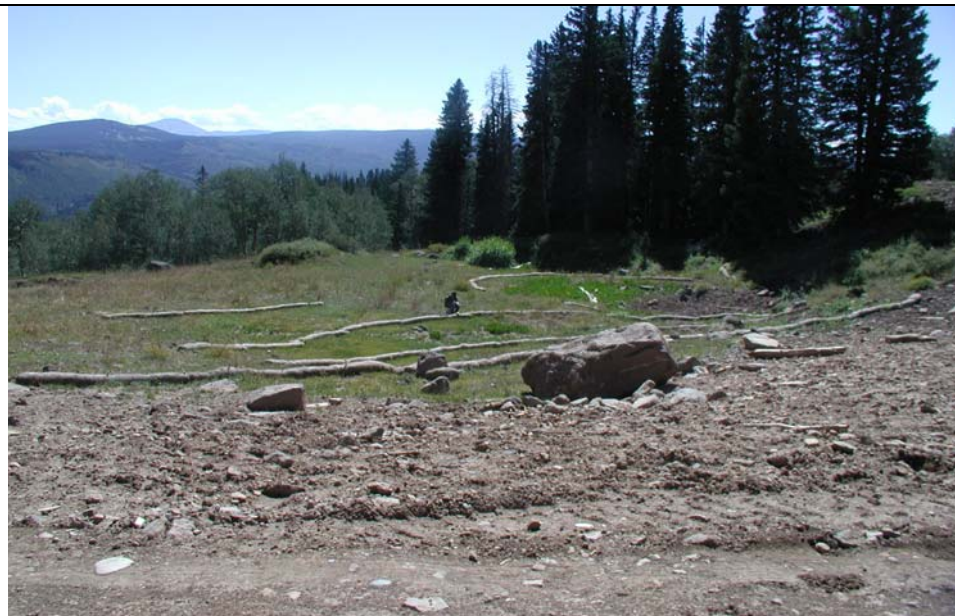
Subject: Photograph shows an overview of the impacted area from the well pad. Straw wattles have been placed roughly perpendicular to the flow of storm water to trap sediment. Storm water flow is direct to the upper right hand side of the photograph. The sensitive areas that receive more water are more lush with vegetation than the surrounding areas.

Date: August 16, 2007

View: East - Southeast

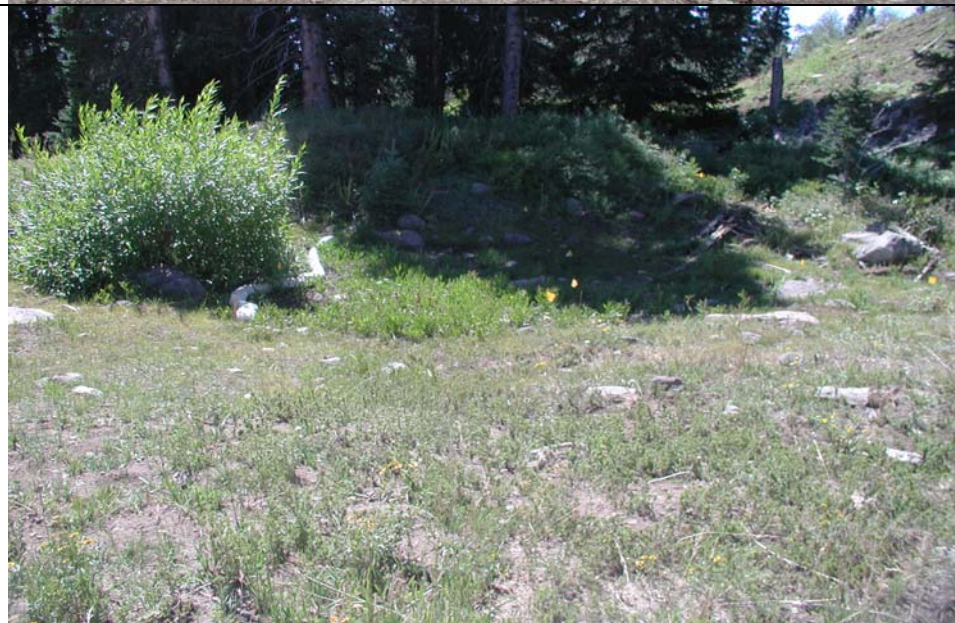
Subject: The sampling grid was set up by staking the perimeter of the investigation area with five green T-Posts (Sample locations #1 - #5) and then marking the interior sample locations with pin flags. Booms were placed in the sensitive area in June 2007 to skim oil from the storm water.

Date: August 16, 2007

View: South

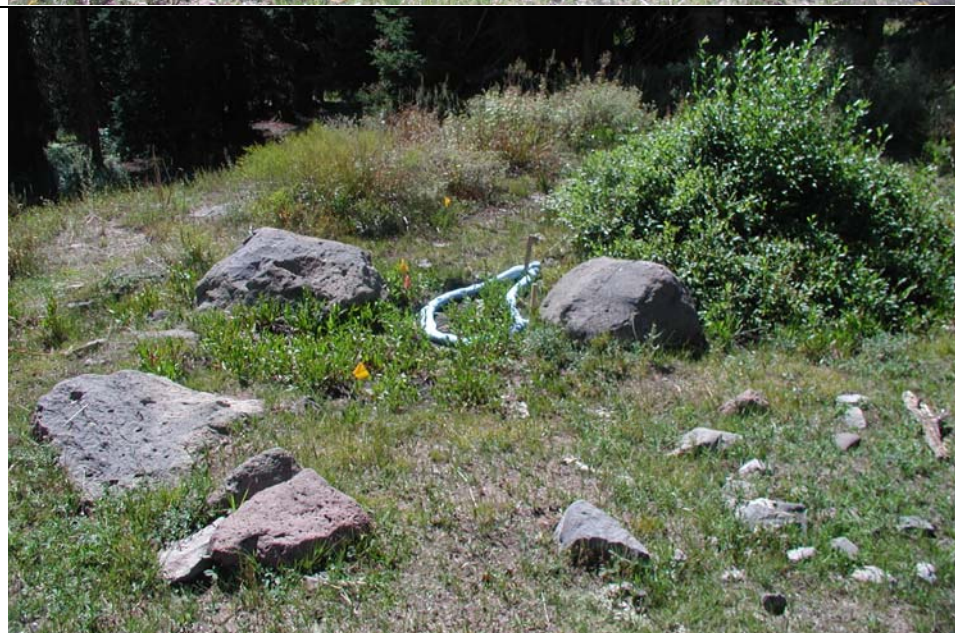
Subject: Photograph shows booms used to skim oil on storm water in June 2007 at the edge of the bench and yellow pin flags showing soil sample locations.

Date: August 16, 2007
