Inspection Photos

Operator: SG INTERESTS I LTD # 77330

Location ID: 429333

Gunnison County, CO

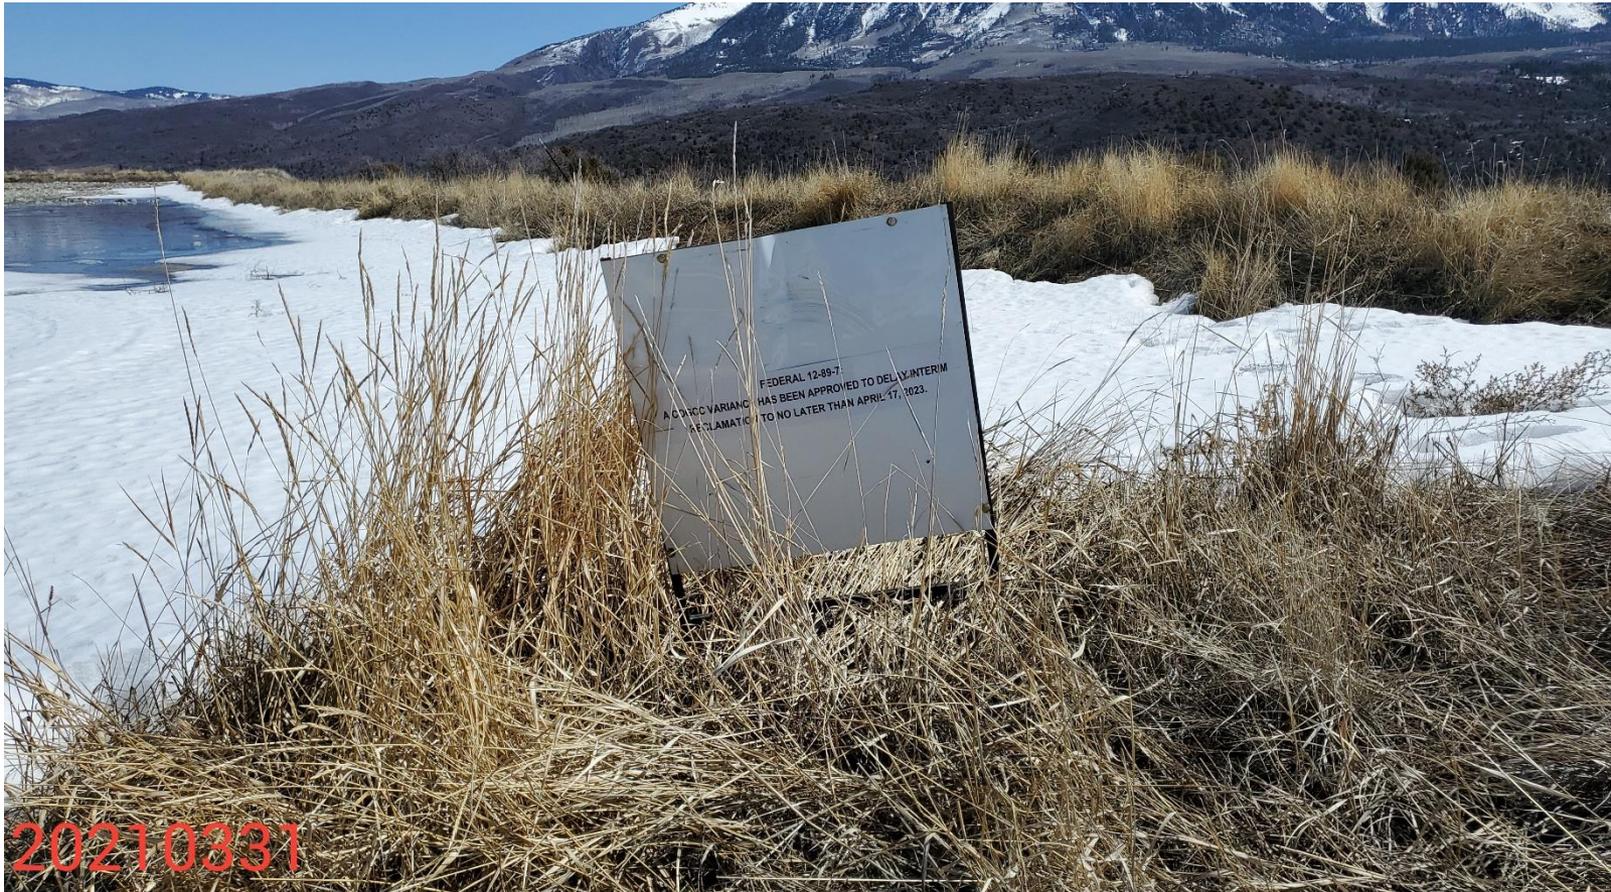
Photo 1: Photo taken from the southern entrance. Photo shows signage has been installed per form 4 and Delayed IR NTO COAs.

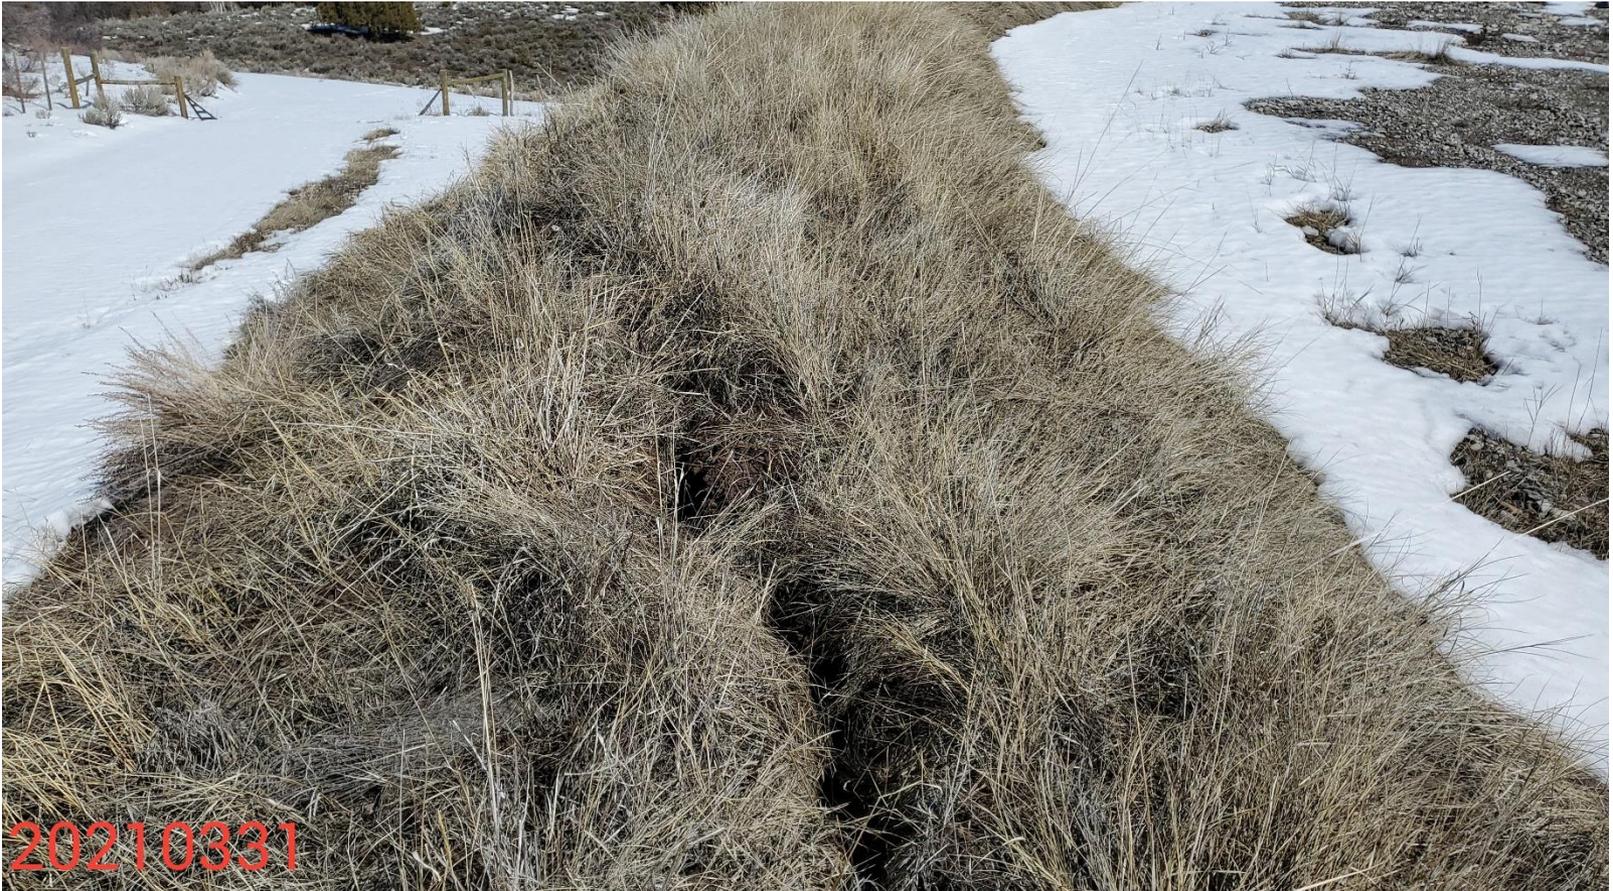
Photo 2: Photo taken from the top of the berm along the northern perimeter of the Pad. Photo shows example of crack/stabilization issues observed throughout the perimeter of the Location and slopes.

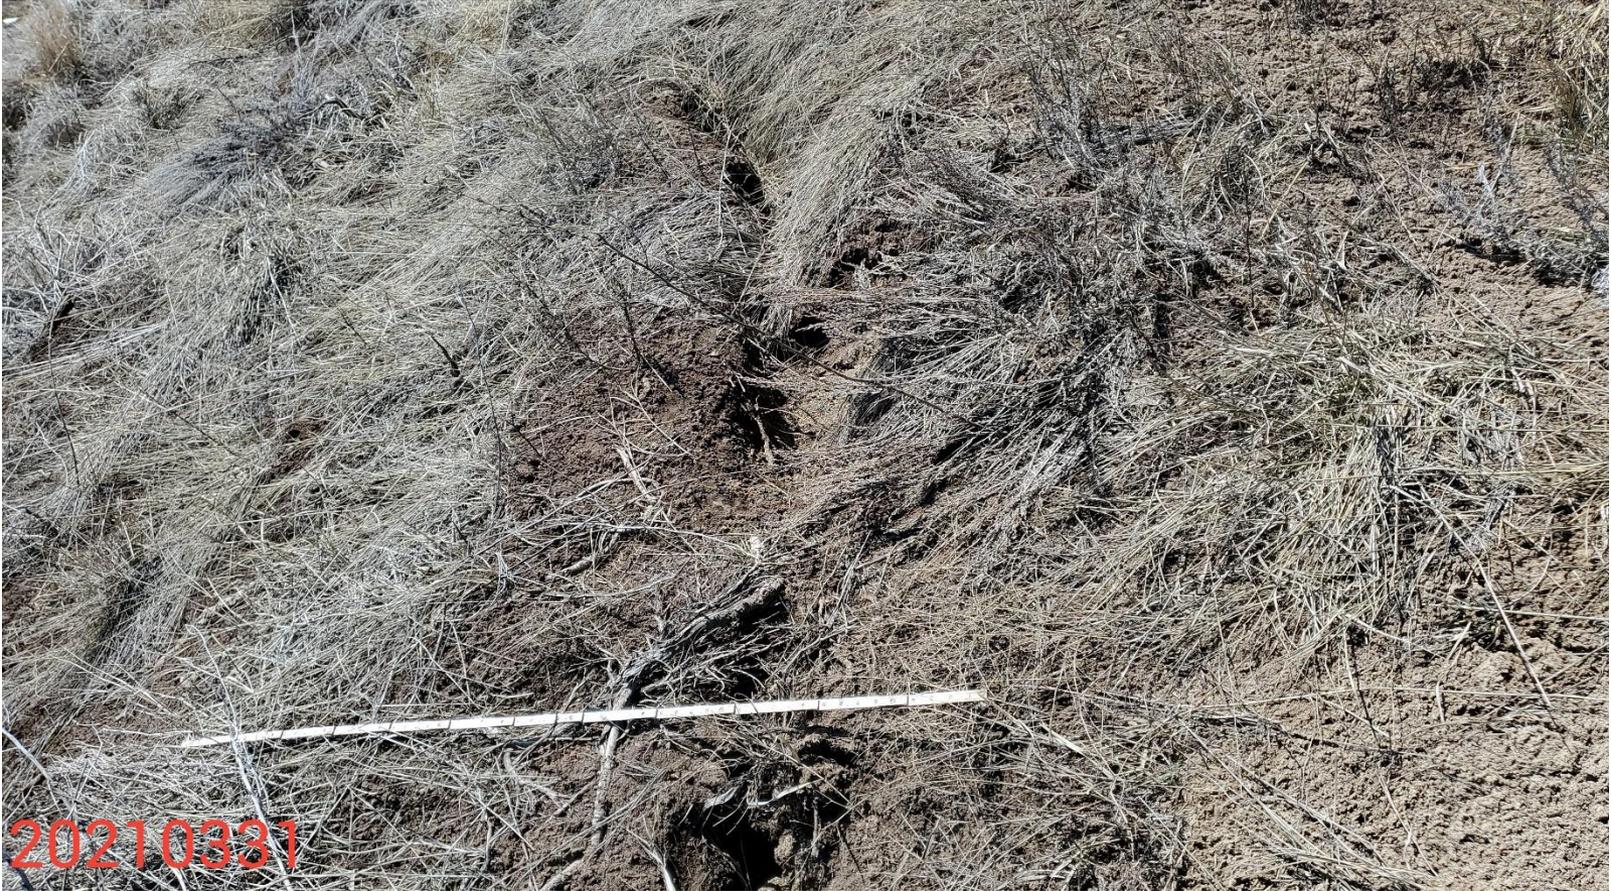
Photo 3: Photo taken from the slopes on the southeast end of the Location. Photo shows example of crack/stabilization issues observed throughout the perimeter of the Location and slopes. 6 foot measuring stick for reference.

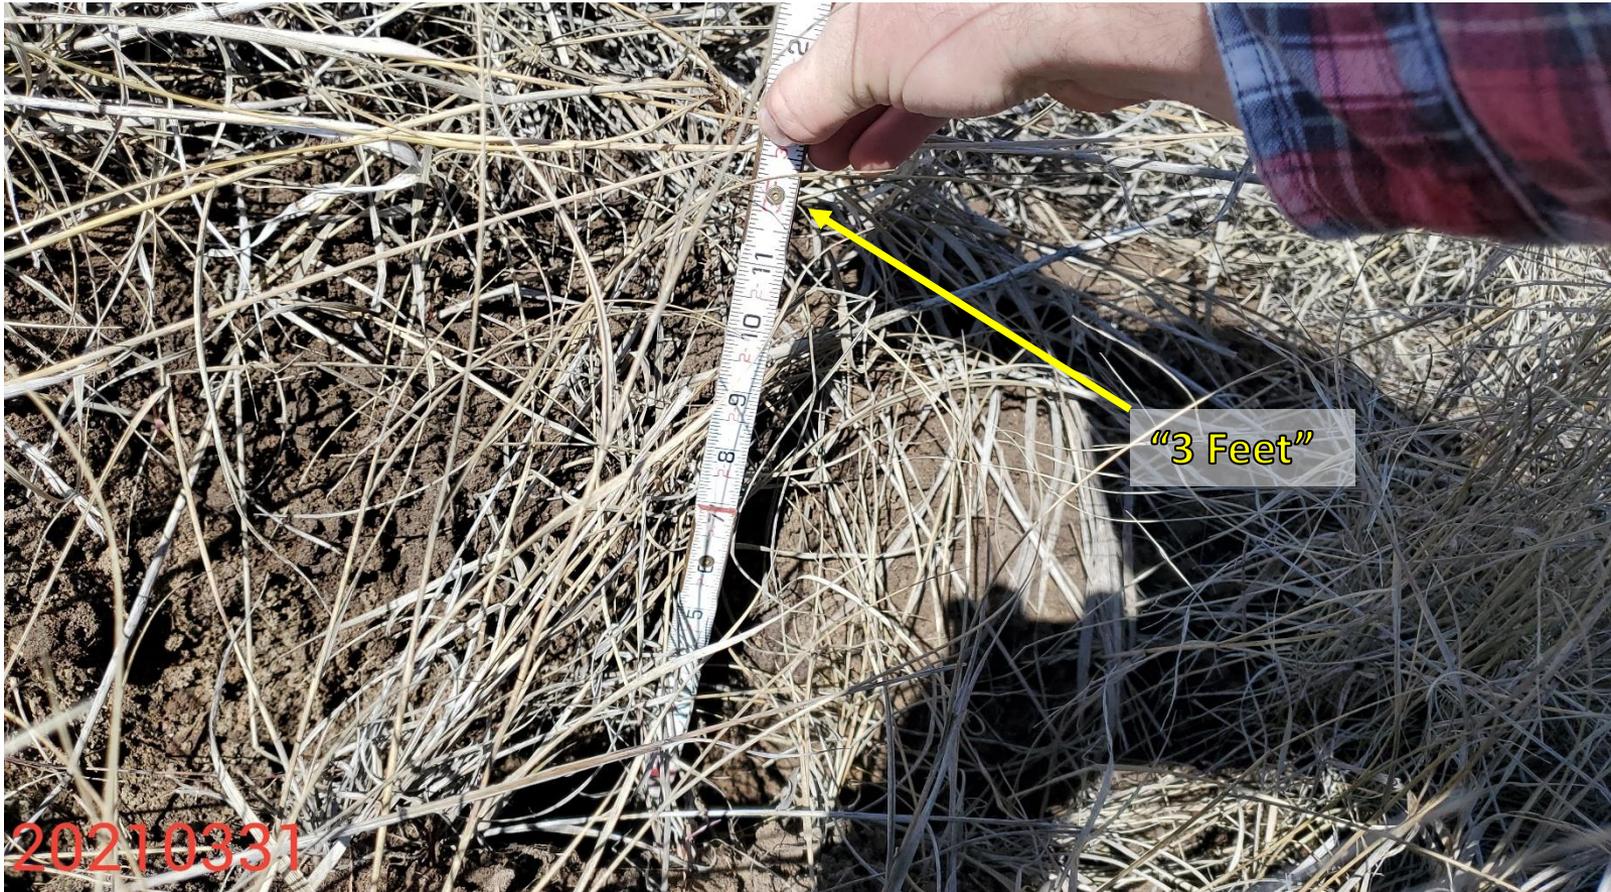
Photo 4: Photo taken from crack on the perimeter of the Location. Photo shows example of areas where cracks on the Location were observed to exceed 30 inches in depth.

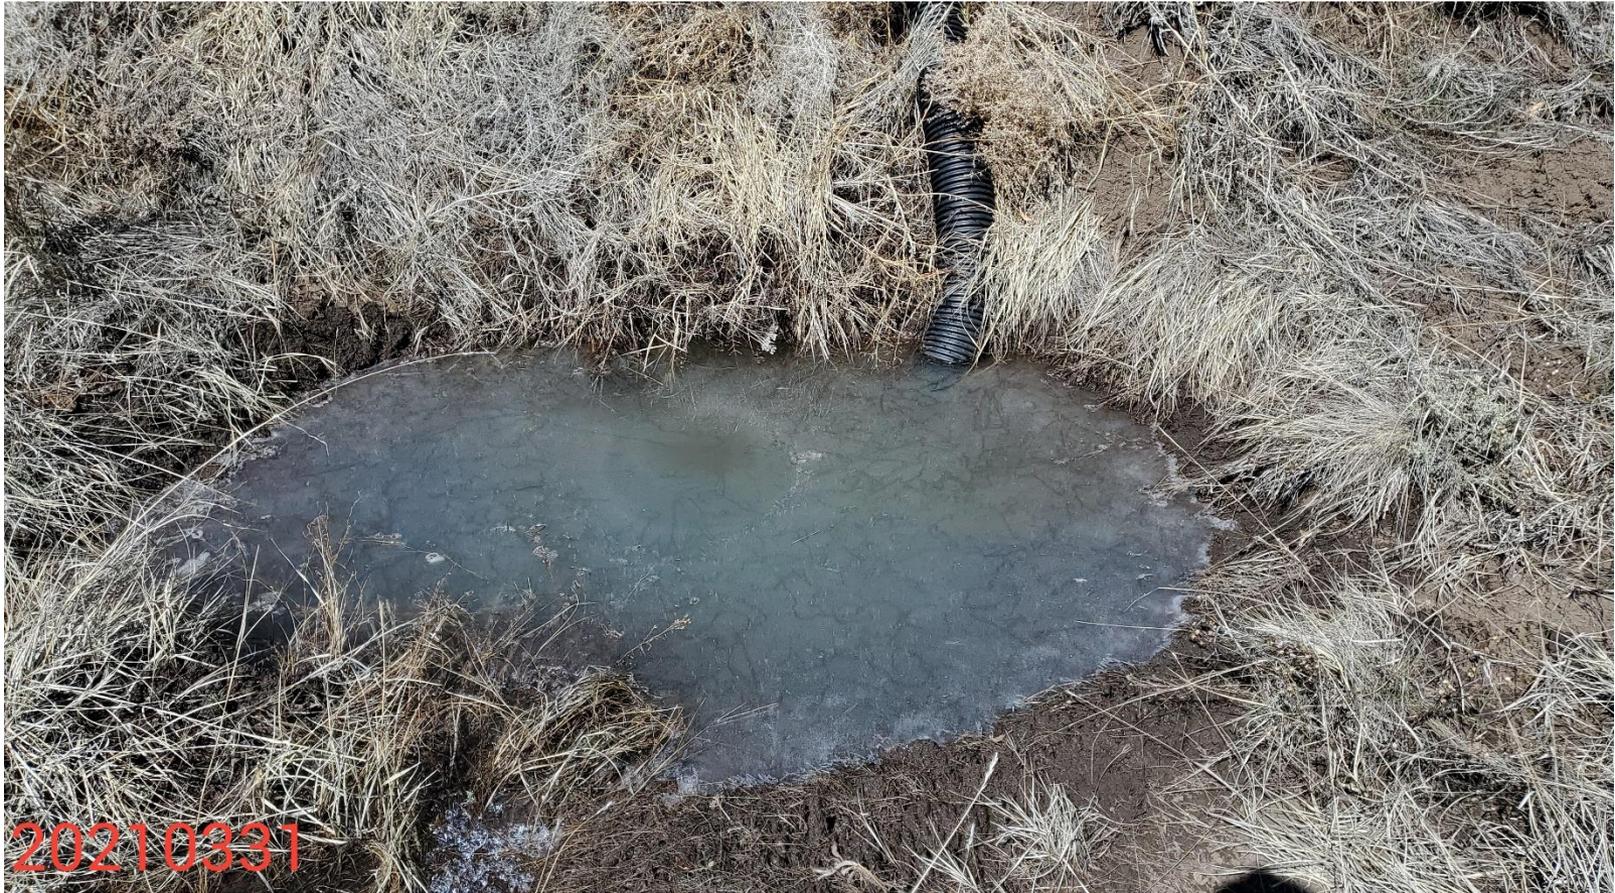
Photo 5: Photo taken from the south end of the Location. Photo shows Sediment trap has not been constructed in accordance with good engineering practices; BMP not constructed with an appropriate inlet/outlet.

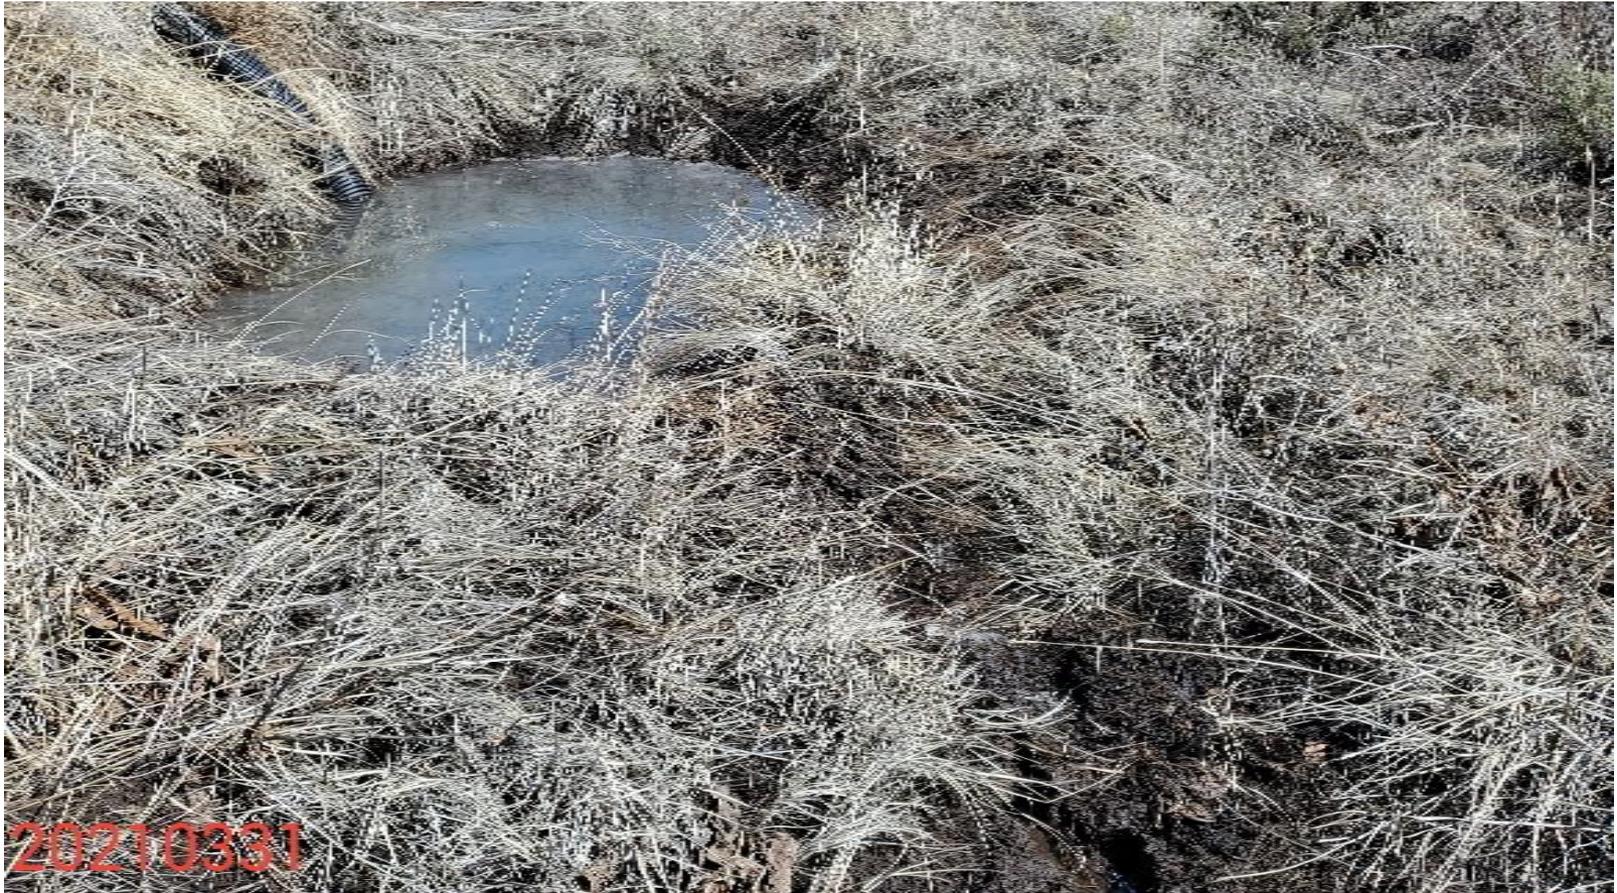
Photo 6: See comments under photo 5.

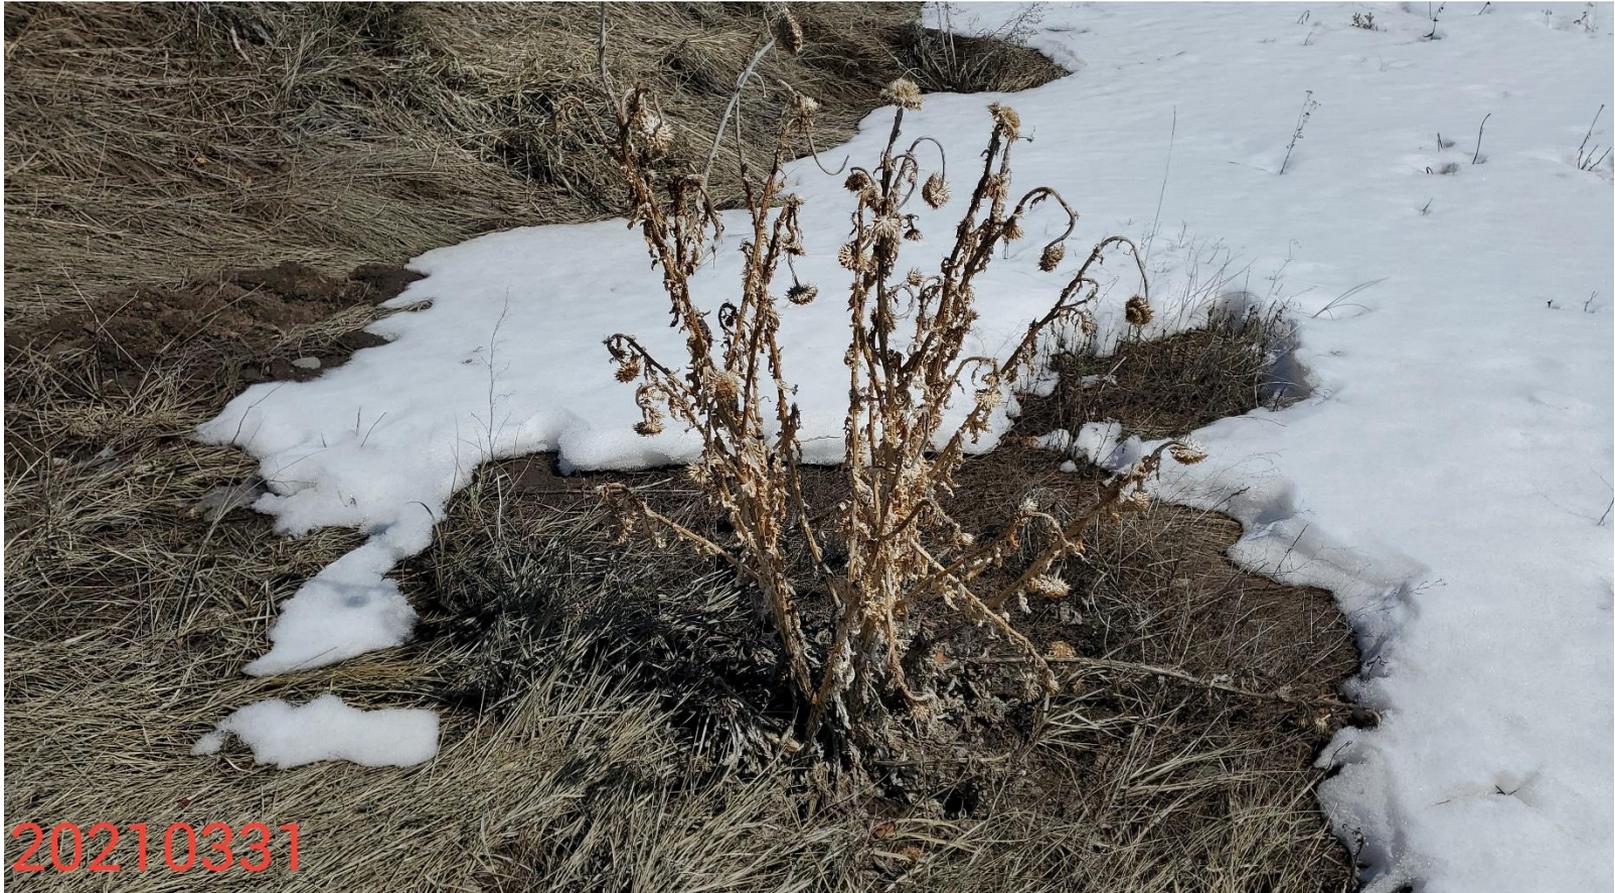
Photo 7: Photo taken from the southern areas of the Location. Photo shows Musk thistle remnants from the 2020 growing season. Common mullein also observed on Location. These are Colorado State listed noxious weeds.
