Inspection Photos

Operator: OXY USA INC - 66561

Location ID: 312503

Mesa County, CO

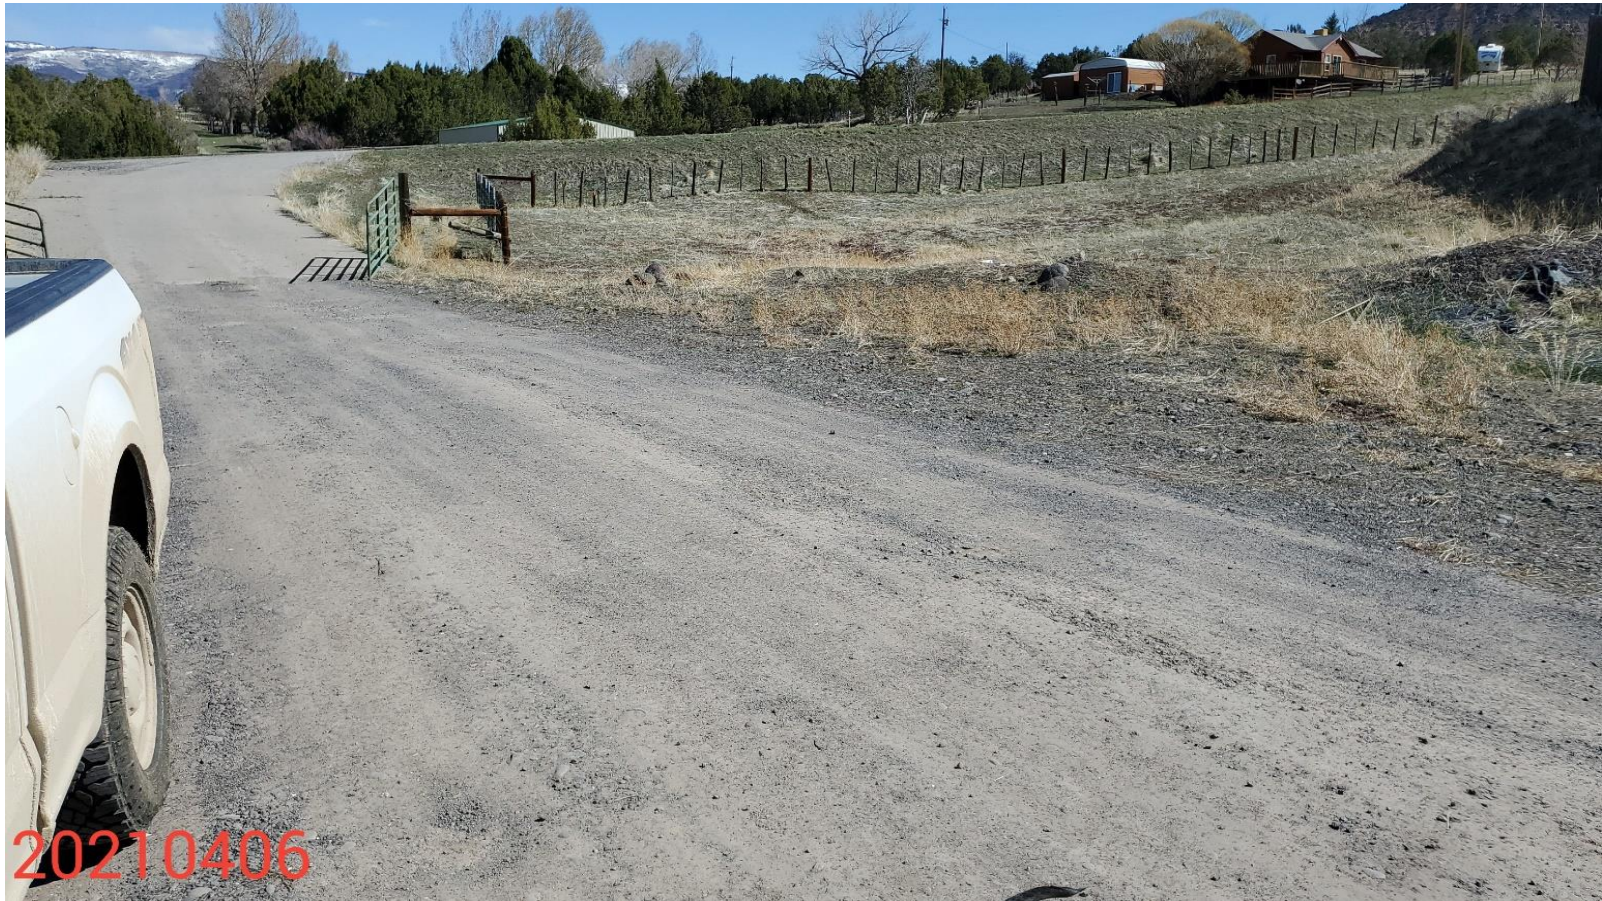
Photo 1: Photo taken from the west end of the Location, facing North. Photos 1-4 provide an overview of the Location from north, northeast, southeast to south. Photos show areas of the well site have not been reclaimed (removal of gravel, recontouring, reclaiming). Areas are being utilized by the surface owner; no 502.b variance to waiver 1004 reclamation requirements have been submitted by the Operator, or approved.

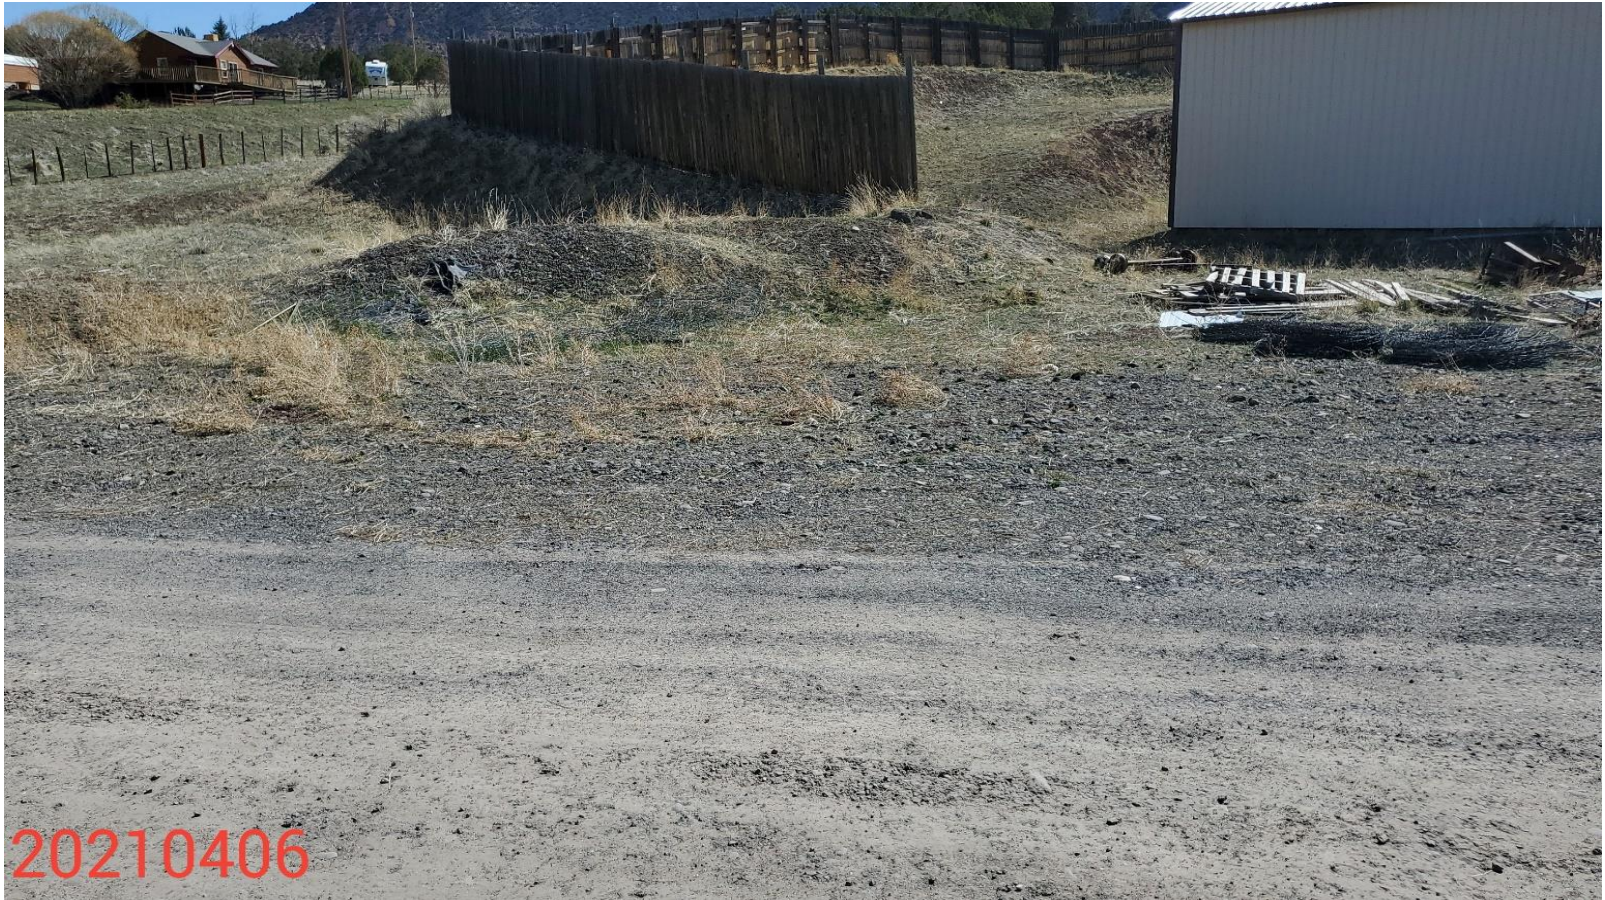
Photo 2: See comments under photo 1.

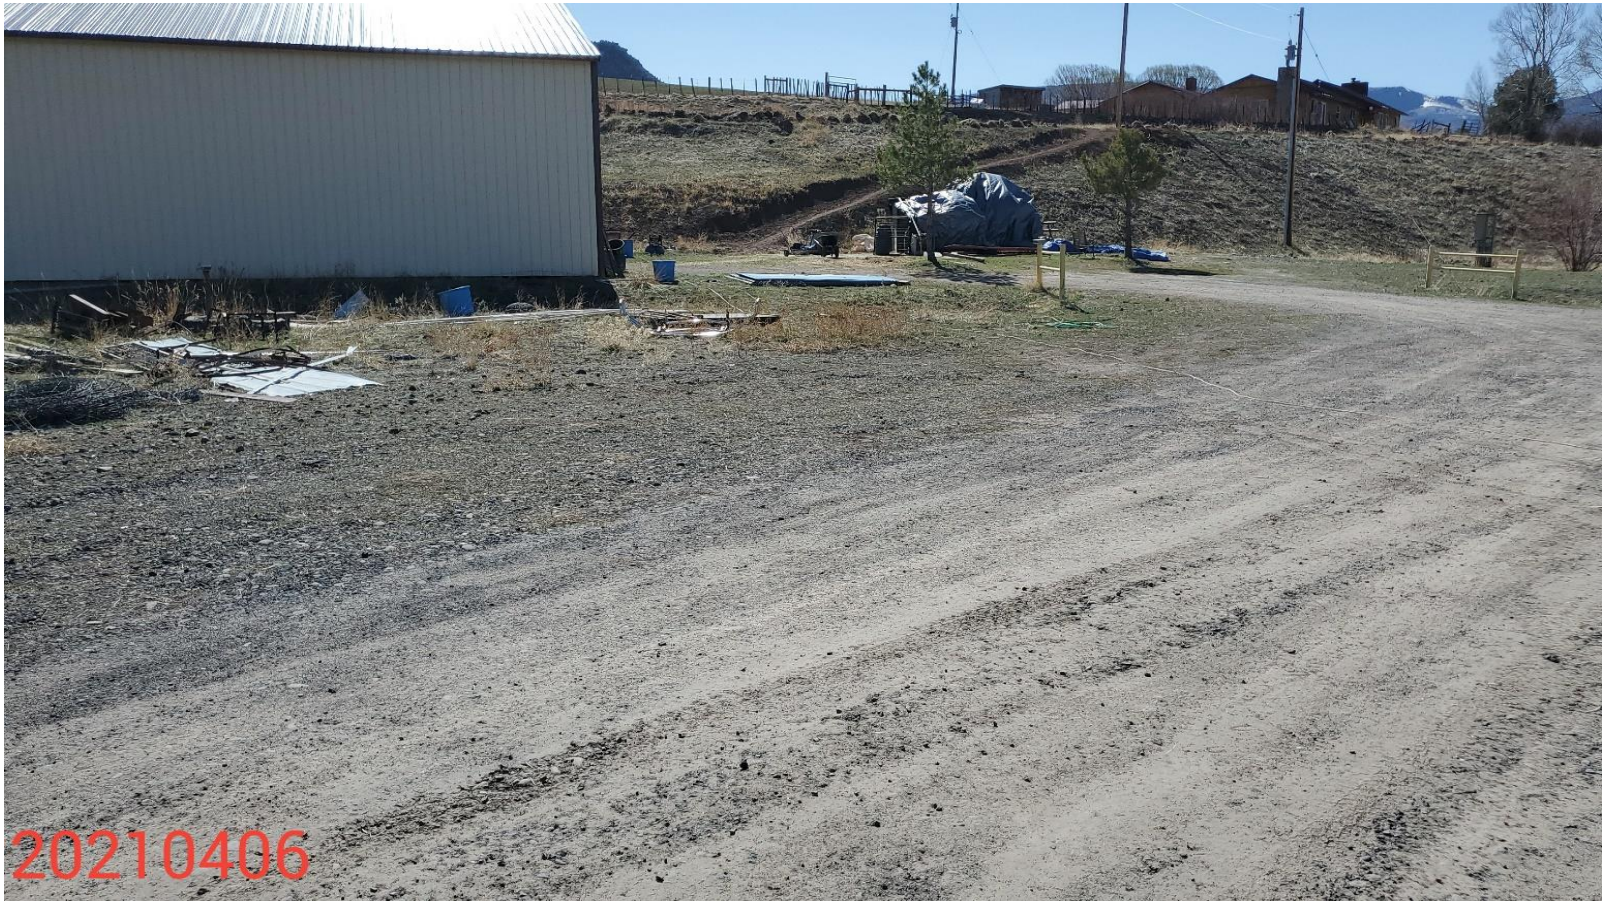
Photo 3: See comments under photo 1.

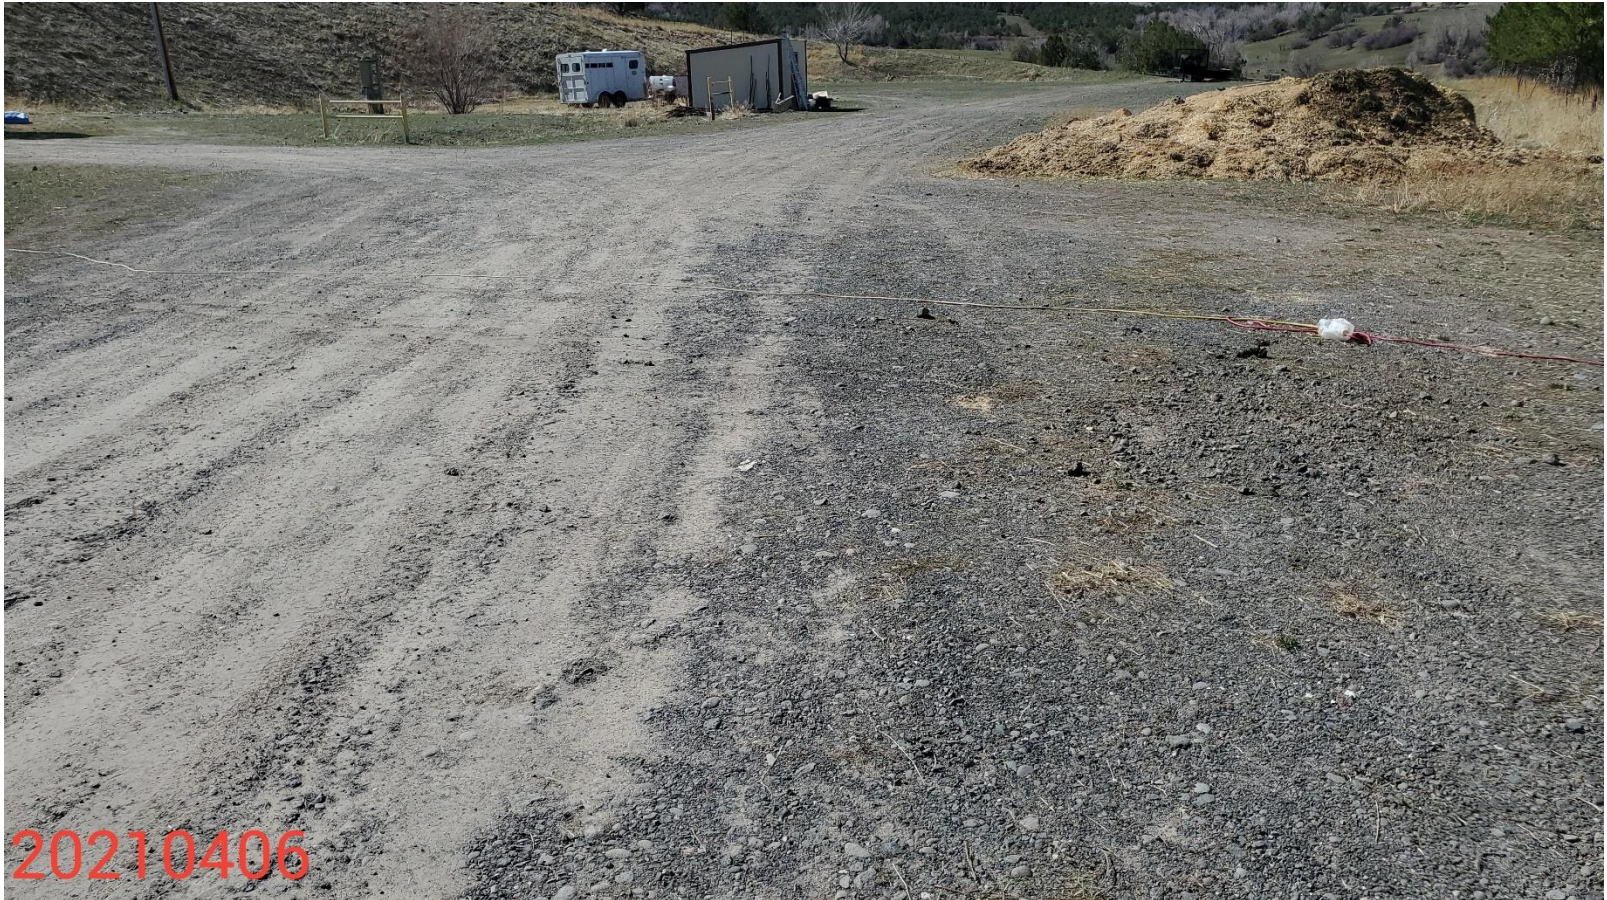
Photo 4: See comments under photo 1. Photo also shows areas where the production equipment associated with the well was Located.
