Inspection Photos

4/6/2021

Operator: LARAMIE ENERGY LLC

Location ID: 334502

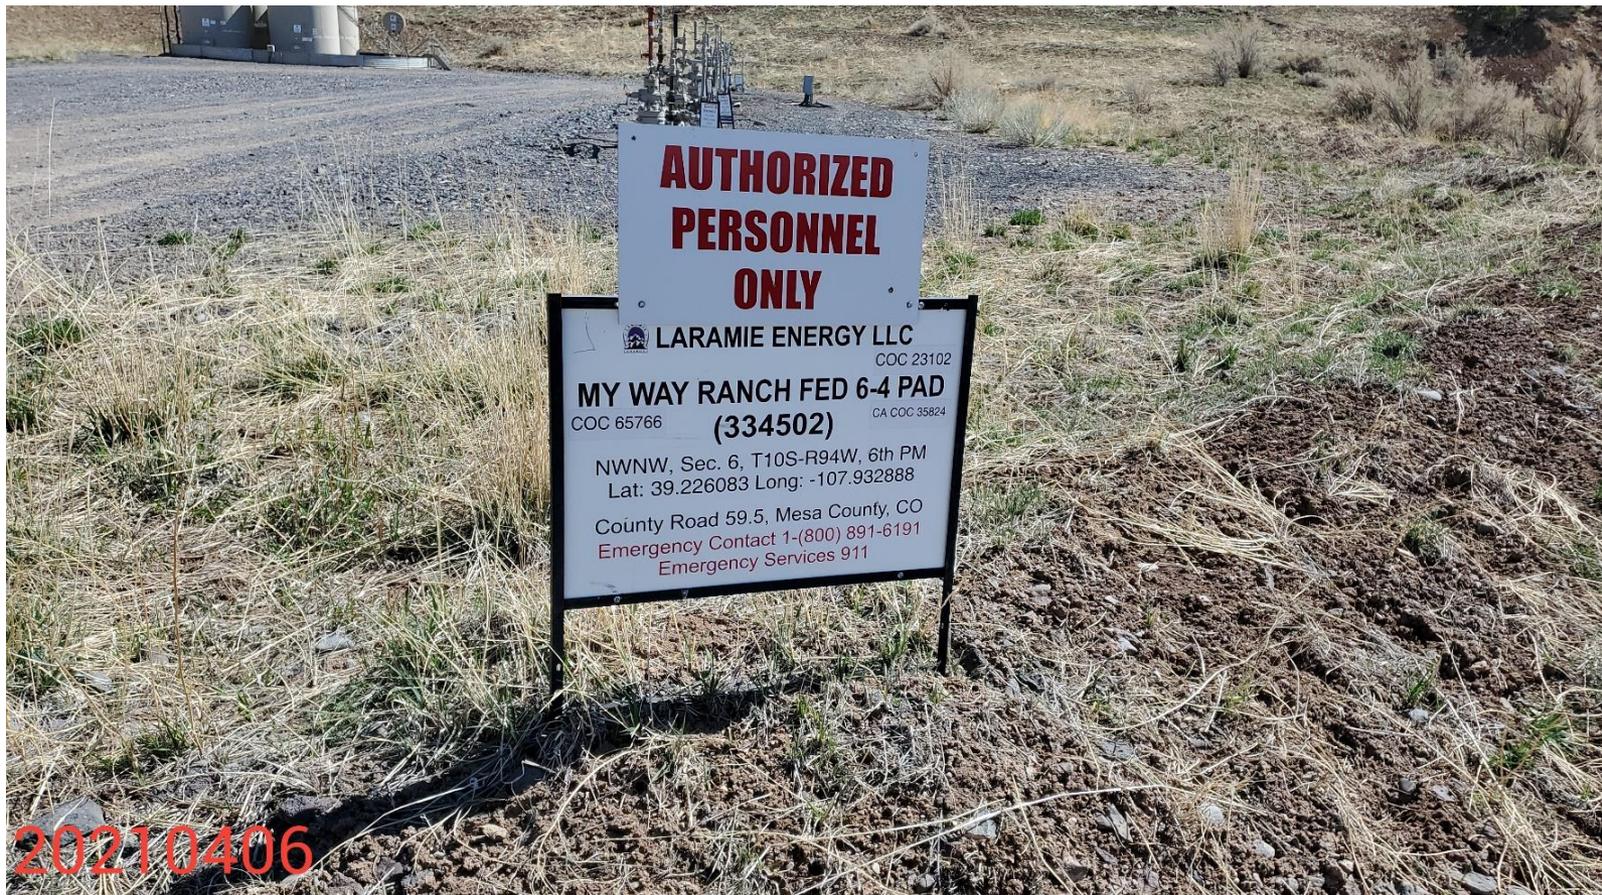
Photo 1: Photo shows sign at Location entrance

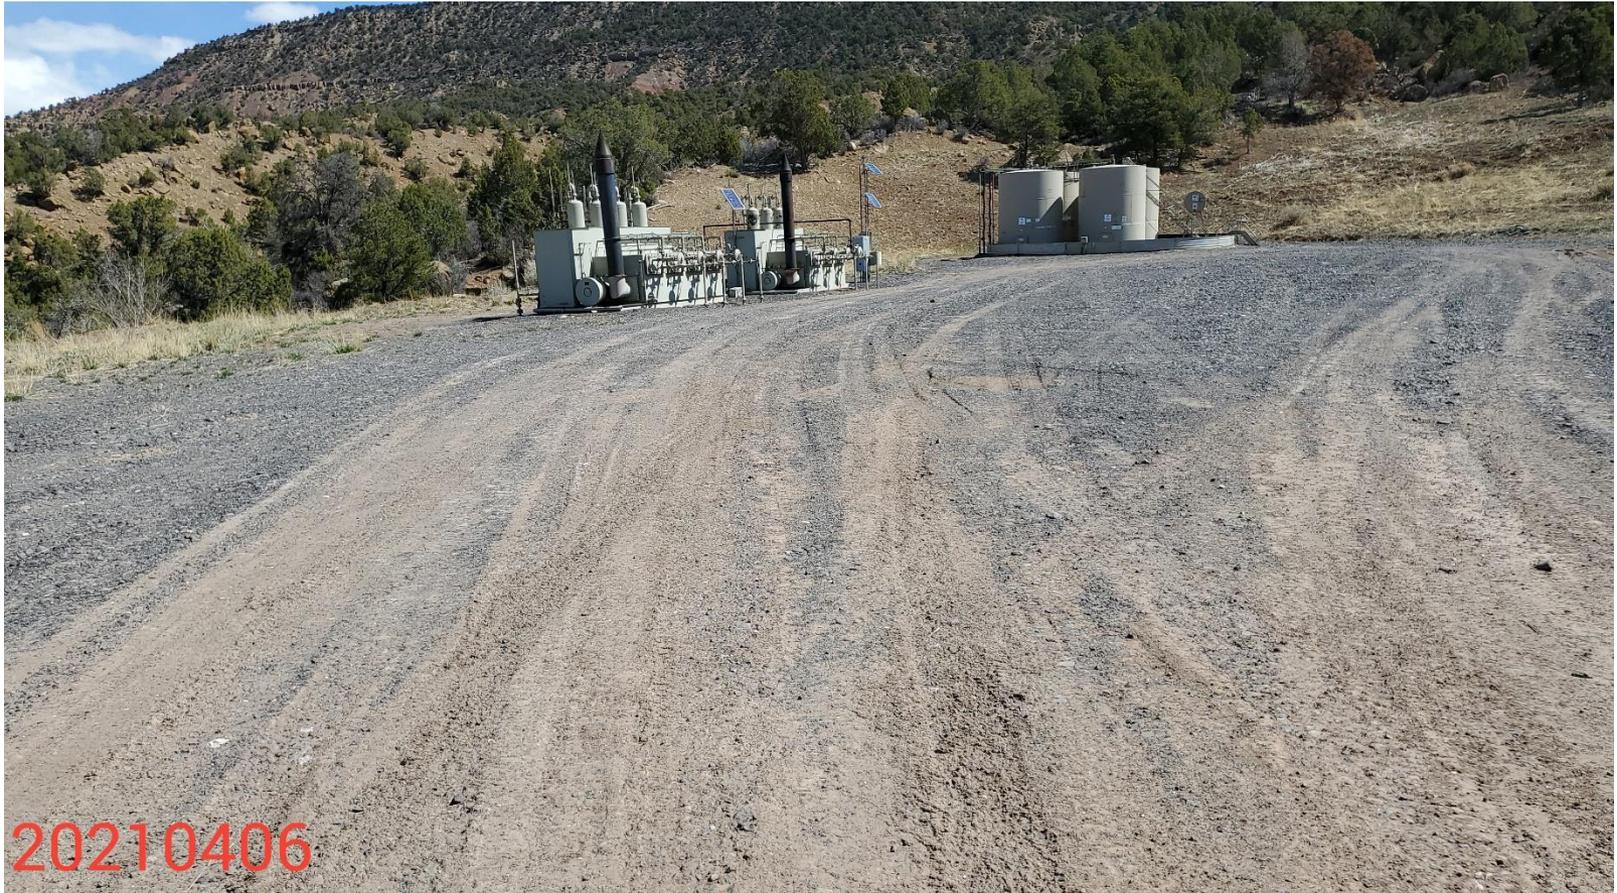
Photo 2: Photo taken from the west end of the Location, facing northeast. Photos 1-2 provide an overview of the Location from northwest to southeast. Photo also shows gravel on production areas is beginning to fill with sediment. Maintenance advised to ensure control measure remains in proper functioning condition to stabilize Location and prevent offsite sediment transport.

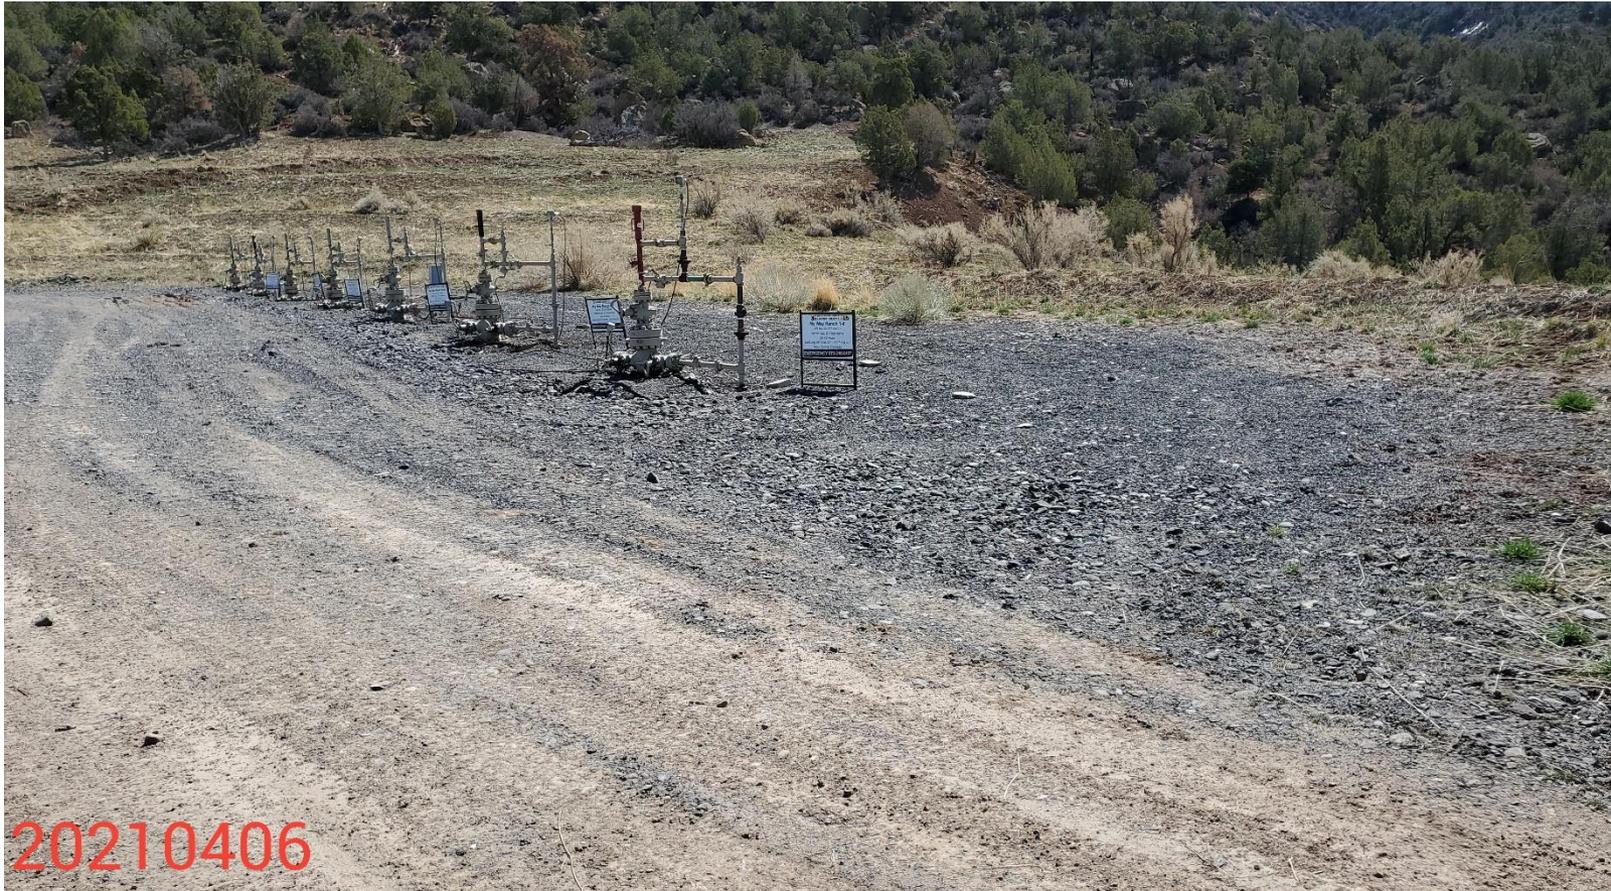
Photo 3: See comments under photo 2.

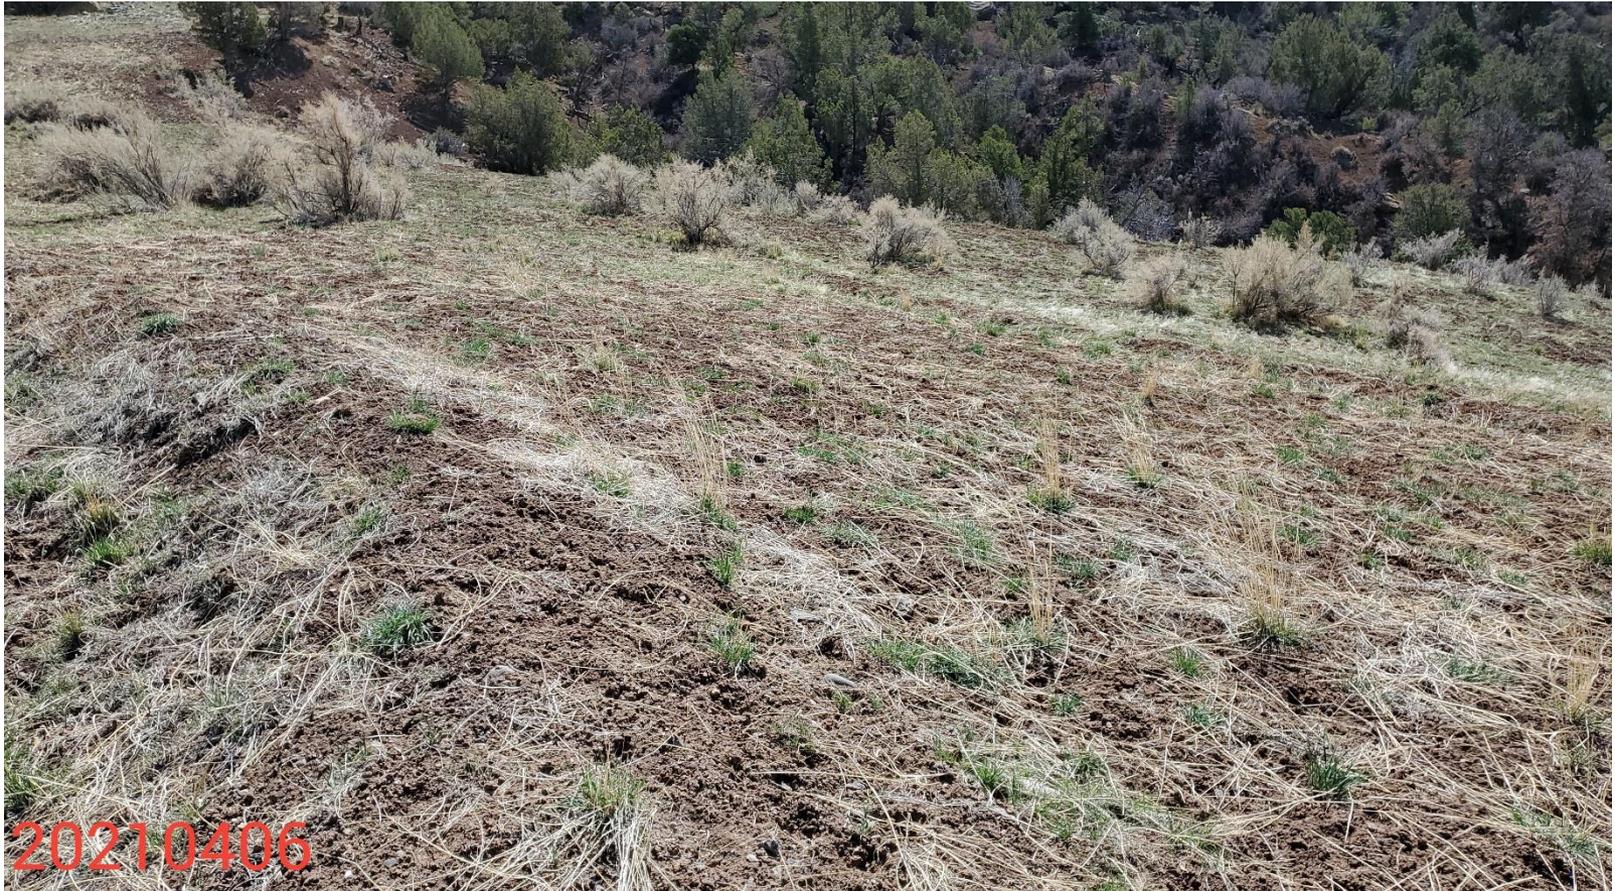
Photo 4: Photo taken from the interim areas on the south end of the Location. Areas appear to be progressing towards 1003 standards.

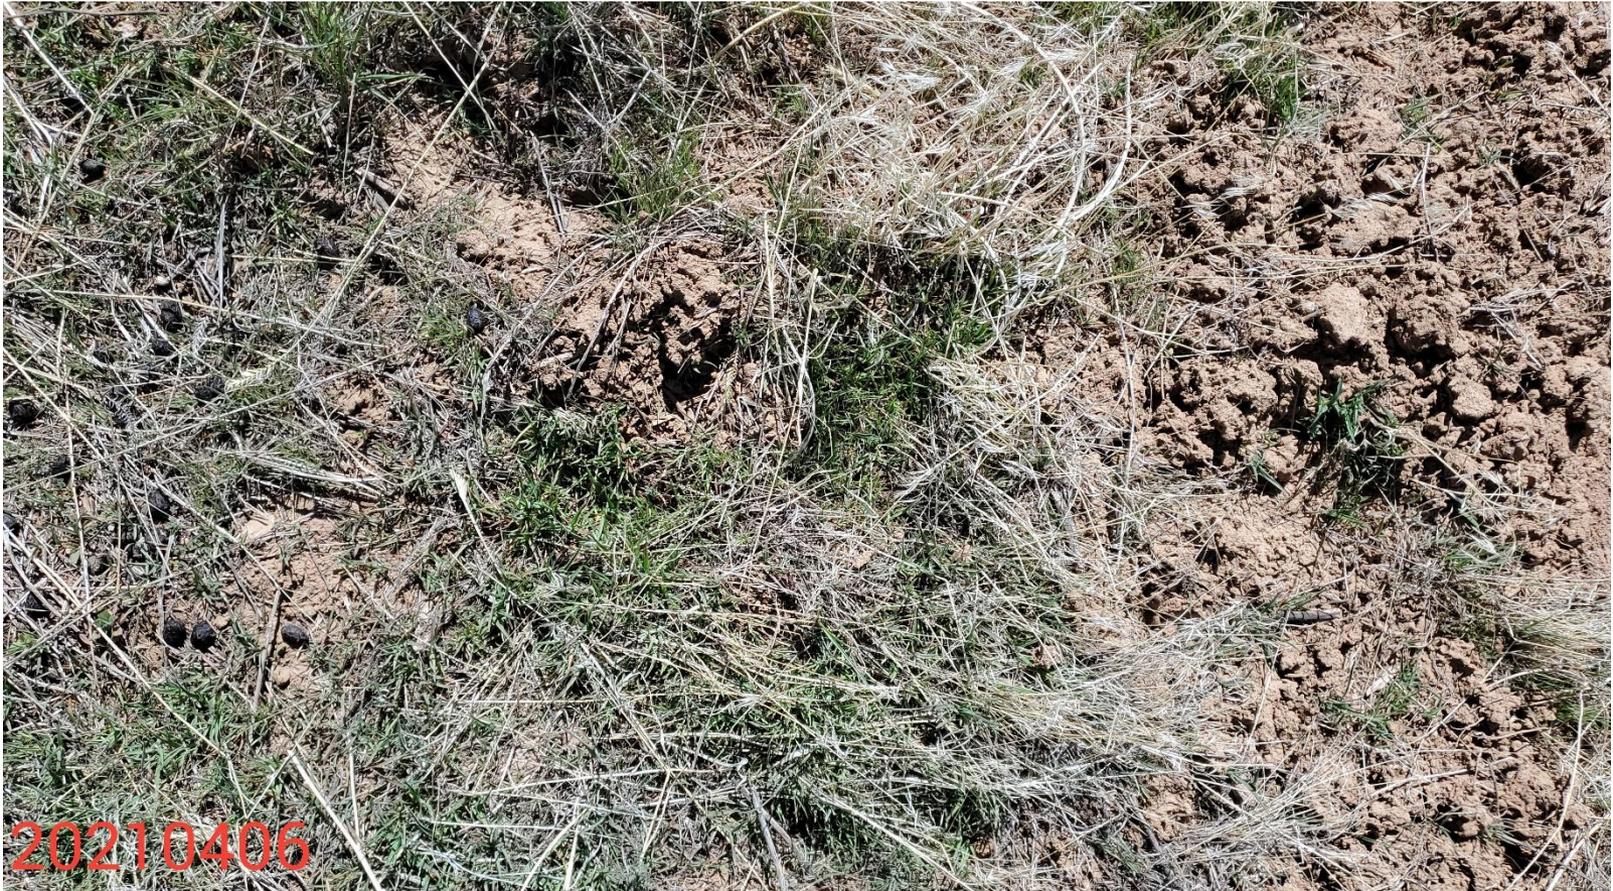
Photo 5: Photo shows example of cheatgrass establishment observed throughout interim areas.

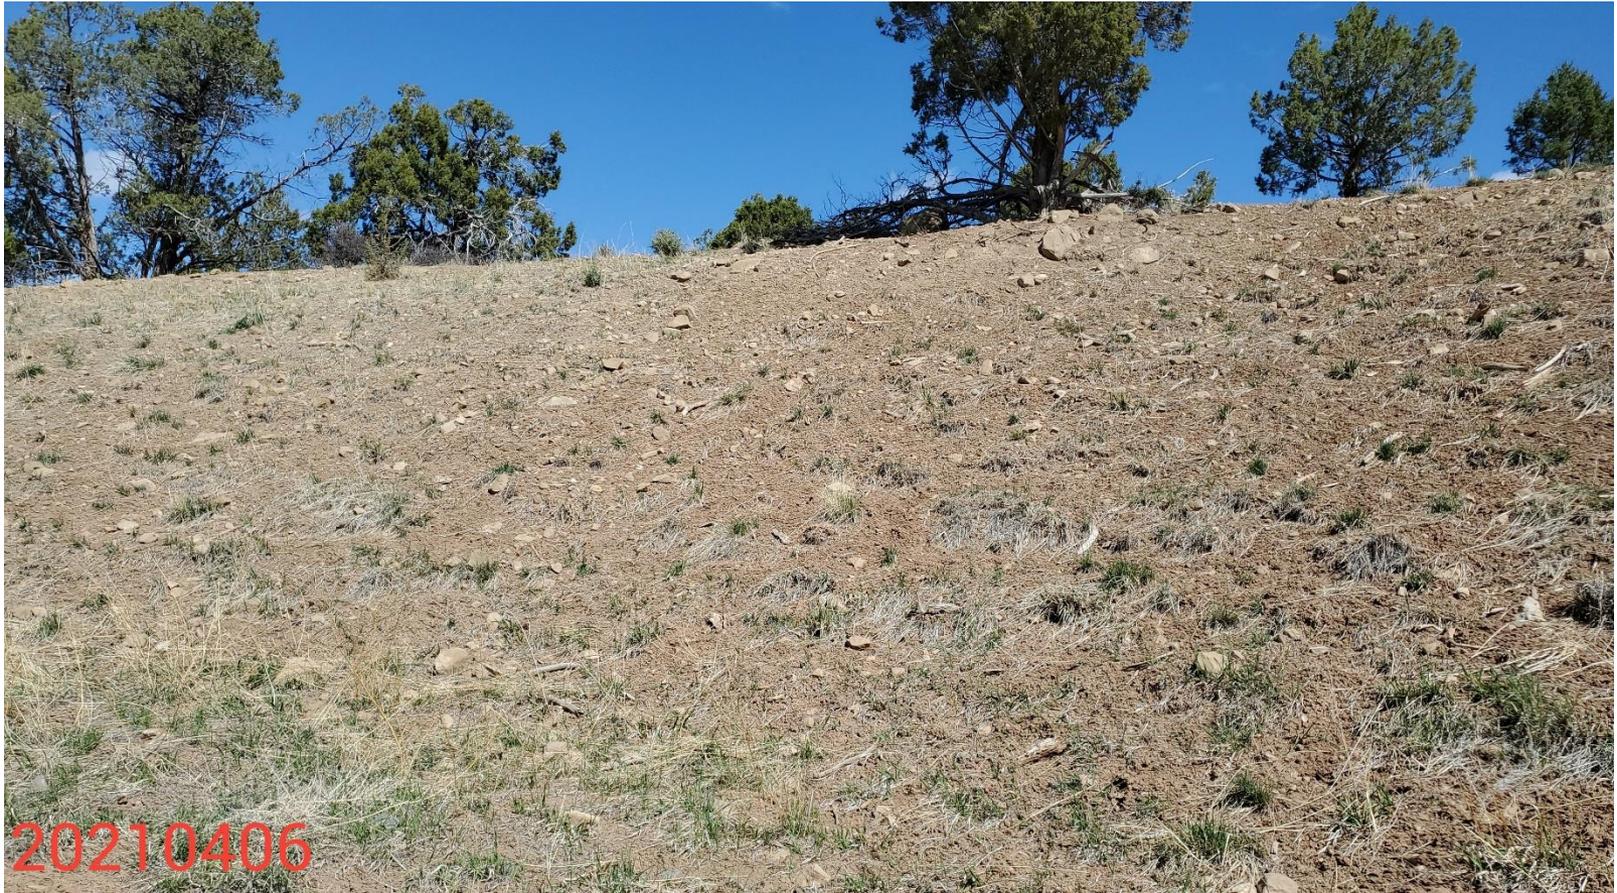
Photo 6: Photo taken from the northeastern interim areas of the Location. Interim areas on the northern/eastern end of the Location may required additional seeding to facilitate reclamation towards 1003 standards.
