# Inspection Photos

Operator: LARAMIE ENERGY LLC #10433

Location ID: 312443

Mesa County, CO

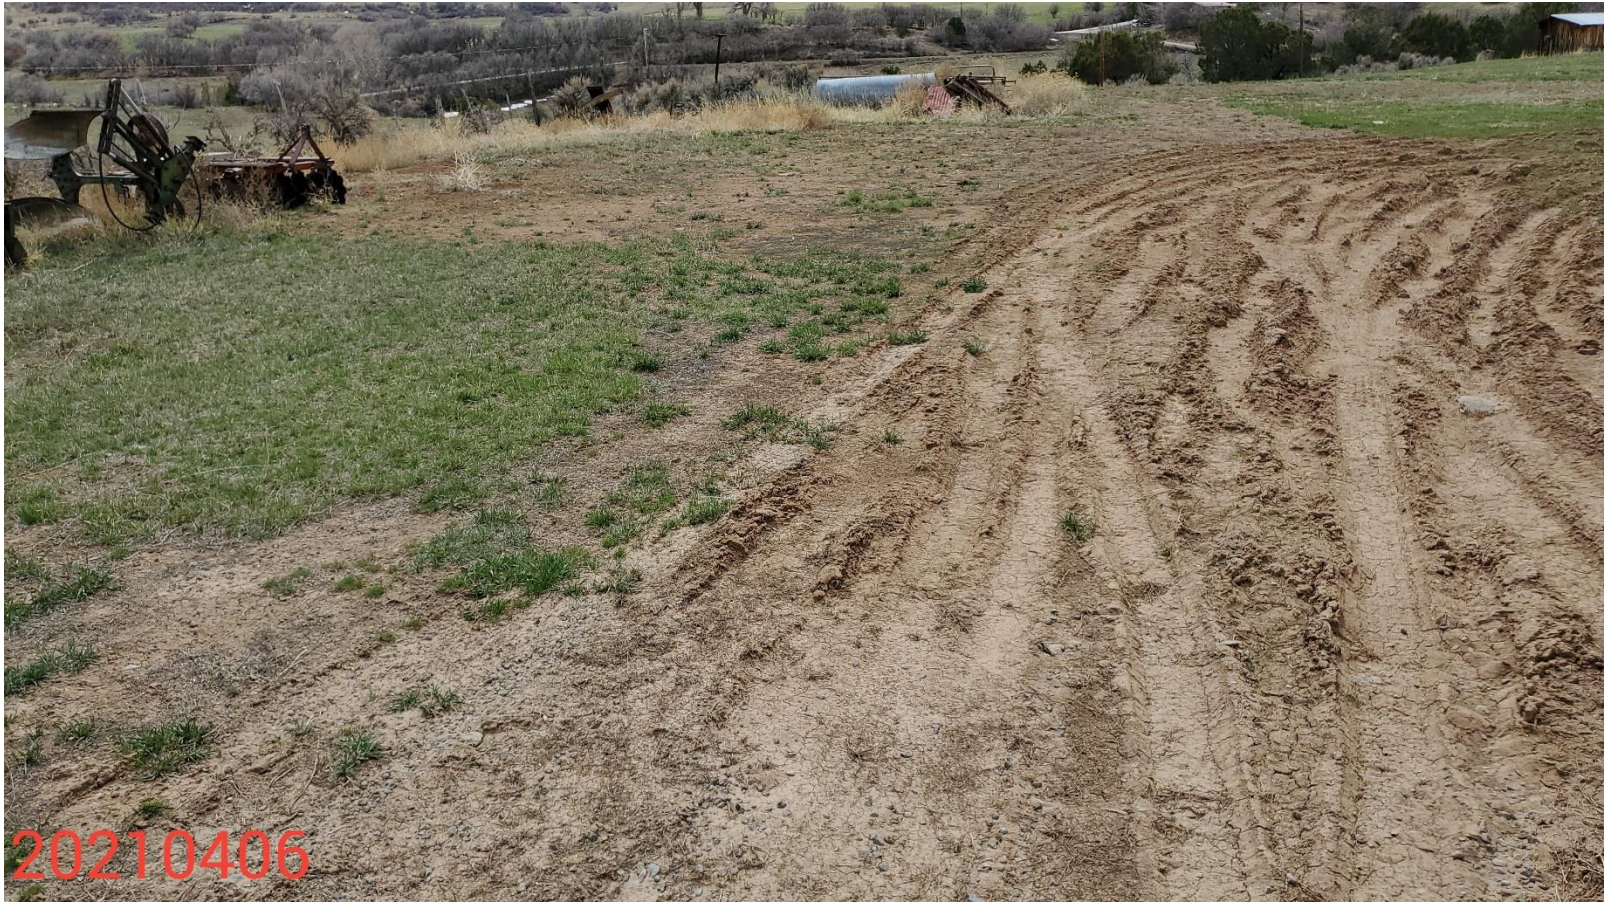
**Photo 2:** Photo taken from the east end of the Location, facing southwest. Photos 2-3 provide an overview of the Location from southwest to west; photos show reclamation is not progressing towards COGCC 1004 standards; Location appears to be is use as a storage area; not 502.b variance has been approved to waive reclamation requirements.

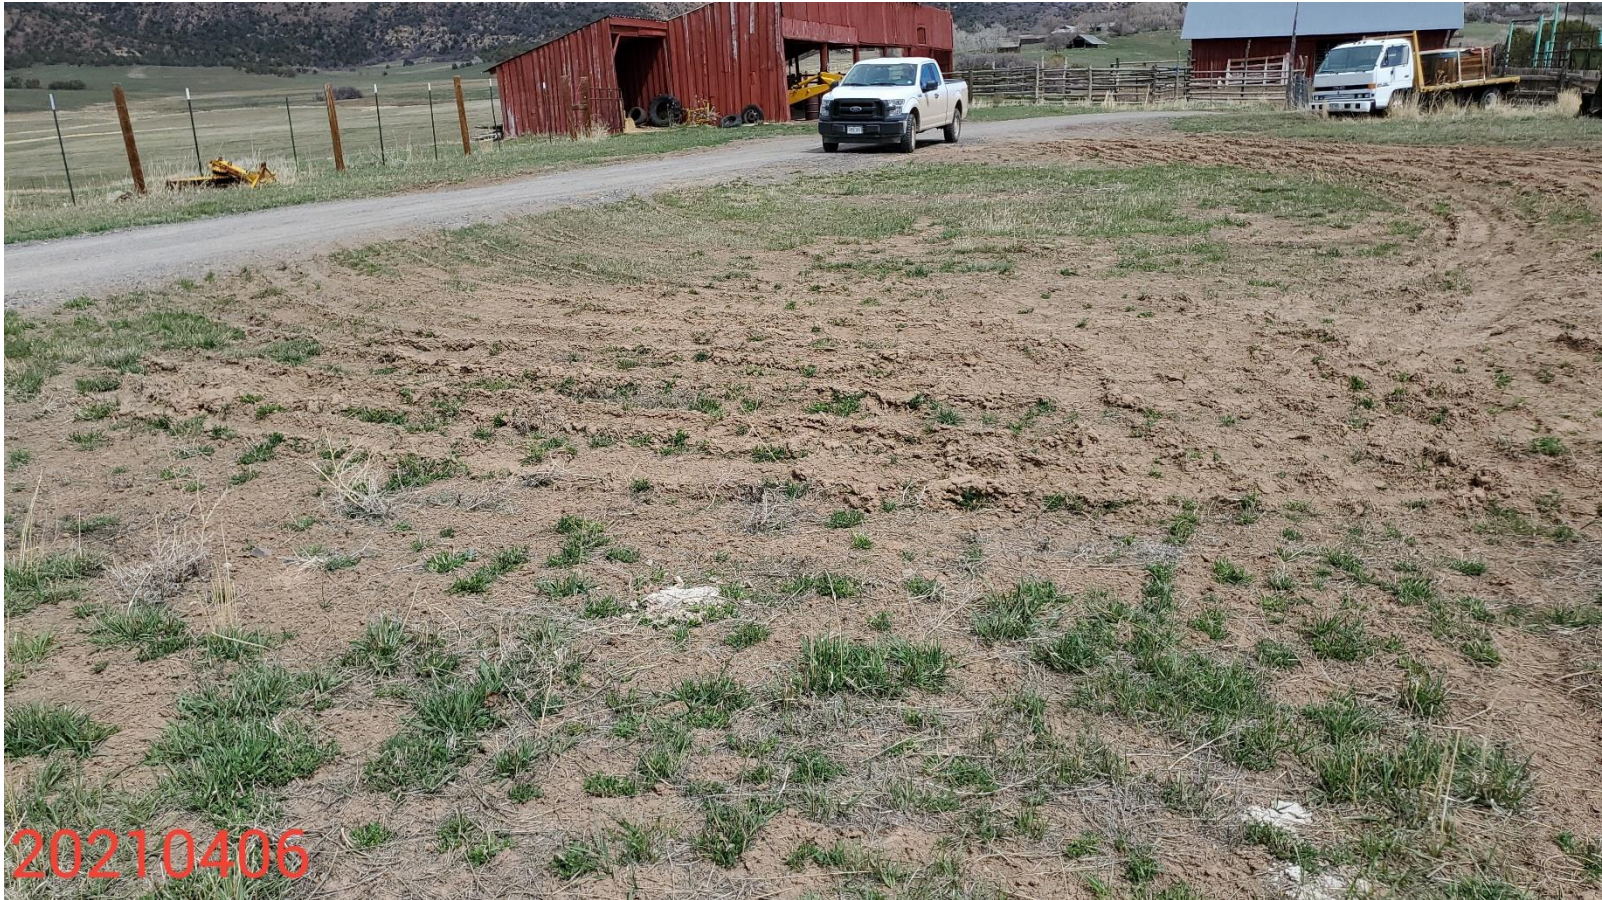
**Photo 4:** Photo taken from the west end of the Location, facing east. Photos 4-6 provide an overview of the Location from east, southeast to south; photos show reclamation is not progressing towards COGCC 1004 standards; Location appears to be is use as a storage area; not 502.b variance has been approved to waive reclamation requirements.
