Inspection Photos

Operator: CAERUS PICEANCE LLC # 10456

Location ID: 335812

NW Reclamation Specialist

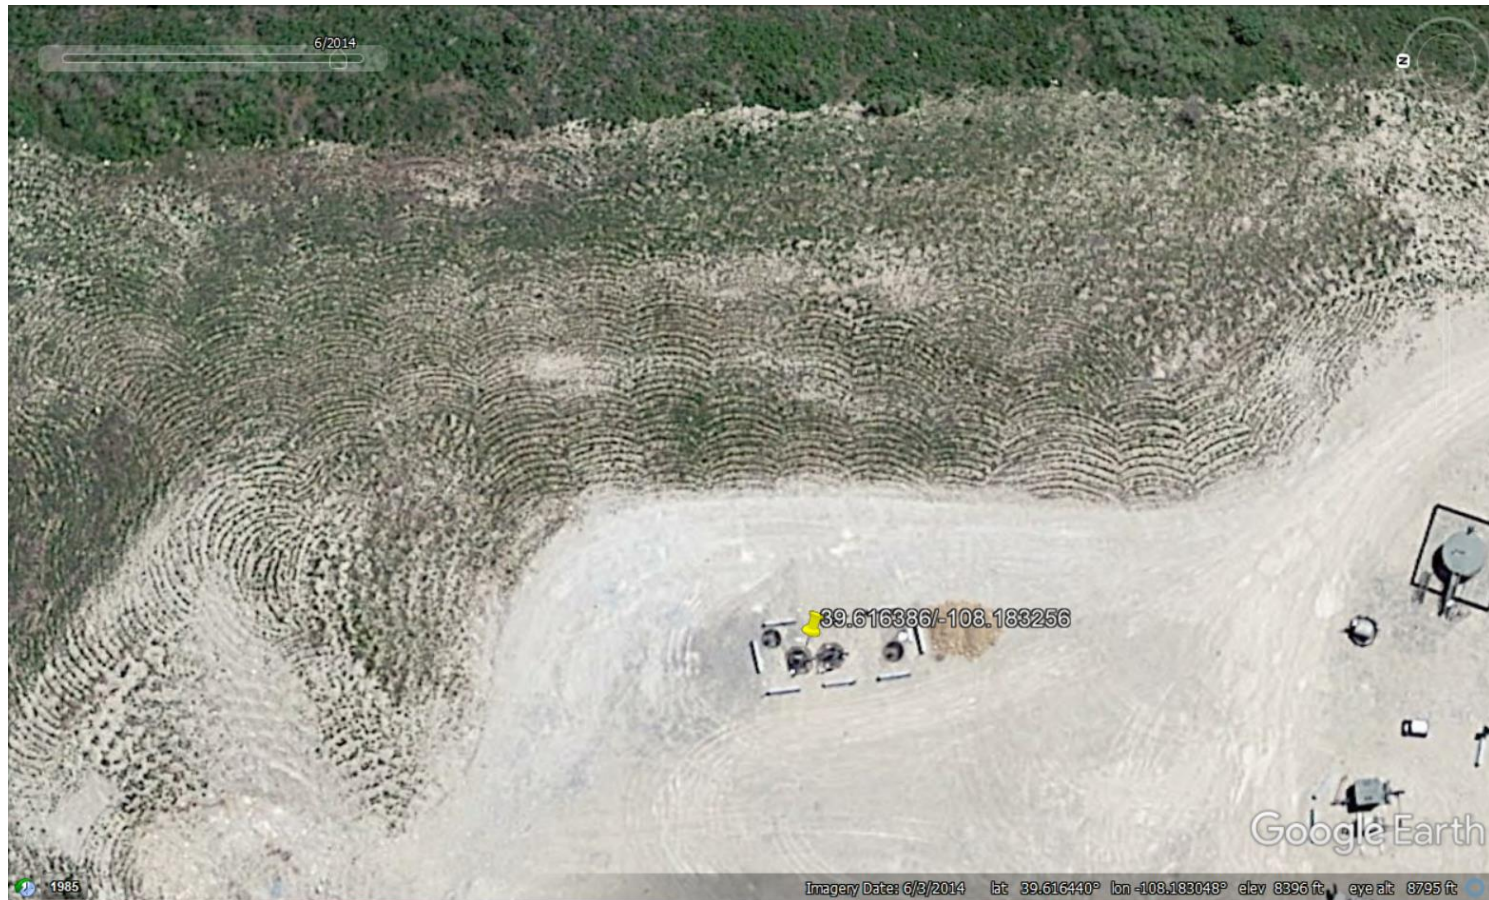
Photo 2: 2014 Google Earth aerial image. Photo shows pits have been closed and interim reclamation conducted.

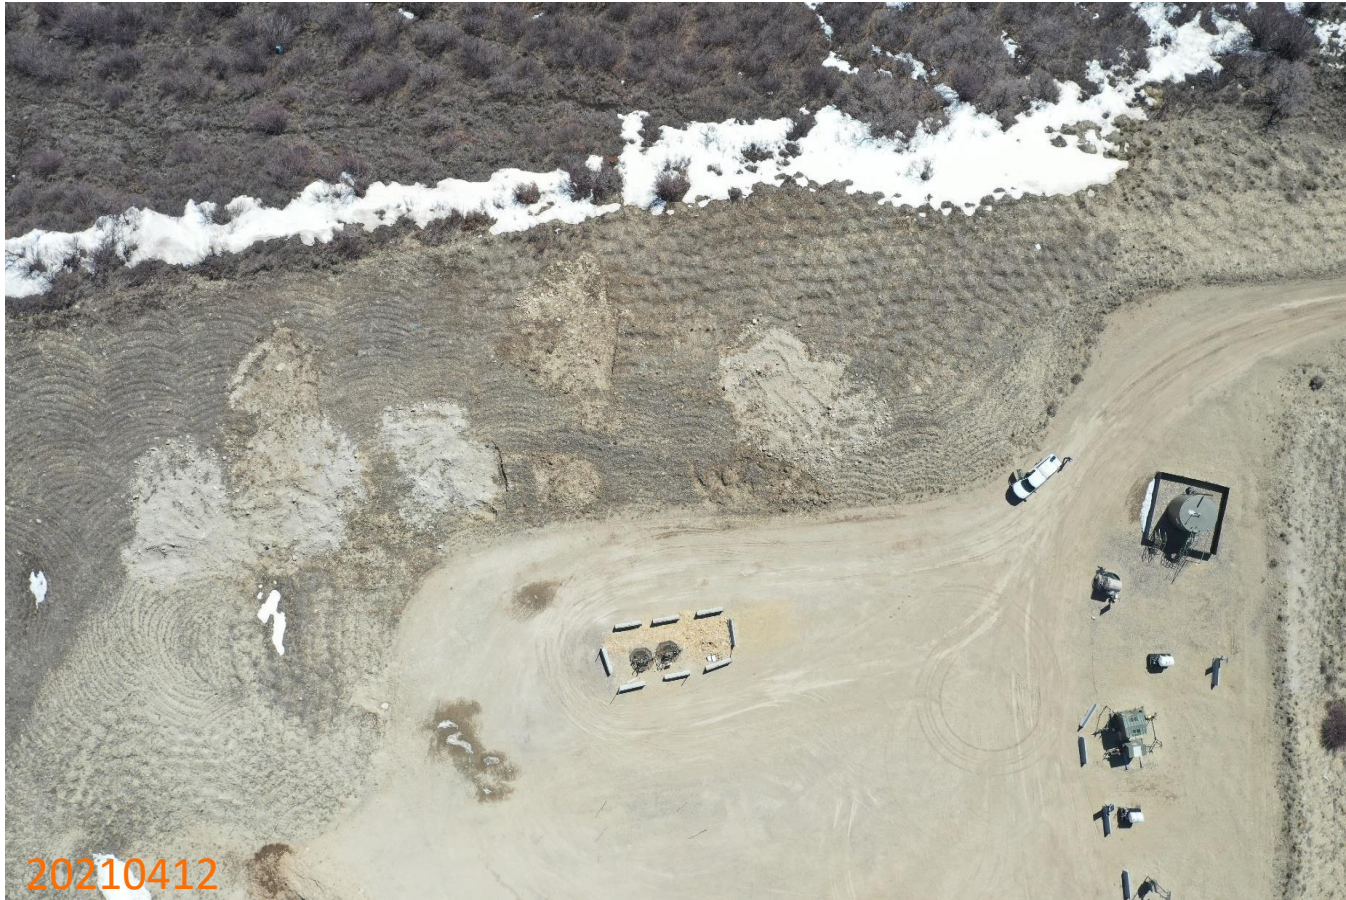
Photo 3: Aerial imager of the Location taken 4/12/2021. Photo shows interim areas on the east end of the Location (top of photo) have been disturbed. Areas require reclamation.

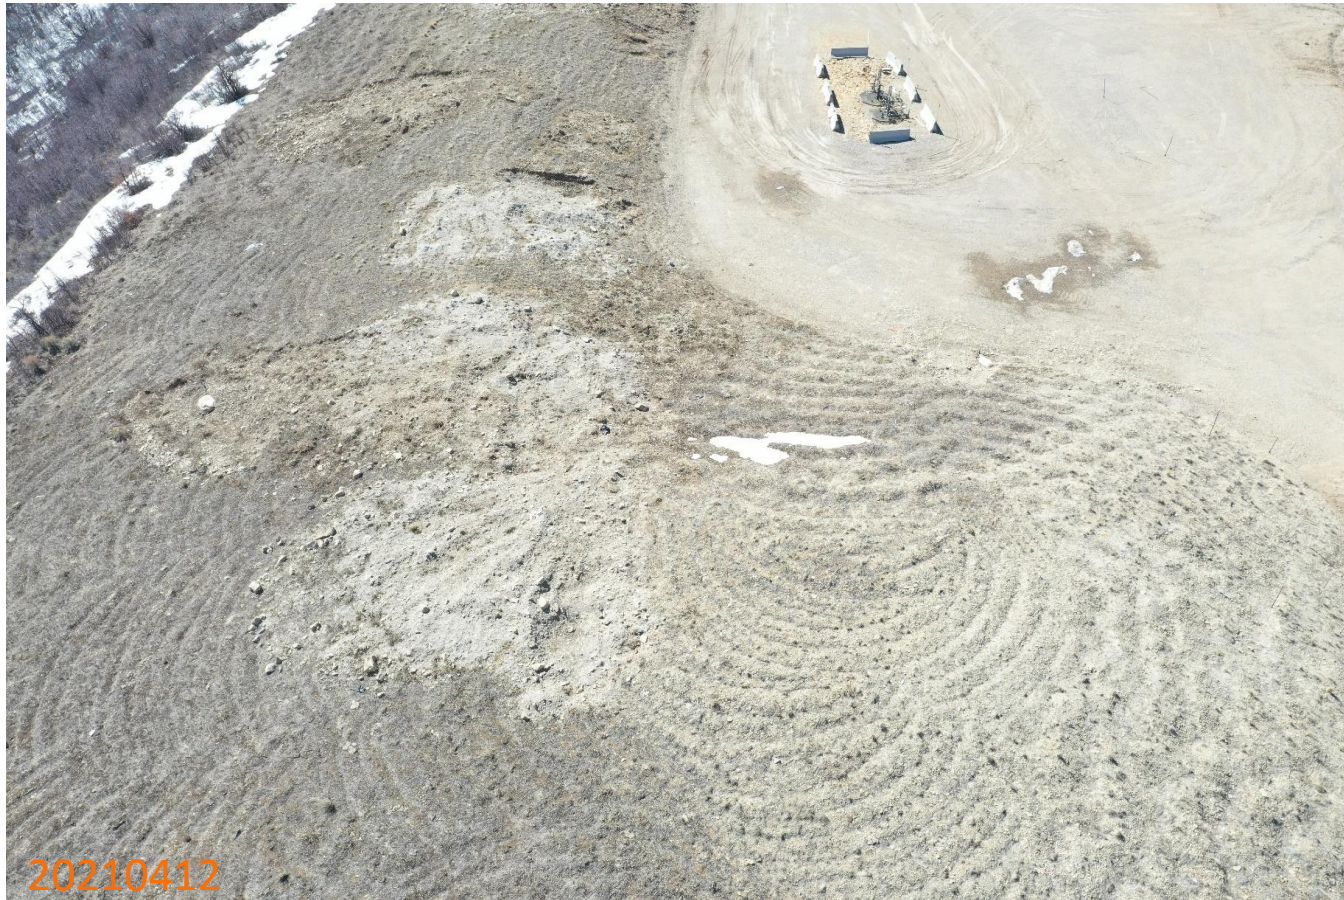
Photo 4: See comments under photo 3.

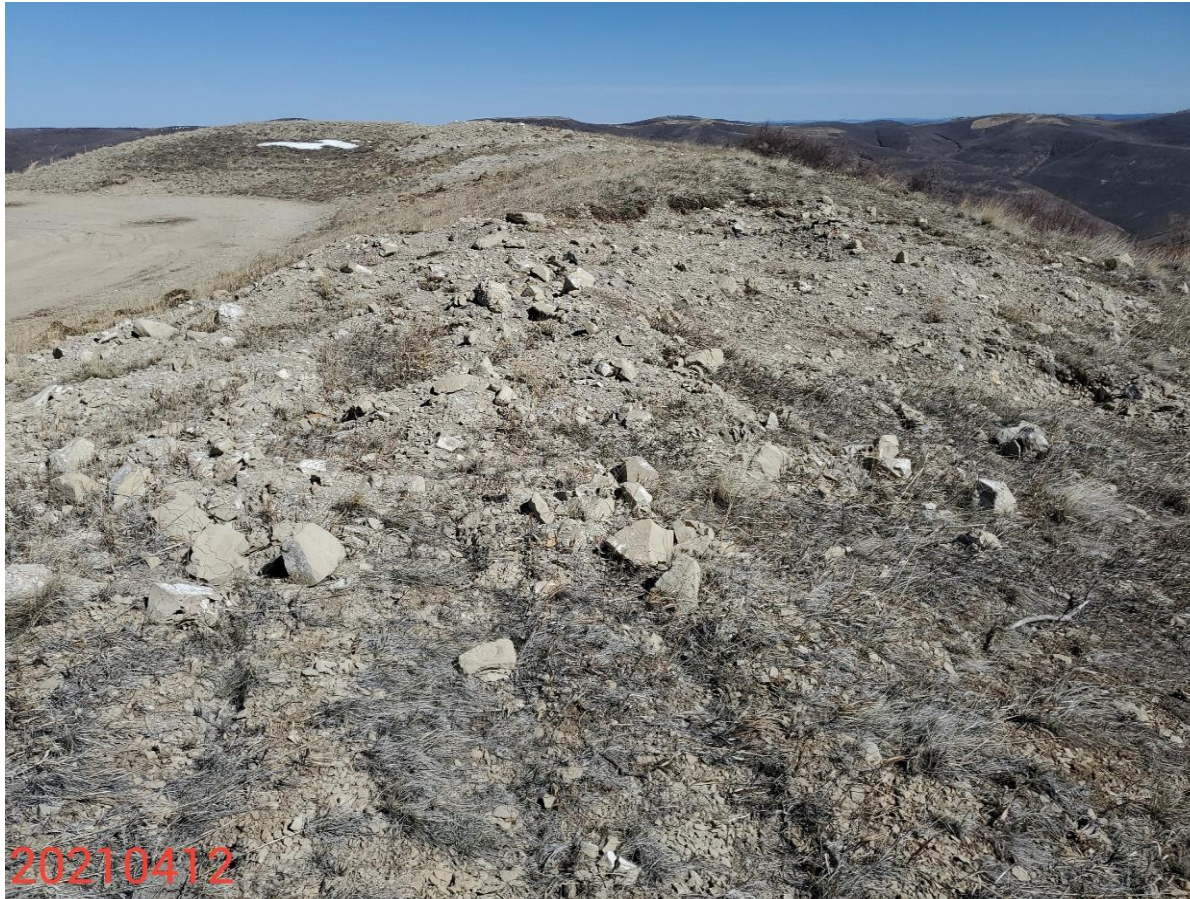
Photo 5: Photo taken from the eastern interim areas of the Location, facing north. Photo shows interim areas re-disturbed by Operator.

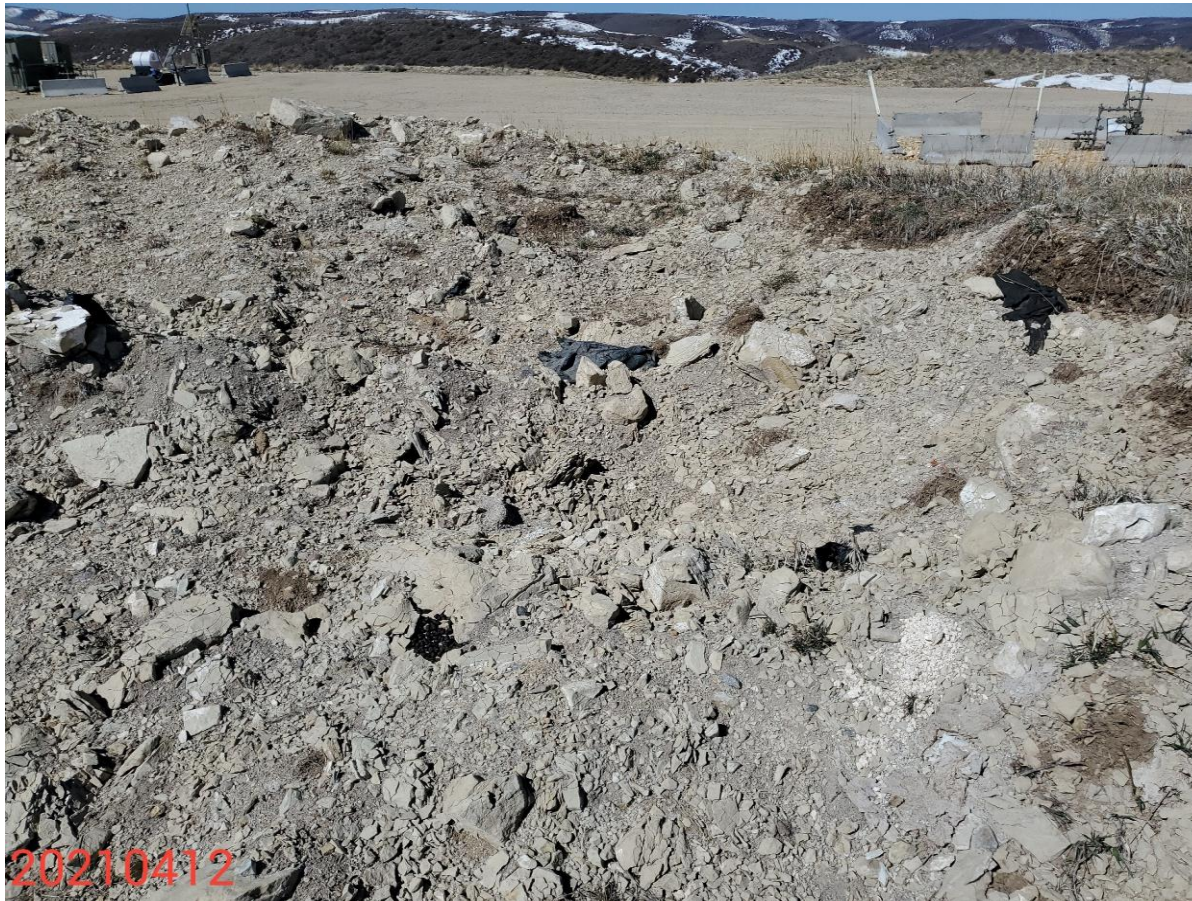
Photo 6: Photo taken from the eastern interim areas of the Location, facing west. Photo shows interim areas re-disturbed by Operator. Areas require reclamation. Various trash debris was also observed within these disturbed areas.

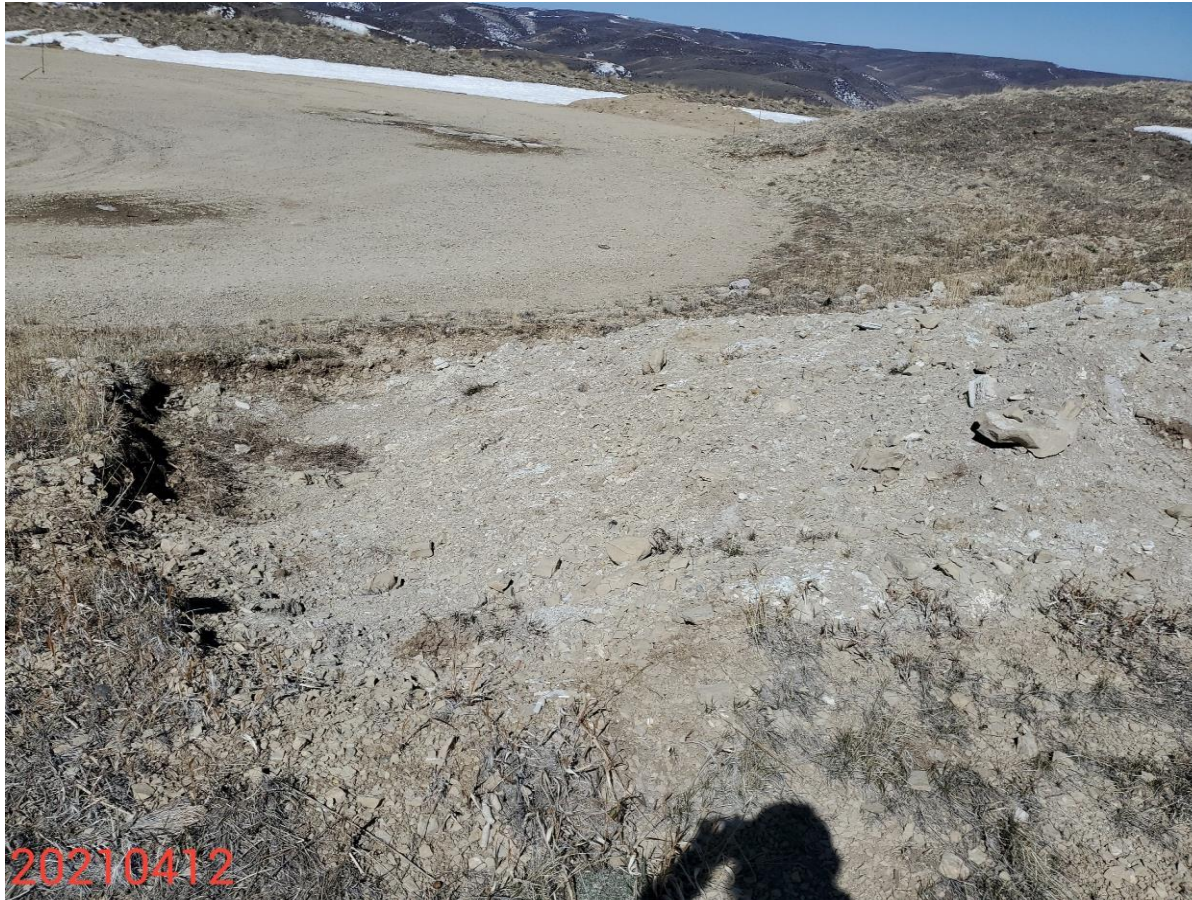
Photo 7: Photo taken from the eastern interim areas of the Location, facing west. Photo shows interim areas re-disturbed by Operator. Areas require reclamation.

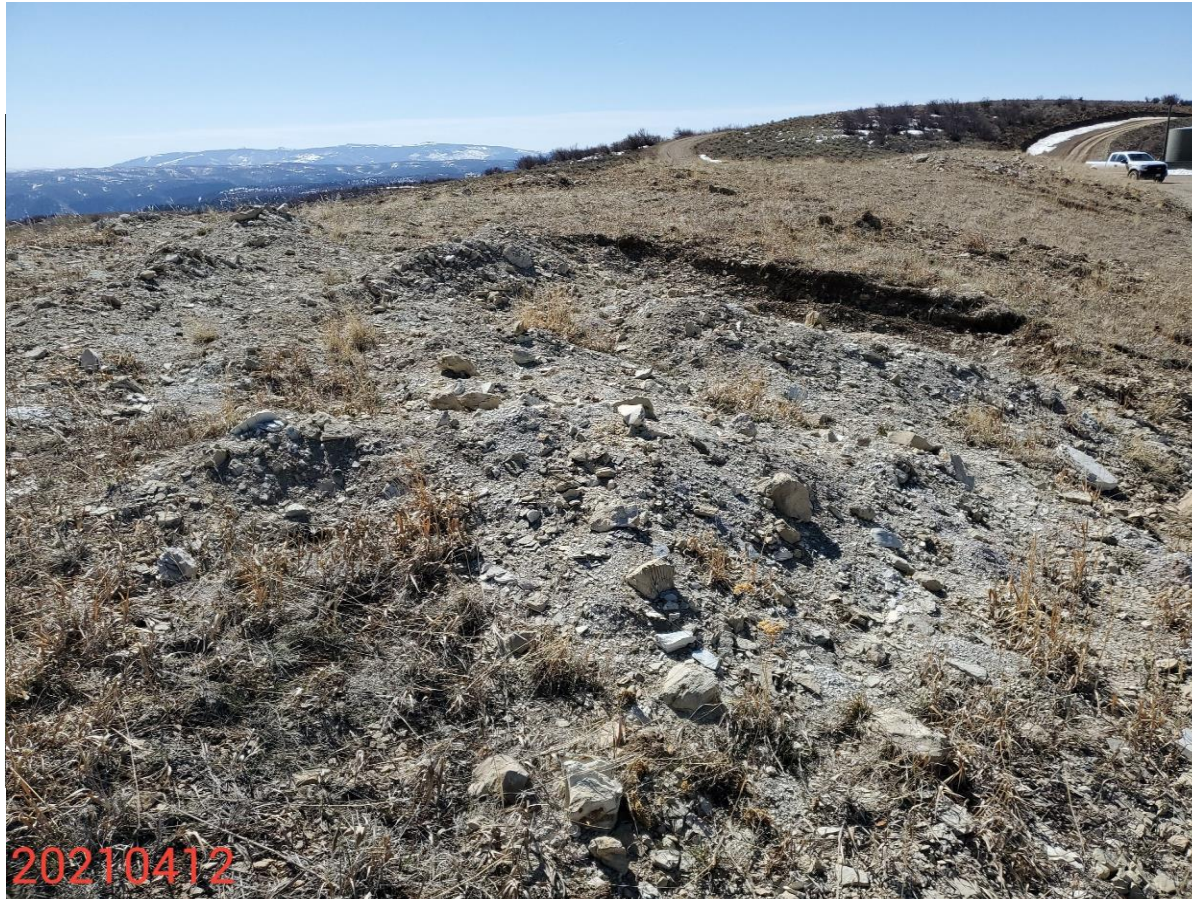
Photo 8: Photo taken from the eastern interim areas of the Location, facing south. Photo shows interim areas re-disturbed by Operator. Areas require reclamation.

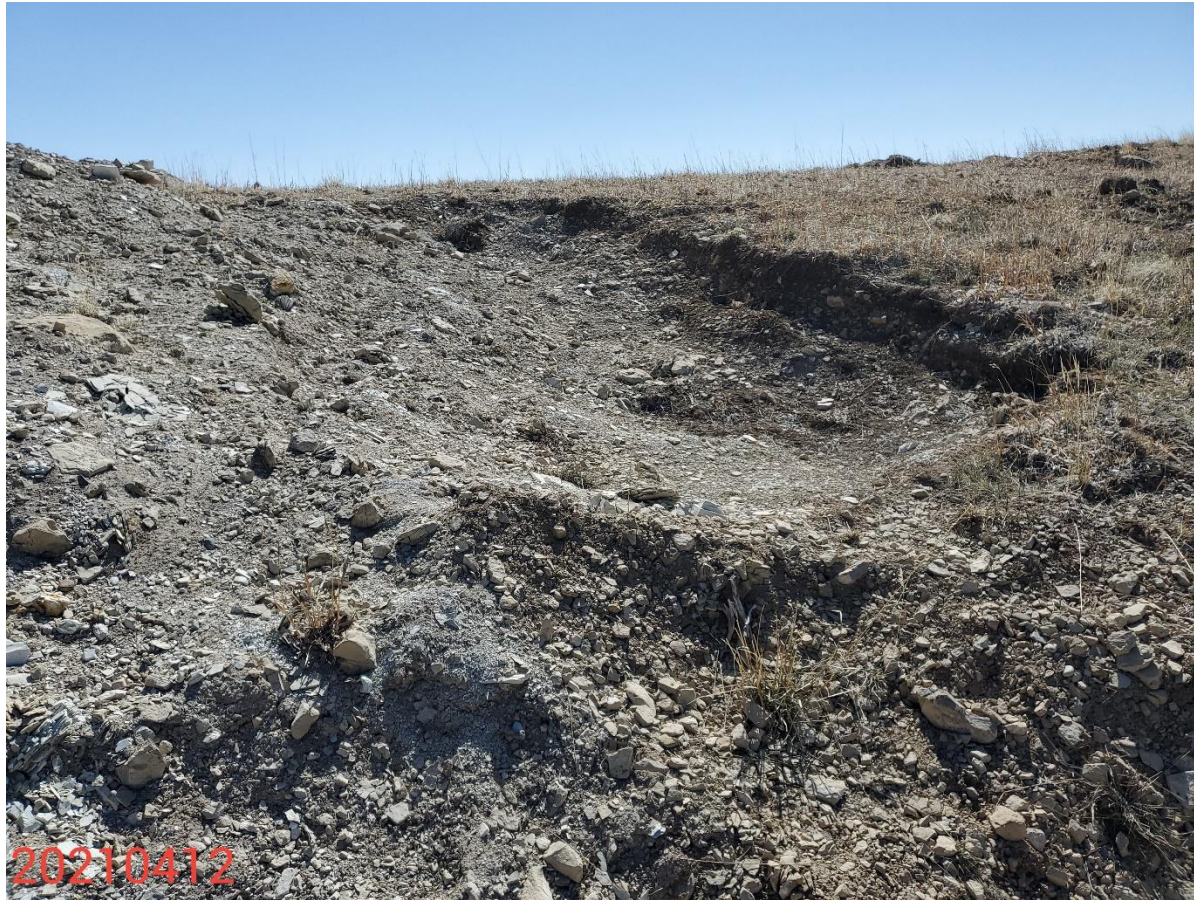
Photo 9: Photo taken from the eastern interim areas of the Location, facing east. Photo shows interim areas re-disturbed by Operator. Areas require reclamation.

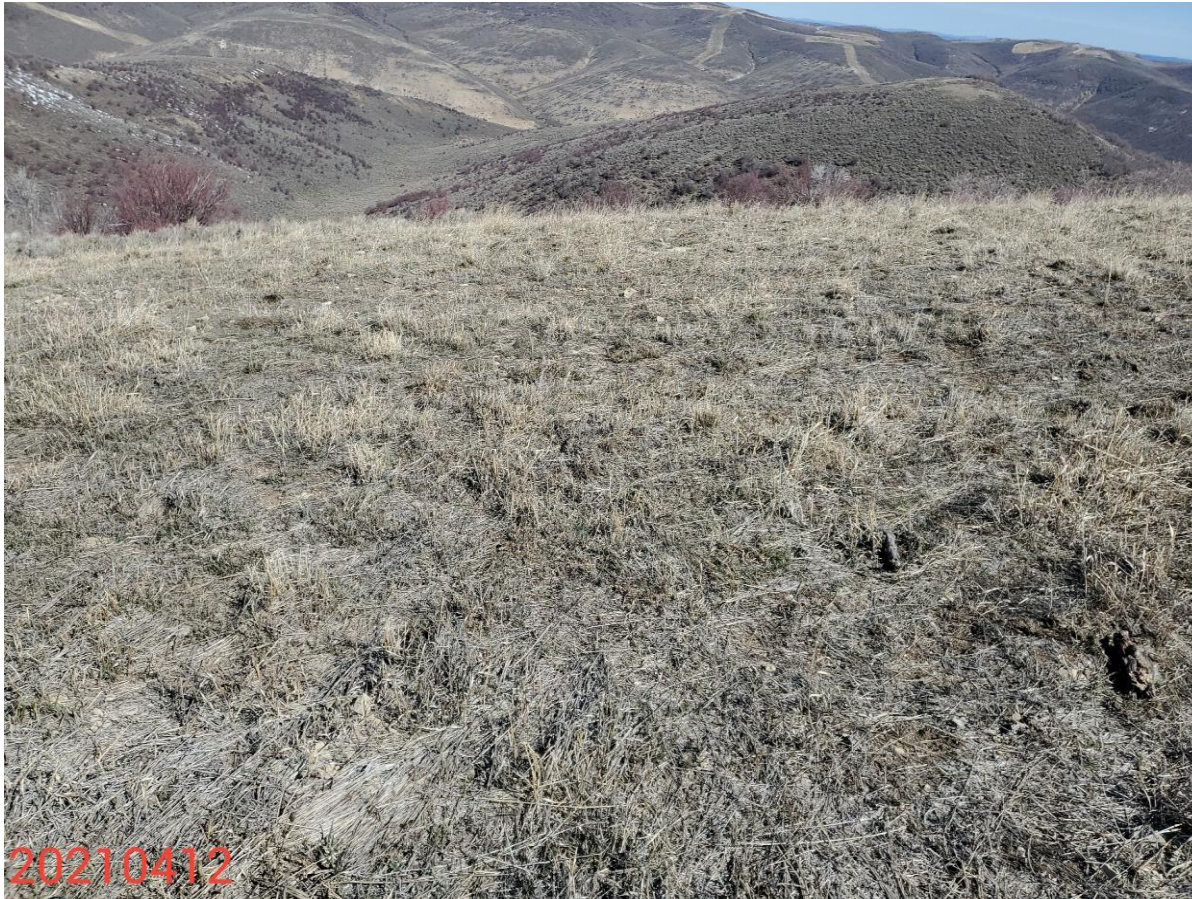
Photo 10: Photo taken from the interim areas on the north end of the Location, facing north. Interim reclamation progressing towards 1003 standards.

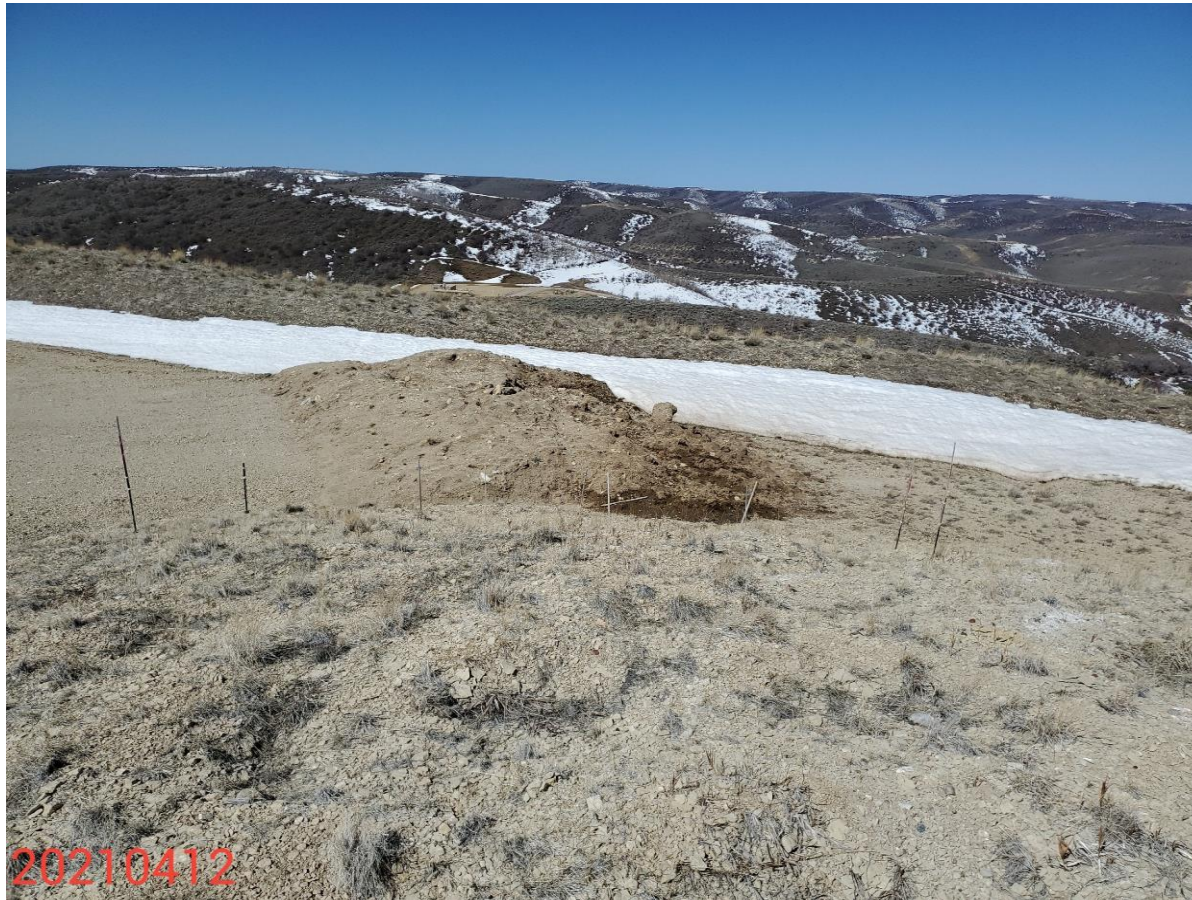
Photo 11: Photo taken from the north end of the Location. Photo shows soil stockpiled on the Location; unclear if this is the topsoil from the disturbed areas.

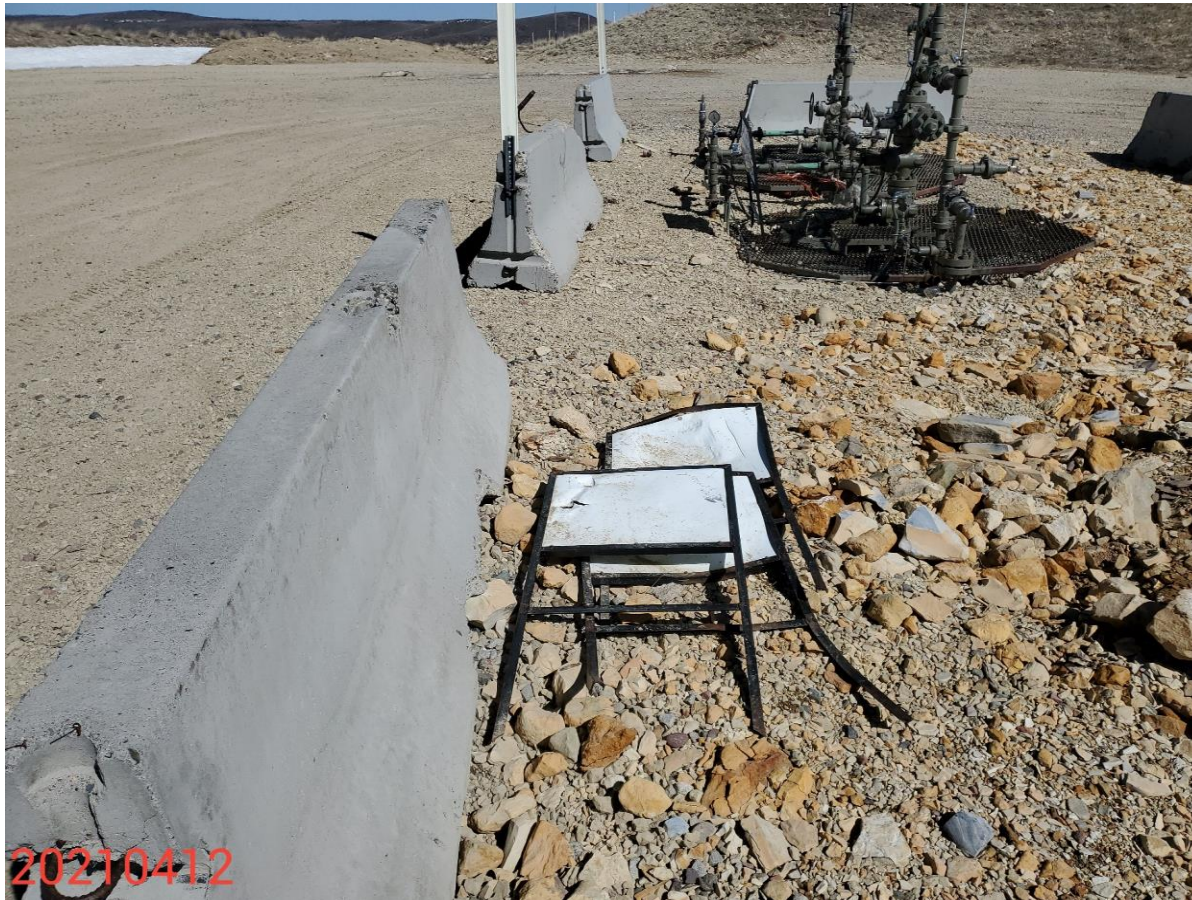
Photo 12: Photo shows unused signs associated with PAd wells stored on the Locaiton.

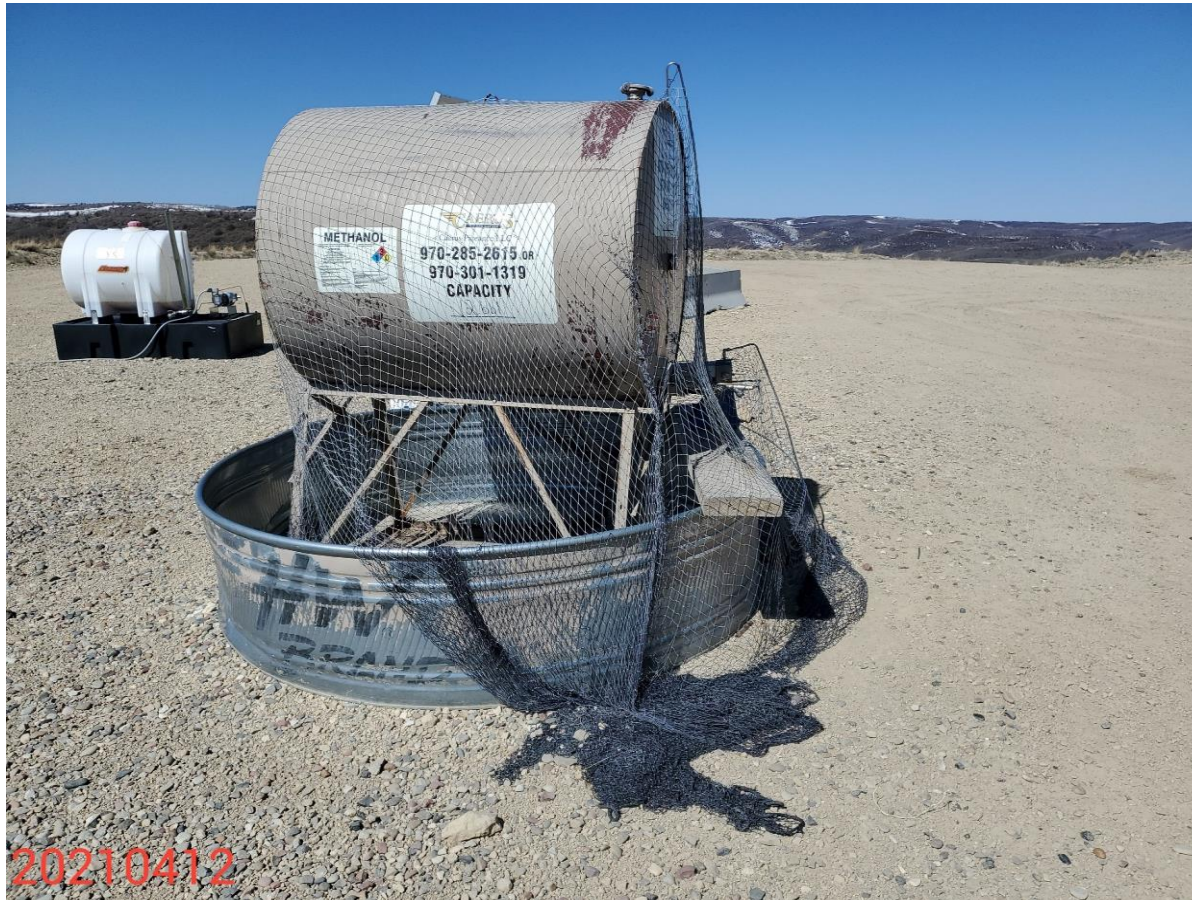
Photo 13: Photo shows the wildlife netting at the methanol tank is inadequate to prevent wildlife access to the containment BMP.

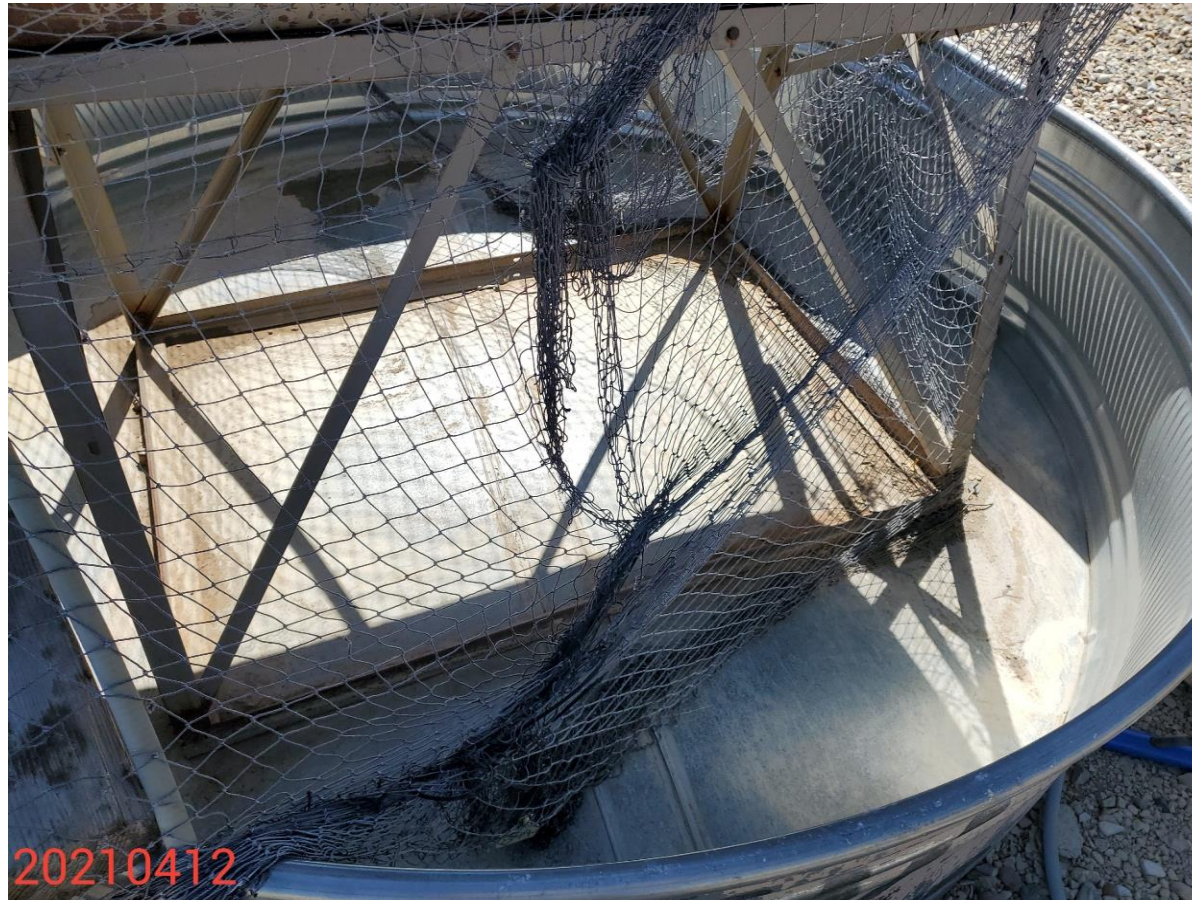
Photo 14: Photo shows the wildlife netting at the methanol tank is inadequate to prevent wildlife access to the containment BMP
