Inspection Photos

Operator: CAERUS PICEANCE LLC # 10456

Location ID: 335929

Garfield County, CO

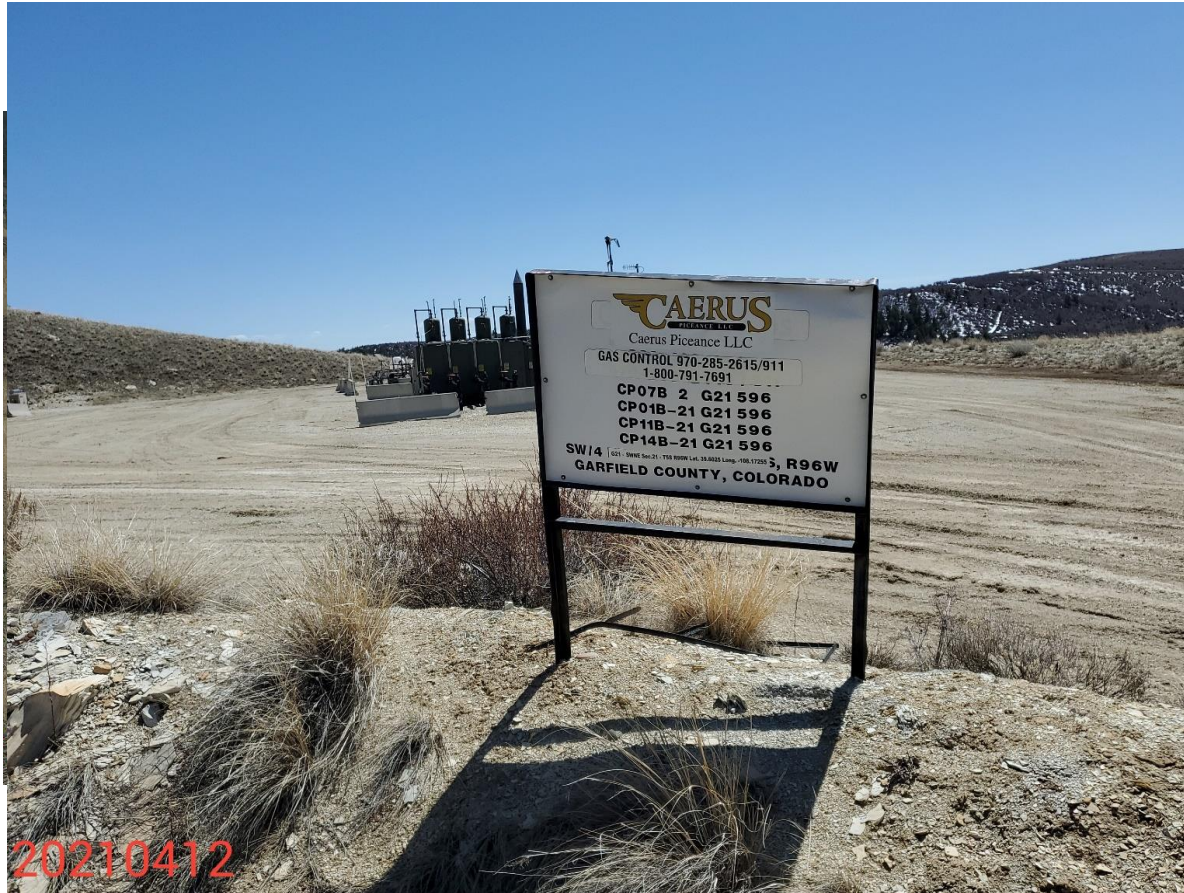
Photo 1: Photo shows sign at Location entrance.

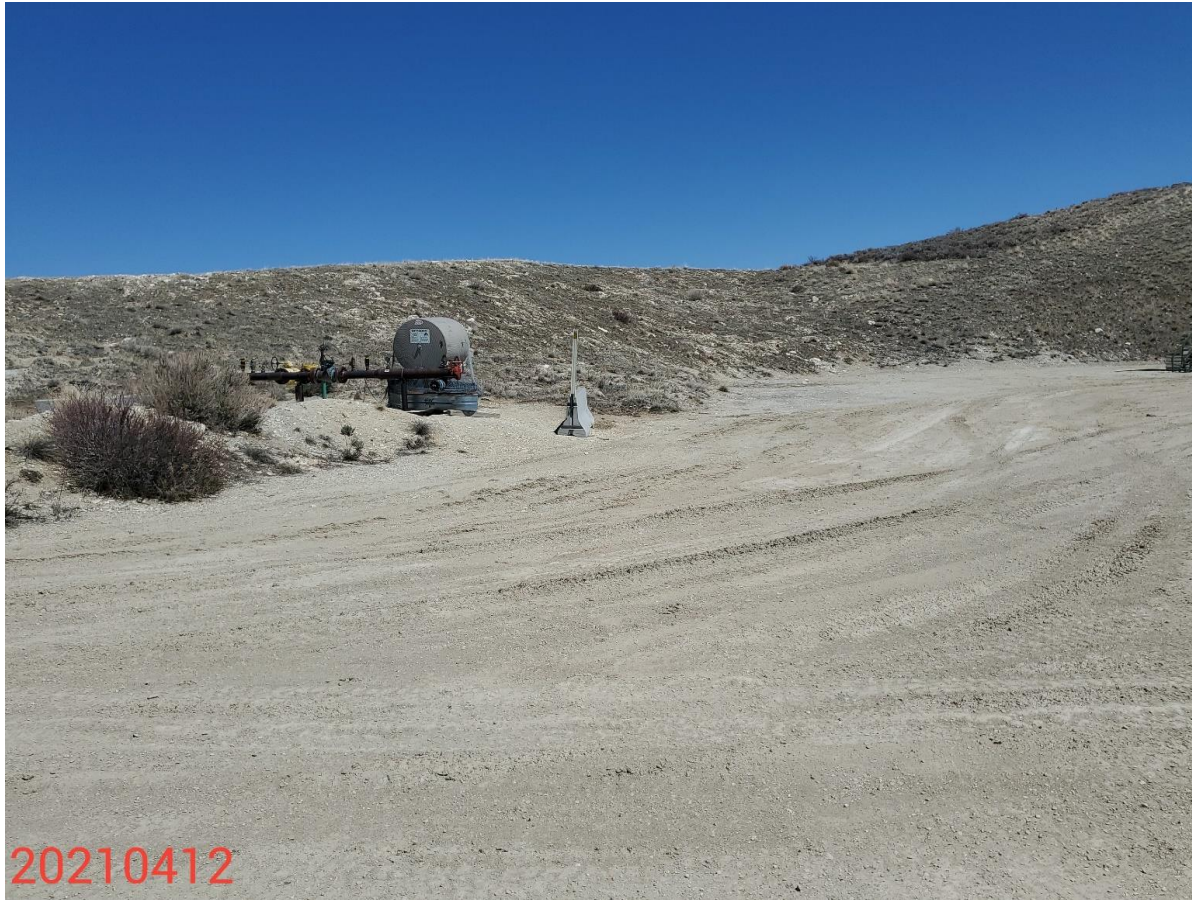
Photo 2: Photo taken from the northwest corner of the Location, facing north. Photos 2-3 provide an overview of the Production area from north, east, to south.

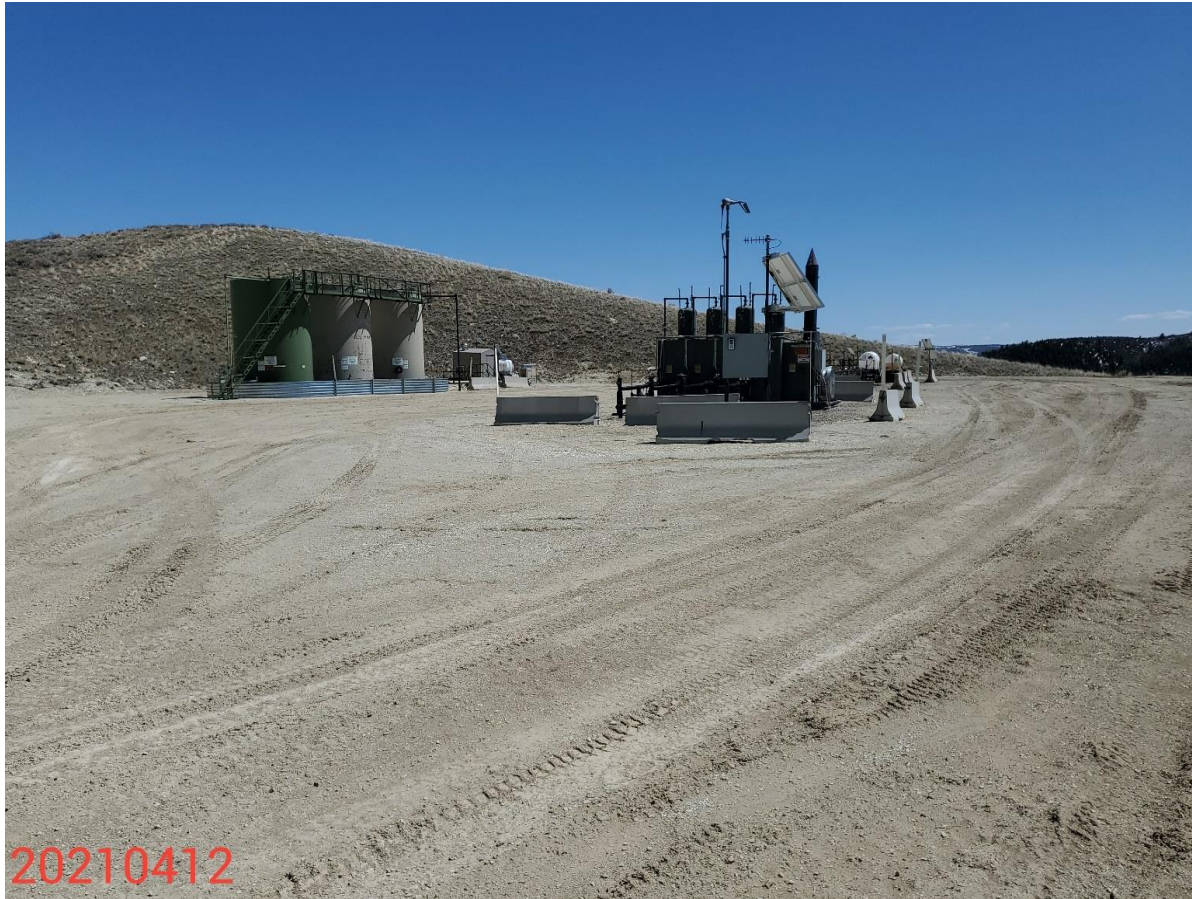
Photo 3: See comments under photo 2.

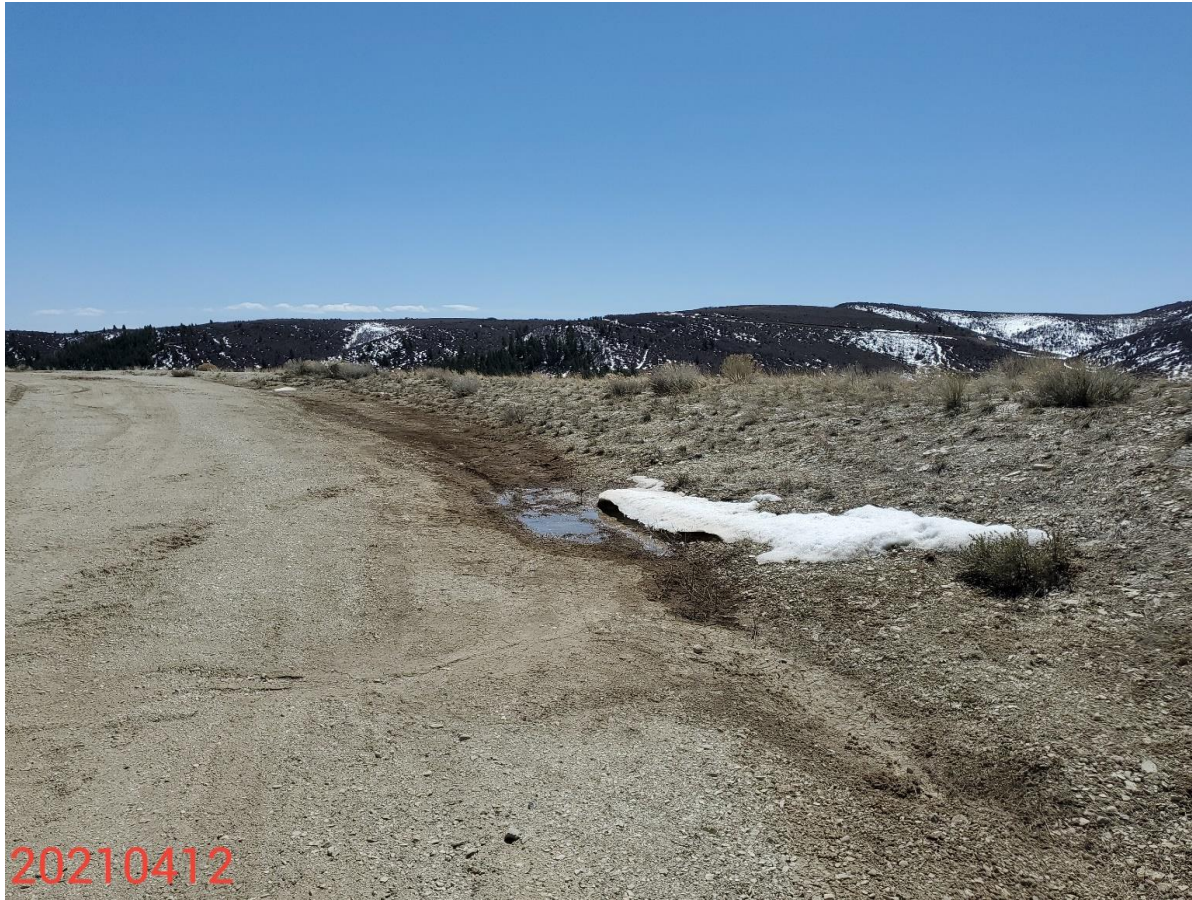
Photo 4: See comments under photo 2.

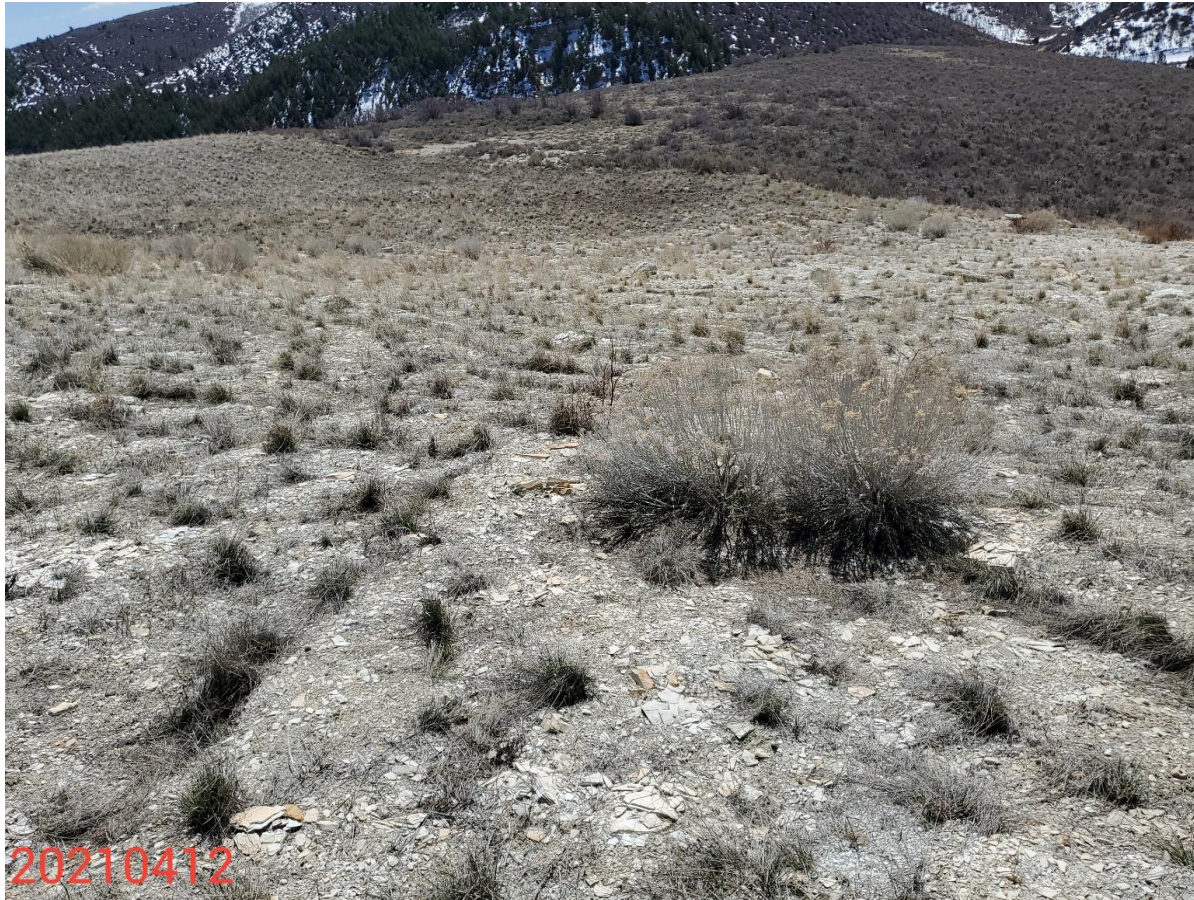
Photo 5: Photo taken from the southern interim areas of the Location, facing south. Photo shows areas where topsoil does not appear to have been replaced during interim reclamation of the Location.

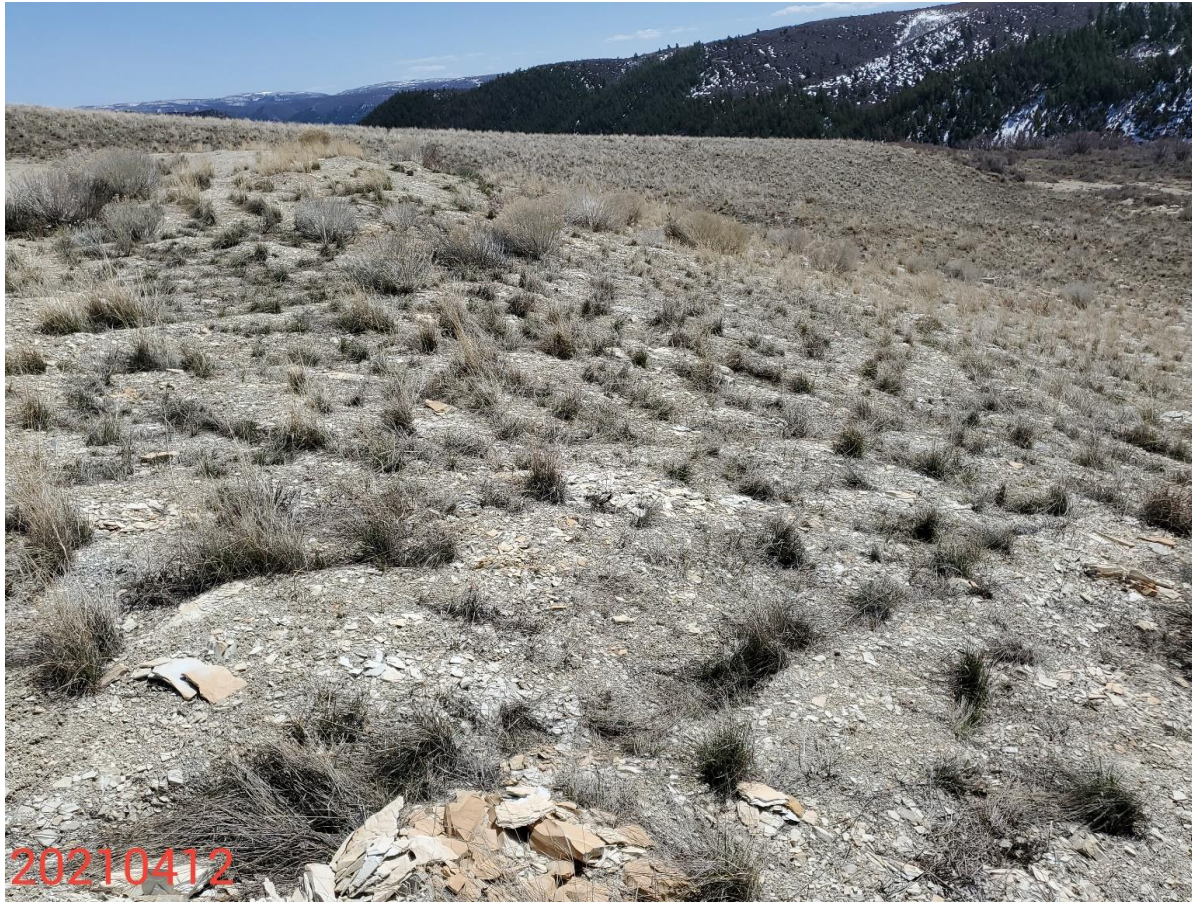
Photo 6: Photo taken from the southern interim areas of the Location, facing southeast. Photo shows areas where topsoil does not appear to have been replaced during interim reclamation of the Location.

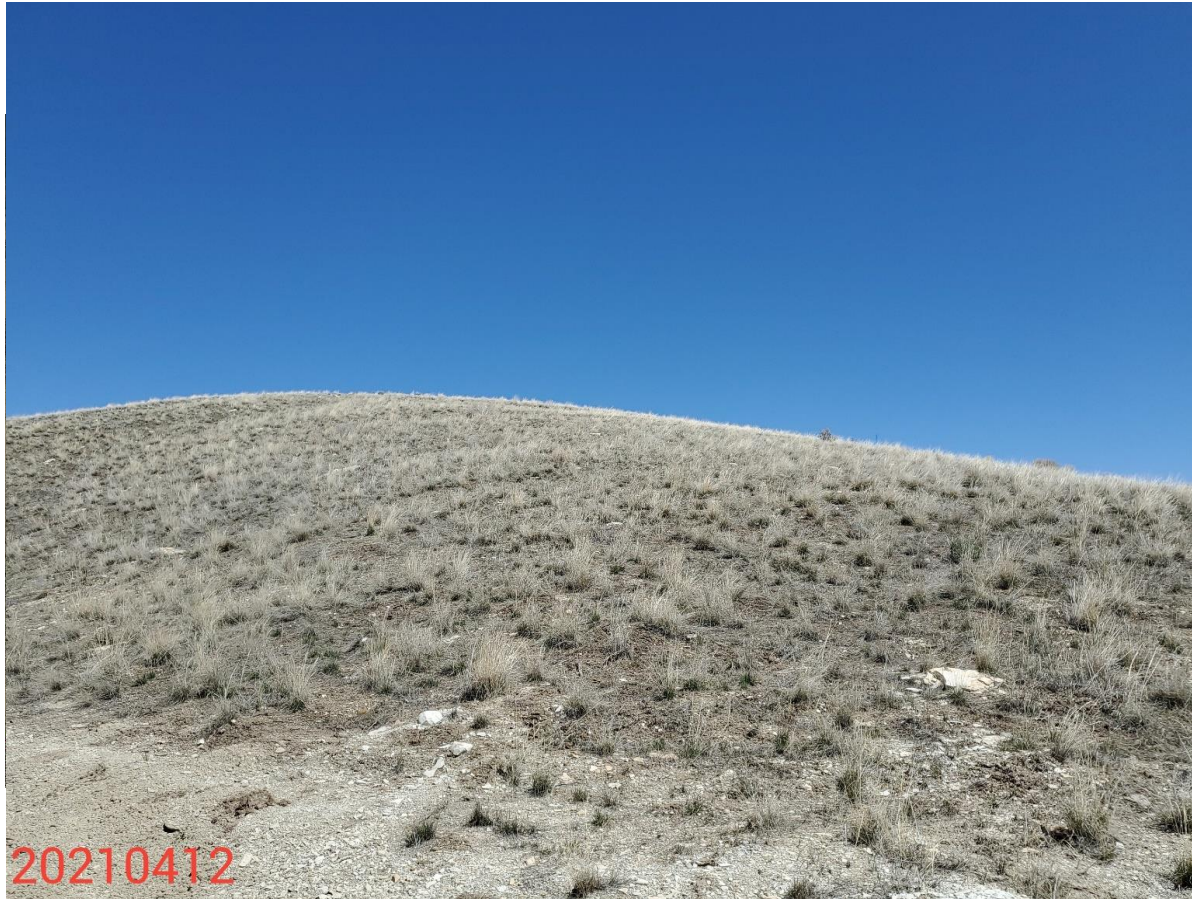
Photo 7: Photo taken from the northeastern end of the Location, facing north. Photo shows interim areas where topsoil appears to have been replaced, and is progressing towards COGCC 1003 revegetation standards.

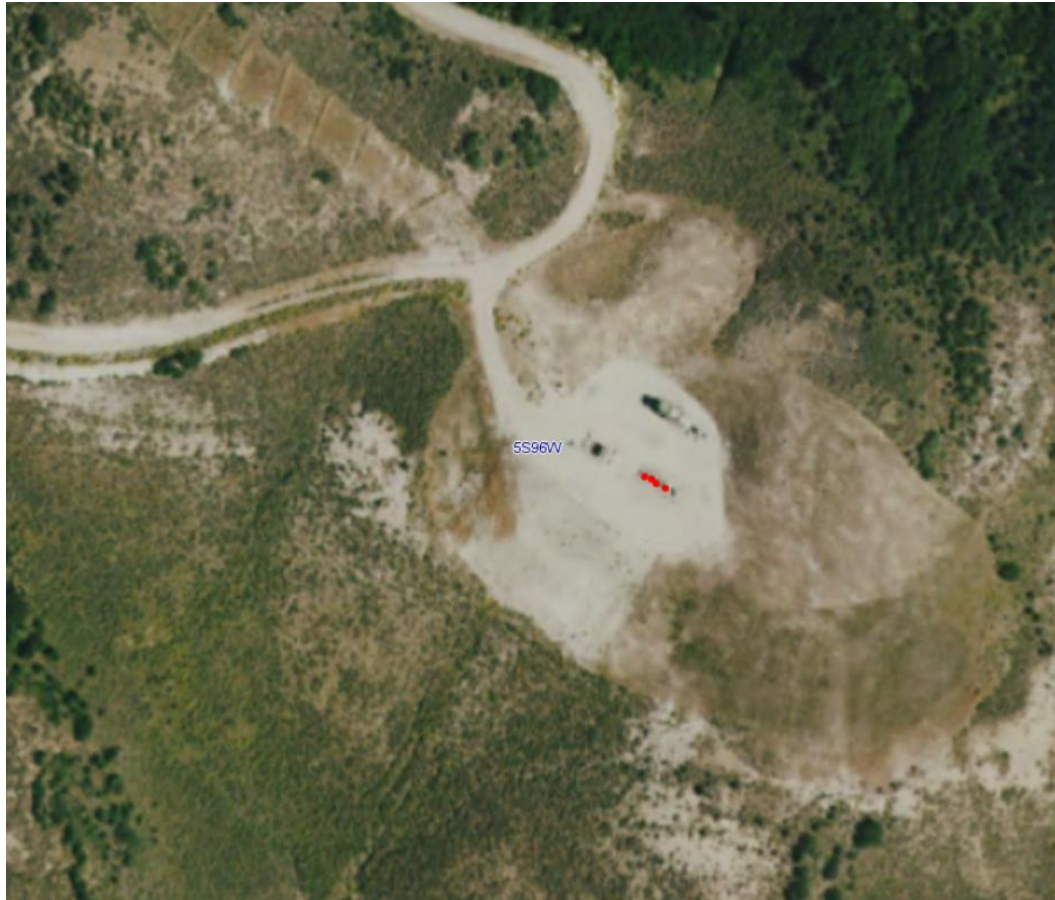
Photo 8: 2019 COGIS aerial imagery. Photo shows areas on the south end of the Location where topsoil does not appear to have been replaced in accordance with 1003.e.(2).
