Final Reclamation and Stormwater Inspection

Operator: PDC ENERGY INC - 69175

Location ID: 331561

Location Name: WYSCAVER 23-5

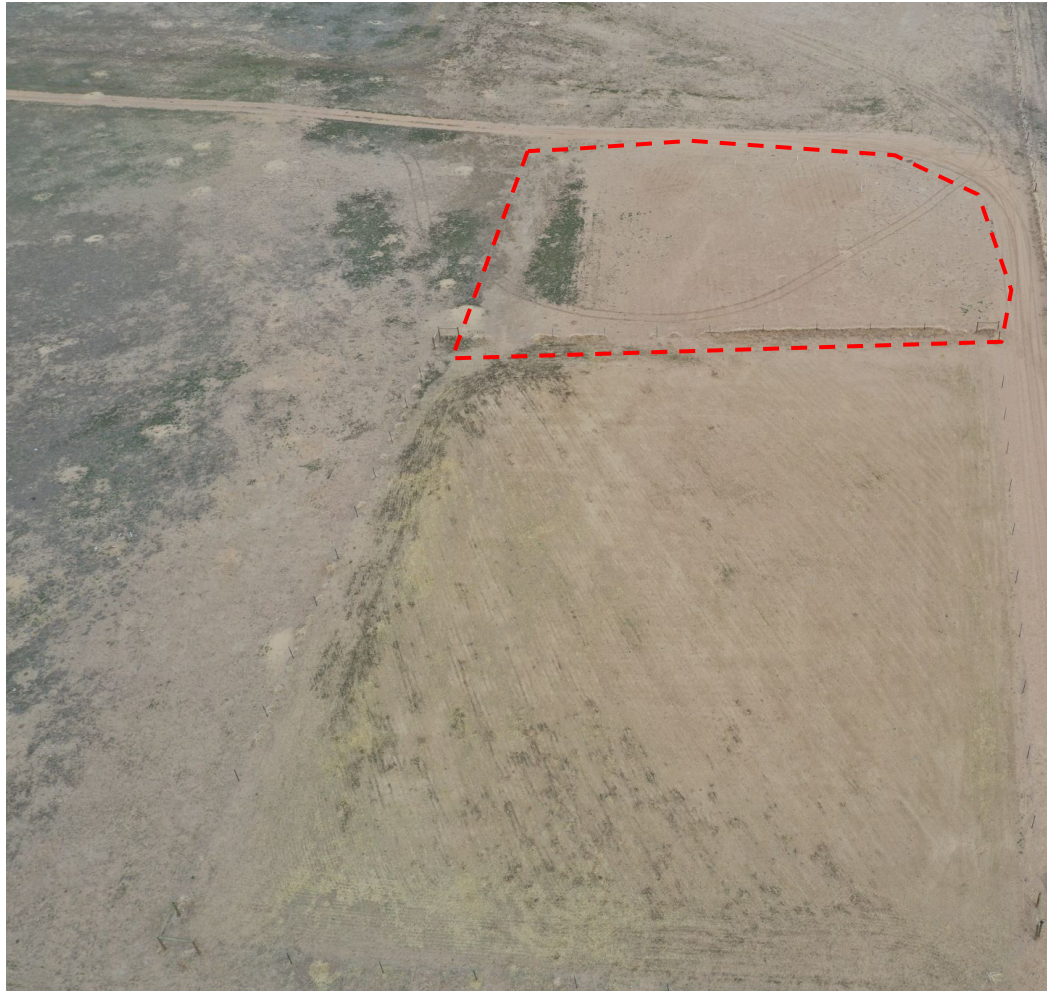
Photo 1. Drone aerial imagery from 4/13/2021 illustrates the associated offsite tank battery which was a shared tank battery. PDC's shared portion is highlighted in the red-dashed line. Wind erosion was observed on PDC's shared portion of the tank battery which is transporting sediment offsite, some of which is going onto Noble's shared portion.

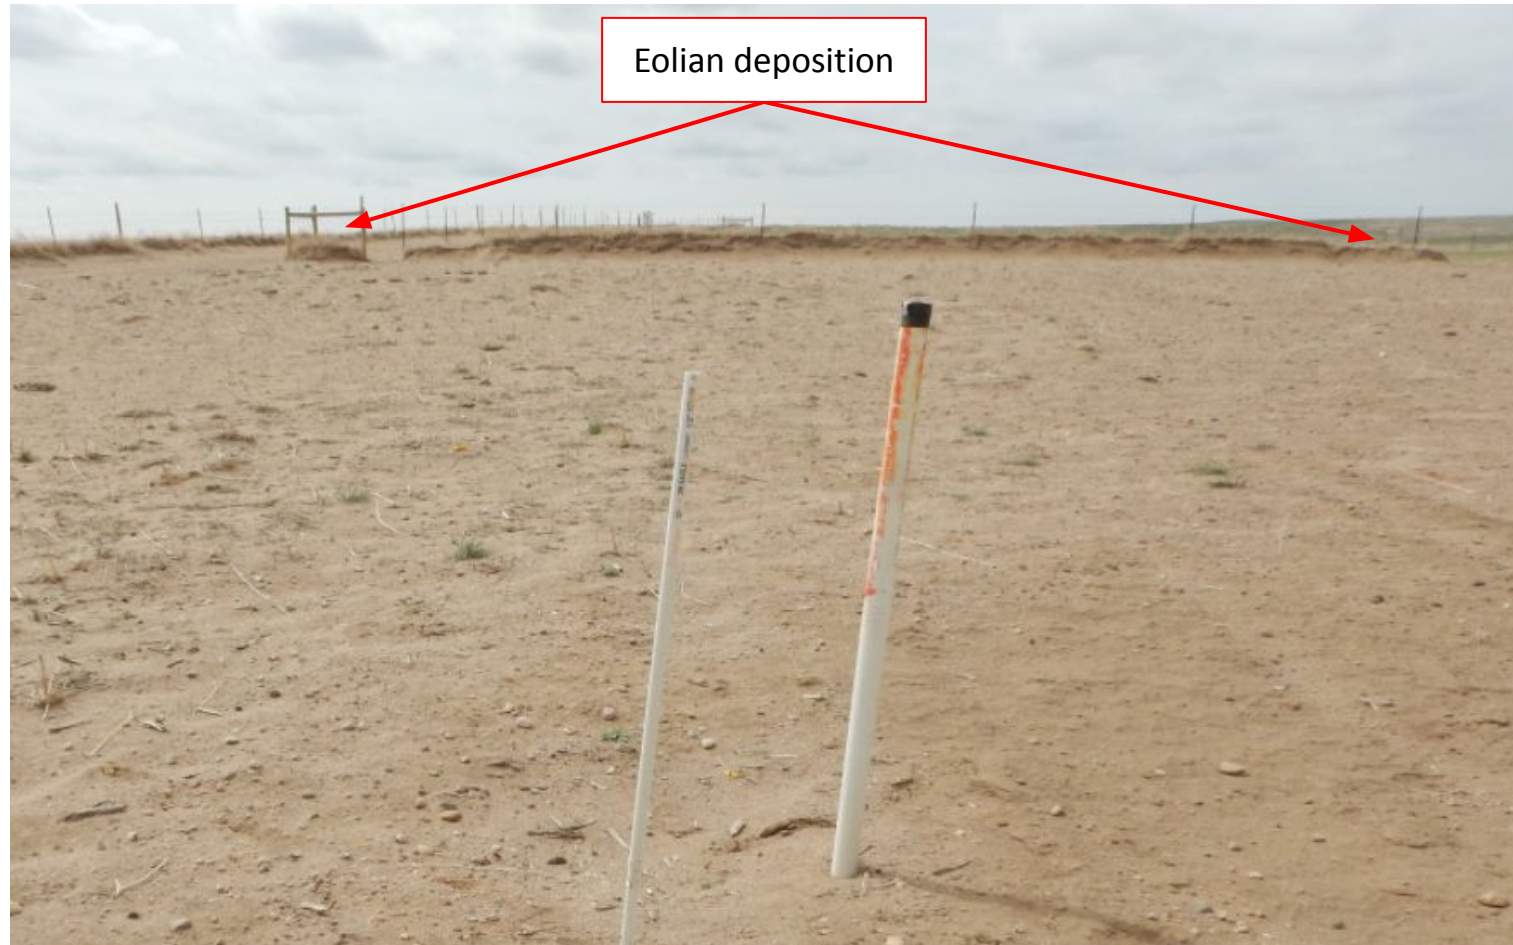
Photo 2. Photo taken from PDC's shared portion of the tank battery, facing South. Photo illustrates eolian (wind) deposition which is accumulating along Noble's northern tank battery. Some of this deposition could also be from nearby reference areas to the north. Regardless, PDC's shared portion of the tank battery is not stabilized to minimize erosion, transport of sediment offsite, and site degradation.

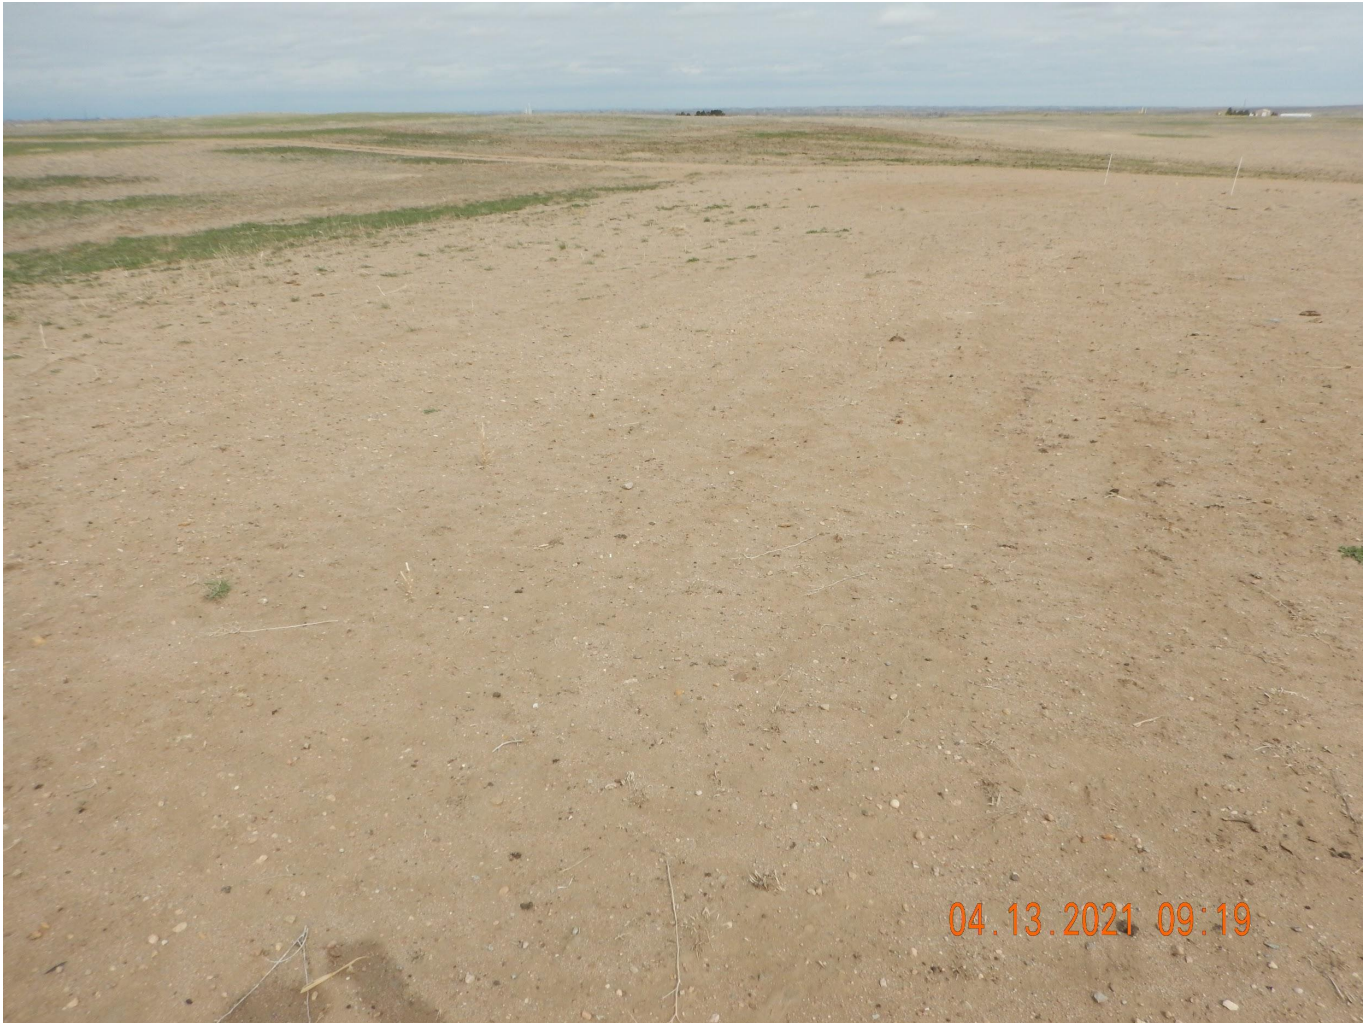
Photo 3. Photo taken from PDC's shared portion of the tank battery, facing North. See comments under Photo 2.

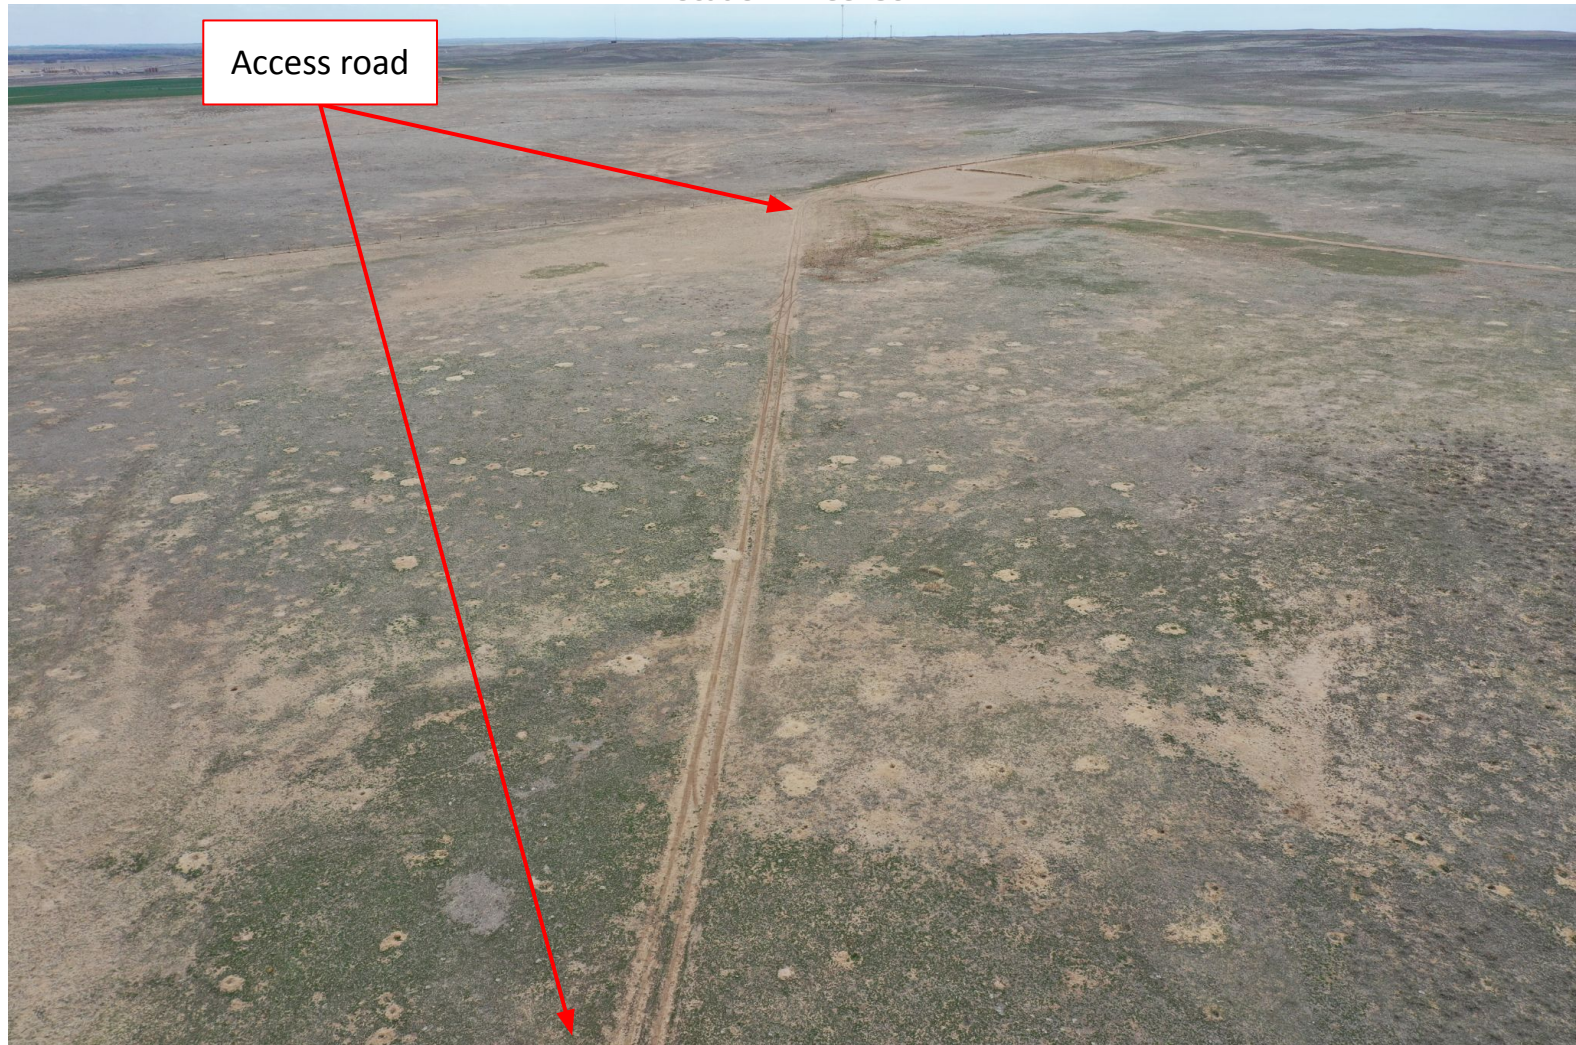
Photo 4. Drone aerial imagery from 4/13/2021, facing Southeast. Photo illustrates the well location access road which has not been properly reclaimed.

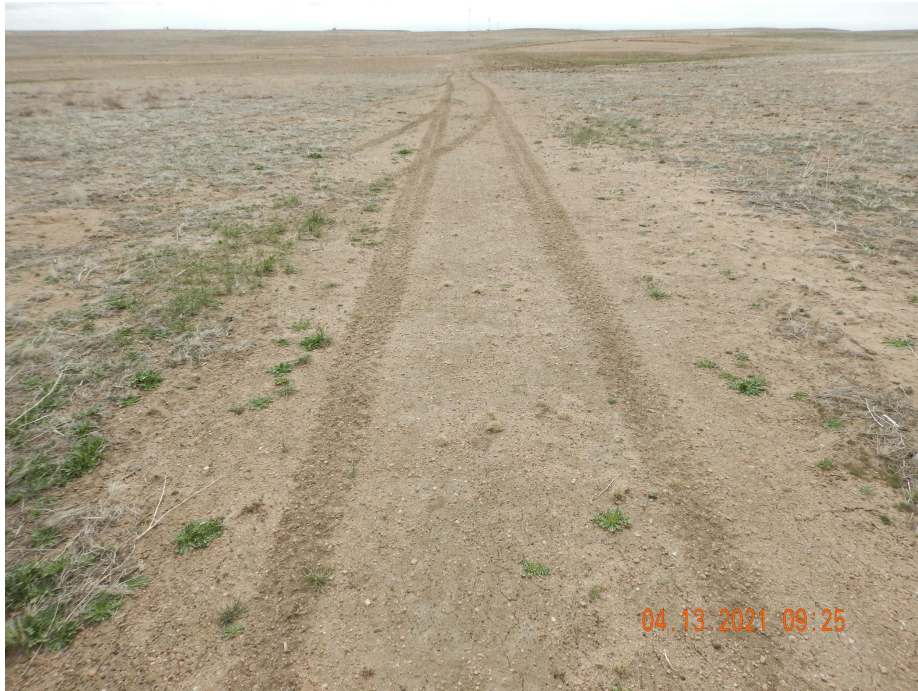
Photo 5. Photo taken from a portion along the well location access road, facing Southeast. Photo illustrates the access road has not been properly reclaimed.

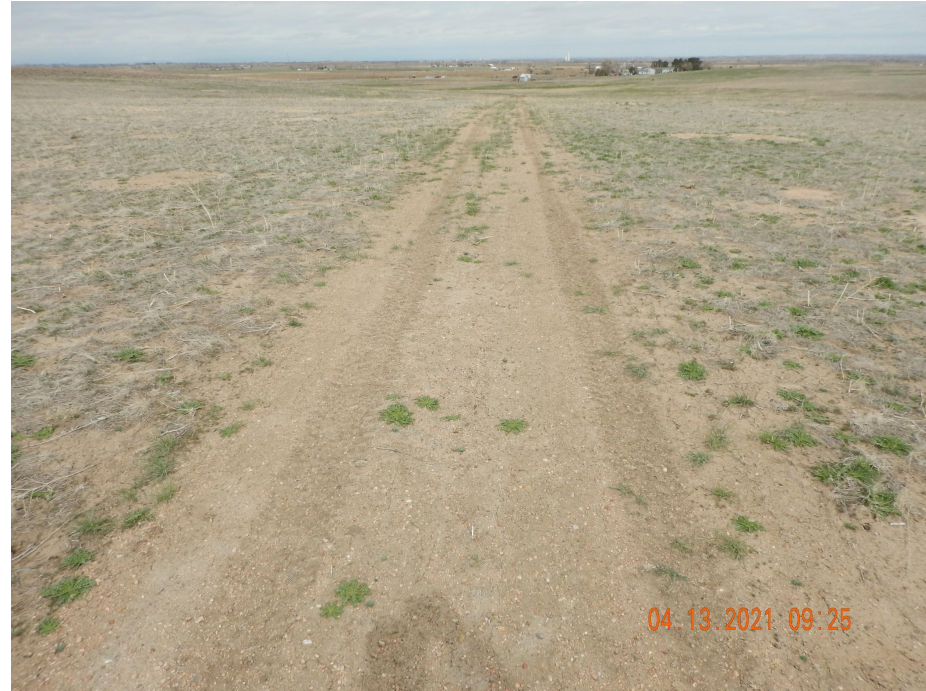
Photo 6. Photo taken from a portion along the well location access road, facing Northwest. See comments under Photo 5.

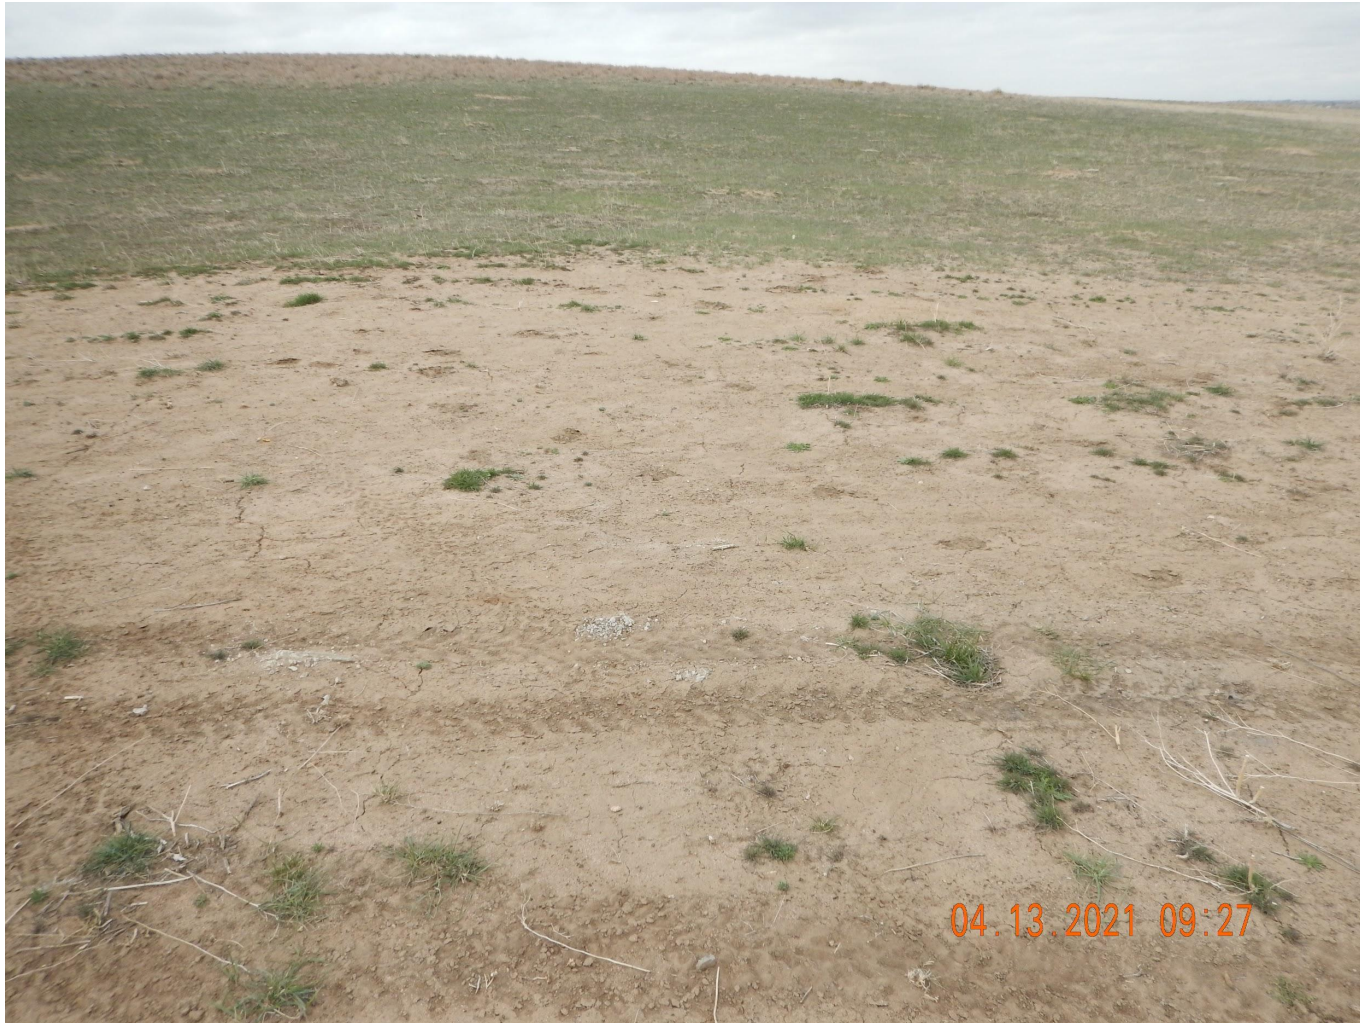
Photo 7. Photo taken from the well location, facing West. Photo illustrates little to no establishment of desirable plant species.
