# Inspection Photos

API: 071-08451

Operator: EVERGREEN NATURAL RESOURCES

Inspection Date: 4/19/2021

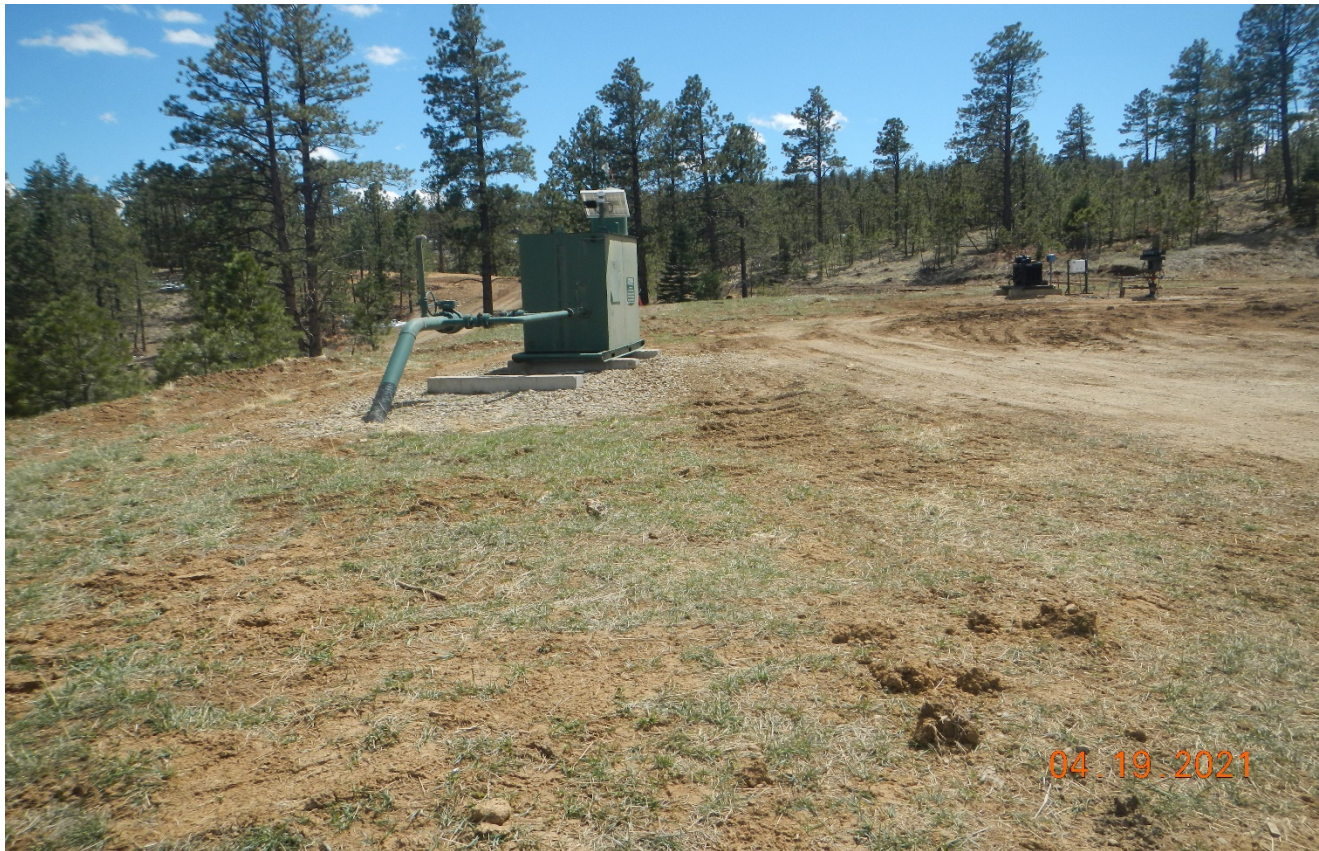
**Photo 1.** Facing south toward the location.

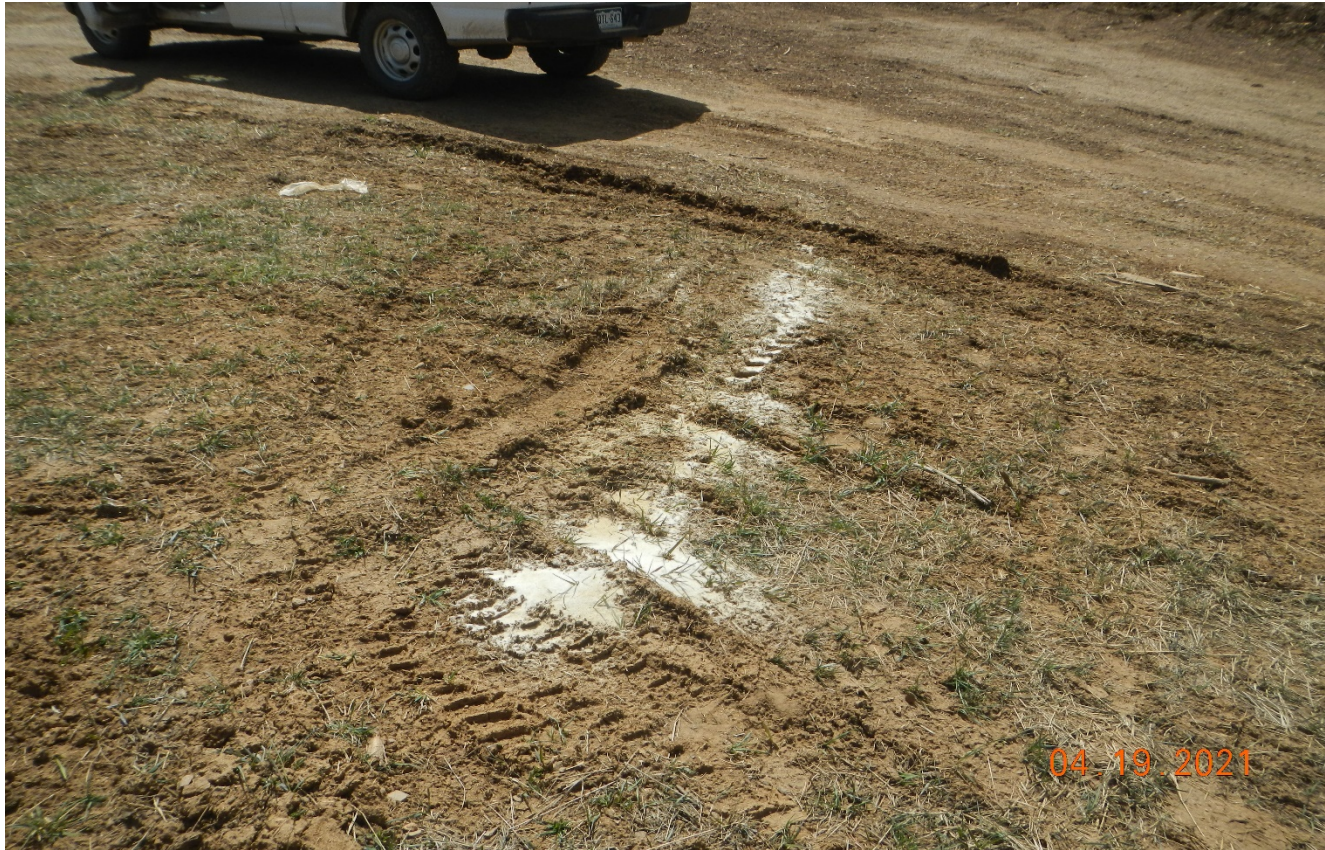
**Photo 2.** There is a white salt like substance spilled on the ground at the north side of the location which needs to be cleaned up.

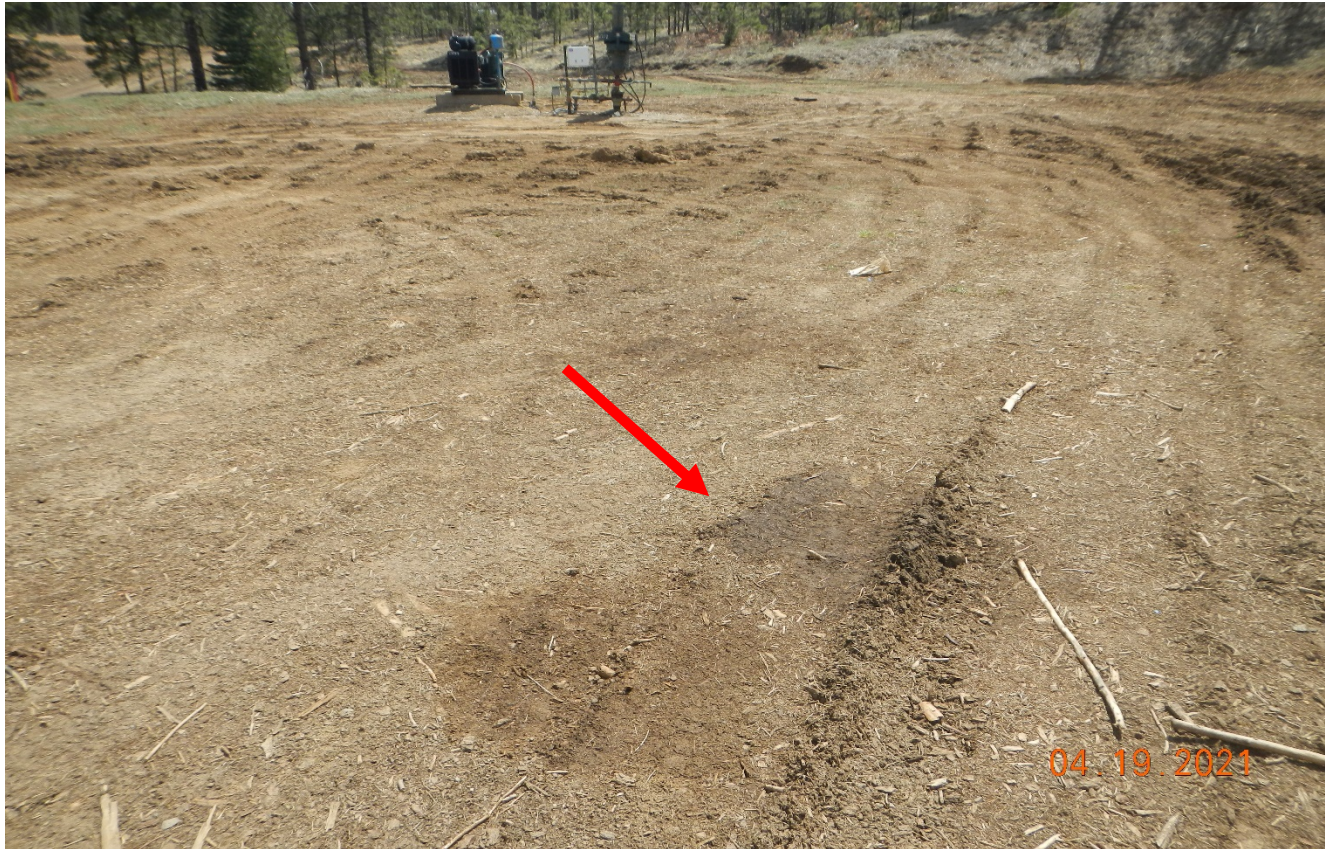
**Photo 3.** Facing south at center of the location. There is oil stained soil shown at red arrow which needs to be cleaned up.

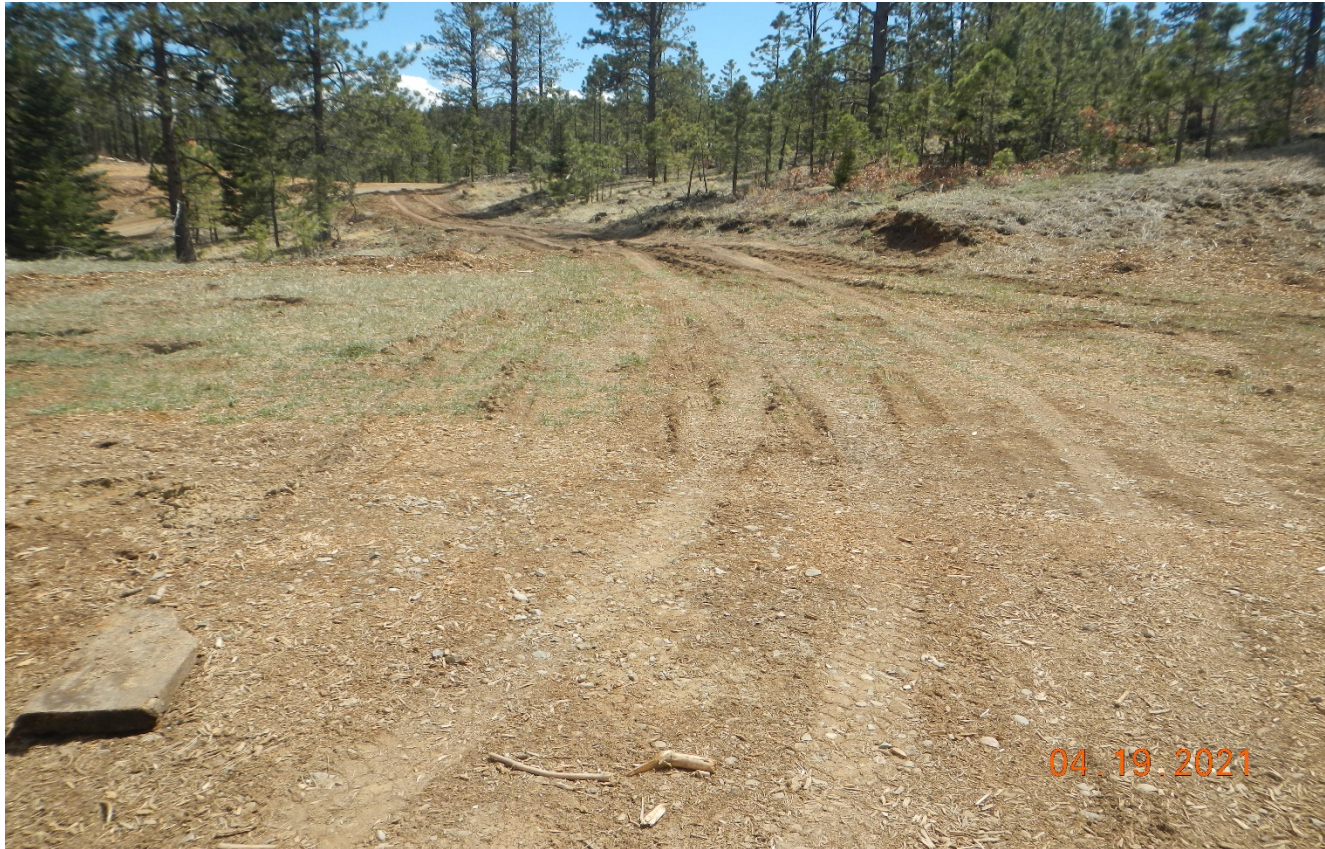
**Photo 4.** There was a road built to the south of the location. The road is causing disturbance of the interim reclamation. Vehicle access needs to be prevented.

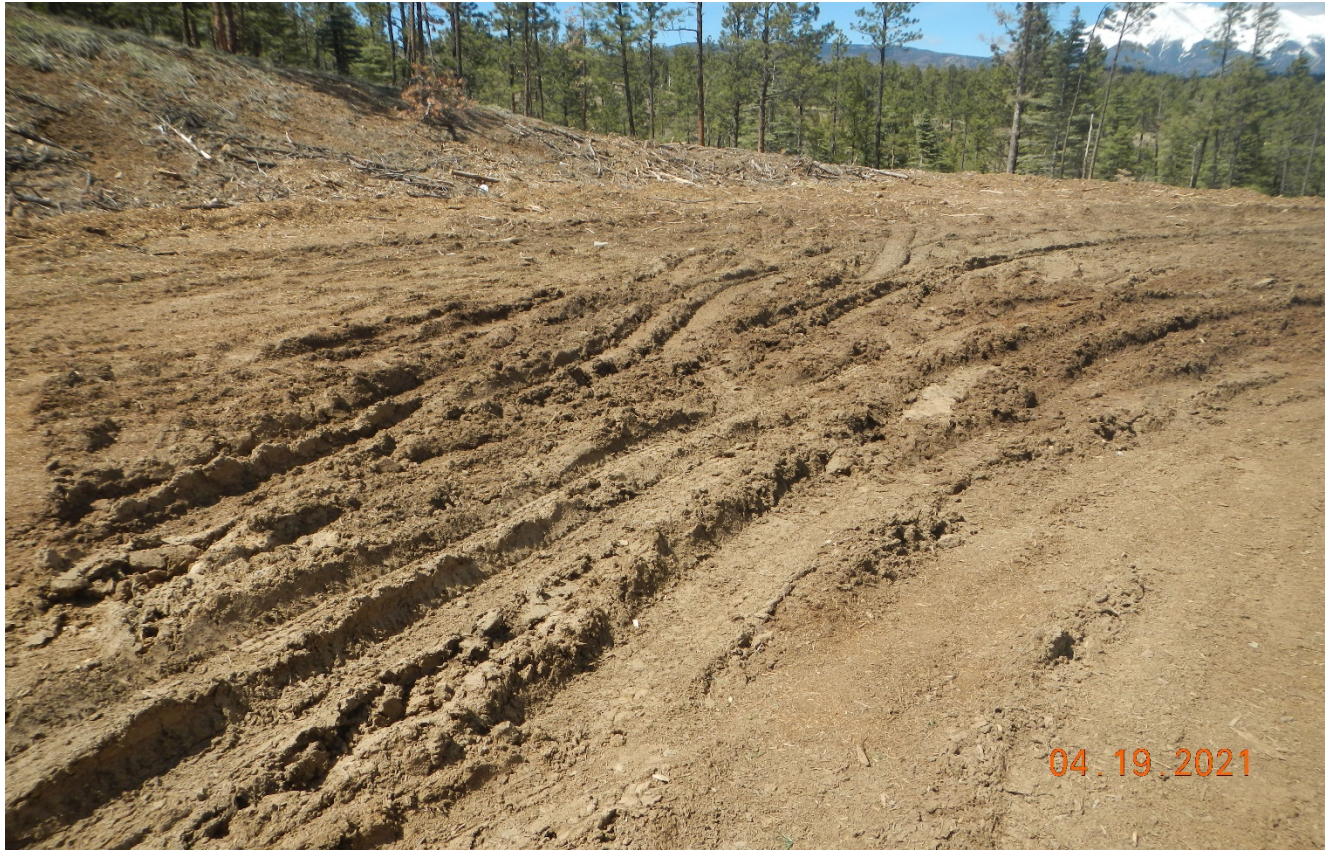
**Photo 5.** There is vehicle rutting and disturbance that occurred which needs to be repaired and reclaimed.
