Inspection Photos

Operator: TEP ROCKY MOUNTAIN LLC #
96850

Location ID: 383332
Garfield County, CO

Aaron Trujillo
NW Reclamation Specialist
COGCC

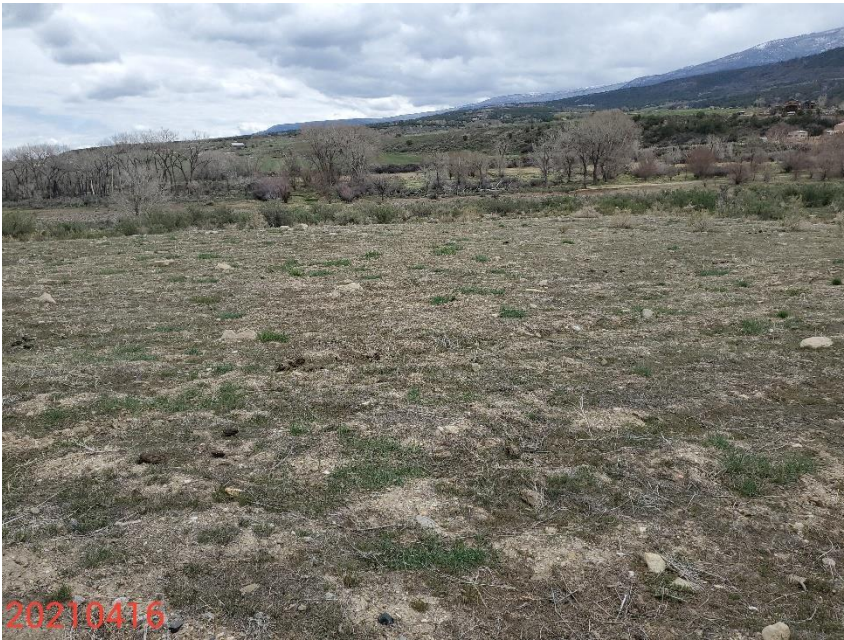
Photo 1: Photo taken from the interim areas on the southeast end of the Location, facing southeast. Photo shows desirable perennial vegetative establishment is not progressing towards 1003 reclamation standards; vegetation predominantly undesirable weedy annual plant species such as cheat grass

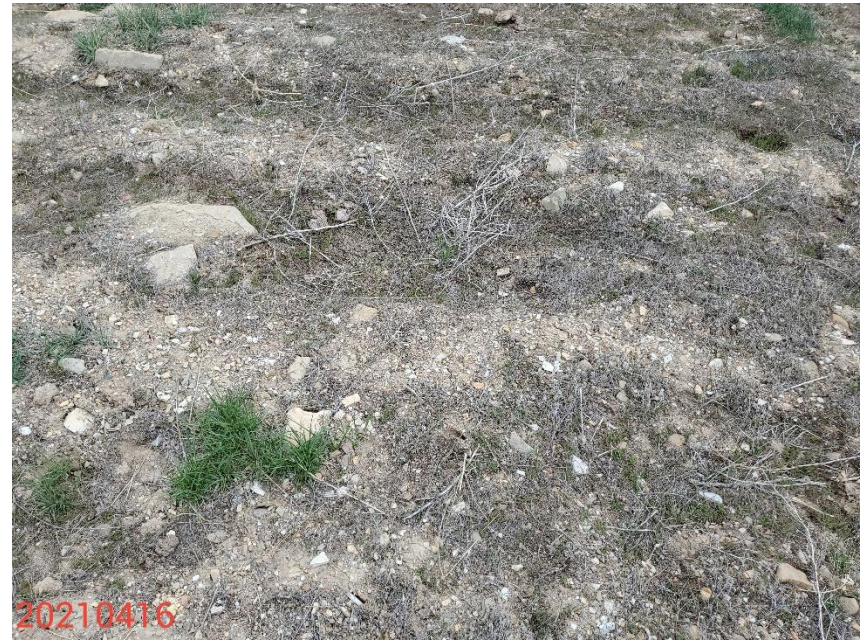
Photo 2: See comments under photo 1.

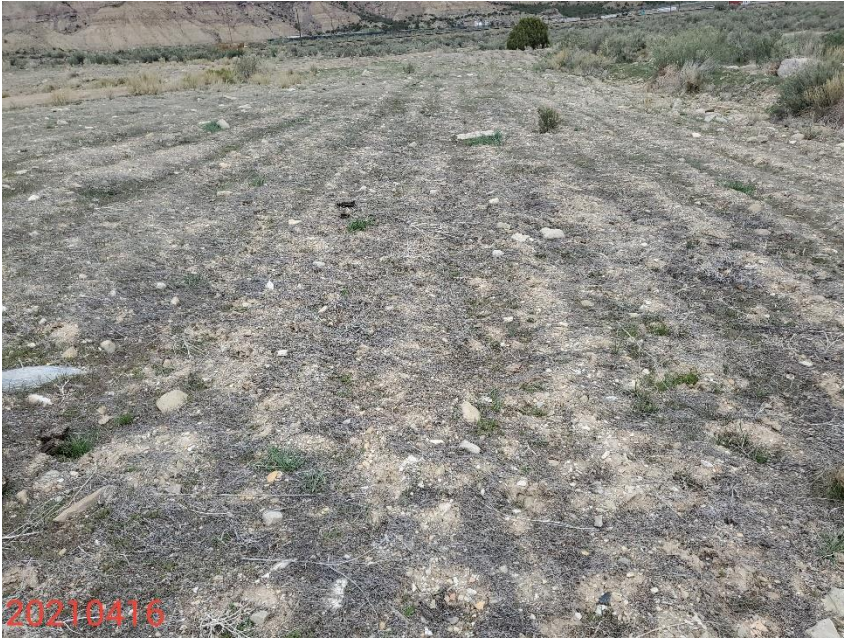
Photo 3: Photo taken from the interim areas on the southeast end of the Location, facing northeast. Photo shows desirable perennial vegetative establishment is not progressing towards 1003 reclamation standards; vegetation predominantly undesirable weedy annual plant species such as cheat grass

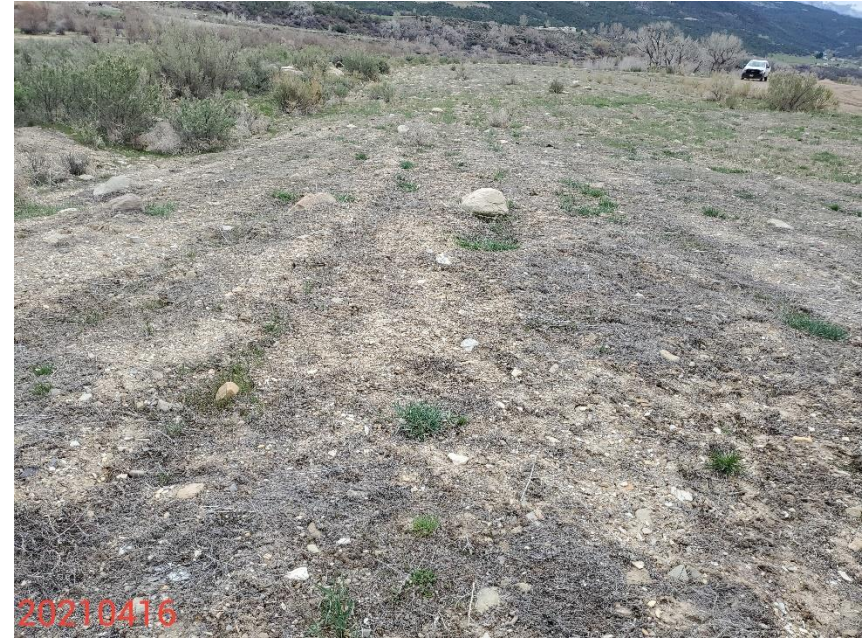
Photo 4: Photo taken from the interim areas on the northeast end of the Location, facing south. Photo shows desirable perennial vegetative establishment is not progressing towards 1003 reclamation standards; vegetation predominantly undesirable weedy annual plant species such as cheat grass

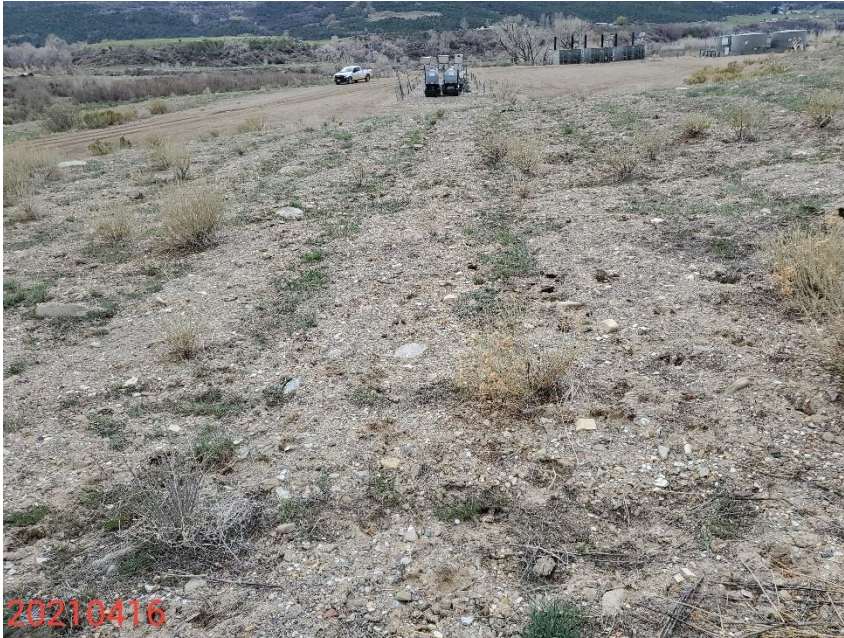
Photo 5: Photo taken from the interim areas on the north end of the Location, facing south. Photo shows desirable perennial vegetative establishment is not progressing towards 1003 reclamation standards; green vegetation observed in photo is predominantly undesirable weedy annual plant species such as cheat grass

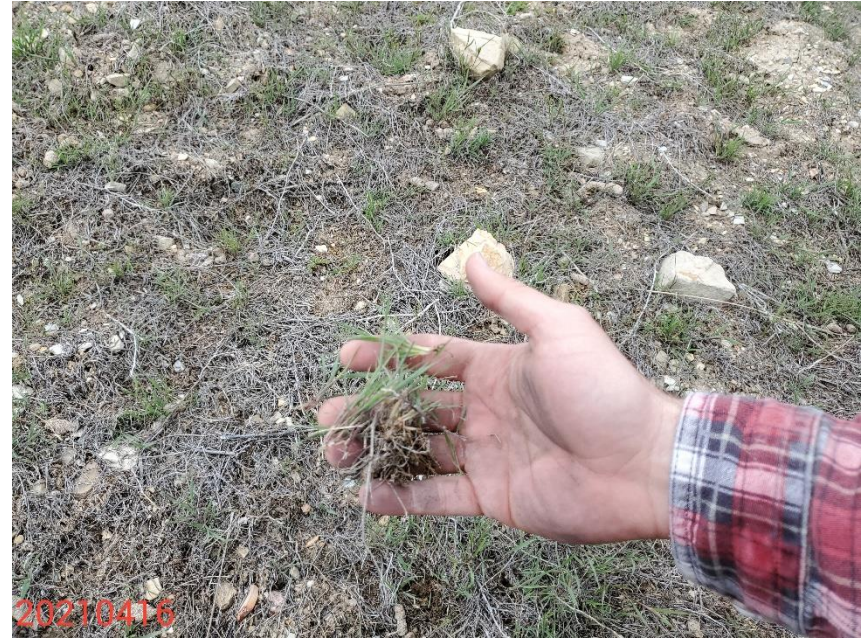
Photo 6: Continued from photo 5. Photo shows vegetation observed is predominantly undesirable weedy annual plant species such as cheat grass

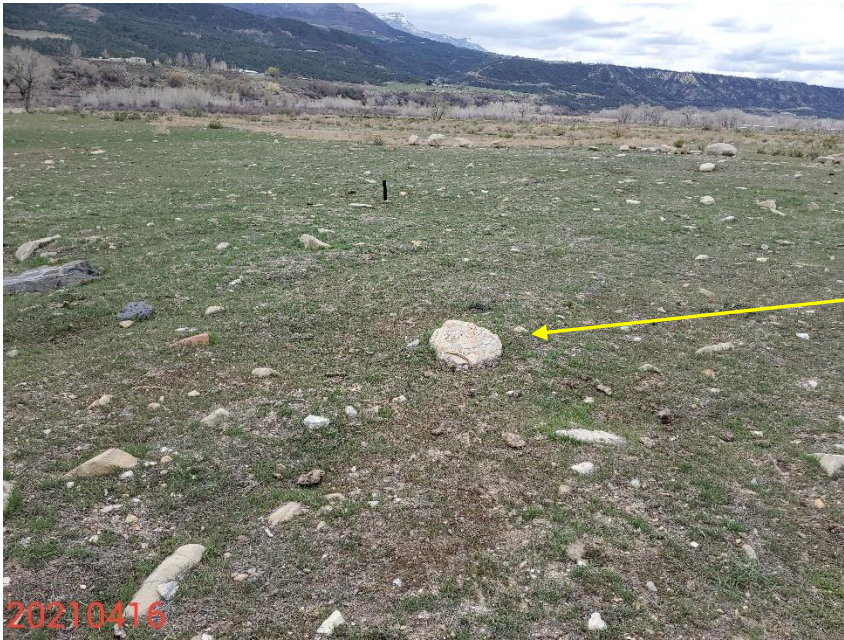
Photo 7: Photo taken from the interim areas on the northwest end of the Location, facing southwest. Photo shows desirable perennial vegetative establishment is not progressing towards 1003 reclamation standards; green vegetation observed in photo is predominantly undesirable weedy annual plant species such as cheat grass

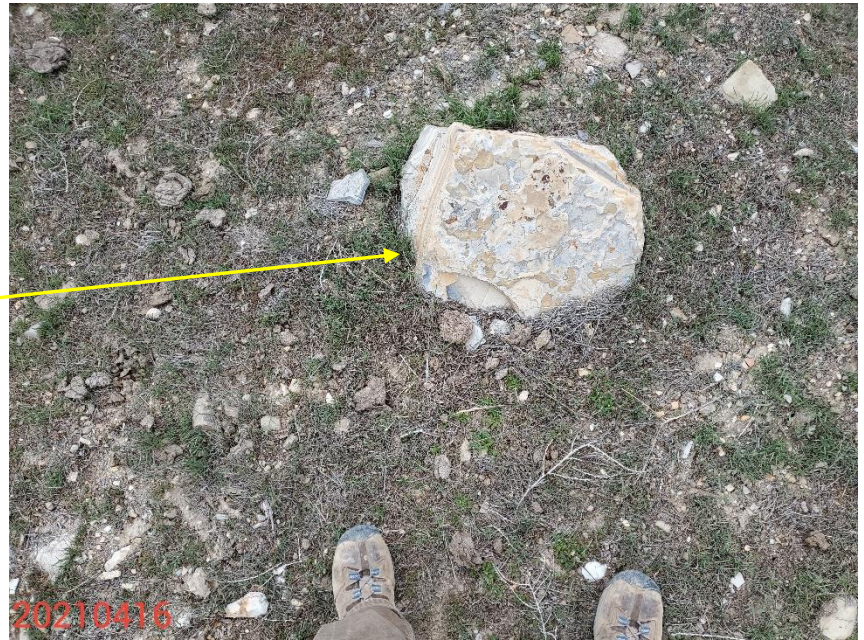
Photo 8: Continued from photo 7. Photo shows vegetation observed is predominantly undesirable weedy annual plant species such as cheat grass

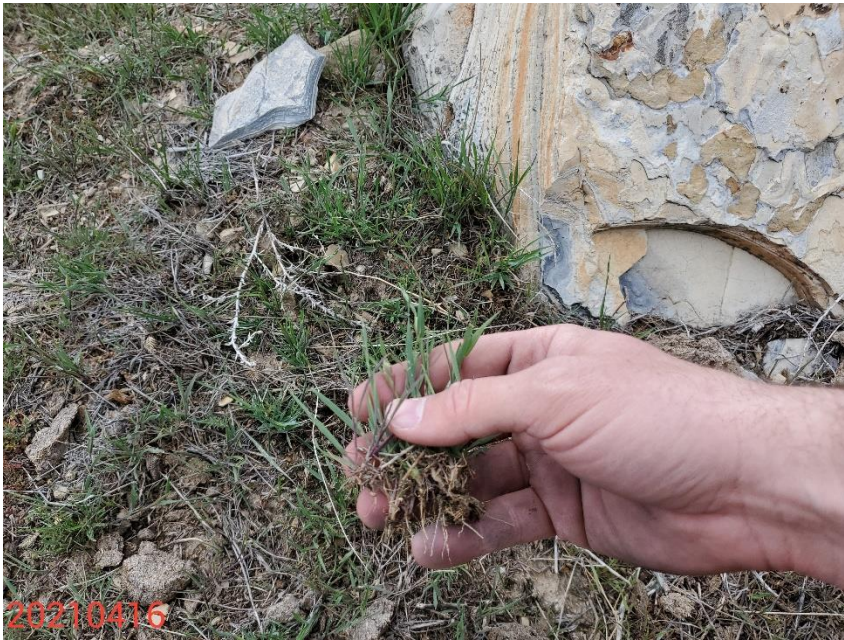
Photo 9: Continued from photo 7. Photo shows vegetation observed is predominantly undesirable weedy annual plant species such as cheat grass

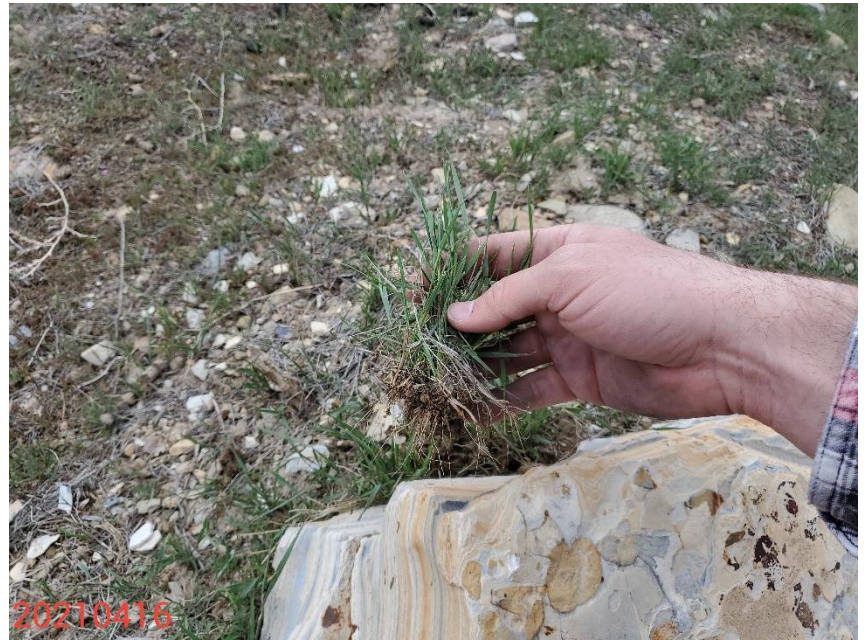
Photo 10: Continued from photo 7. Photo shows vegetation observed is predominantly undesirable weedy annual plant species such as cheat grass
