# Inspection Photos

Operator: CHEVRON USA INC #16700

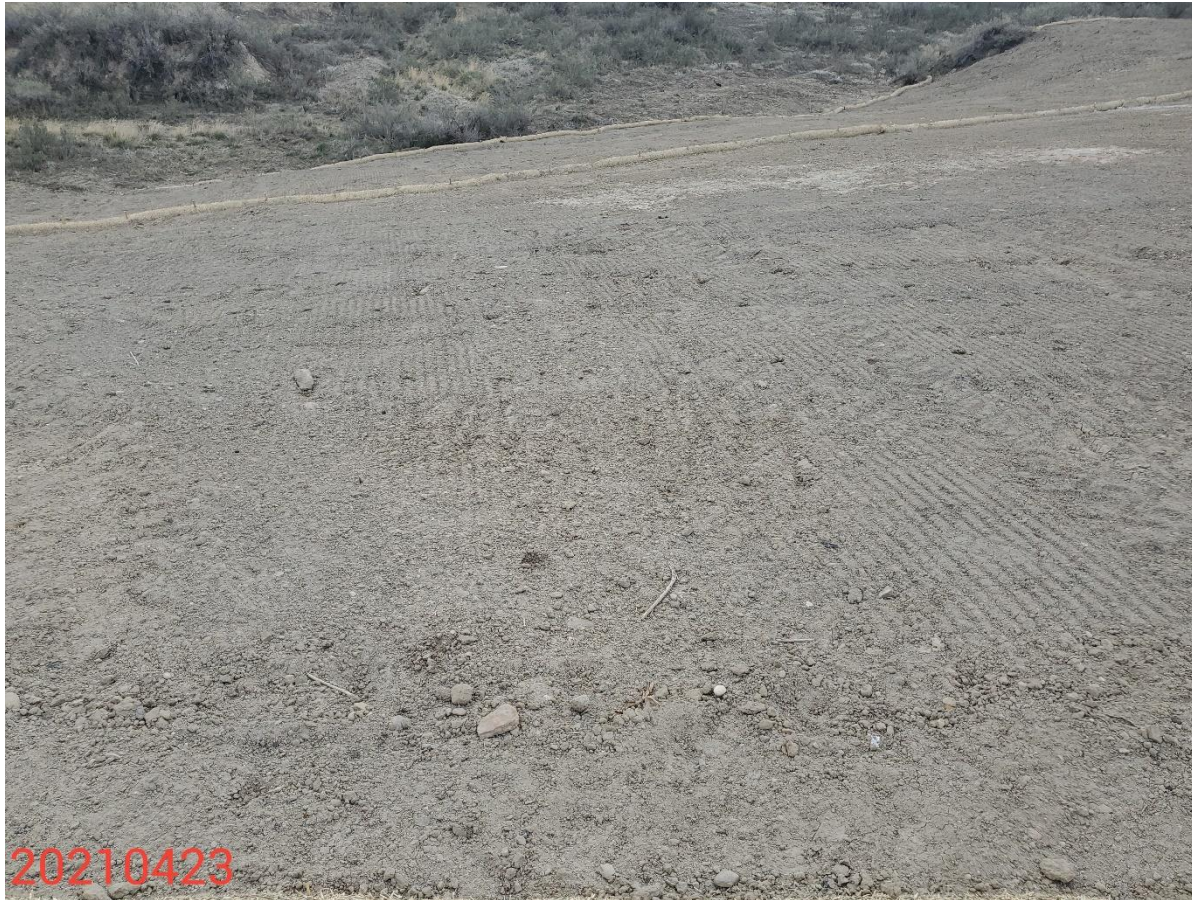
**Photo 2:** Photo taken from the east end of the Location, facing east. Photo shows additional erosion logs have been installed. Unclear if BMPs are sufficient or adequate for the site's conditions

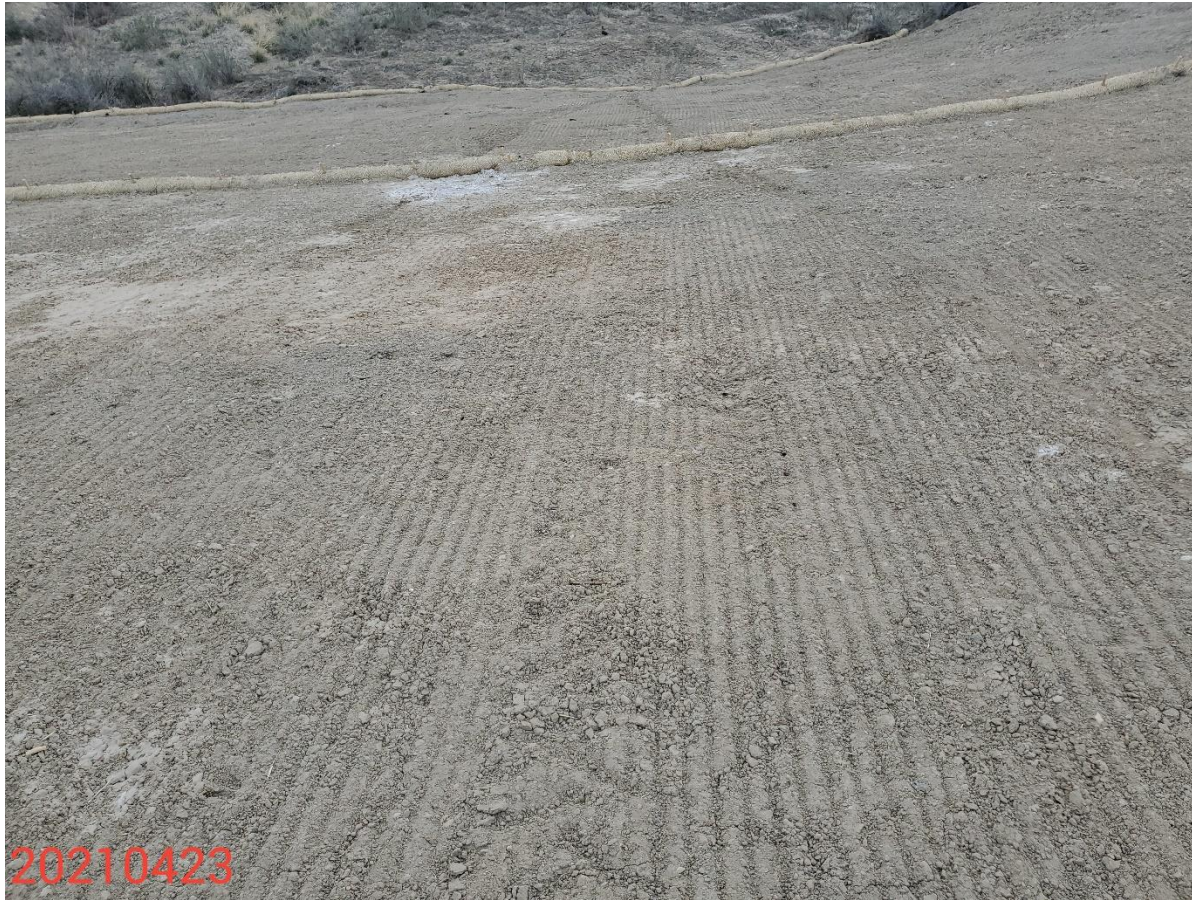
**Photo 3:** Photo taken from the eastern areas of the Locating, facing east. Photo shows Operator has seeded up the slopes of the Location, rather than along the contour; this is not good engineering practice and will facilitate concentration of stormwater and degradation
