# Inspection Photos

Operator: RIO MESA RESOURCES INC - 74740

Location ID: 315237

Rio Blanco County, CO

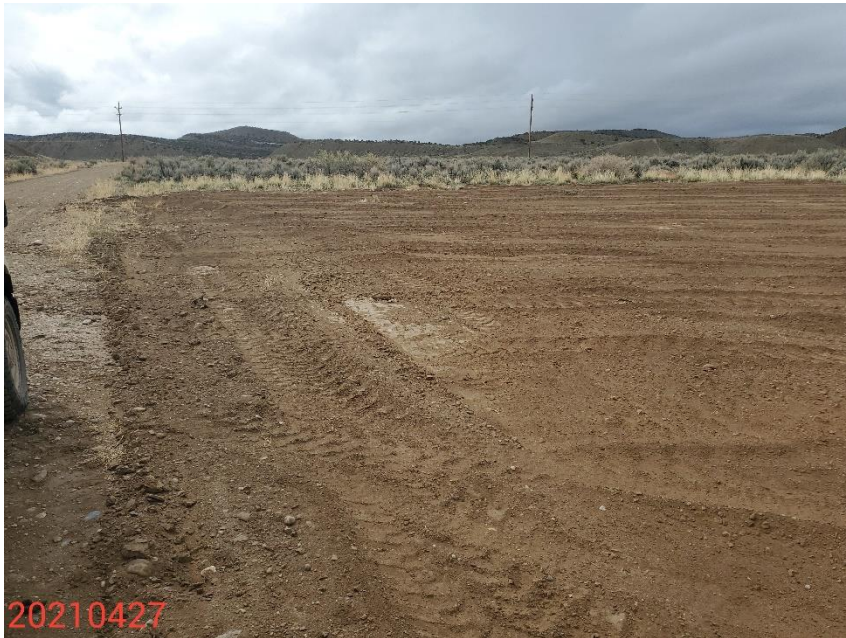
**Photo 1:** Photo taken from the east end of the Location, facing south. Photos 1-4 provide an overview of the Location from south, southwest, northwest to north. Photo shows additional reclamation has been performed, however, compaction issues are apparent on the Location, and stormwater control measures have not been implemented.

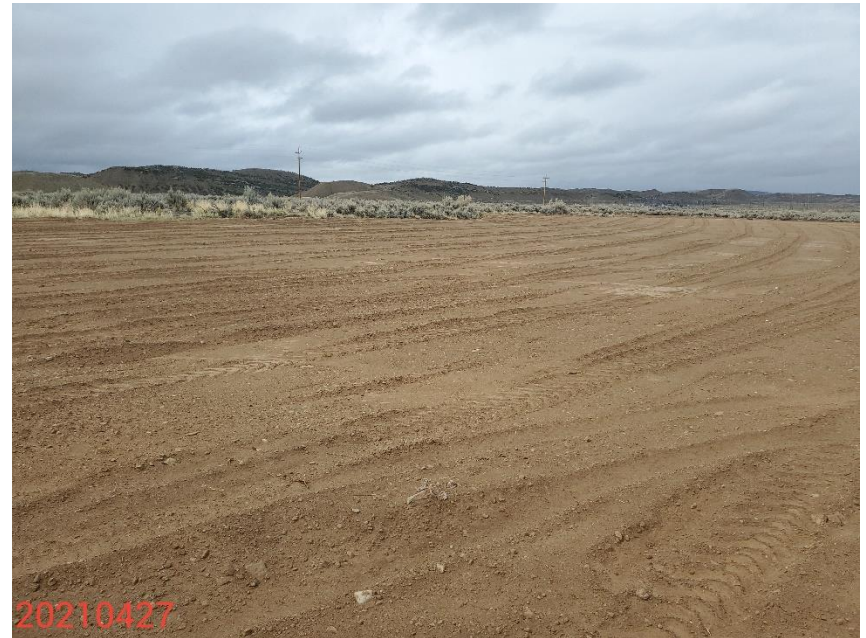
**Photo 2:** See comments under photo 1.

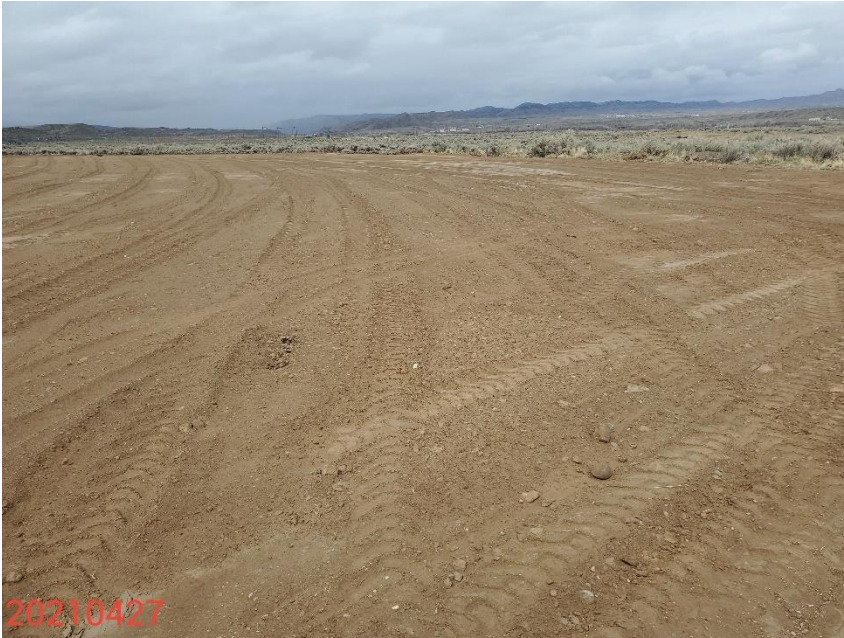
**Photo 3:** See comments under photo 1.

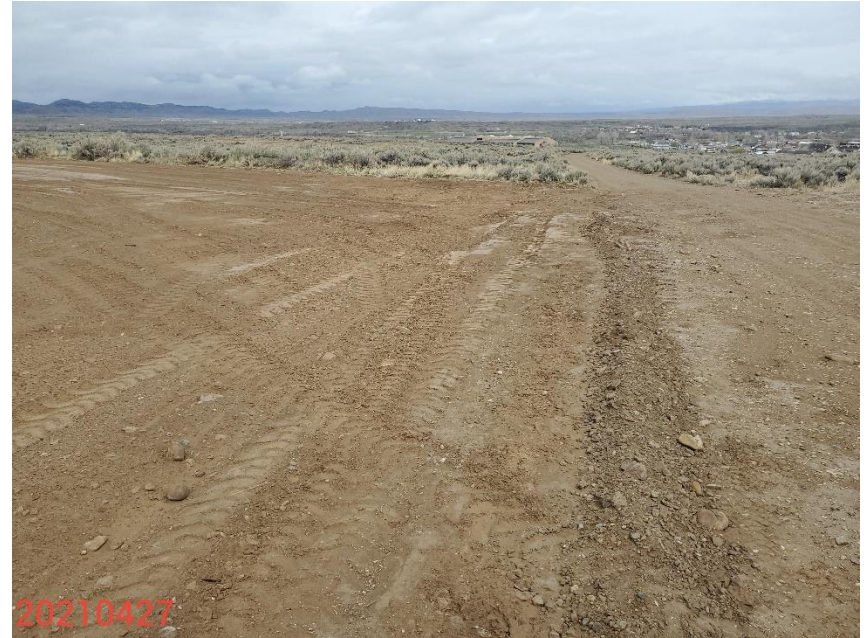
**Photo 4:** See comments under photo 1.

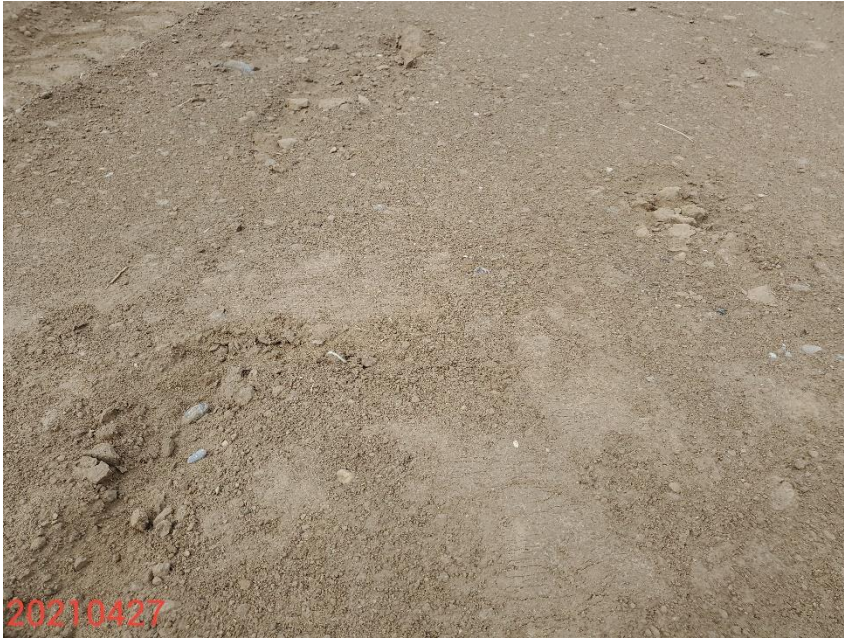
**Photo 5:** Photo shows the soil surface of the Location. Location has been regraded and soils replaced. However, Reclamation Specialist was unable to find any evidence that revegetation (seeding) activities have been performed per Rules and Corrective actions. Photo also shows that stabilization control measures have not been implemented per corrective actions.

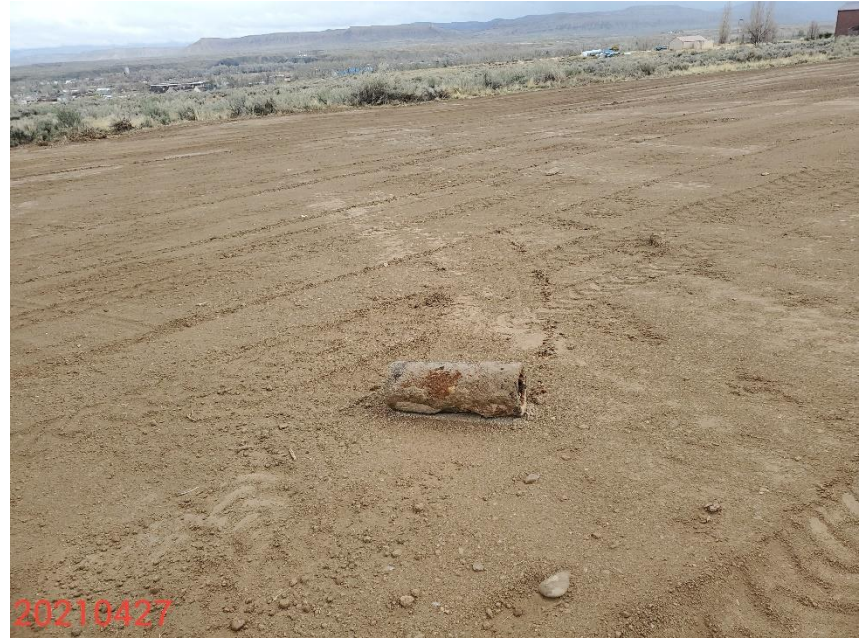
**Photo 6:** Photo taken from the western end of the Location, facing northeast. Photo shows pipe debris that has not been removed from the Location.

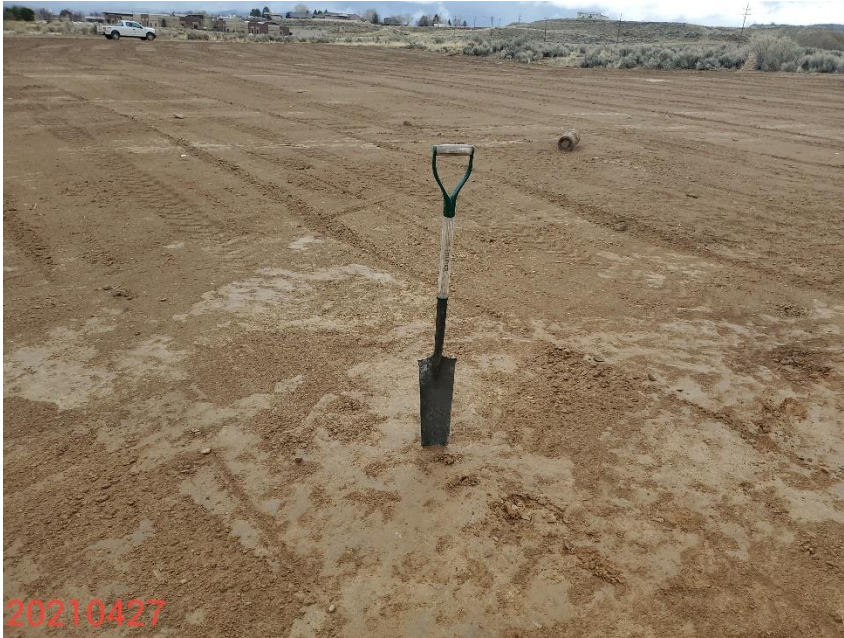
**Photo 7:** Photo taken from the western areas of the Location, facing southeast. Photo shows examples of the Location where compaction issues area apparent as the surface.

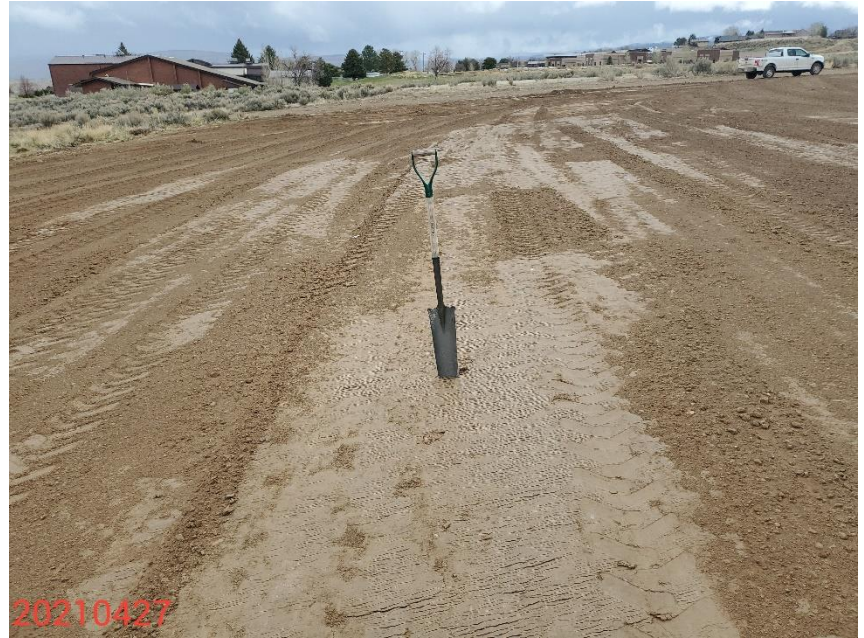
**Photo 8:** Photo taken from the eastern areas of the Location, facing southeast. Photo shows examples of the Location where compaction issues area apparent as the surface.

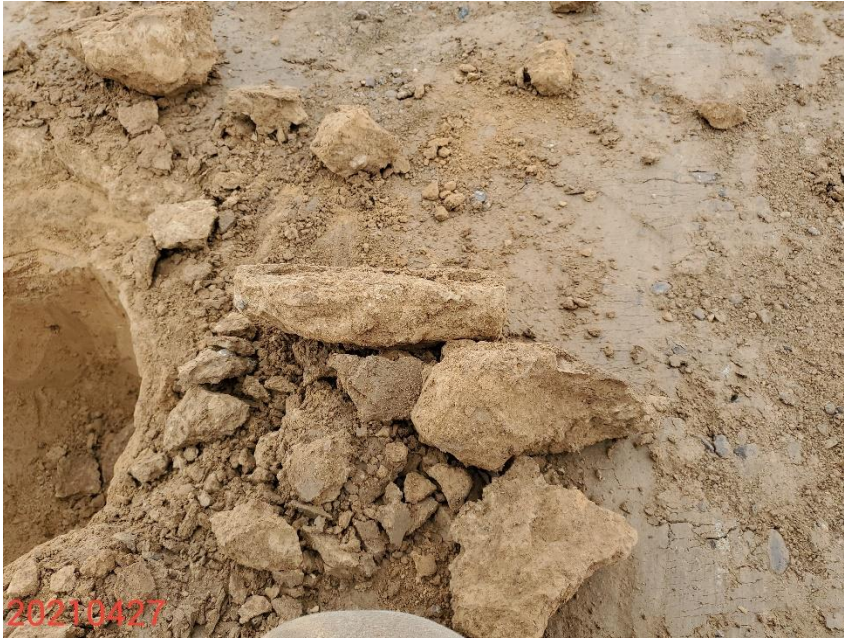
**Photo 9:** Reclamation Specialist dug a test pit on the Location to determine compliance with compaction alleviation requirements; comaction issues were observed in the top 4-5 inches of the soil; it is unclear if compaction alleviation has been performed per COGCC Rules.

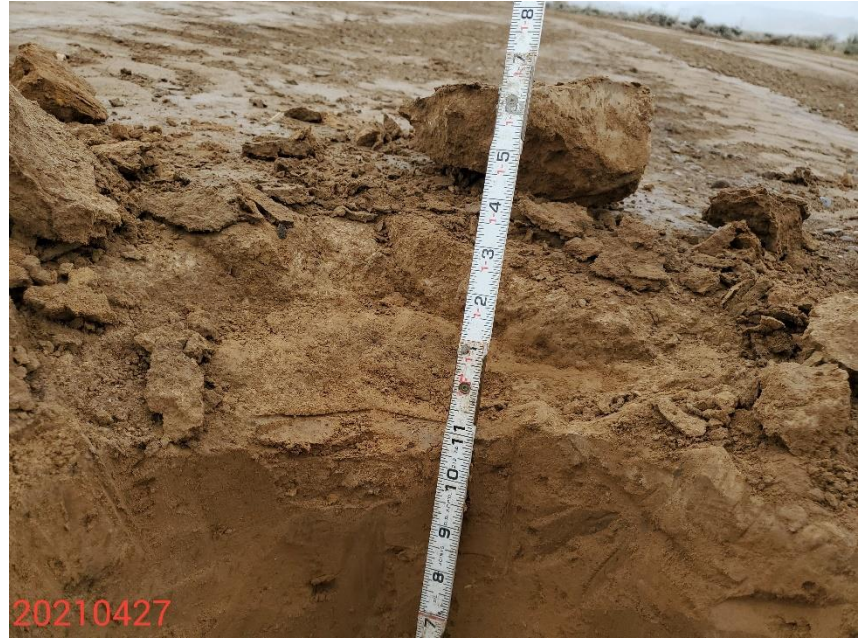
**Photo 10:** See comments under photo 9.

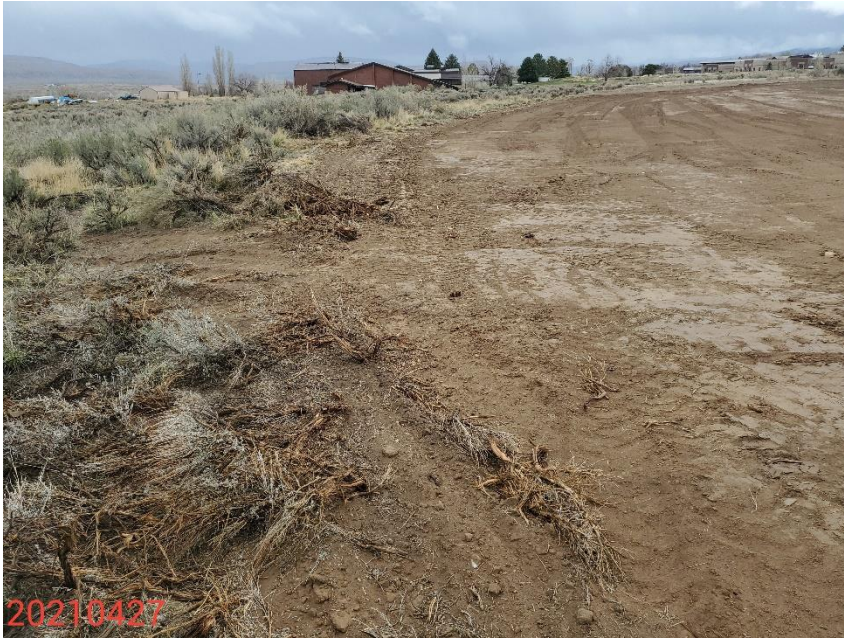
**Photo 11:** Photo taken from the northwestern corner of the Location, facing east. Photo shows requires stormwater and erosion control measures have not been implemented on the Location per Rules, and corrective actions.

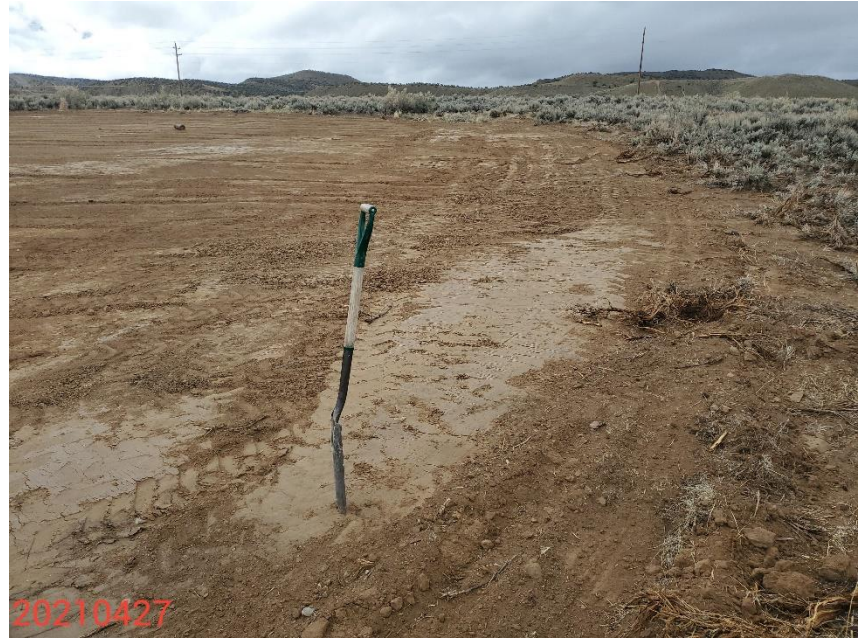
**Photo 12:** Photo taken from the northwestern corner of the Location, facing south. Photo shows requires stormwater and erosion control measures have not been implemented on the Location per Rules, and corrective actions.
