Inspection Photos

Operator: C & J FIELD SERVICES - 10027

Location ID: 311815

Rio Blanco County, CO

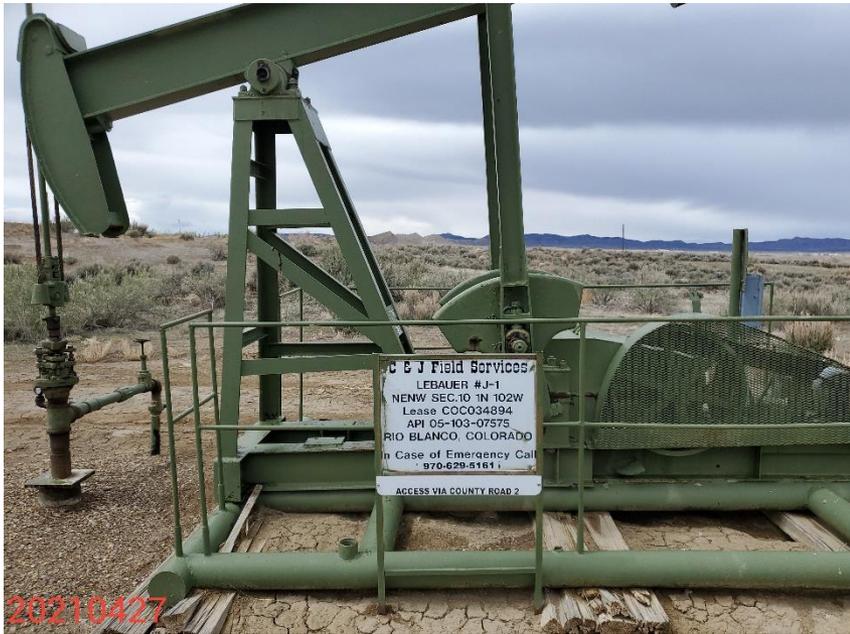
Photo 1: Photo of sign and wellhead.

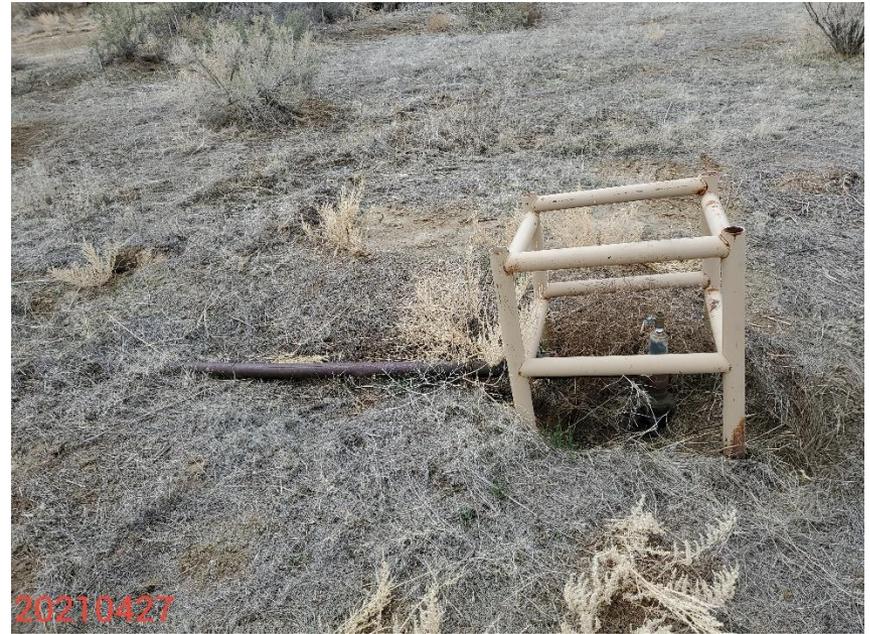
Photo 2: Photo taken from the flowline riser on the North end of the Location. Integrity issues were observed on the flowline/flowline system. Additionally, flowline equipment does not appear to have been registered/mapped pursuant to the 1101 Rules.

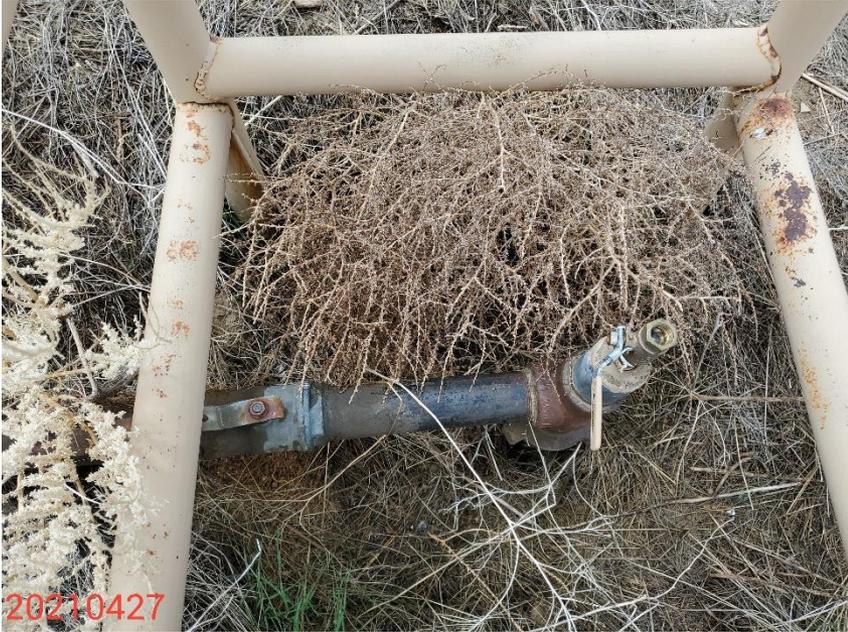
Photo 3: See comments under photo 2.

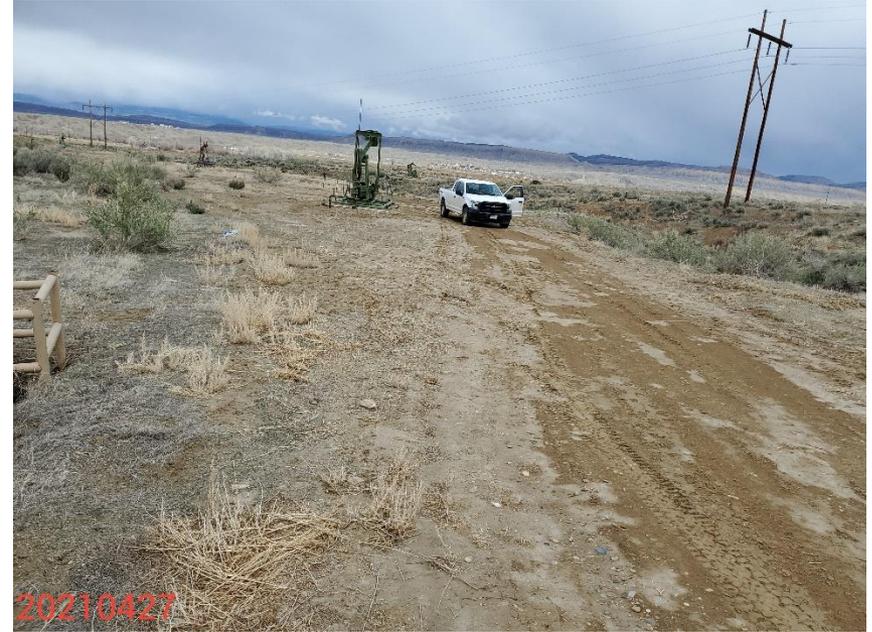
Photo 4: Photo taken from the north end of the Location, facing south. Photo shows Halogeton establishment that was observed on the interim and production areas of the Location.

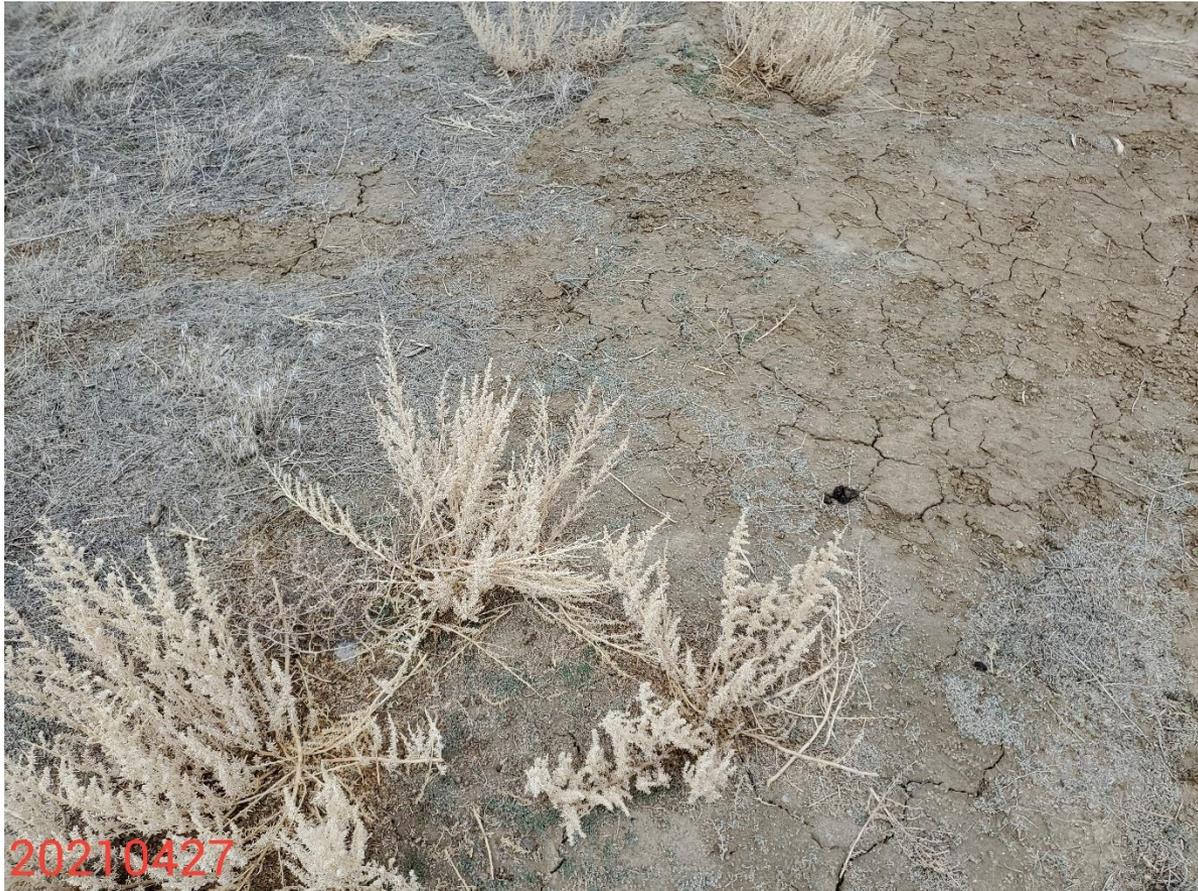
Photo 5: See comments under photo 4. Yellowed plants in lower area of photos is Halogeton that had established in the 2020 growing season. Smaller green vegetation seen in photo is germinating Halogeton plants, as well as other undesirable weedy plant species.
