Construction and Stormwater Inspection

Operator: NOBLE ENERGY INC- #100322

Location ID: 477361

Inspection Photos
Location Name: A30-01 /Pad
Location ID: 477361

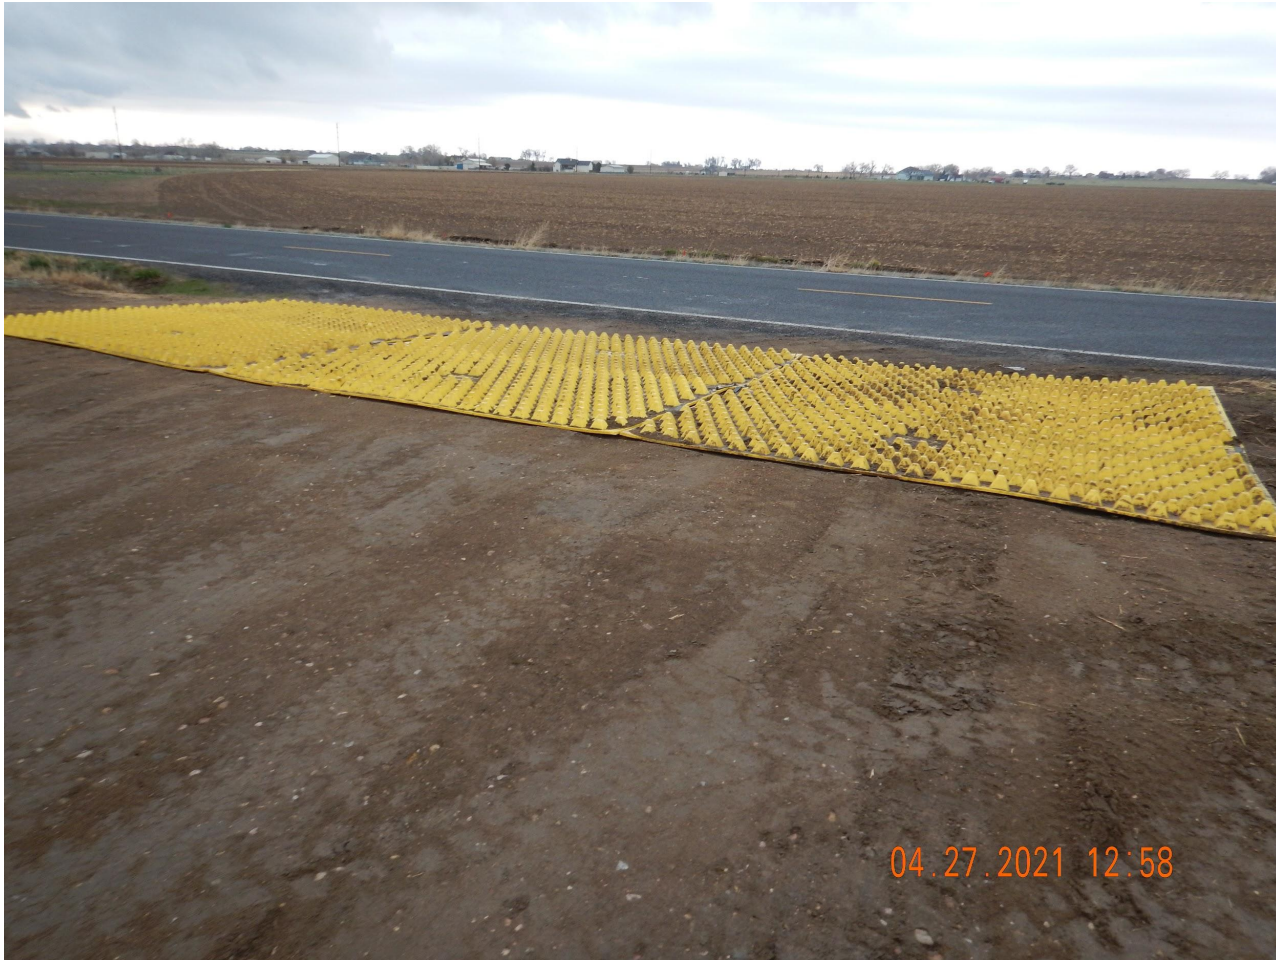
Photo 1. Photo taken from the entrance of location, facing East. Photo illustrates Operator has installed a vehicle tracking device BMP. At the time of this inspection, no vehicle track out issues were observed.

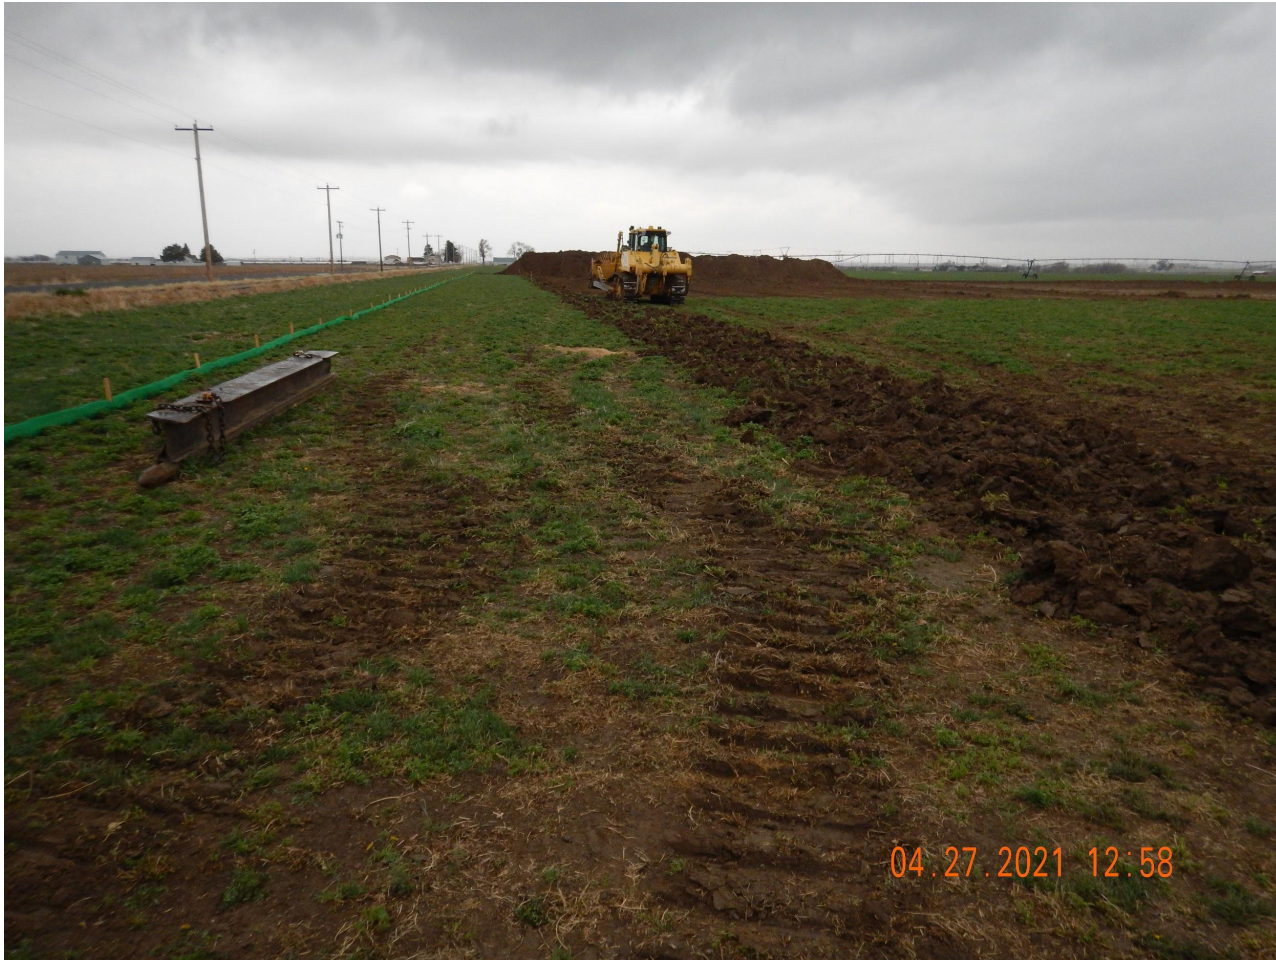
Photo 2. Photo taken from the northeastern location, facing South. Photo illustrates Operator has installed surface roughening and filter wattle BMPs around the entire perimeter of location. Topsoil is being salvaged and stored along the southern and western perimeter of the location.

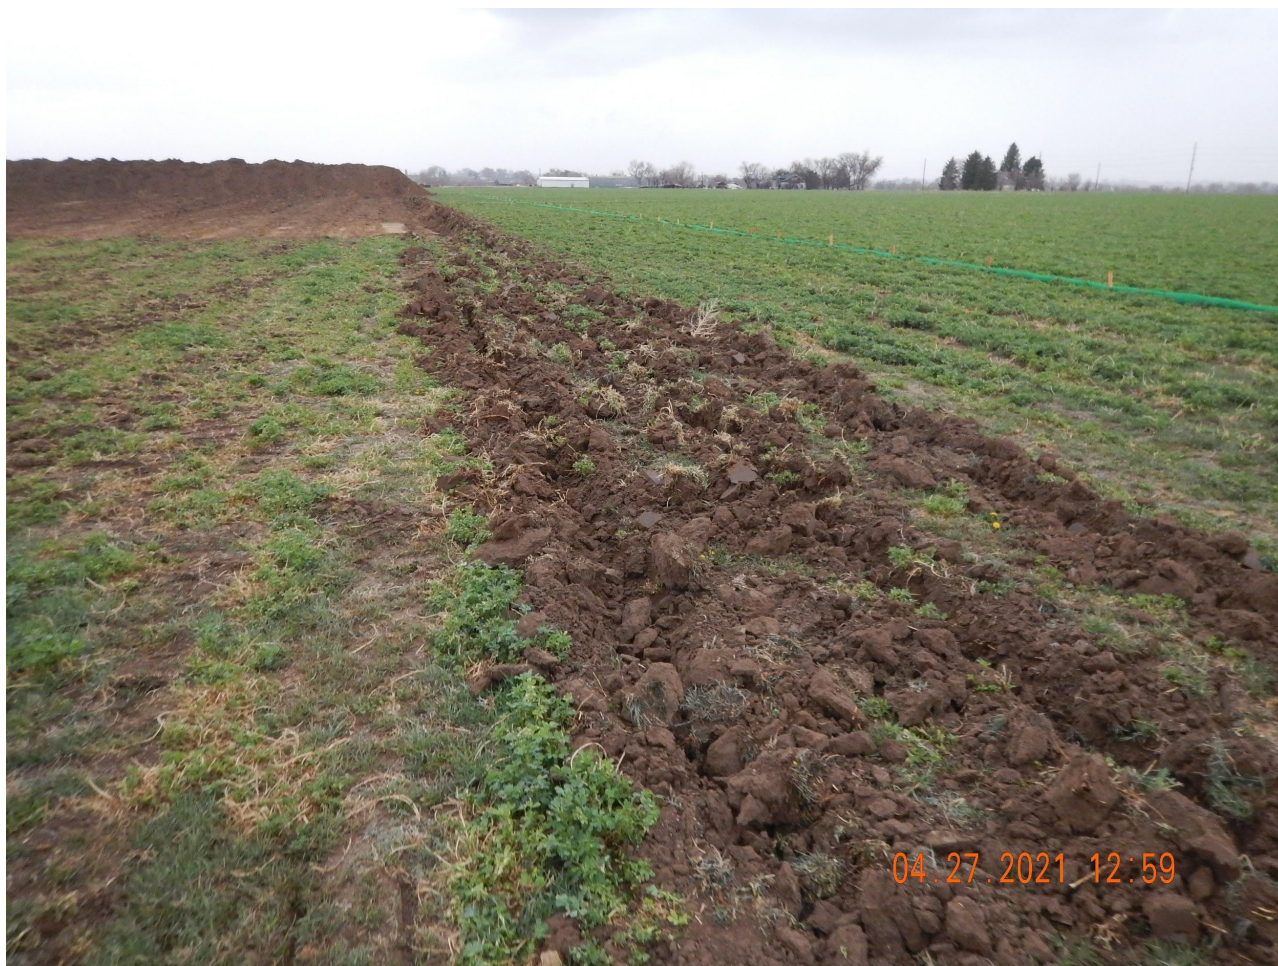
Photo 3. Photo taken from the northeastern location, facing West. See comments under Photo 2.

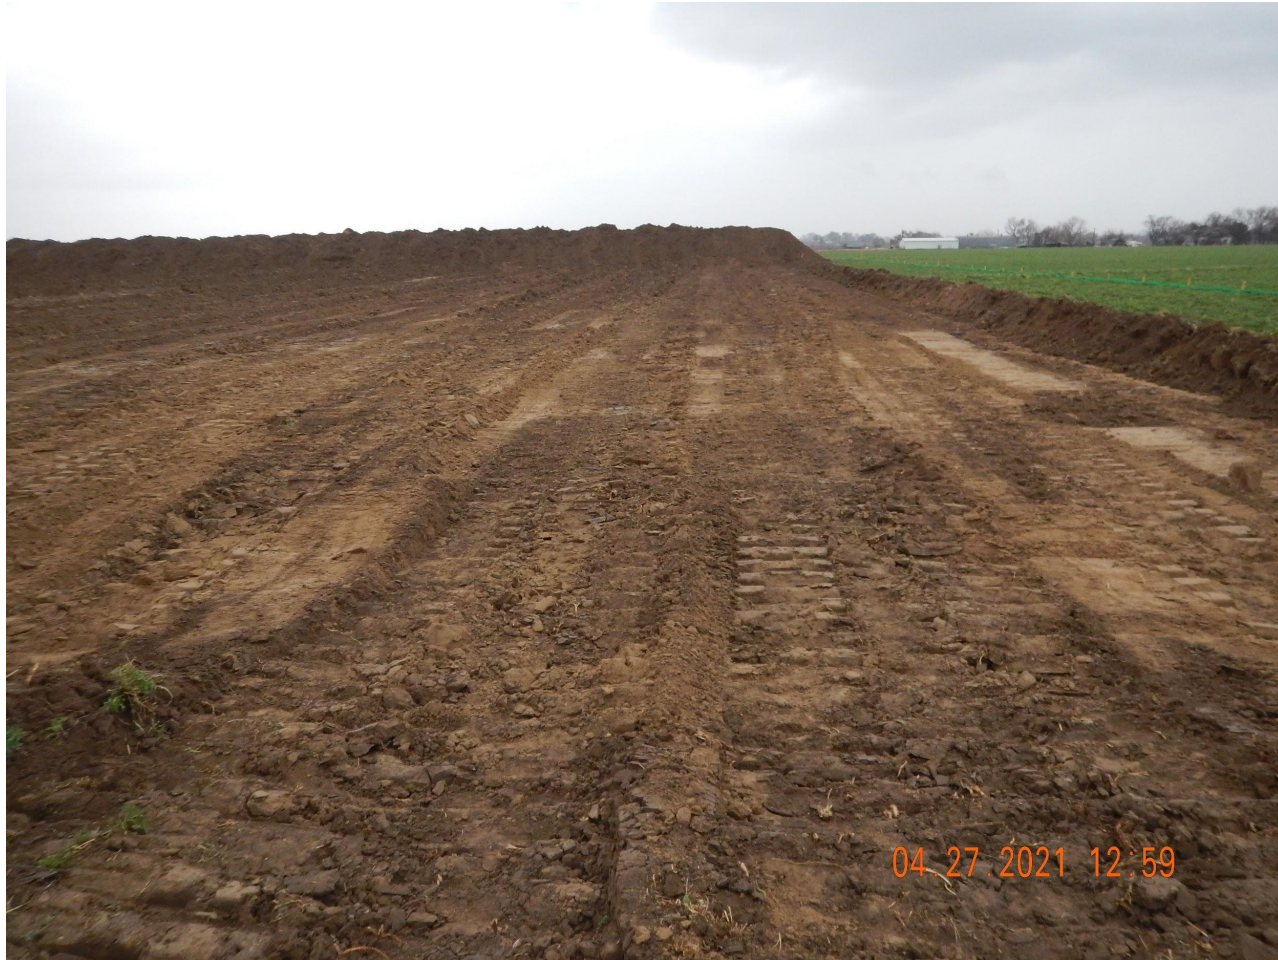
Photo 4. Photo taken from the northern location, facing West. Operator indicated that ~17.5" of topsoil was being salvaged.

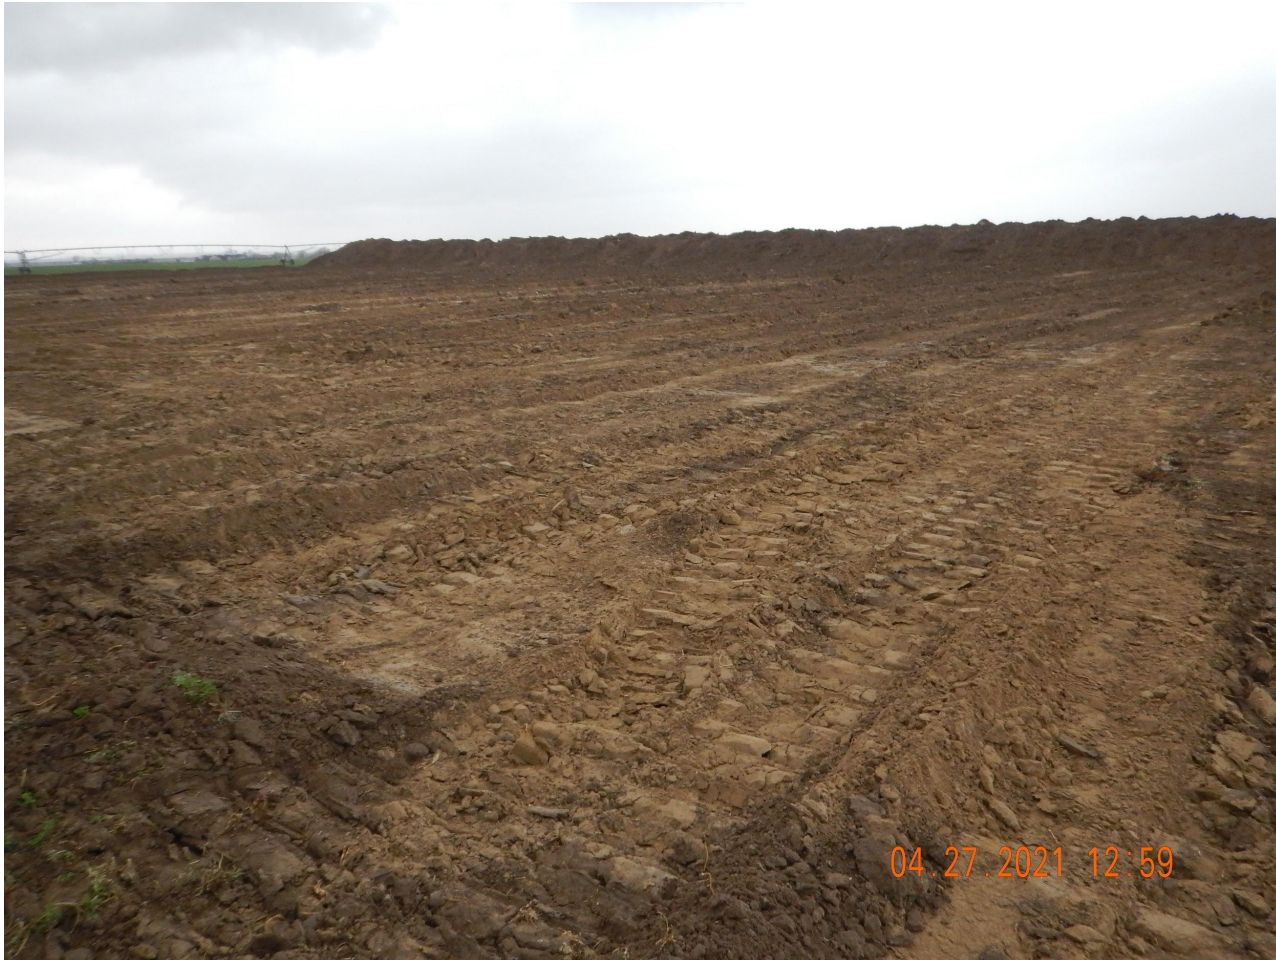
Photo 5. Photo taken from the northern location, facing Southwest. See comments under Photo 4.

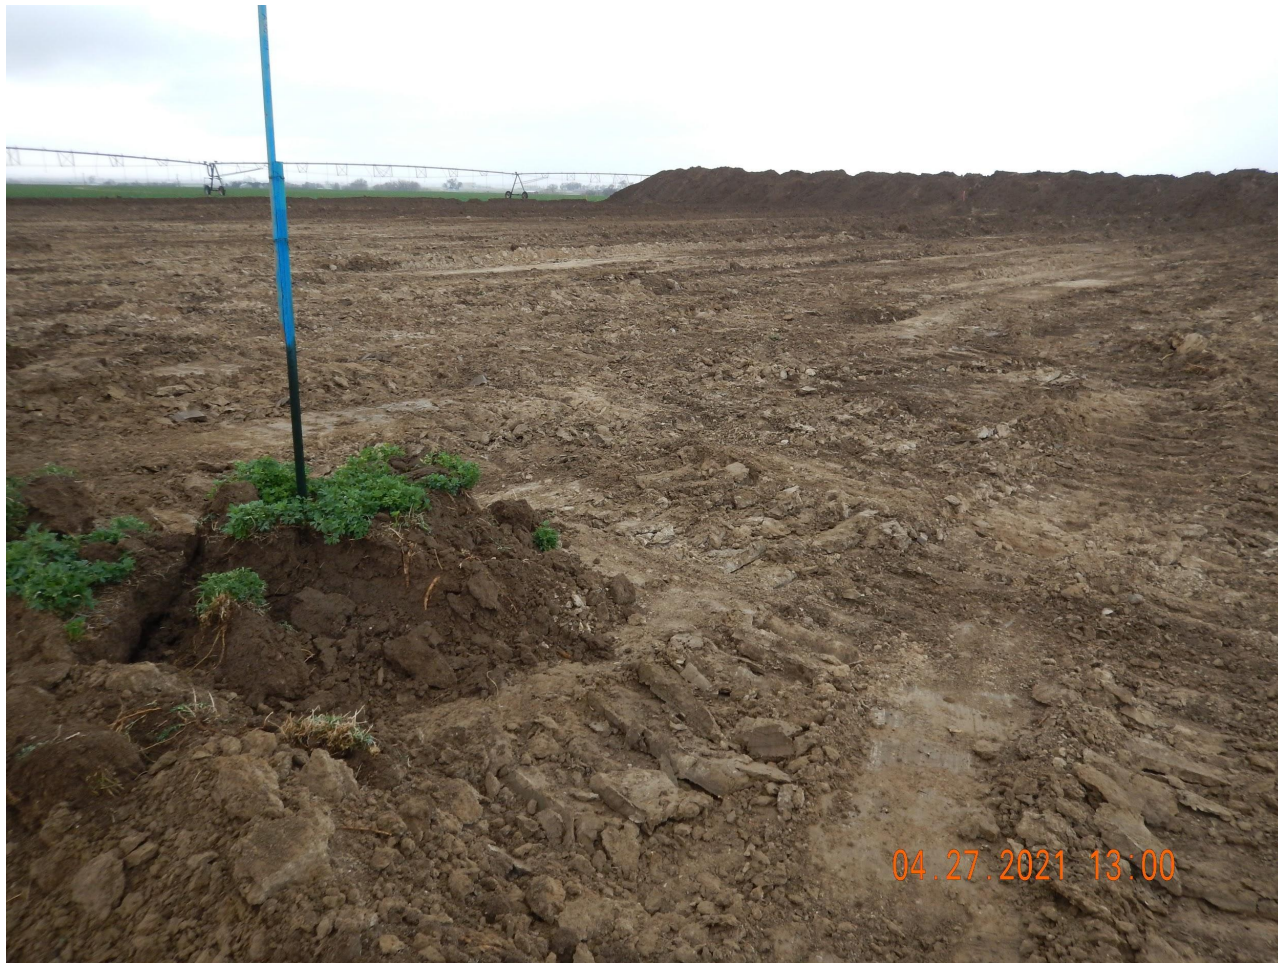
Photo 6. Photo taken from the central location, facing Southwest. See comments under Photo 4.
