Inspection Photos

4/30/2021

Operator: TEP ROCKY MOUNTAIN LLC - 96850

Location ID: 335145

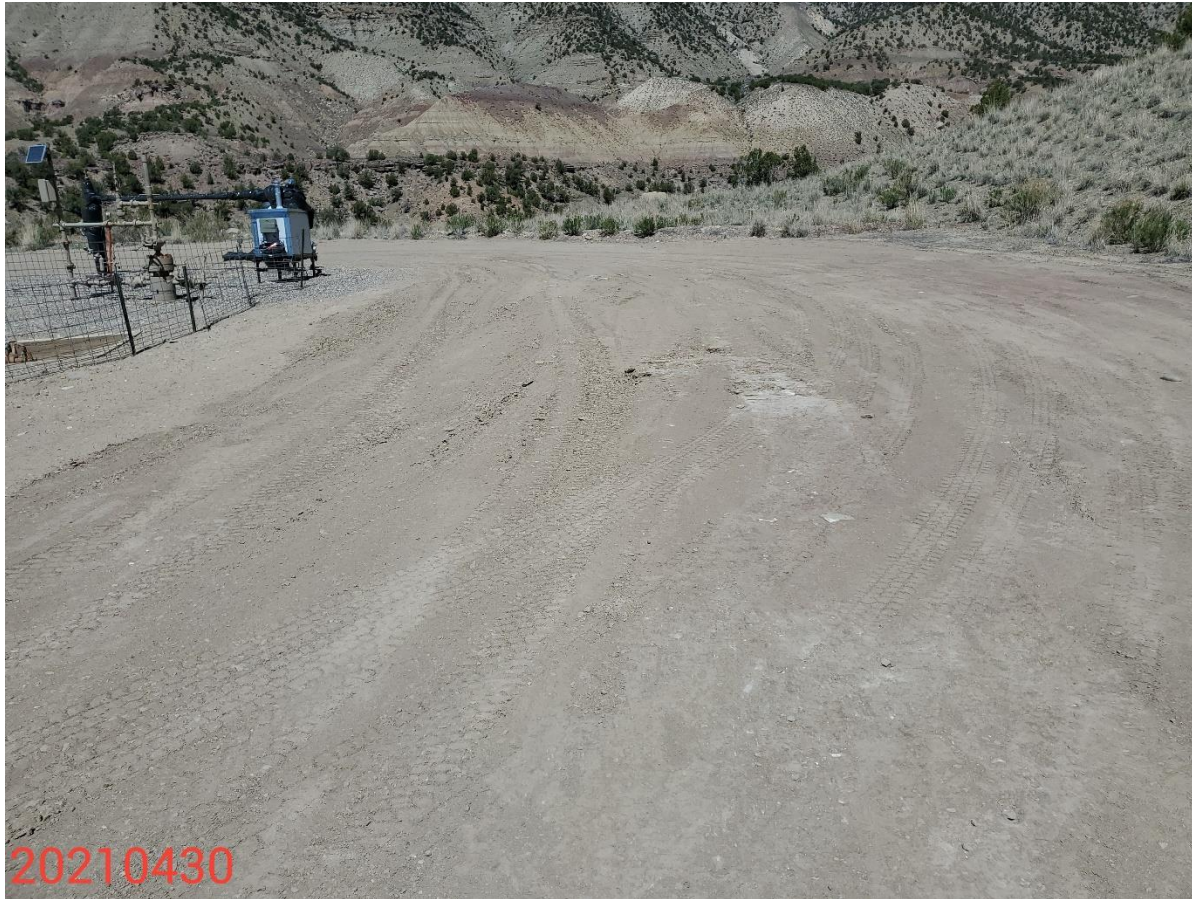
Photo 1: Photo taken from the northeast corner of the Location, facing northwest. Previous inspection observed that control measures to stabilize/protect unpaved areas. Photo shows Operator has regraded the production areas, however control measures to stabilize/protect pad and prevent offsite sediment transport during wet conditions remain missing or insufficient.

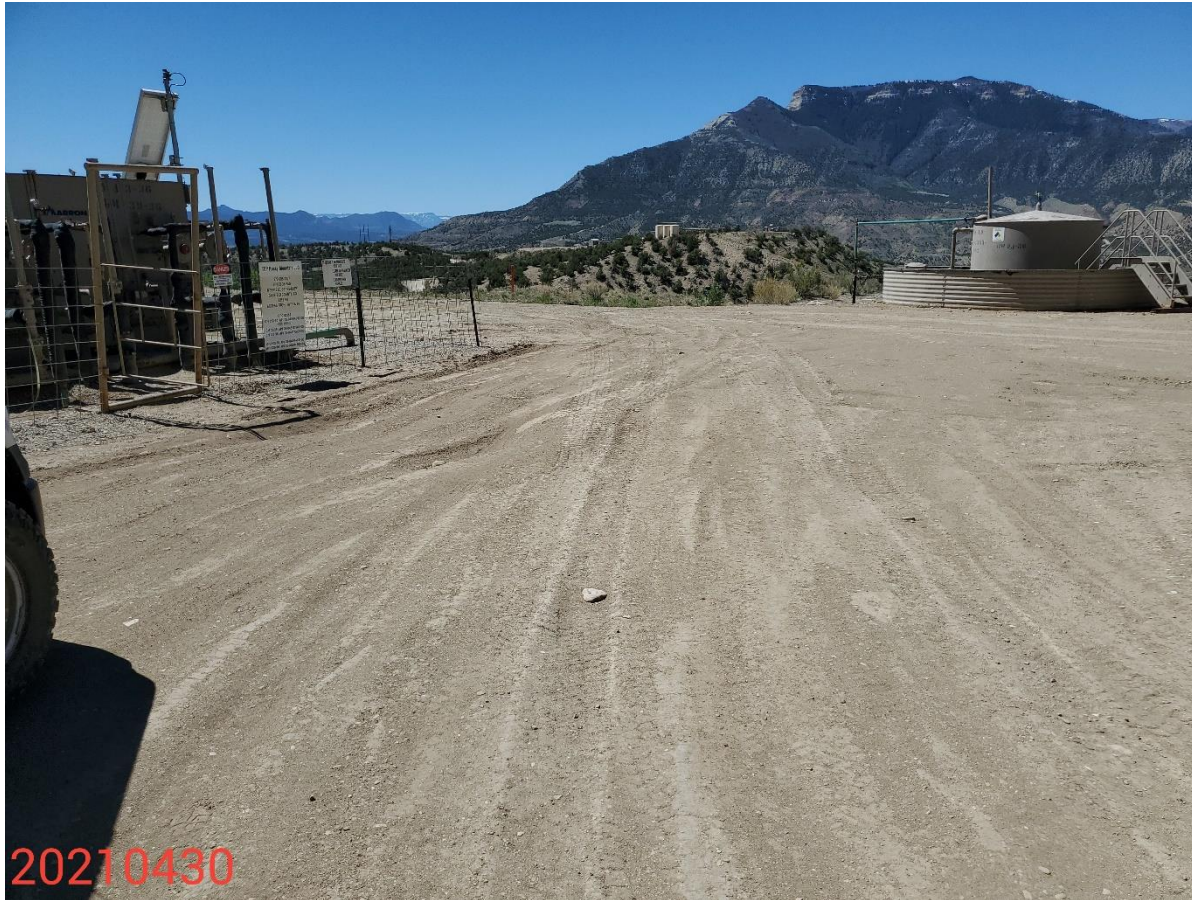
Photo 2: Photo taken from the northeast corner of the Location, facing south. Previous inspection observed that control measures to stabilize/protect unpaved areas. Photo shows Operator has regraded the production areas, however control measures to stabilize/protect pad and prevent offsite sediment transport during wet conditions remain missing or insufficient.

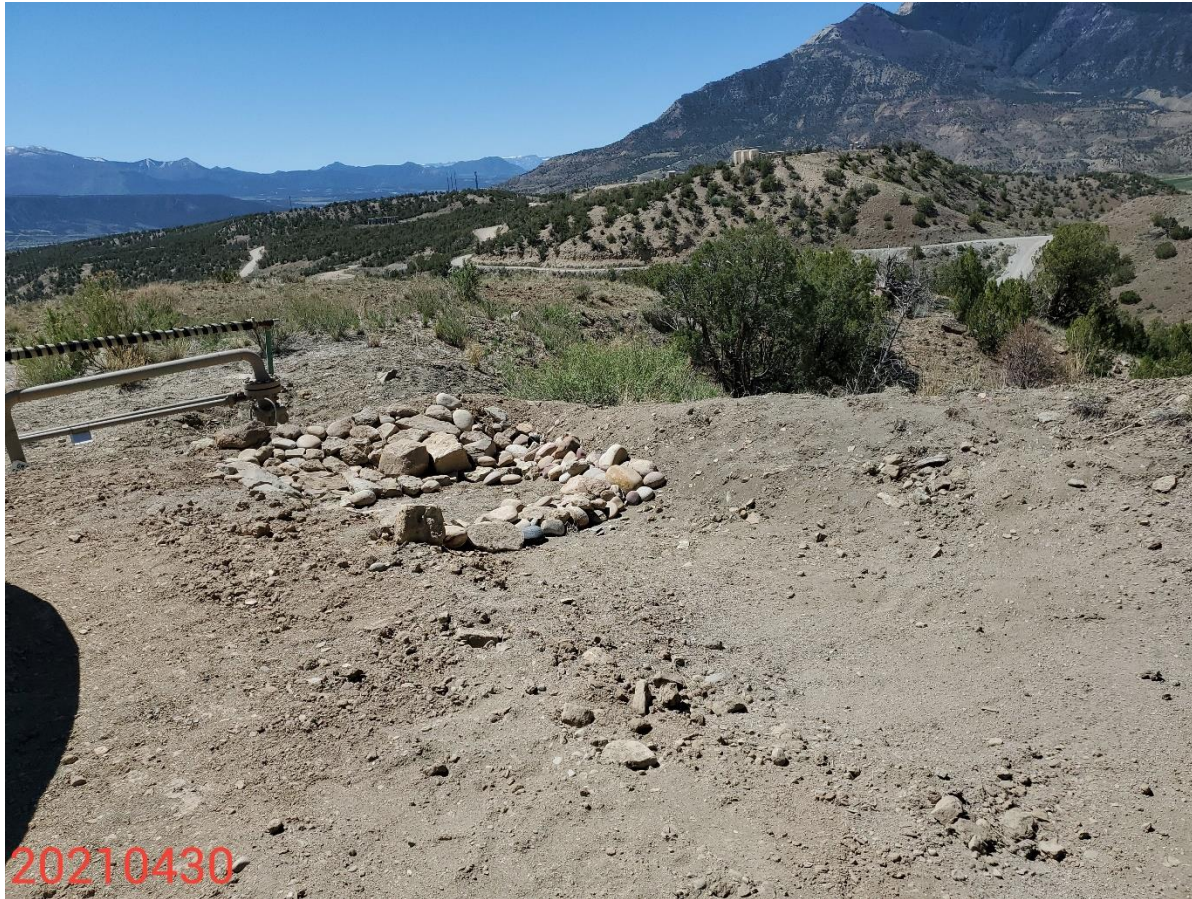
Photo 3: Photo taken from the south end of the Location, facing southwest. Photo shows Operator has installed a sediment trap and slope drain; It is unclear at time of inspection if control measures are adequate or sufficient for the site's conditions.

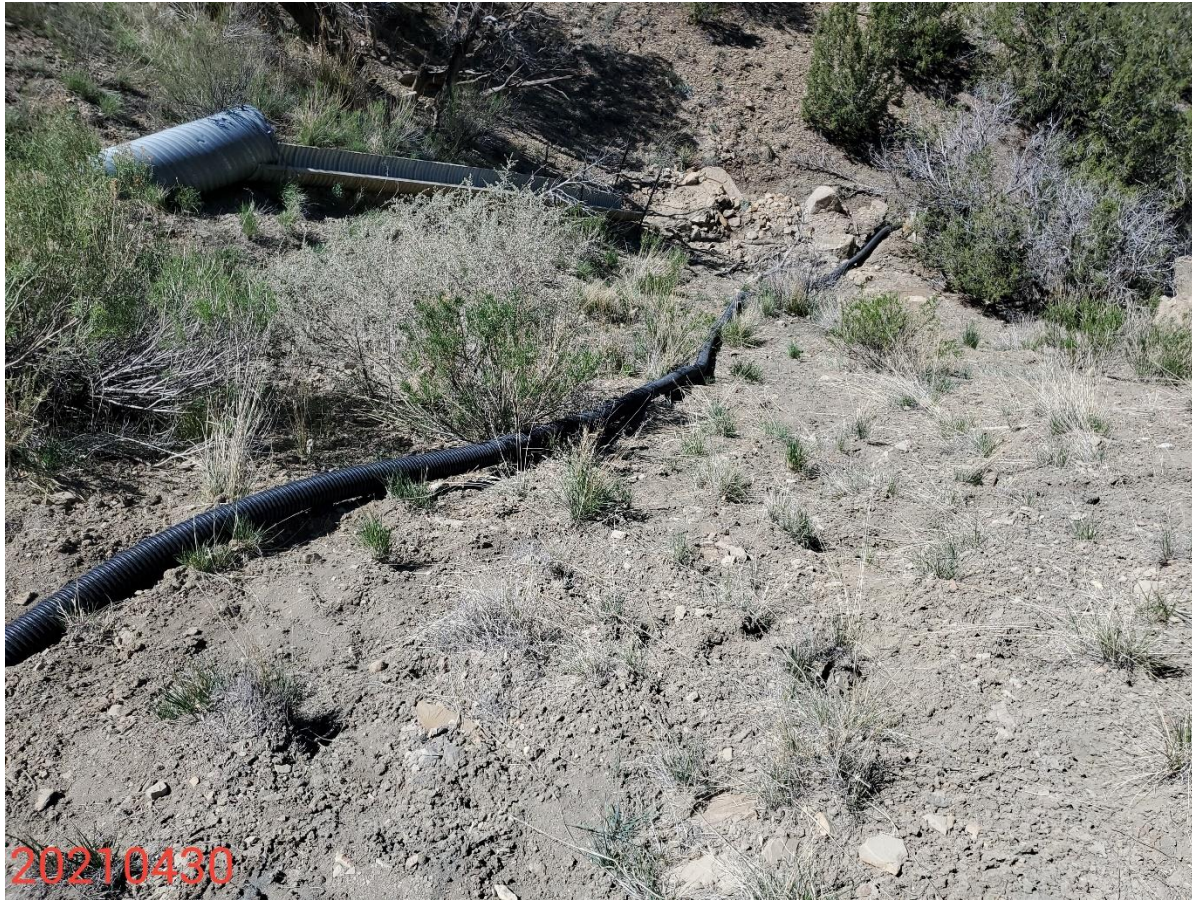
Photo 4: Photo of the slope drain. See comments under photo 3.

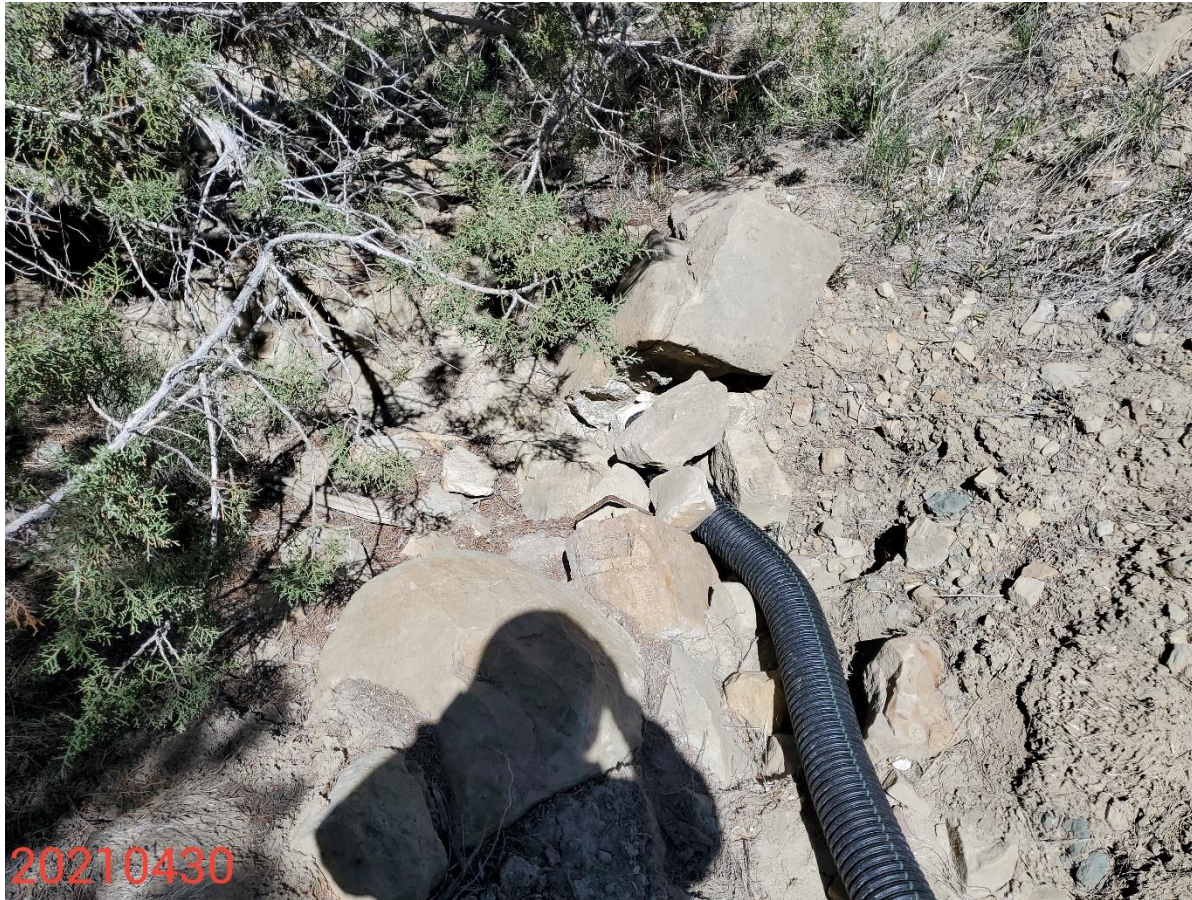
Photo 5 Photo of the slope drain outlet. See comments under photo 3.

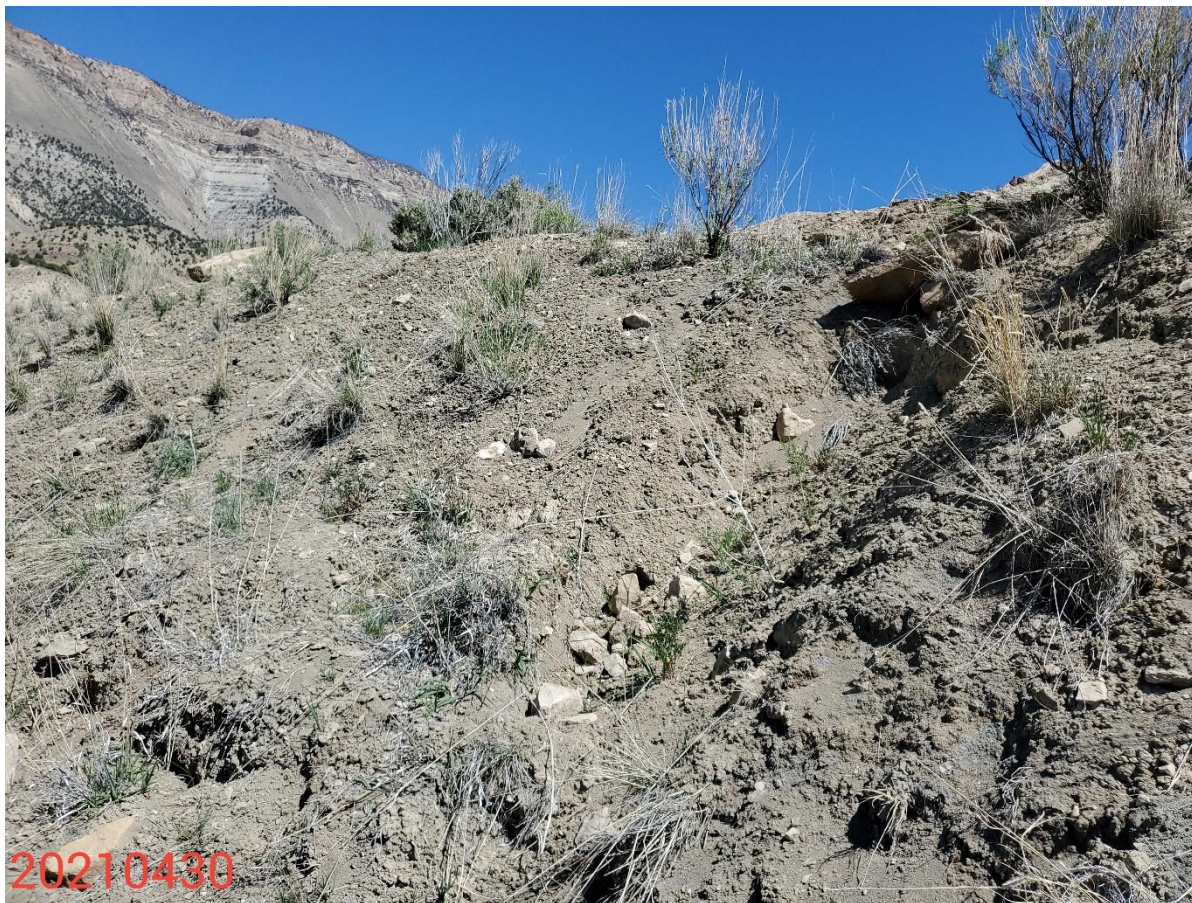
Photo 6: Photo taken from the slopes on the west end of the Location. Photo shows erosion degradation remains evident on the slopes; control measures to stabilize/protect slopes remain missing or insufficient.

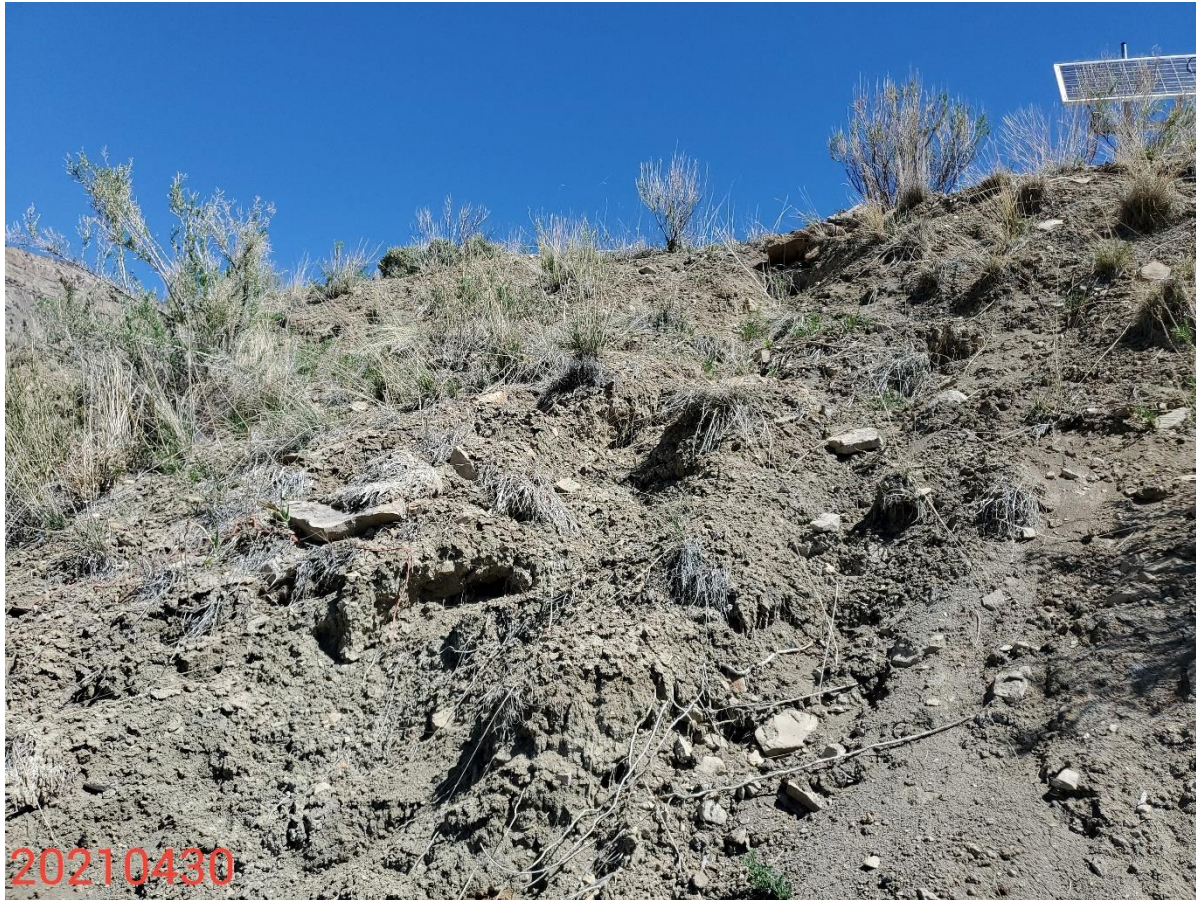
Photo 7: See comments under photo 6.

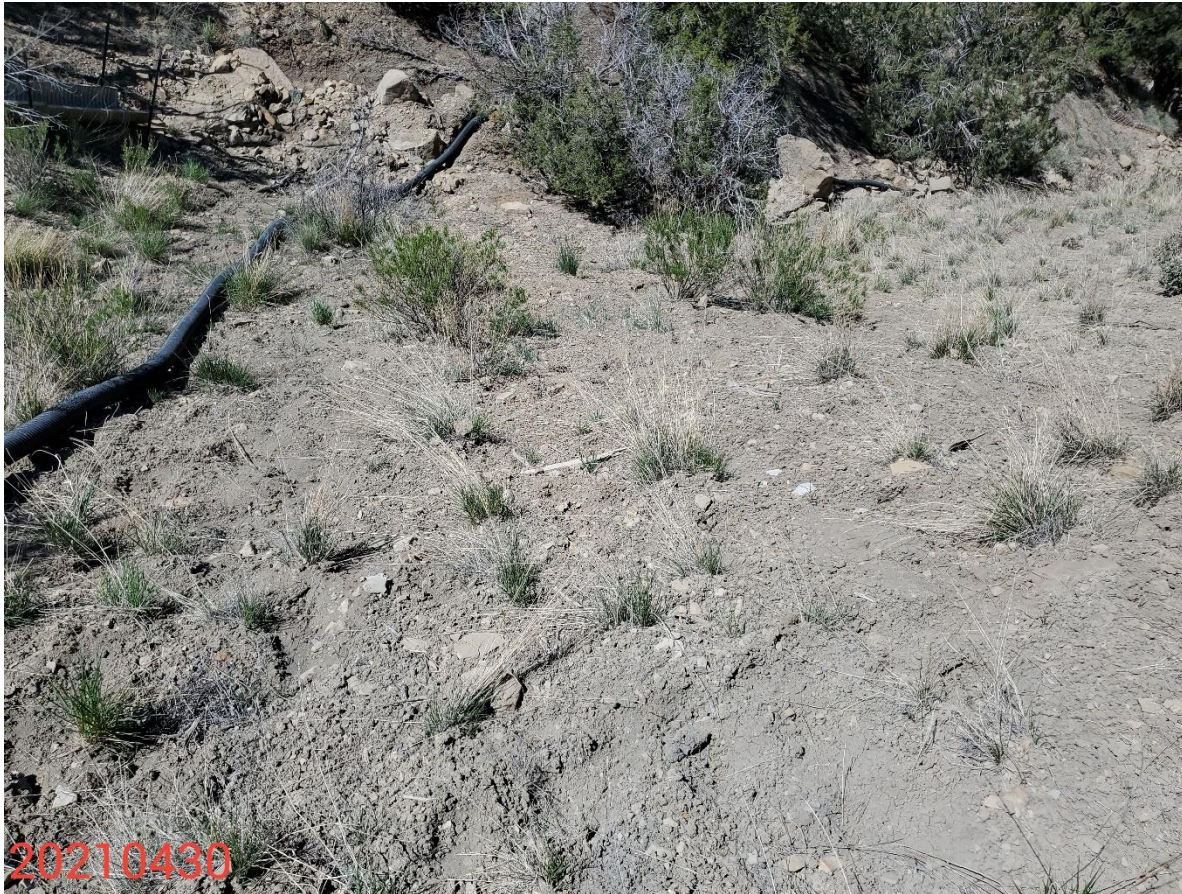
Photo 8: See comments under photo 6.
