# Inspection Photos

API: 071-06128

Operator: OGRIS OPERATING LLC

Inspection Date: 5/17/2021

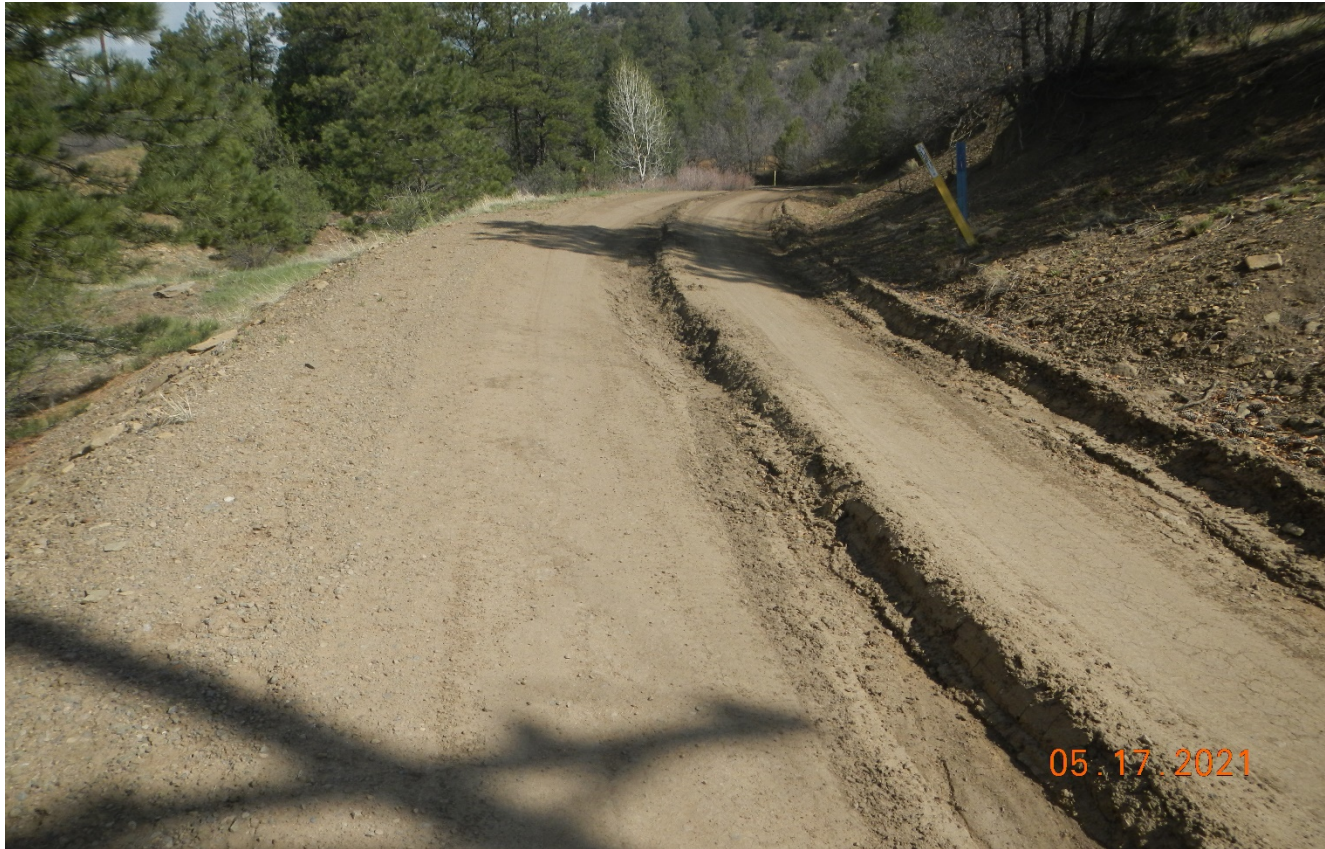
**Photo 1.** There is vehicle rutting along the main road. Areas of rutting need to be stabilized.

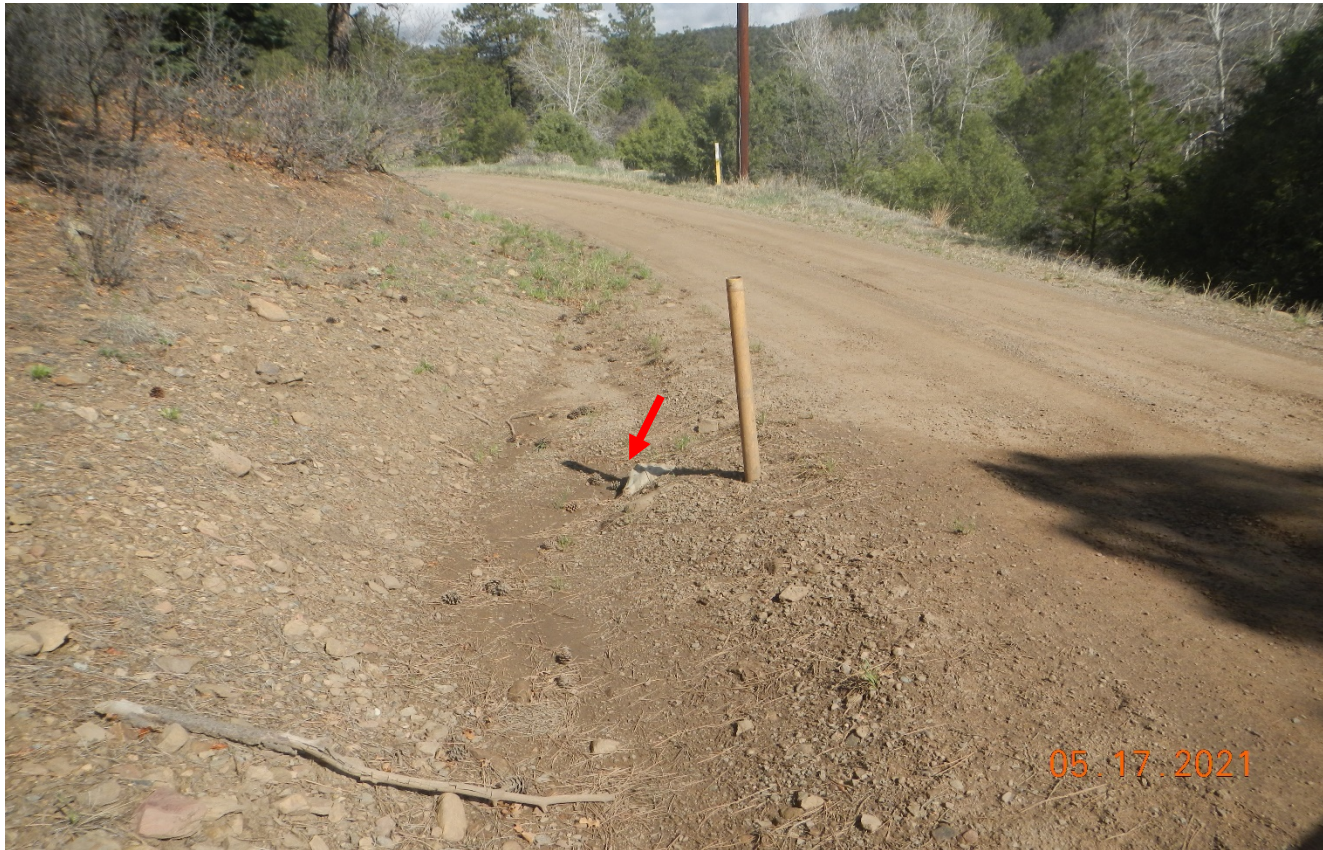
**Photo 2.** There is a plugged culvert along the main road (red arrow). Previous corrective action was not performed.

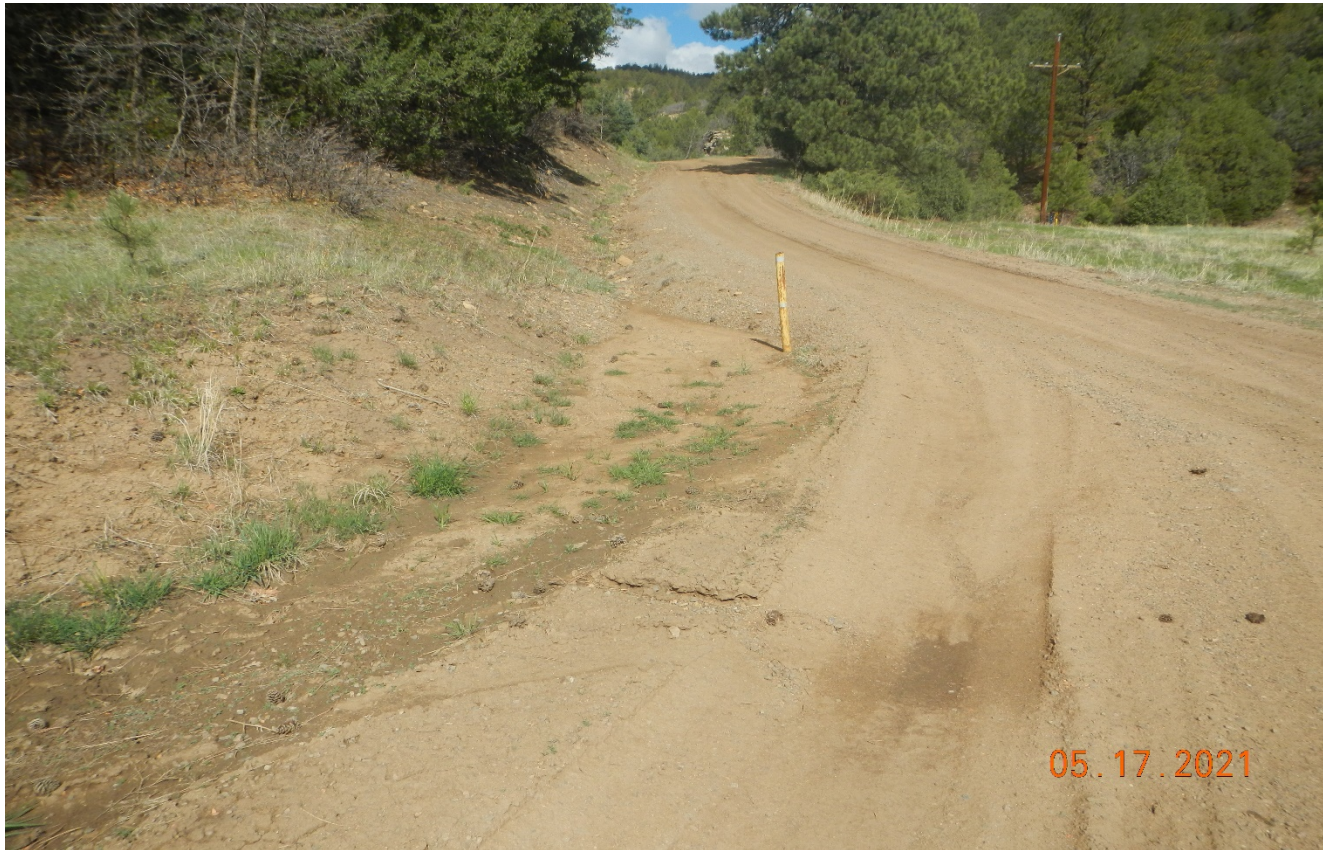
**Photo 3.** The culvert is filled in with sediment causing stormwater to flow down the road. All culverts need to be maintained. Previous corrective action was not performed.

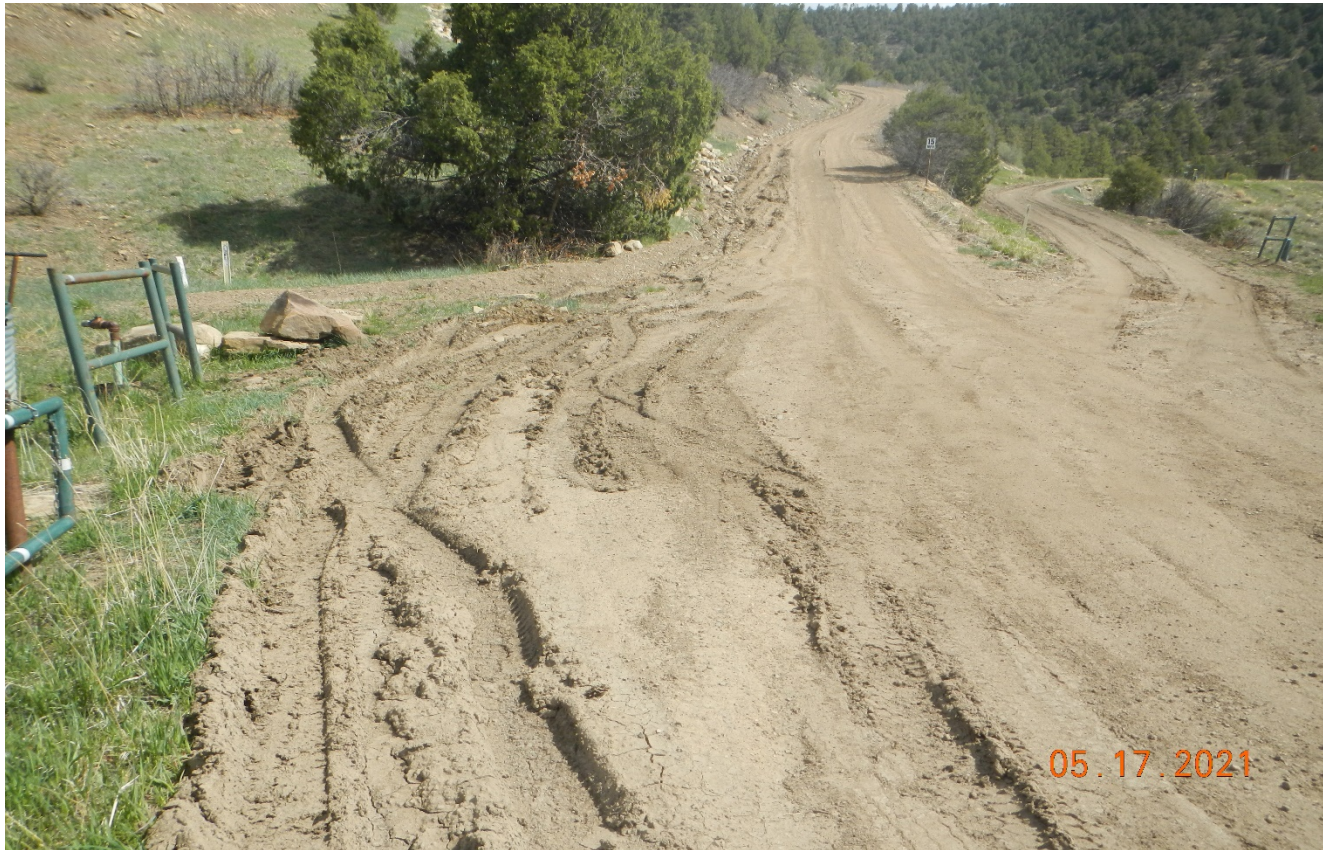
**Photo 4.** There is vehicle rutting off the side of the road., This area needs to be stabilized. BMP's are also needed along the steep grade of the road to prevent erosion.

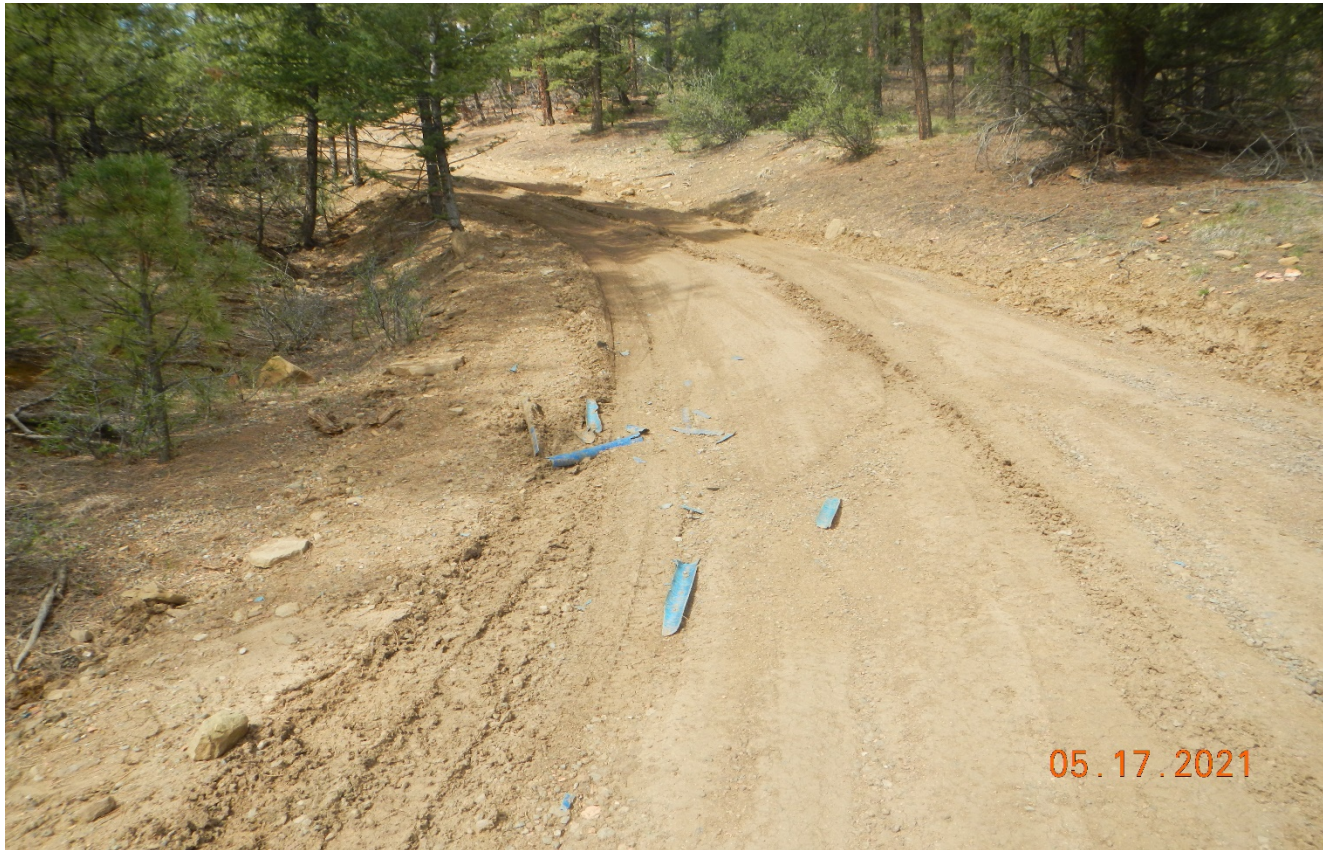
**Photo 5.** There is pieces of blue pipe laying on the road. This debris needs to be disposed.

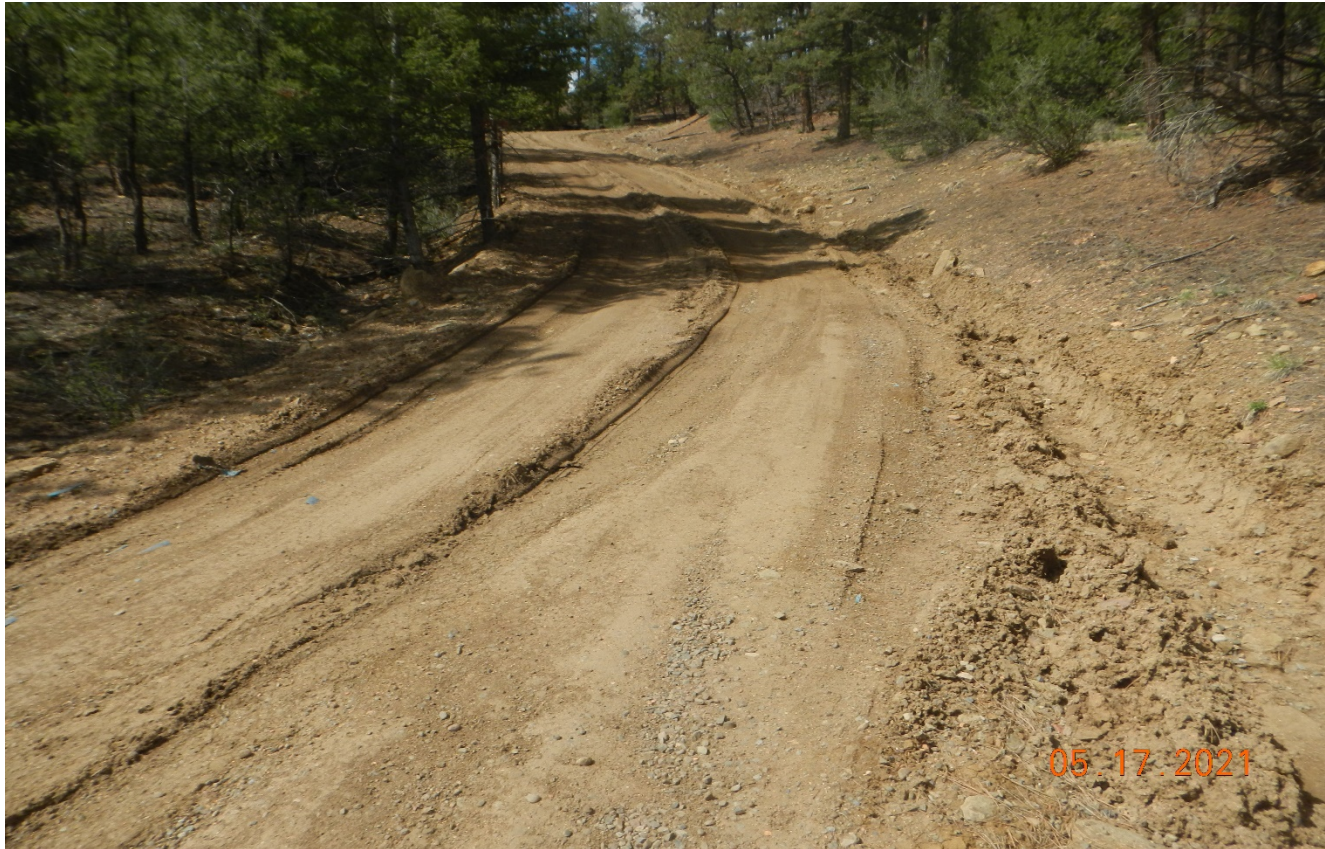
**Photo 6.** The vehicle rutting has not been repaired since previous inspection. Areas of the road are not stabilized and susceptible to further erosion.

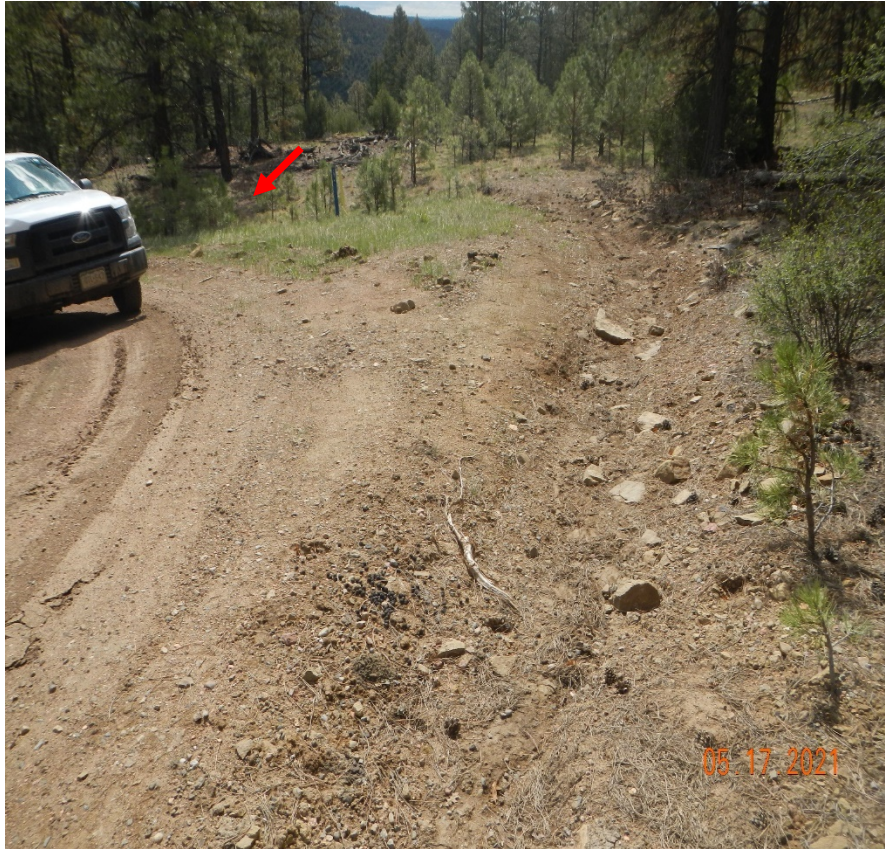
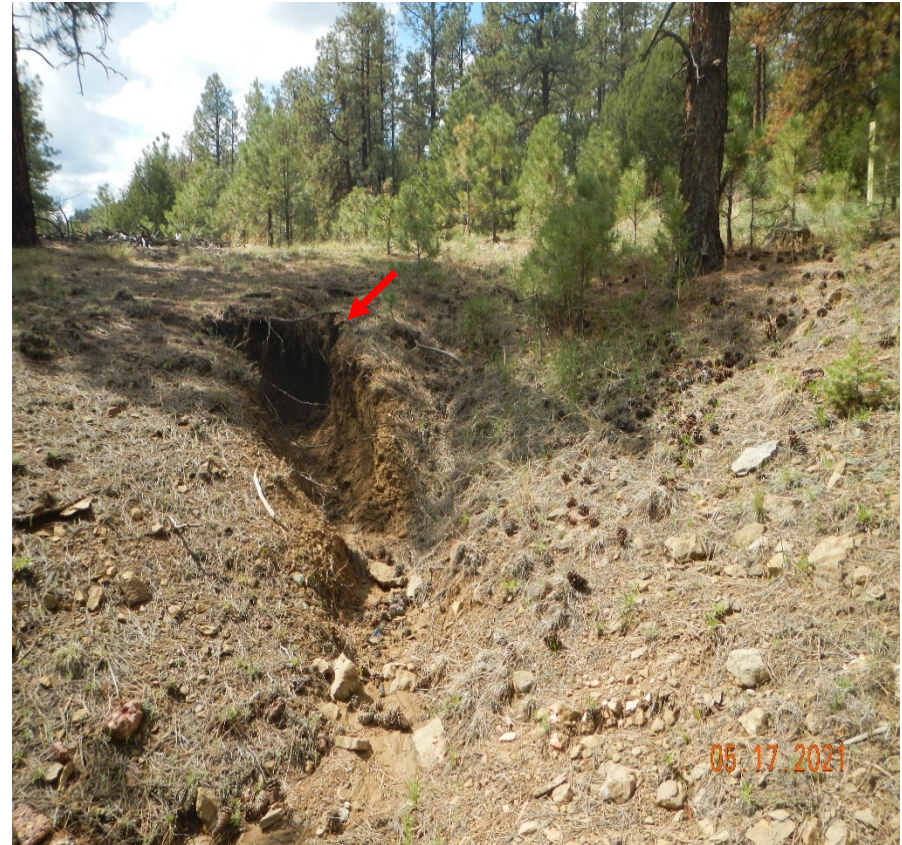
**Photo 7.** Stormwater directed from the road has caused a washout at area shown at red arrows.  
Lat/Long:37.09432,-104.94607
