Inspection Photos

5/14/2021

Operator: TEP ROCKY MOUNTAIN LLC - 96850

Location ID: 452055

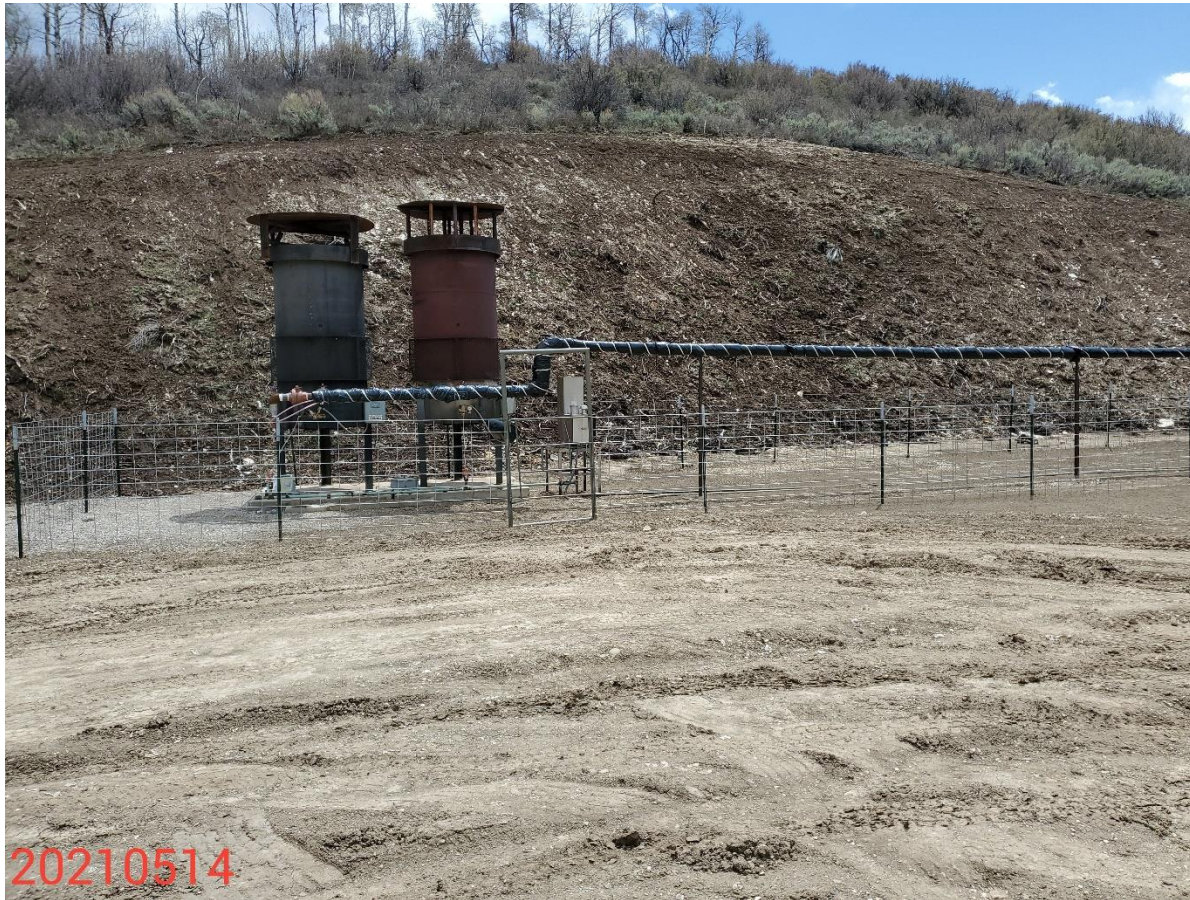
Photo 1: Photo taken from the north end of the Location, facing east. Photos 1-4 provide an overview of the production area from east, south, southwest to west.

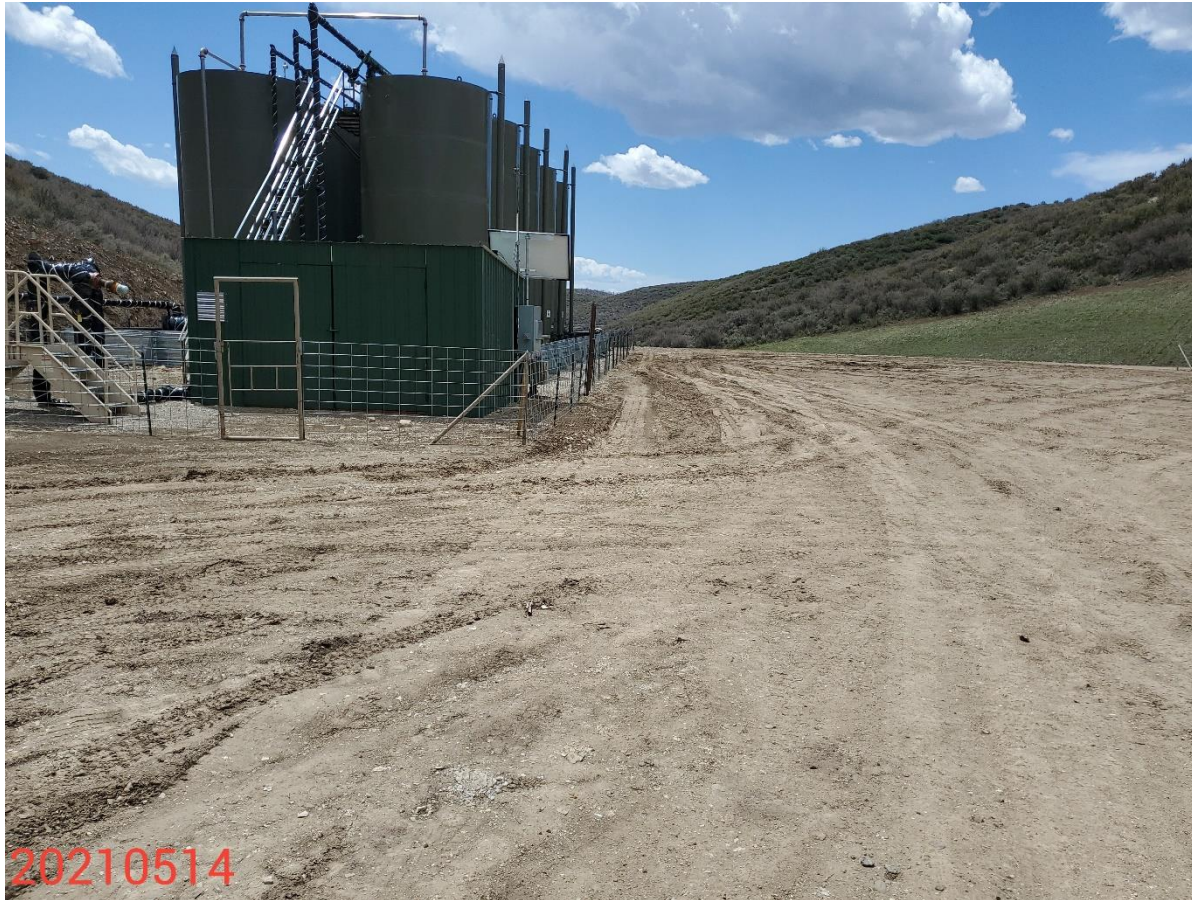
Photo 2: See comments under photo 1.

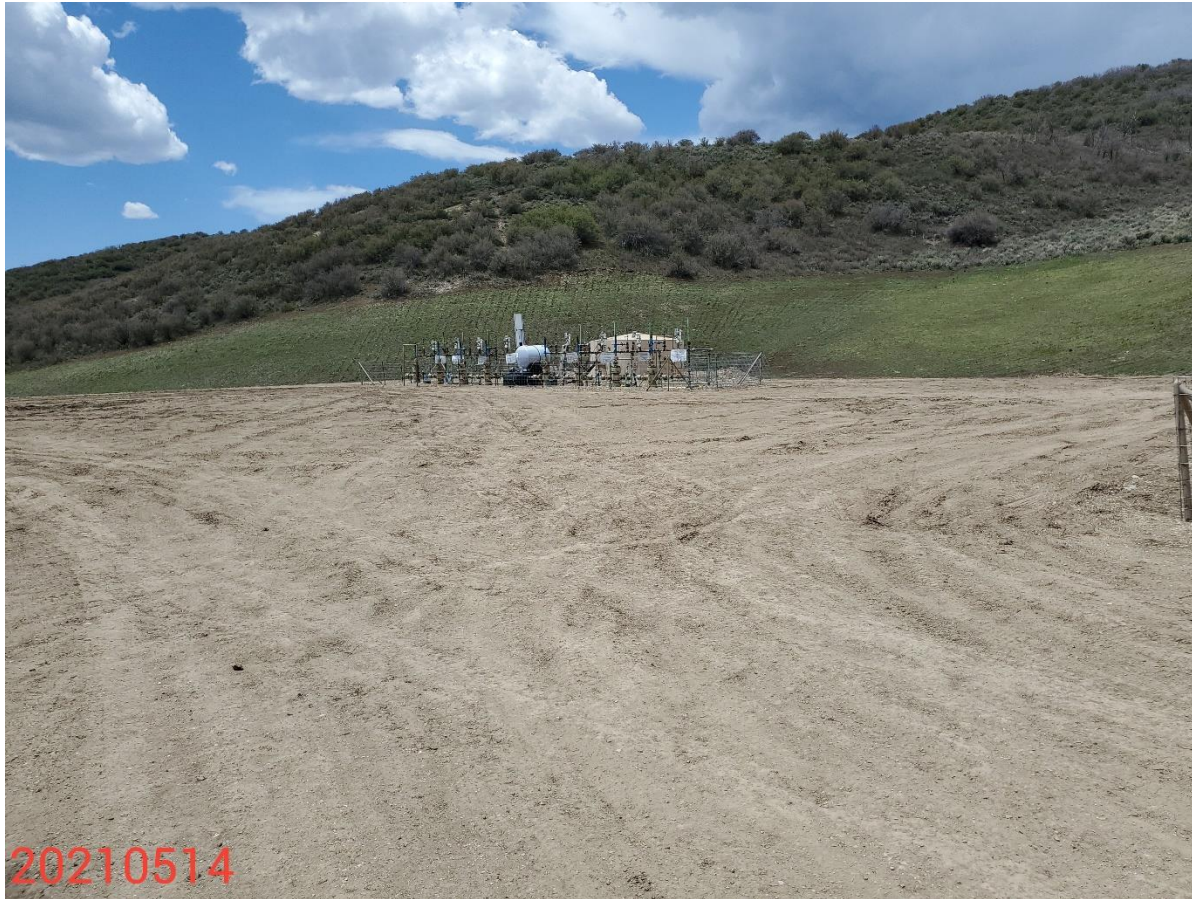
Photo 3: See comments under photo 1.

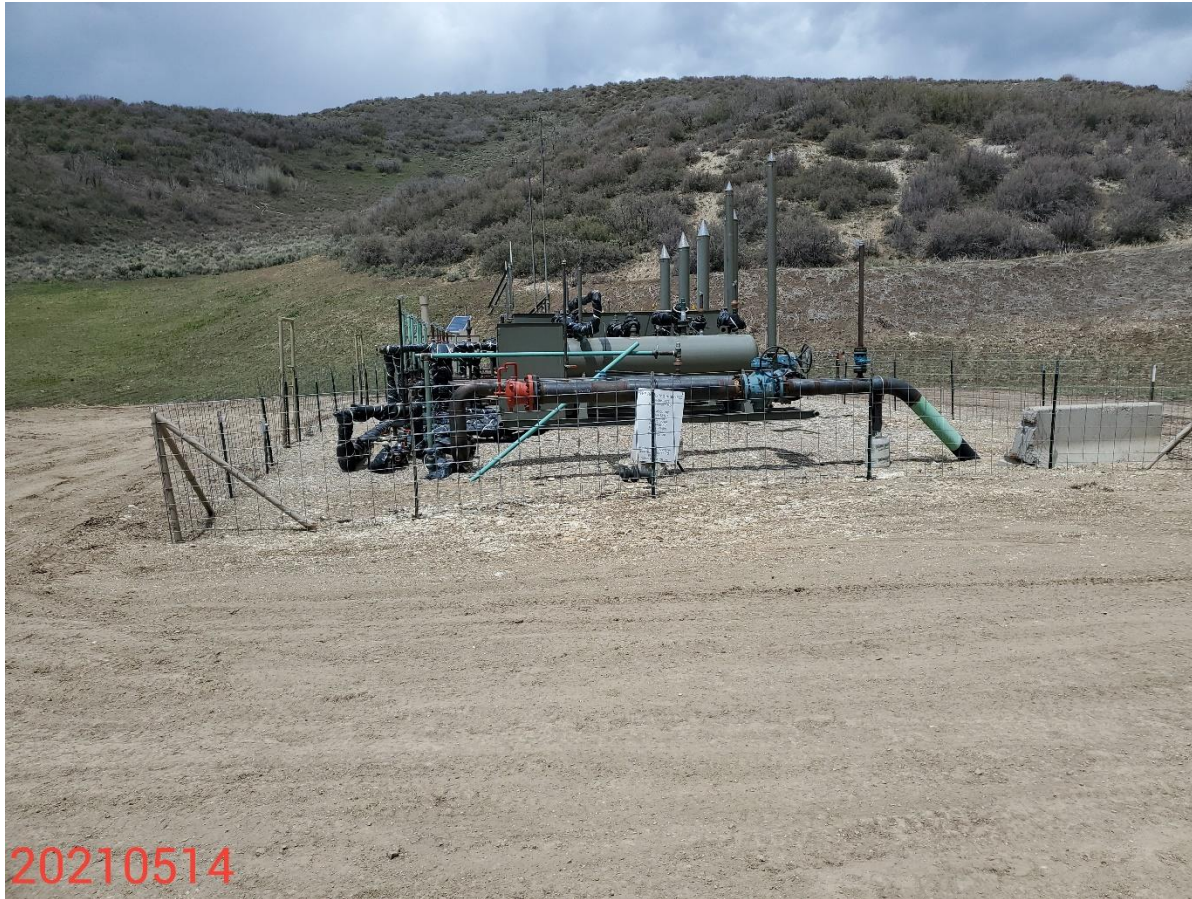
Photo 4: See comments under photo 1.

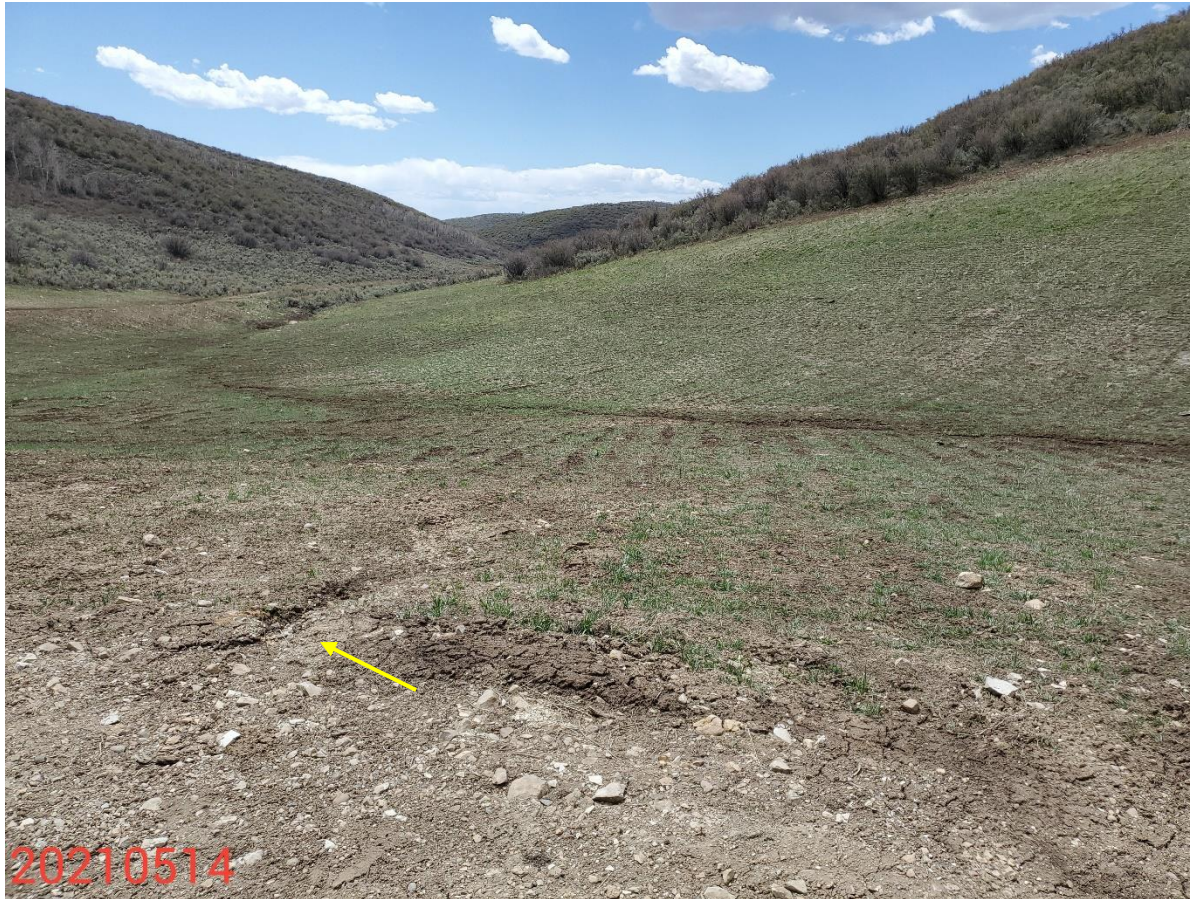
Photo 5: Photo taken from the interim areas on the south end of the Location, facing south. Interim reclamation in process. Photo also shows rill erosion becoming evident on the south end of the Location. BMPs to manage stormwater runoff from the Location, and to protect/stabilize slopes missing or insufficient.

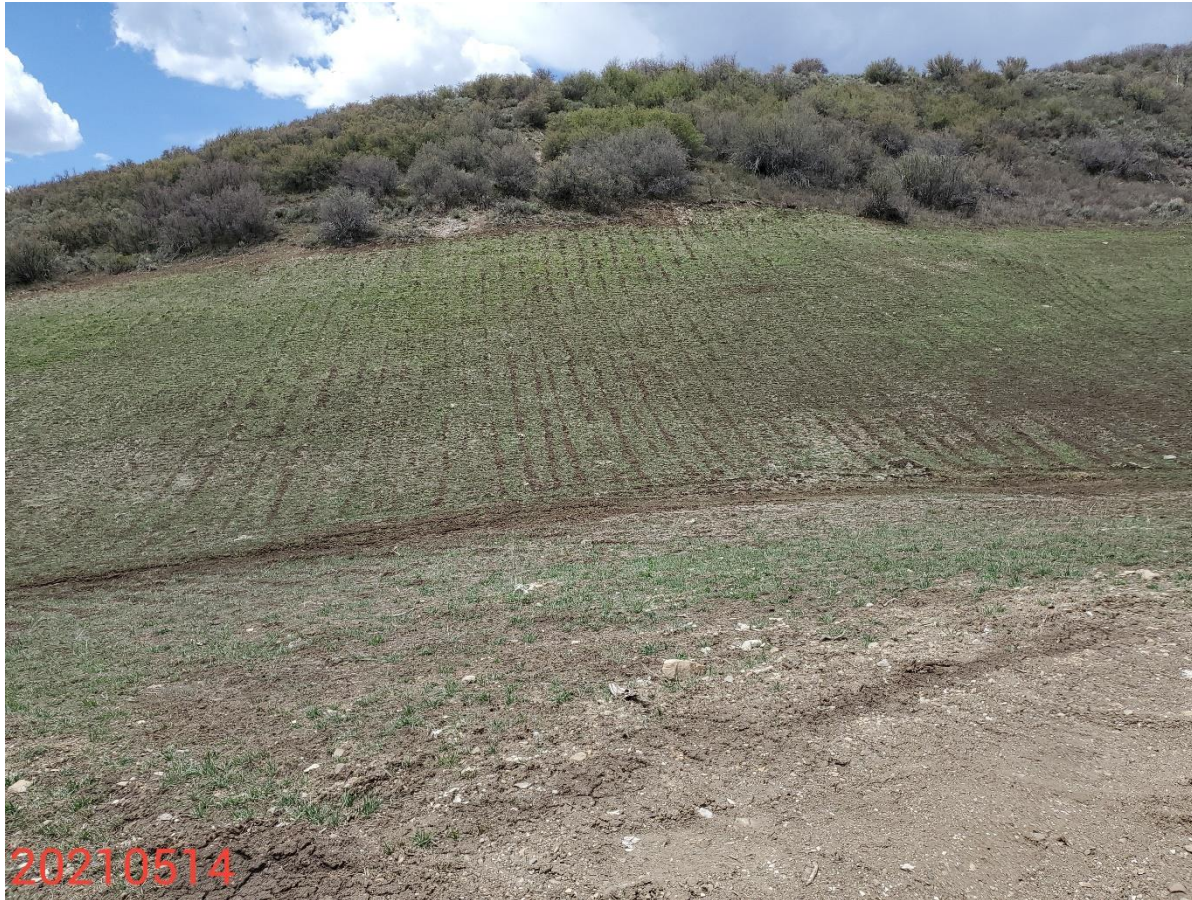
Photo 6: Photo taken from the interim areas on the southwest end of the Location, facing west. Interim reclamation in process.

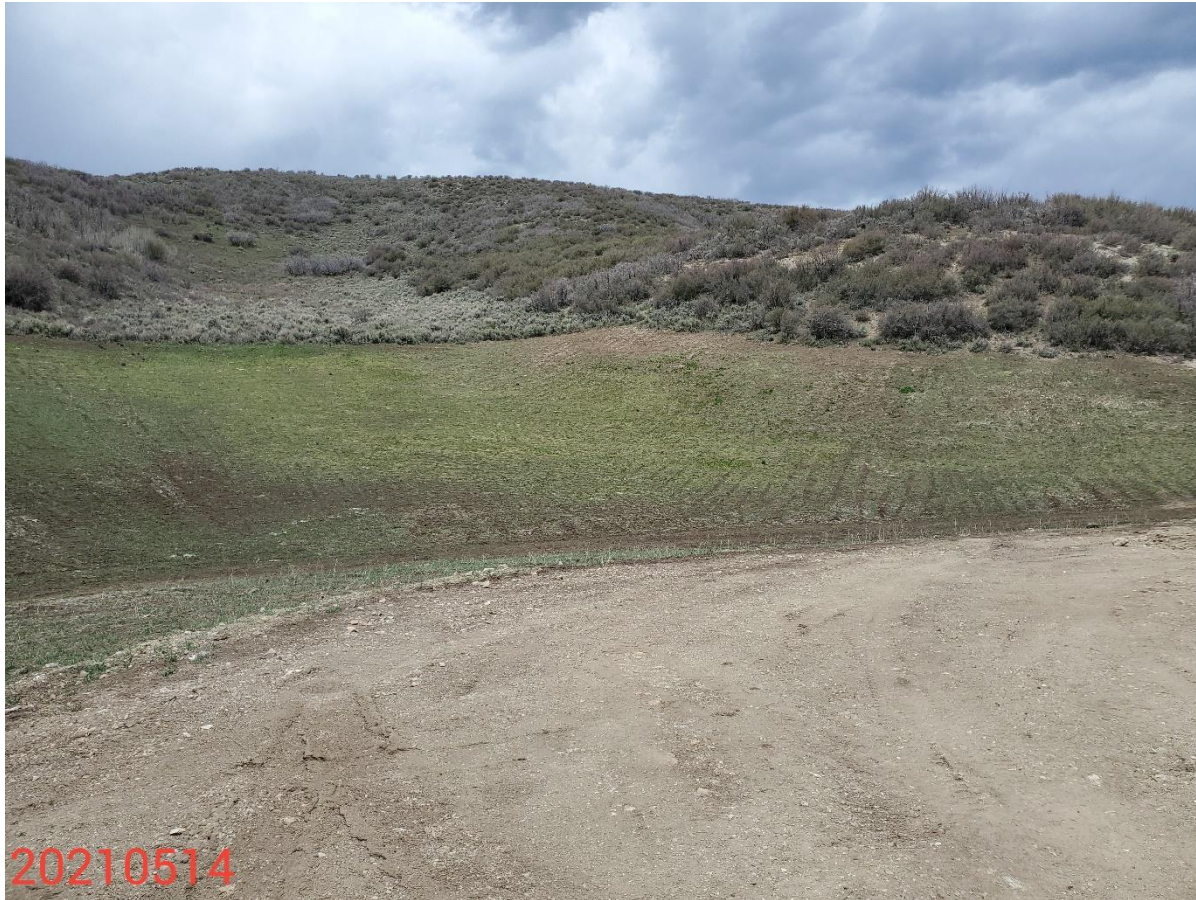
Photo 7: Photo taken from the interim areas on the southwest end of the Location, facing northwest. Interim reclamation in process.

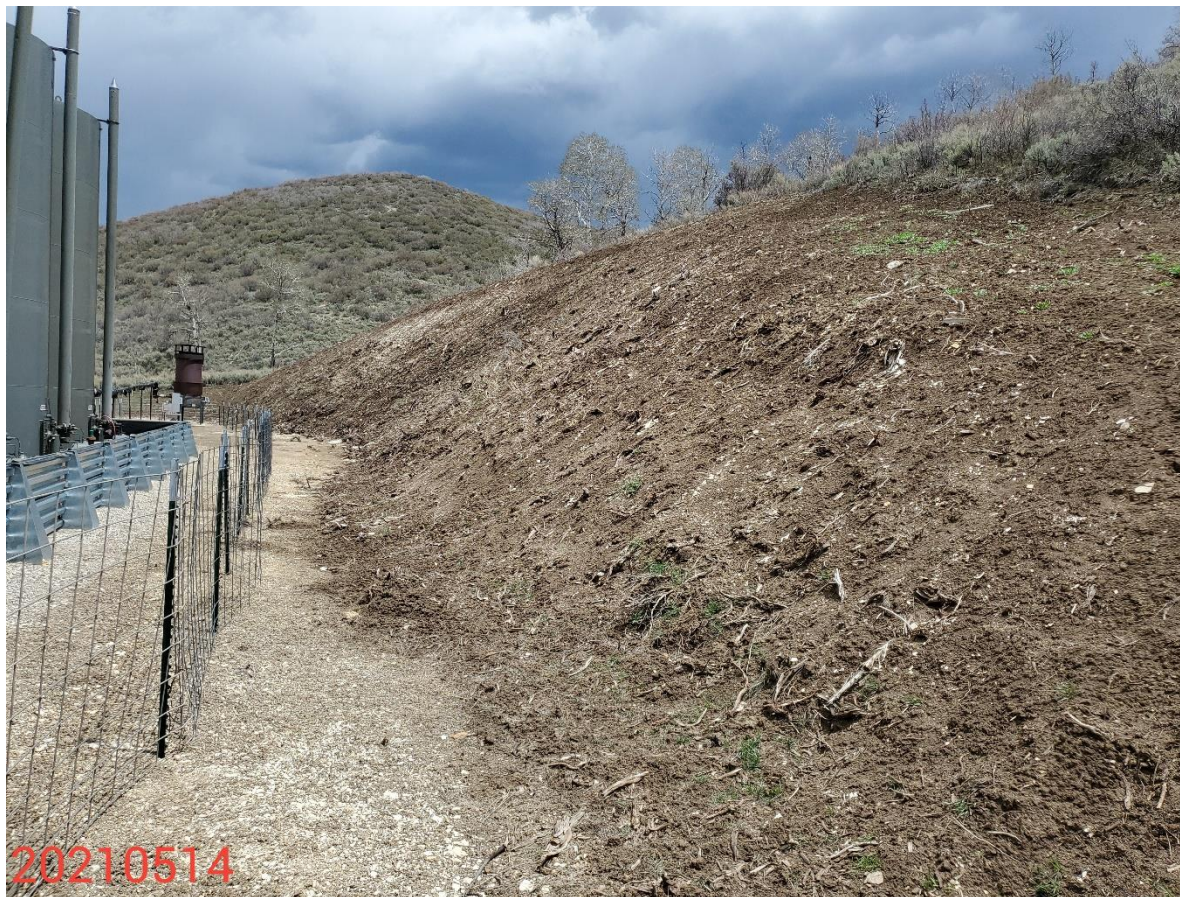
Photo 8: Photo taken from the cut slopes on the east end of the Location. Operator appears to have previously installed a hydromulch to the cut slopes; BMP is no longer in proper functioning condition; control measures to protect/stabilize cut slopes missing or insufficient.

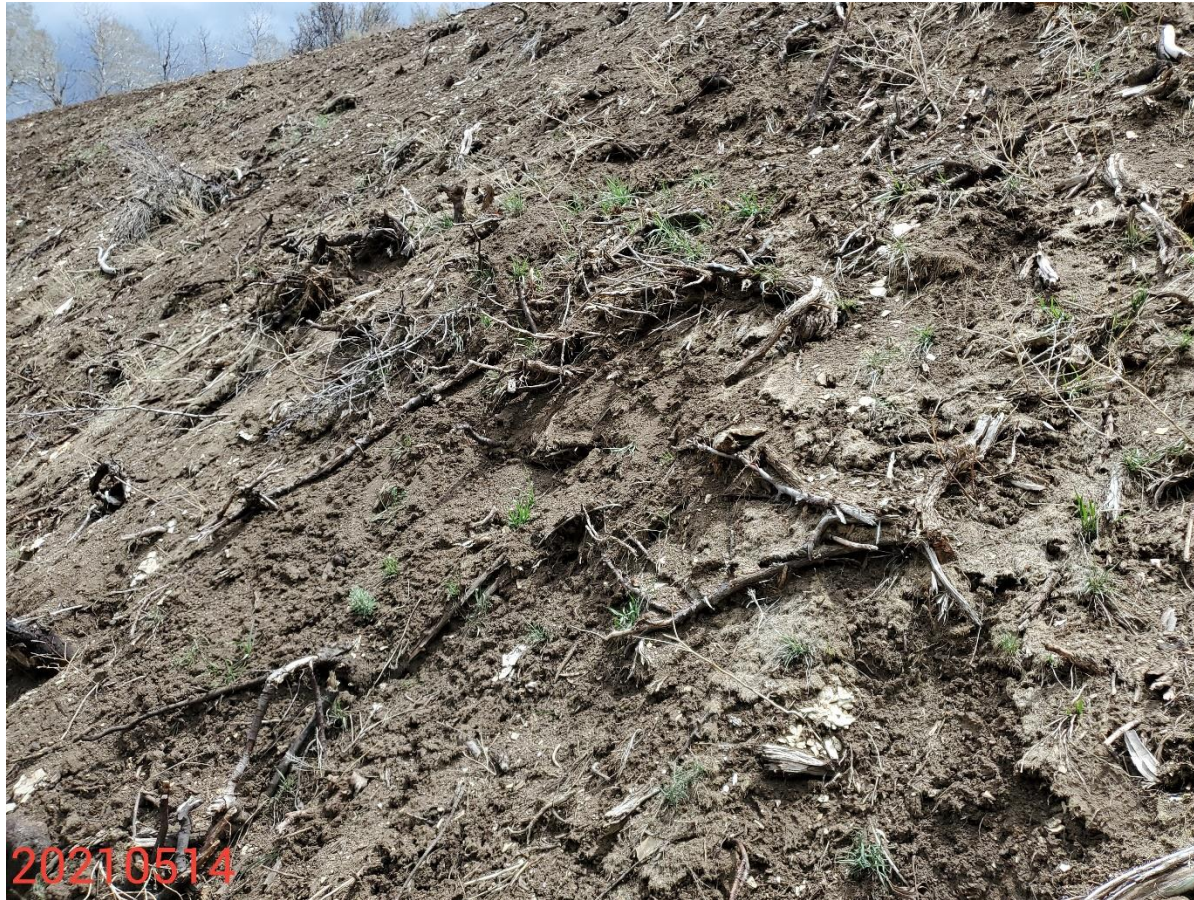
Photo 9: See comments under photo 8
