# Inspection Photos

API: 055-06283

Operator: EDWARDS ENERGY CORPORATION

Inspection Date: 5/20/2021

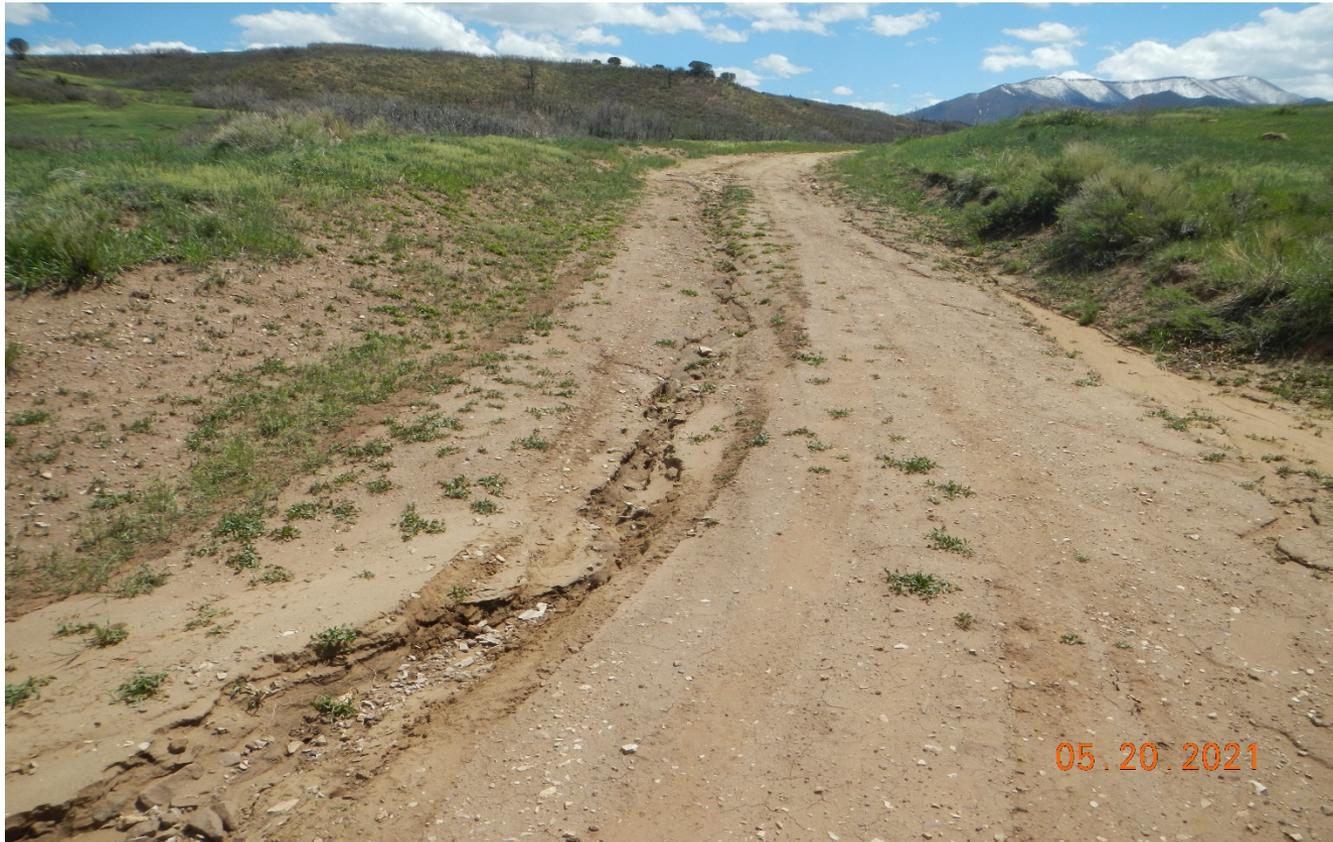
**Photo 1.** Facing south along the former access road which appears to be mostly pre-existing. There is erosion occurring along areas of the road which need to be stabilized.

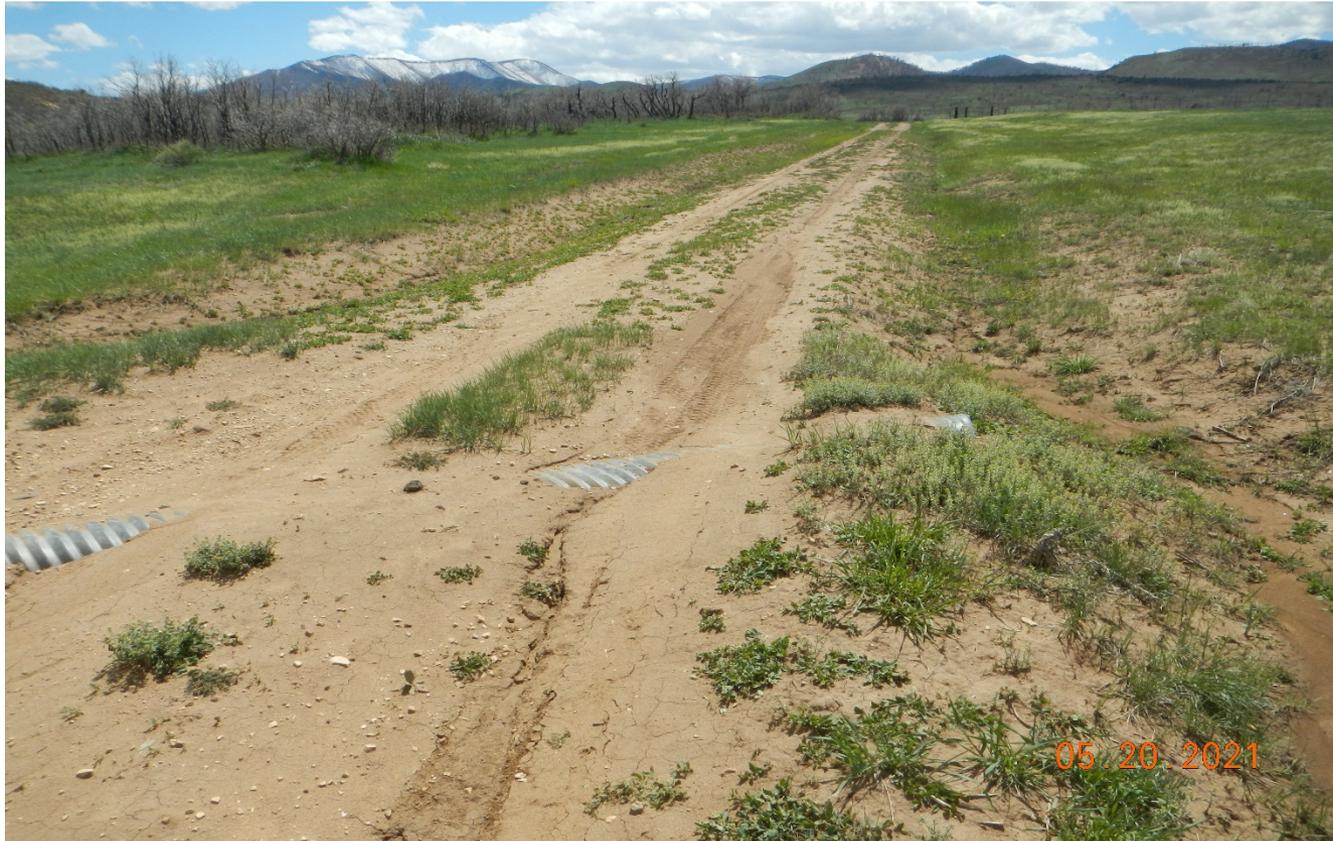
**Photo 2.** The culvert installed along the access road is not maintained and stormwater is bypassing the culvert. Lat/Long:37.50521,-105.07444.

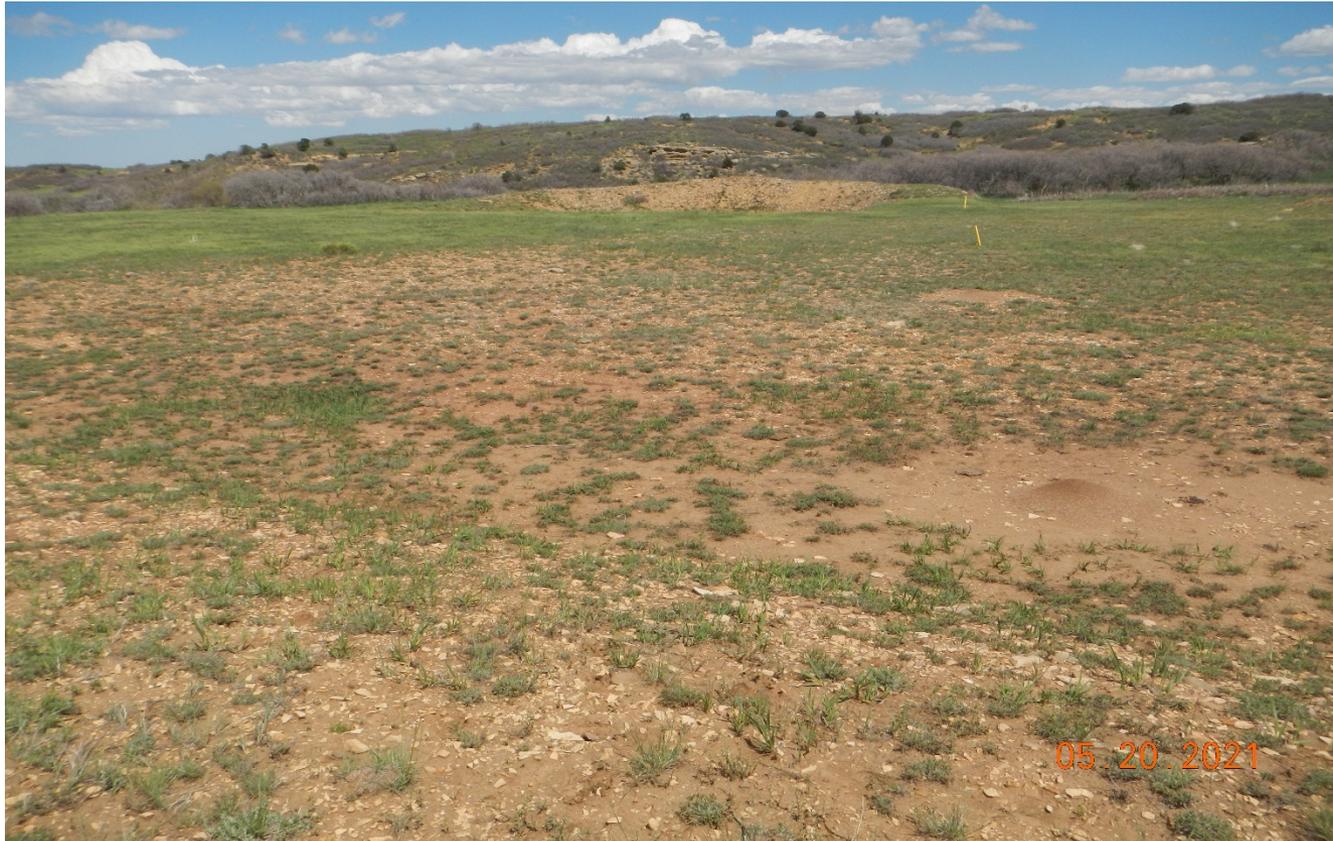
**Photo 3.** Facing northeast toward the location which was never recontoured and reclaimed per 1004 Rules.

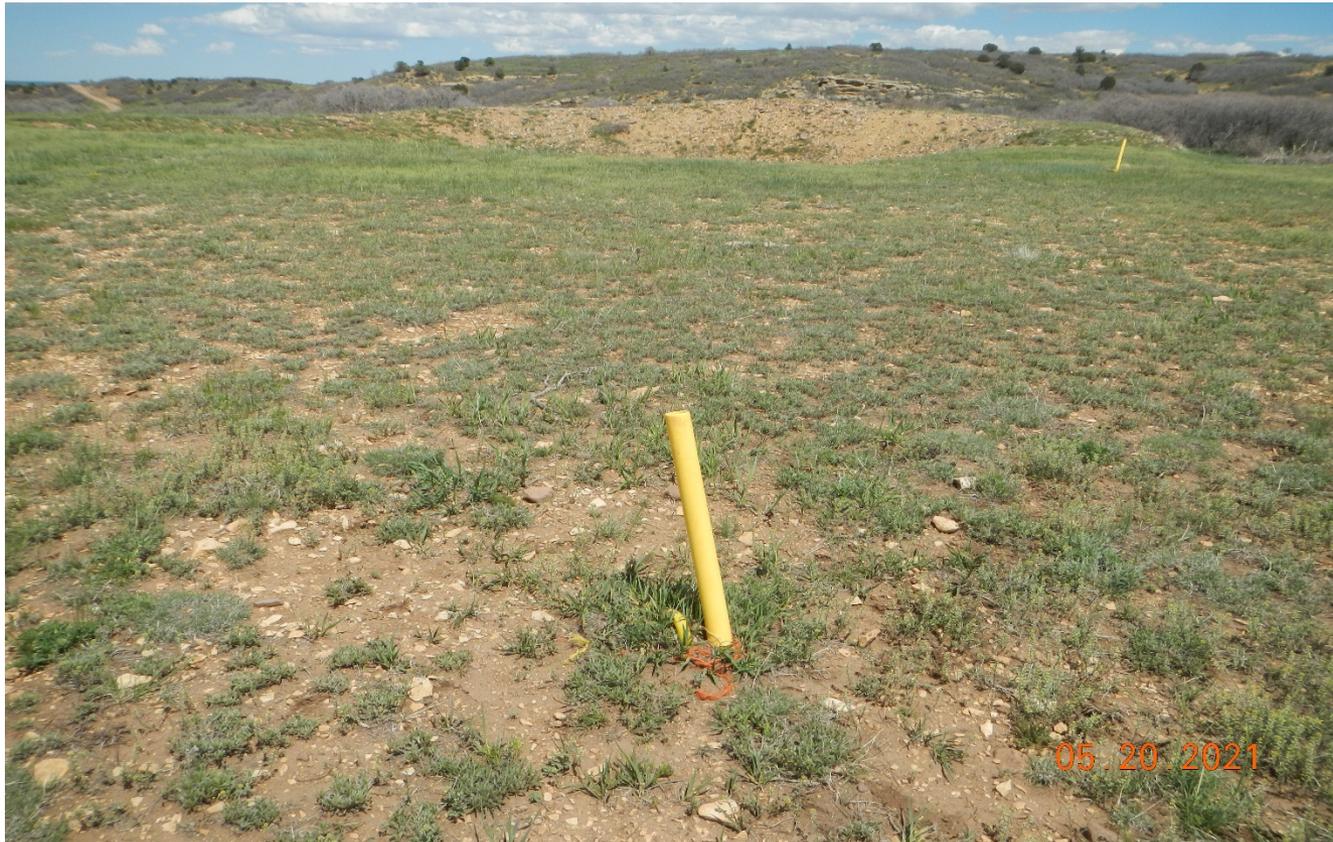
**Photo 4.** There are four guy line anchors that remain which should have been removed within 3 months of abandoning the well.

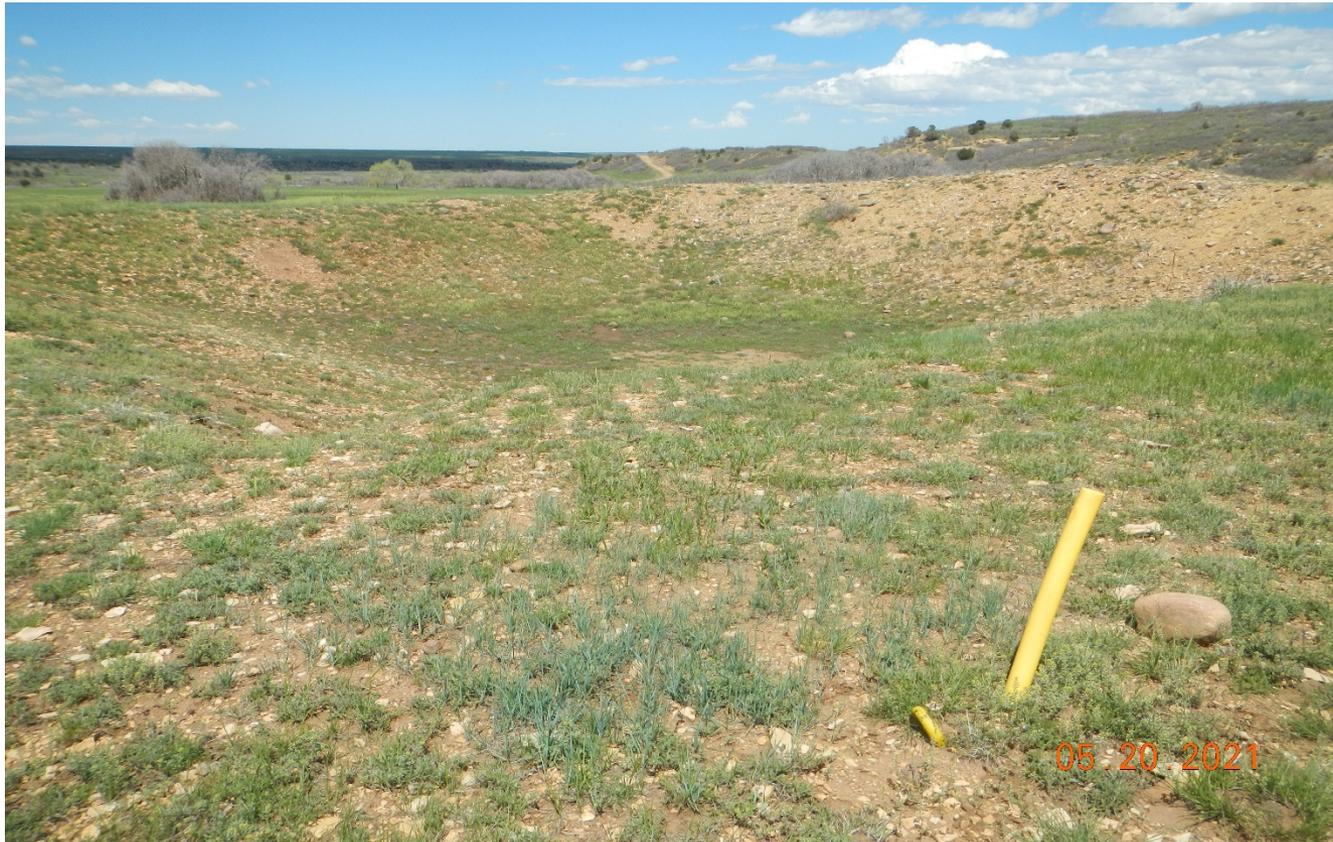
**Photo 5.** Facing northeast toward the pit which was never backfilled and reclaimed.

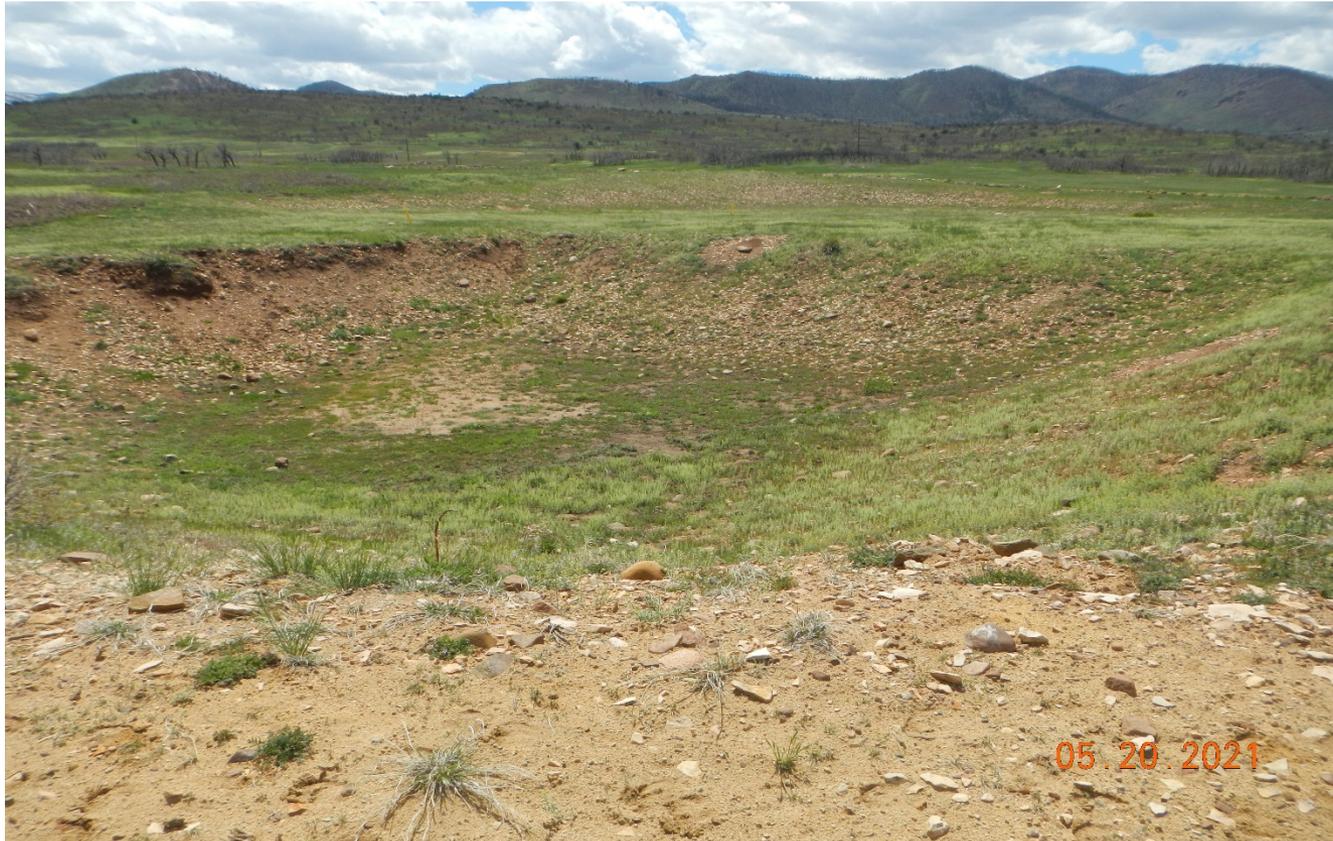
**Photo 6.** Facing southwest toward the pit which is approximately 100'x100' in size.

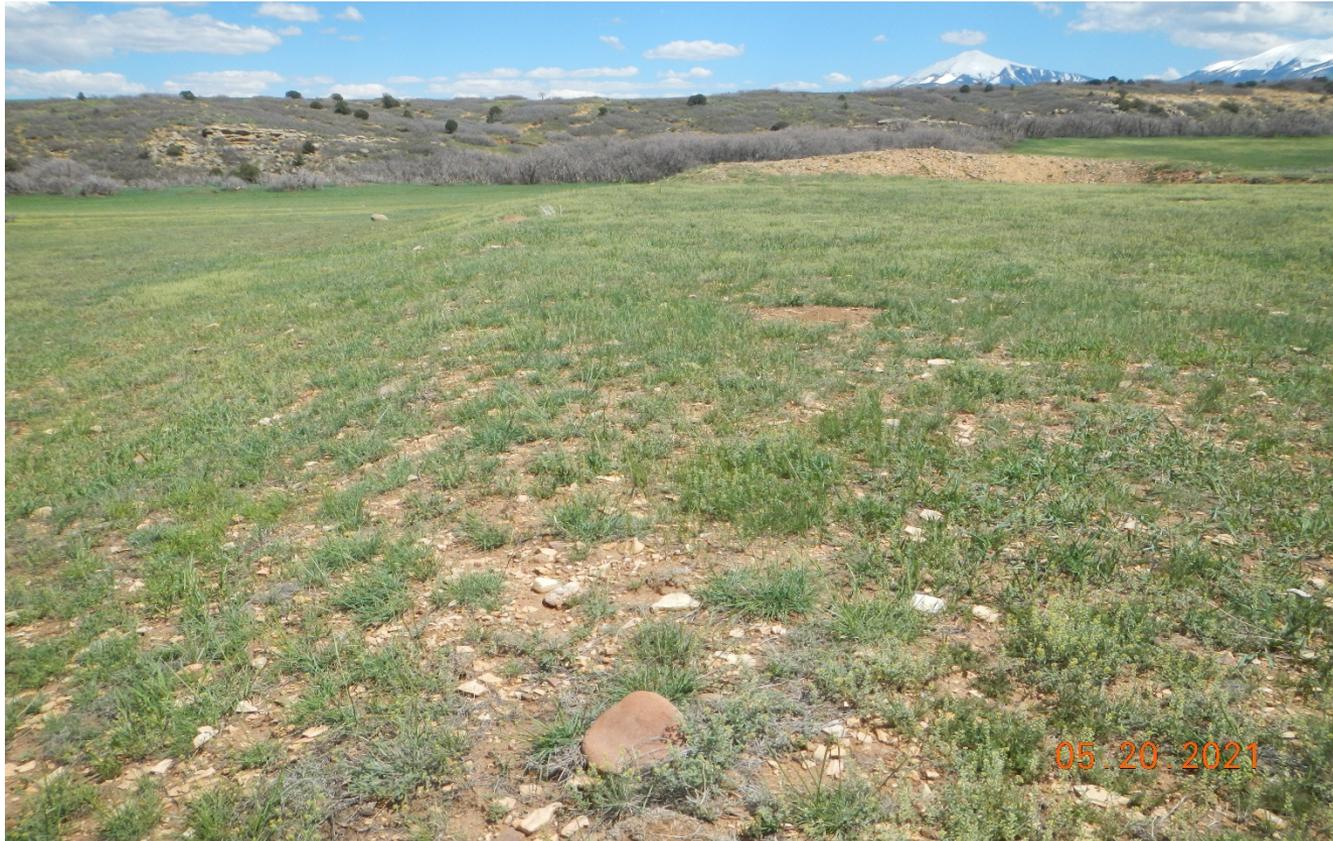
**Photo 7.** Facing southeast along the fill slope of the location which was never recontoured back to the original contours of the terrain.

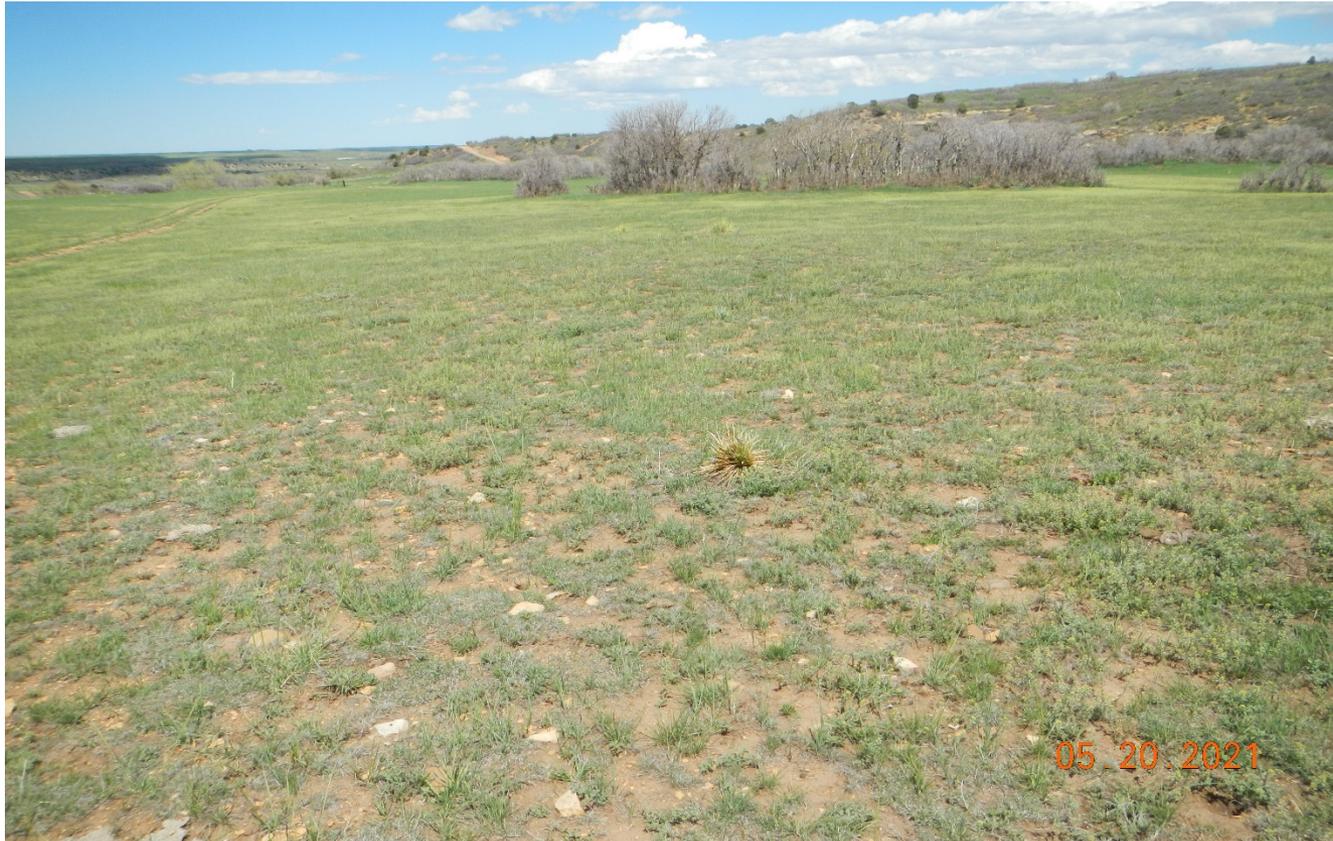
**Photo 8.** Facing northeast toward the surrounding undisturbed pasture which consists of perennial native vegetation.
