Colorado Oil and Gas Conservation Commission

Gunnison Energy- Trail Gulch #453805 Issue Report

Operator: GUNNISON ENERGY LLC # 10515

Location ID: 324464

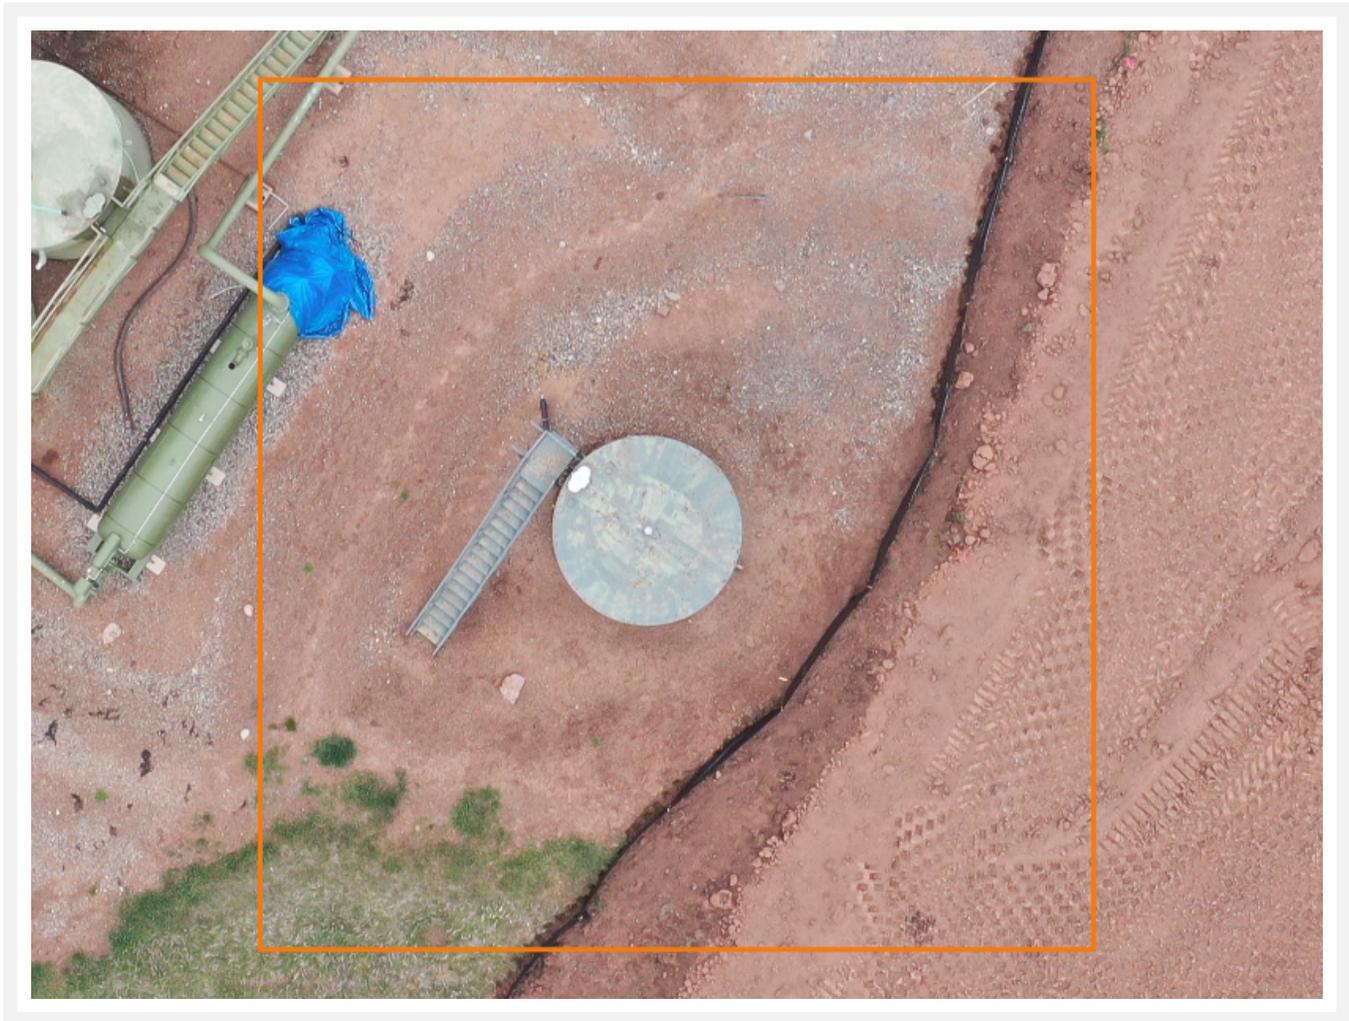
1 - Other **OPEN**

Summary
Construction of the silt fence appears to have compromised the integrity of the containment BMP at the tank.

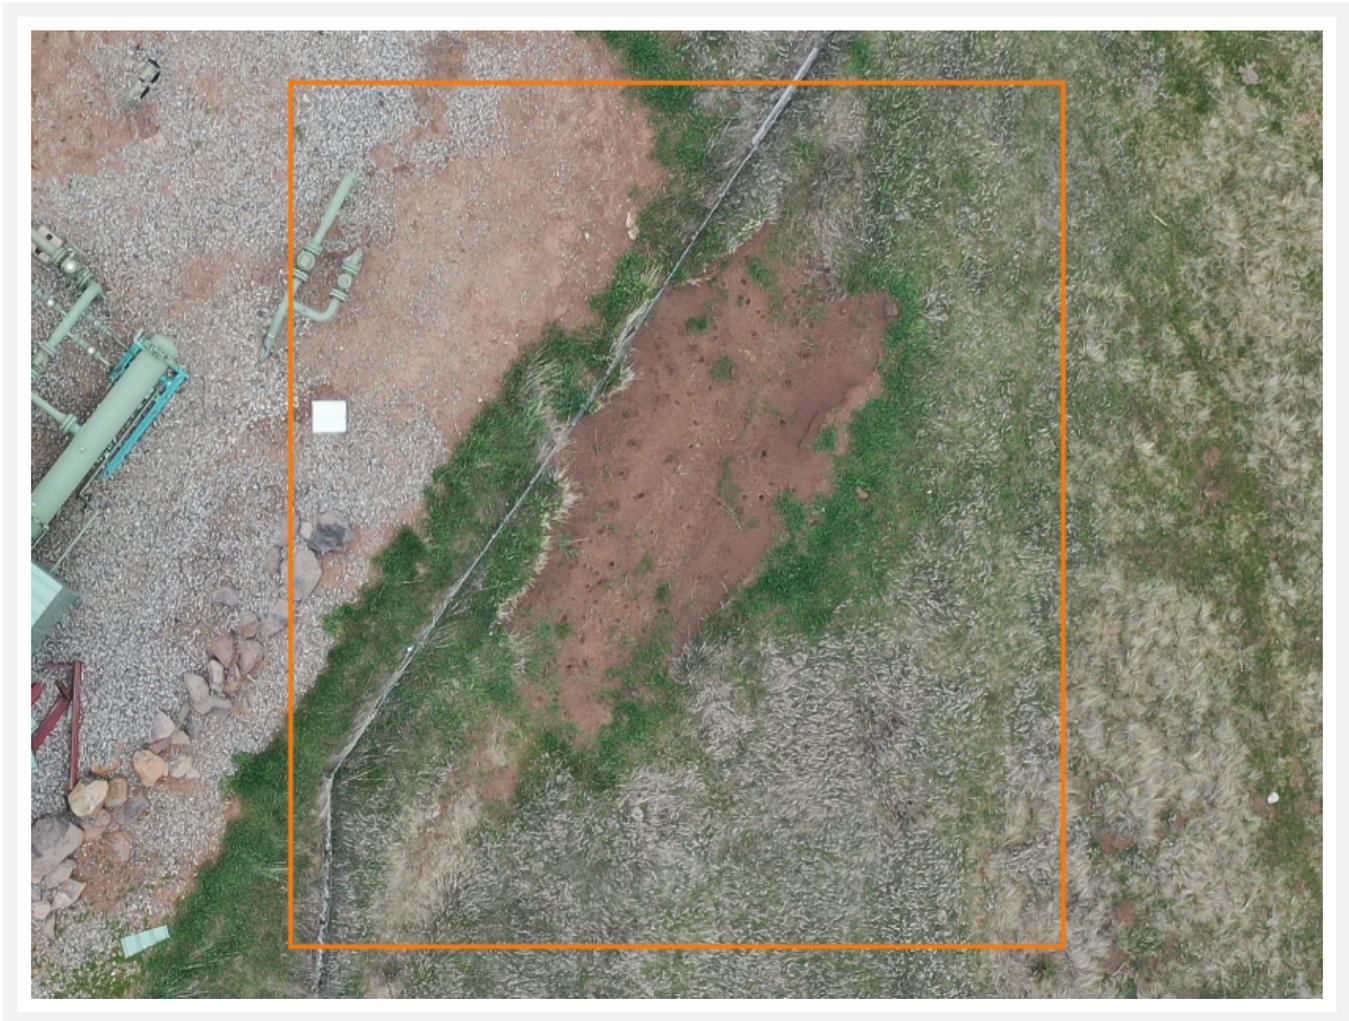
2 - Other **OPEN**

Summary
Canada thistle rosettes observed within sediment trap.

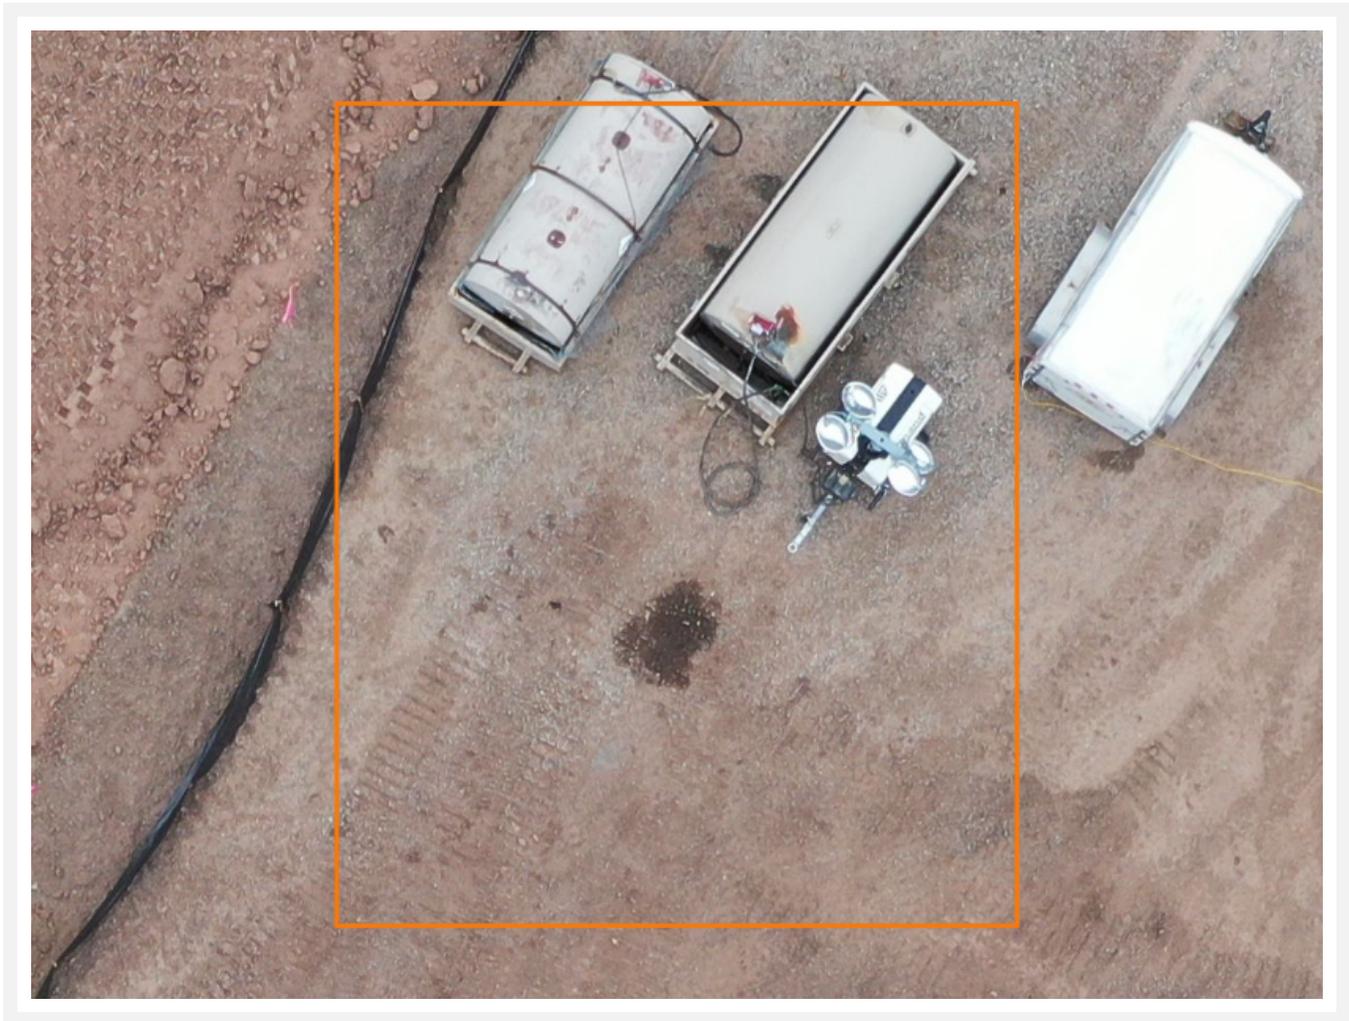
3 - Other **OPEN**

Summary
Spill, requires cleaning

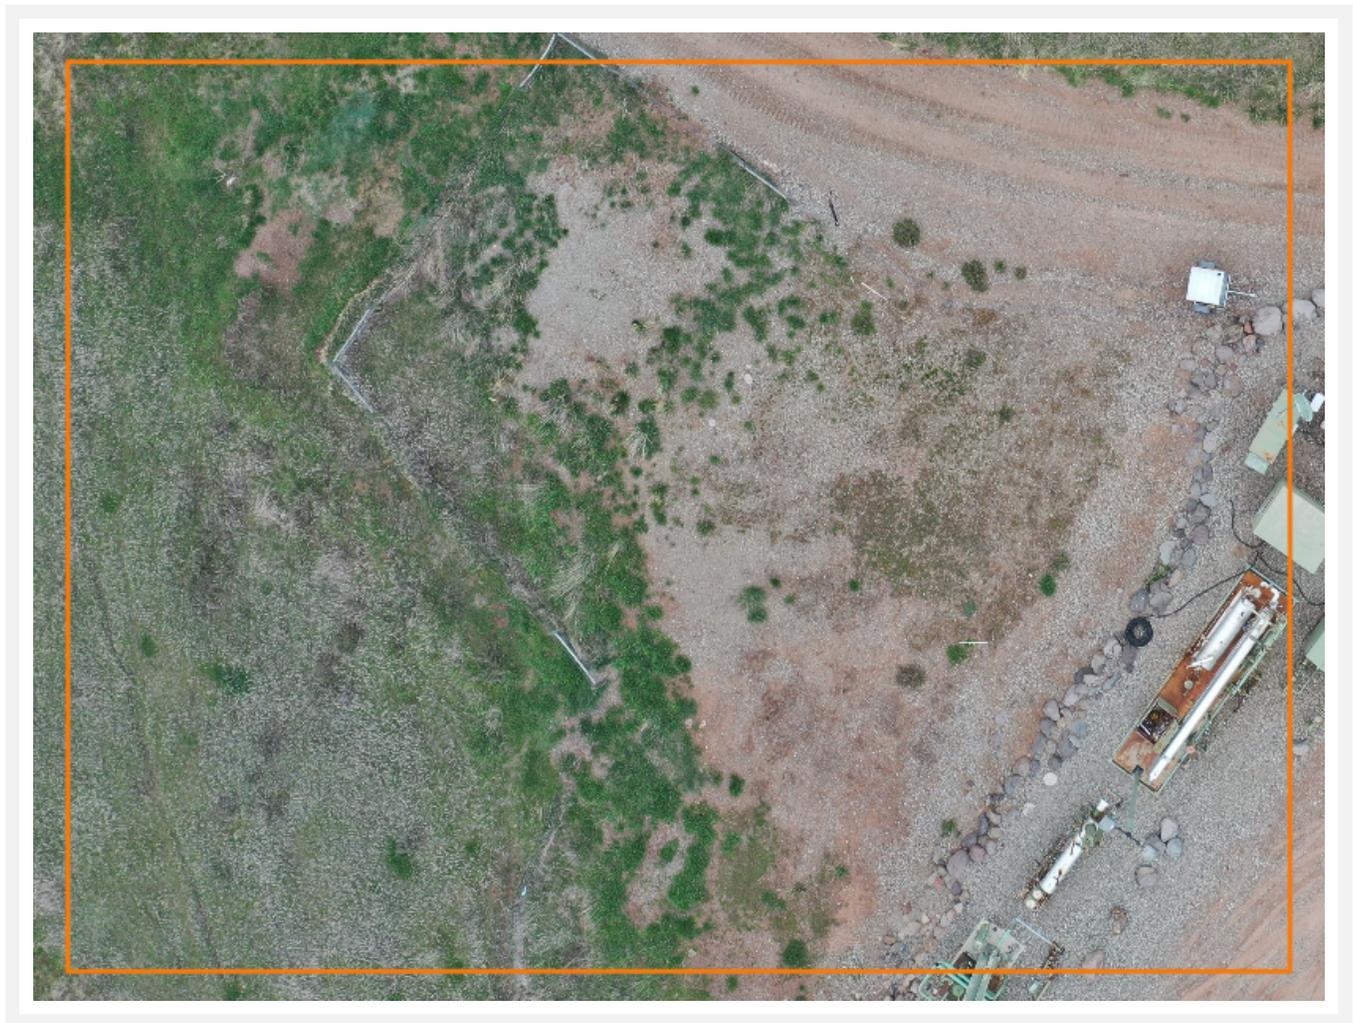
4 - Other OPEN

Inspection #696202645 required 1003.b reclamation for southern disturbed areas of the Location not needed for production. A portion of these areas have since been staked for the construction of a sediment trap/pond, as part of the construction of the Trail Gulch Unit 1090 /30. Corrective action will remain applicable for unused areas on the south end of the Location not part of the sediment trap, unless BMP is not constructed, at which point the all unused, disturbed areas remain subject to Rule 1003.b.

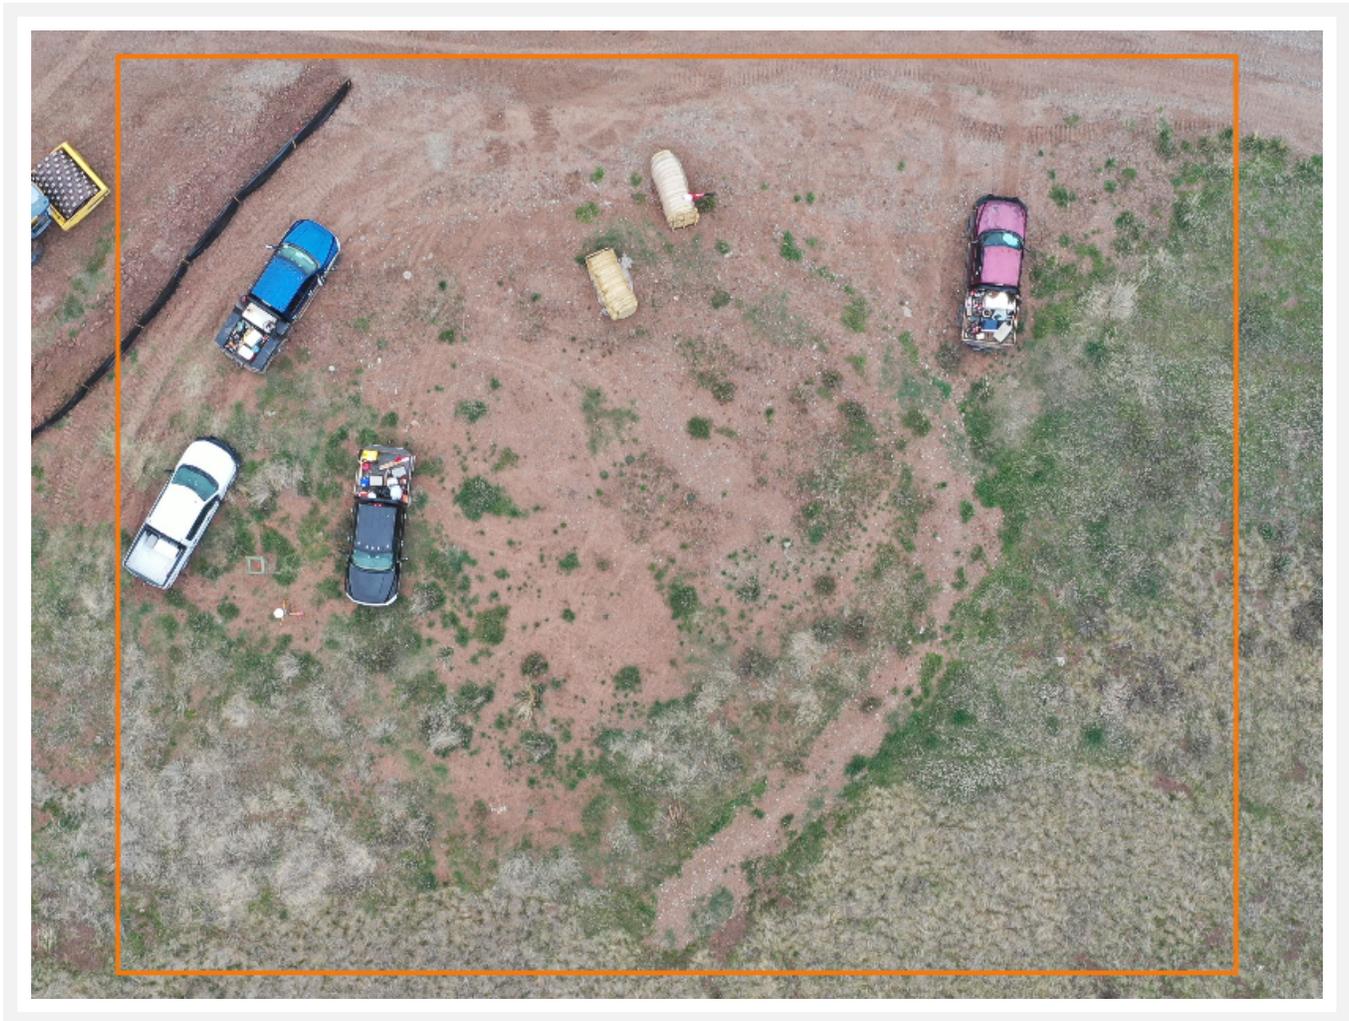
5 - Other **OPEN**

Summary
Northwestern unused disturbed areas requiring 1003 reclamation.

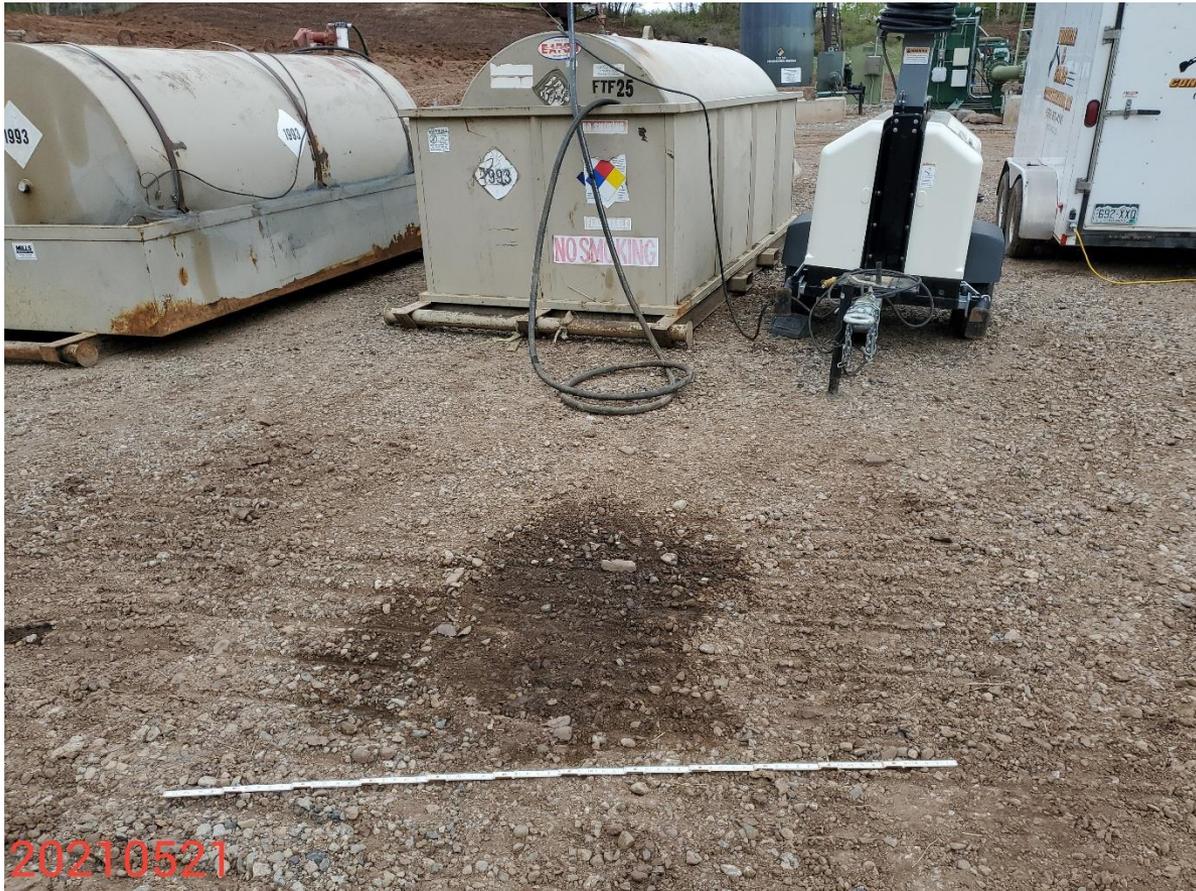
Photo 1: Photo shows stained soils in front of diesel tank.

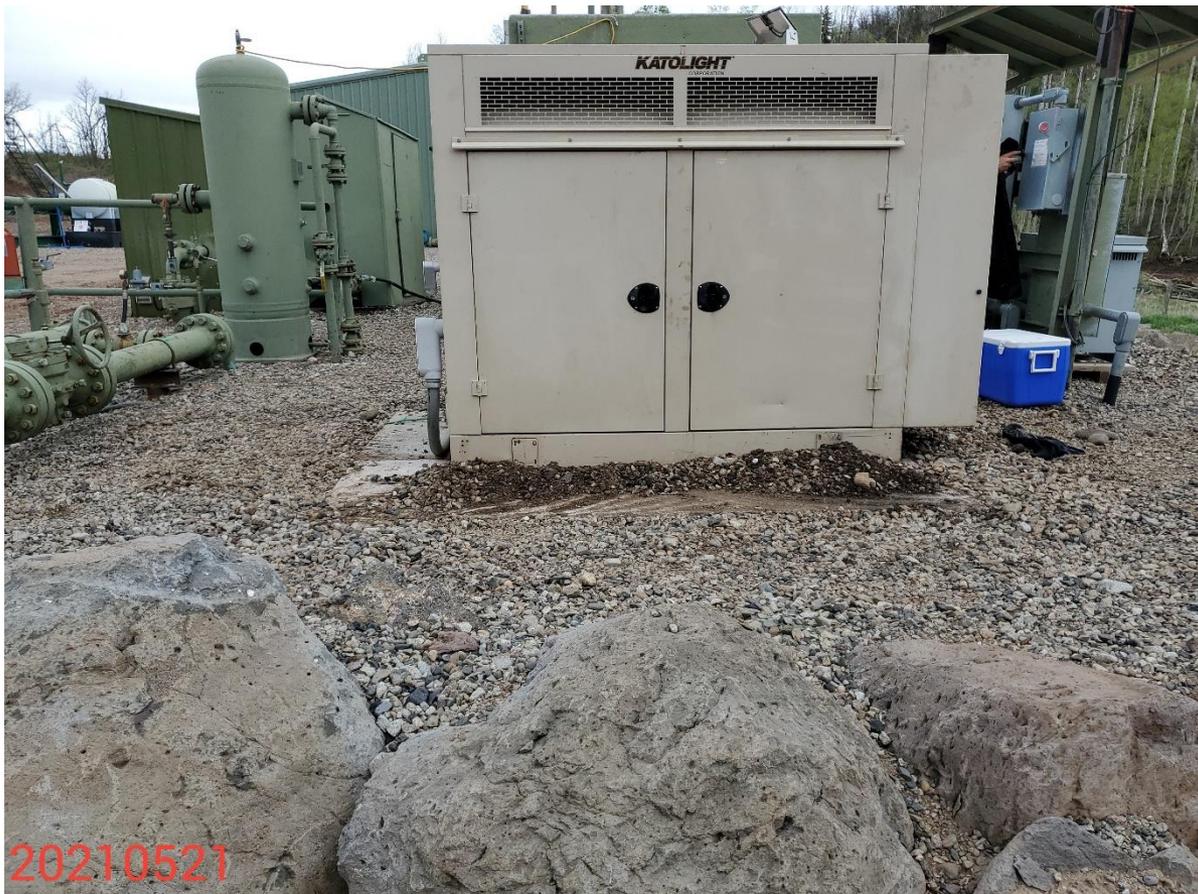
Photo 2: Photo show repair equipment and clean-up of stained soils around equipment was in process at time of inspection

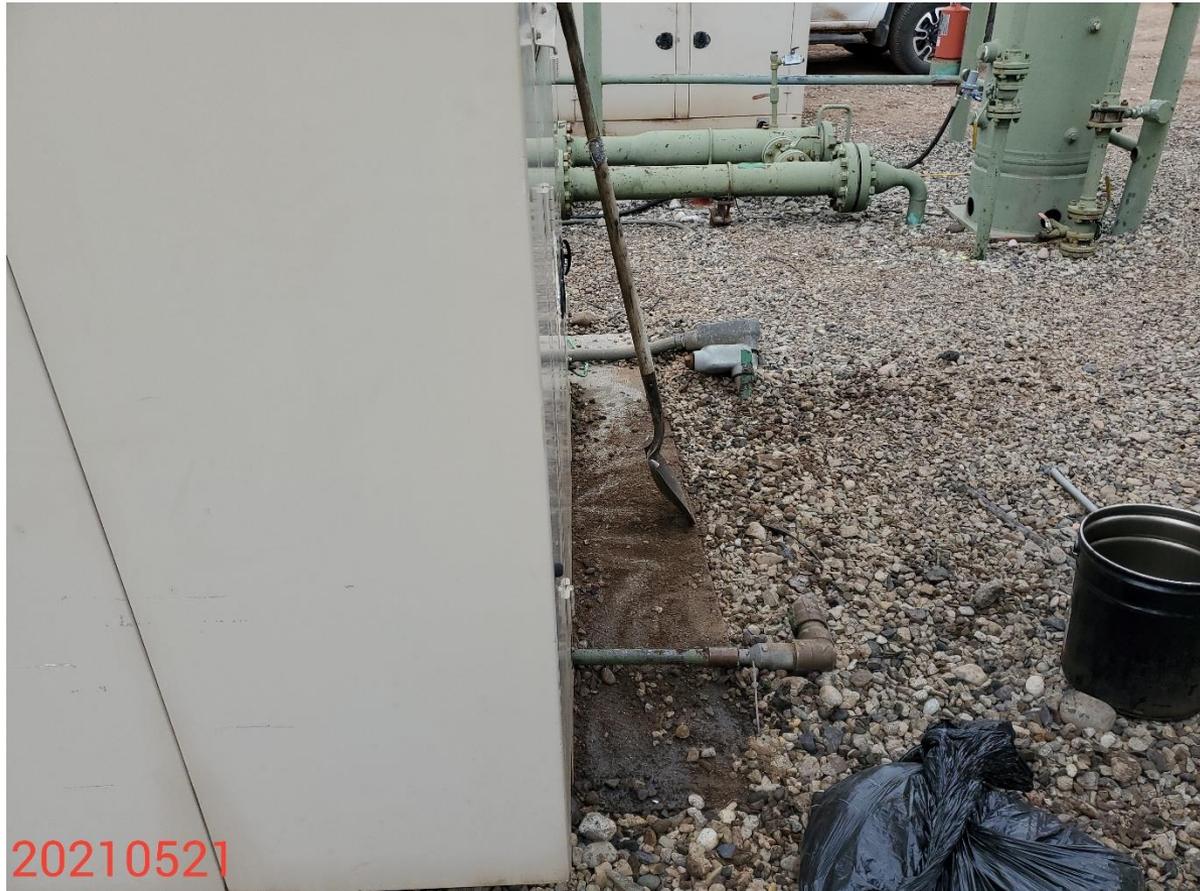
Photo 3: Photo show repair equipment and clean-up of stained soils around equipment was in process at time of inspection

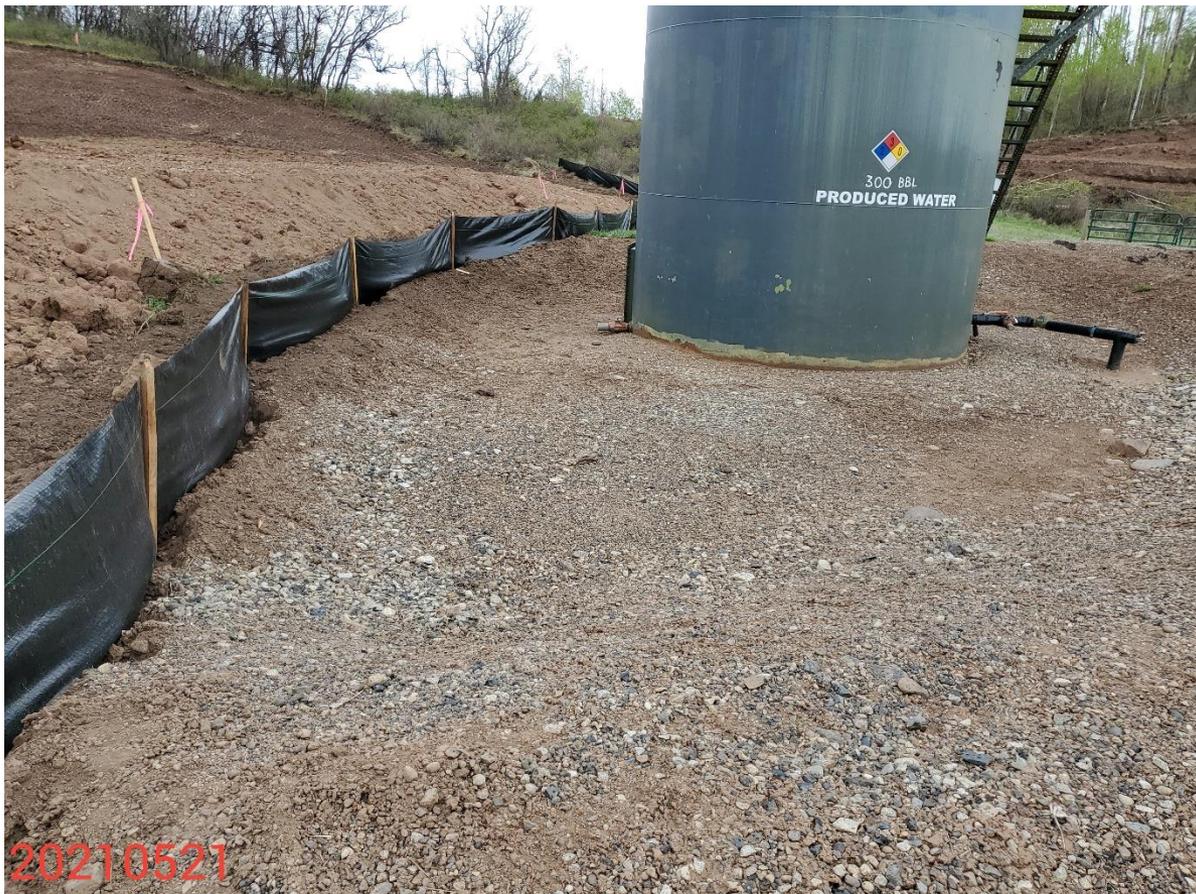
Photo 4: Photo taken from the 300 bbl produced water tank on the Location. Photo shows that the integrity of the containment berm BMP has been compromised during the construction of a silt fence.

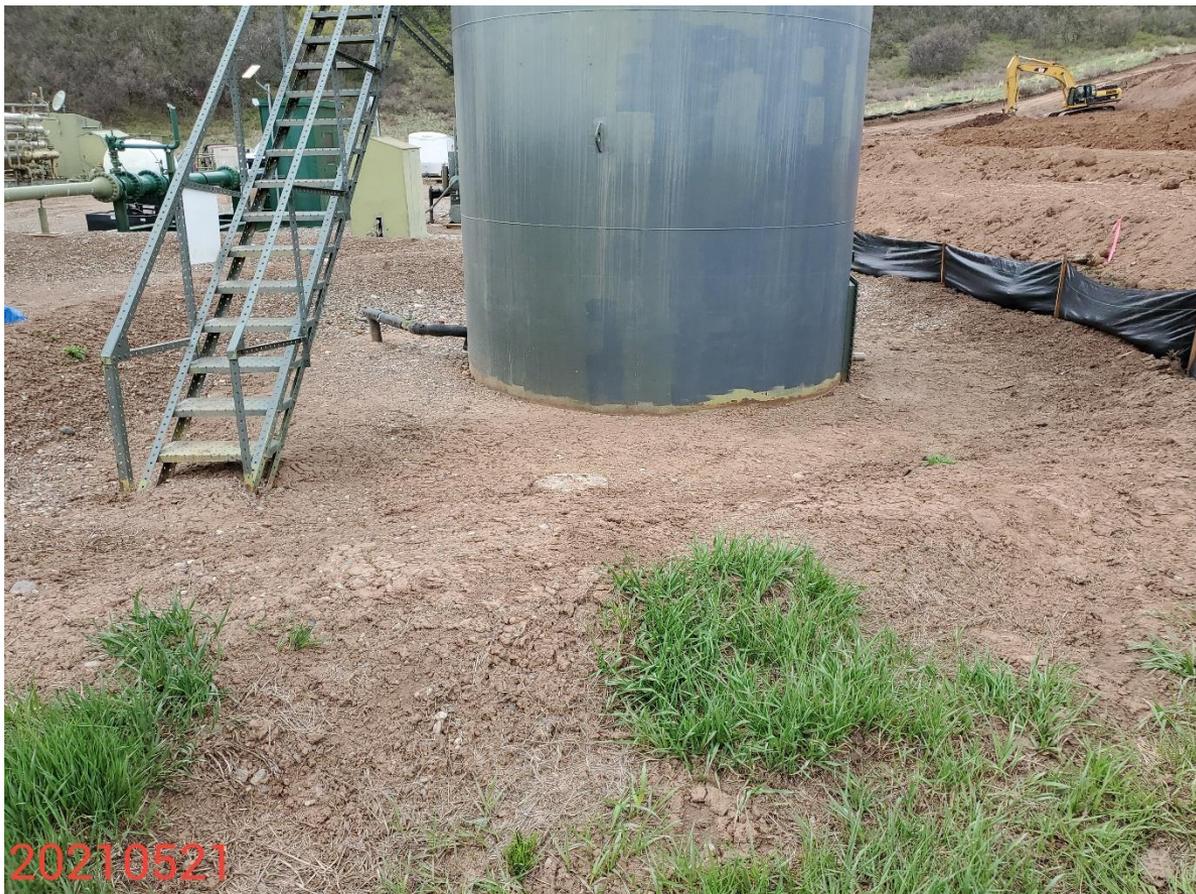
Photo 5: Photo taken from the 300 bbl produced water tank on the Location. Photo shows that the integrity of the containment berm BMP has been compromised during the construction of a silt fence.

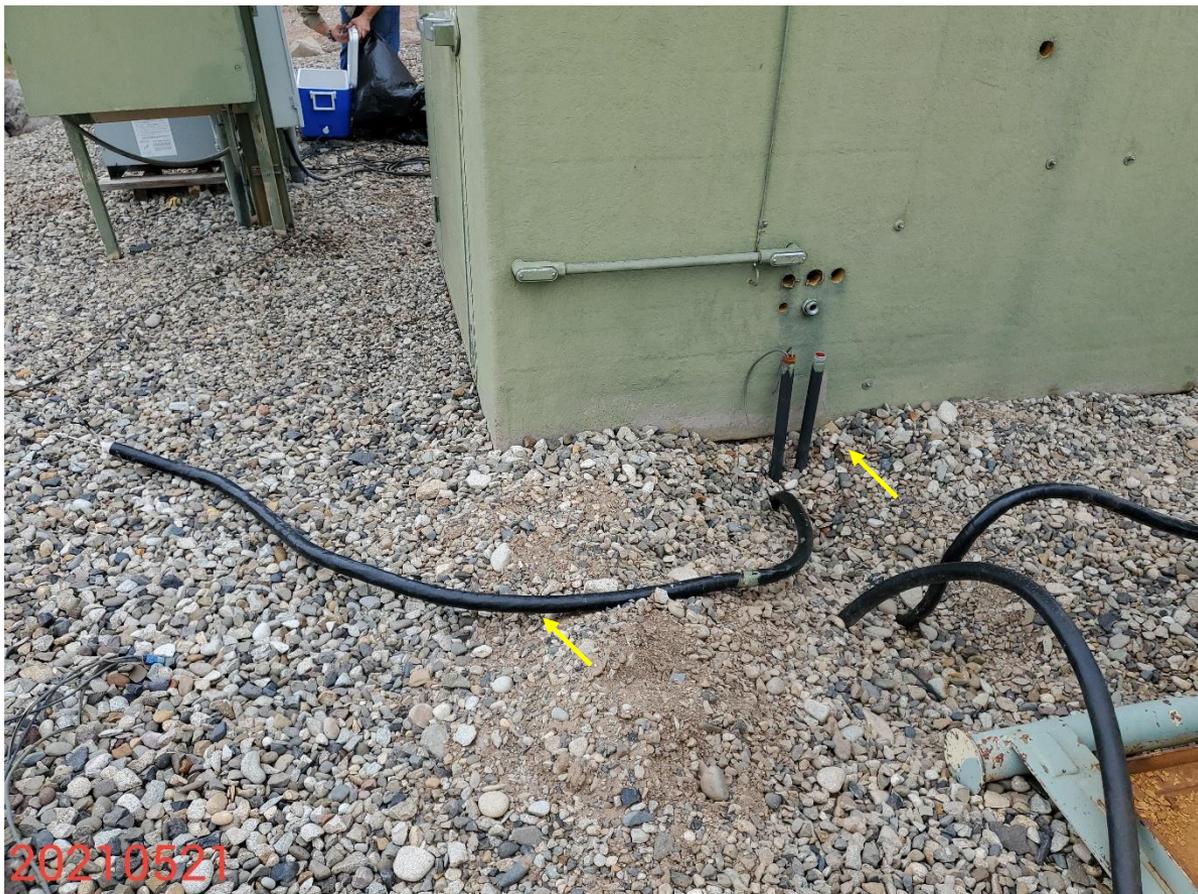
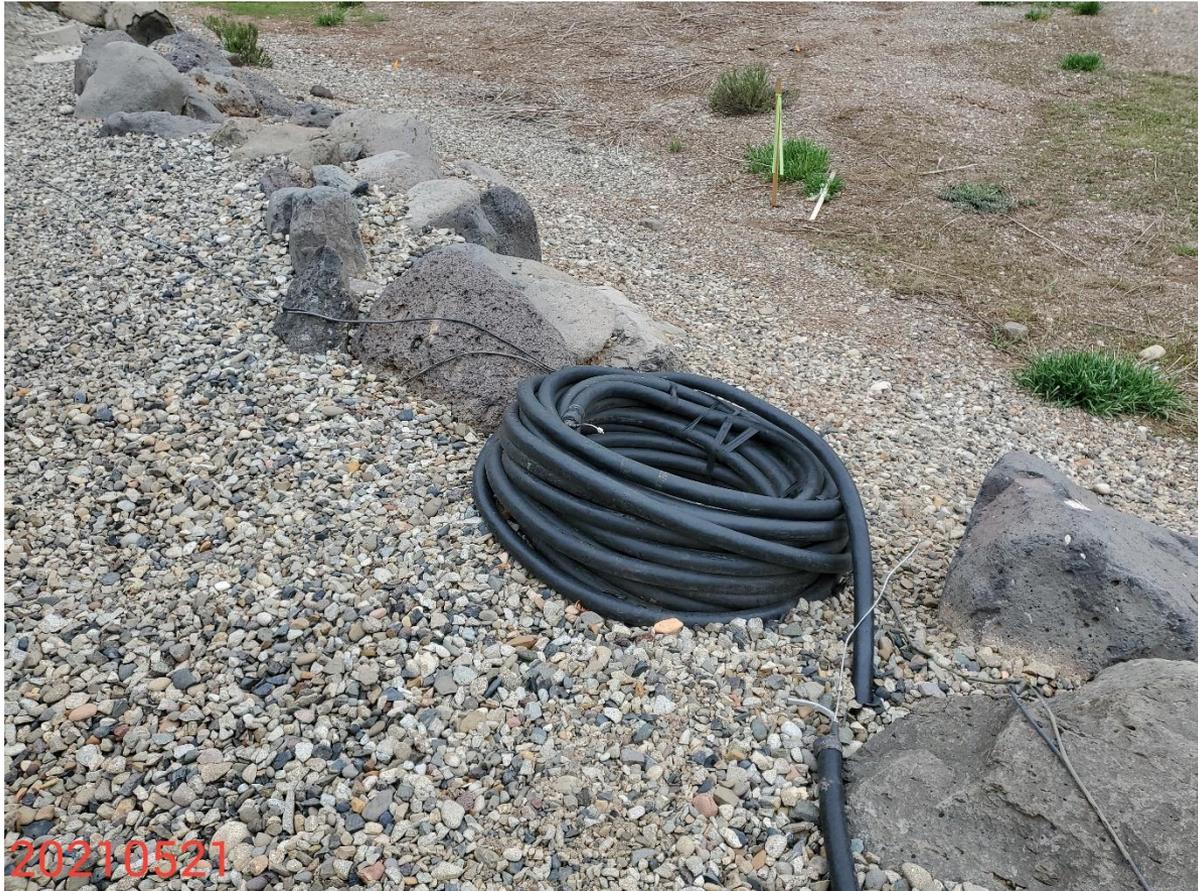
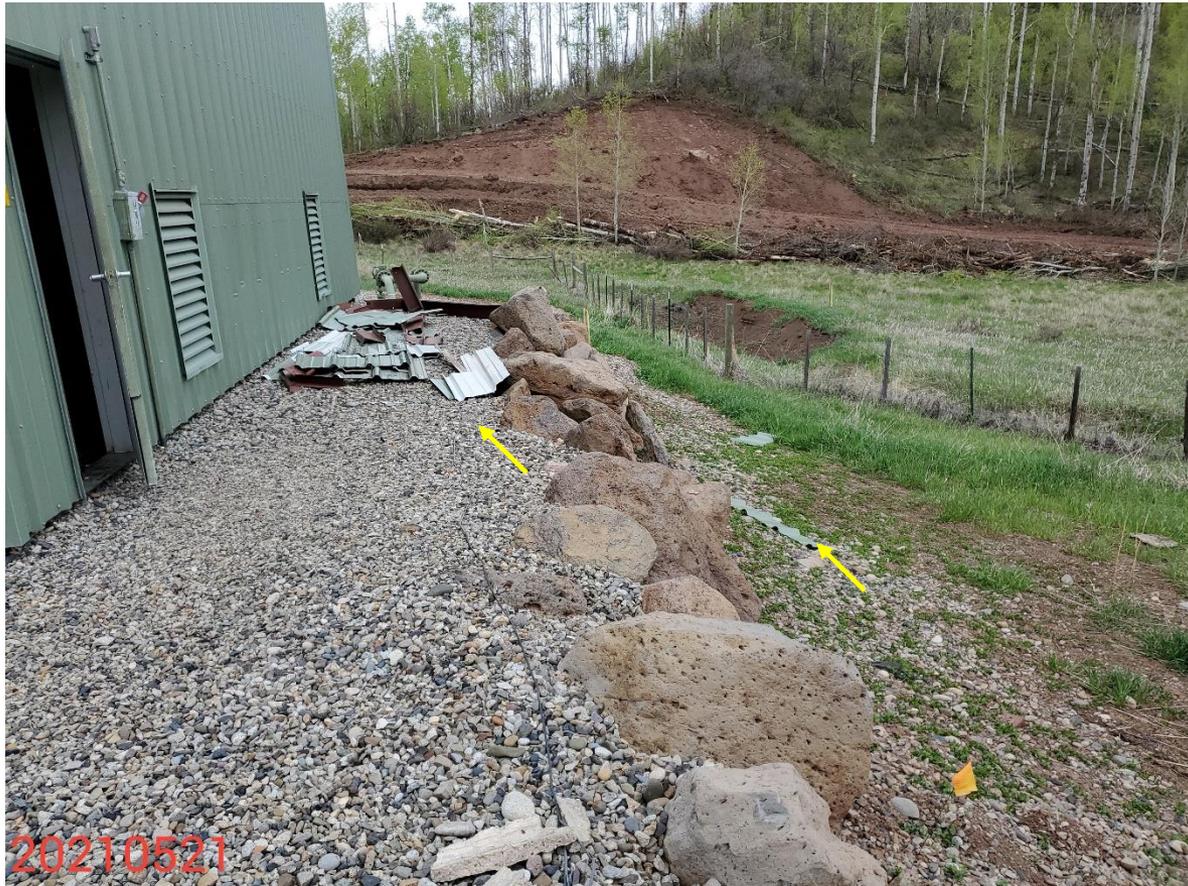
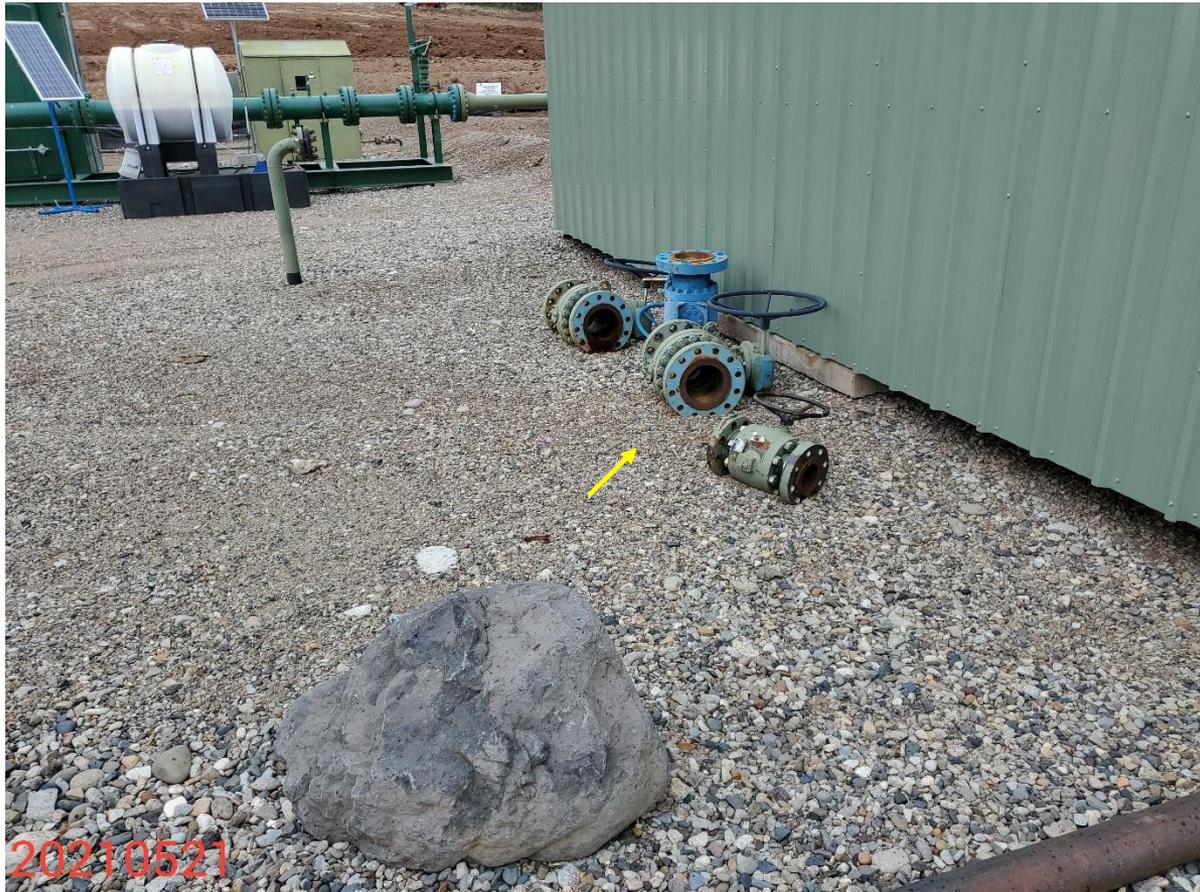
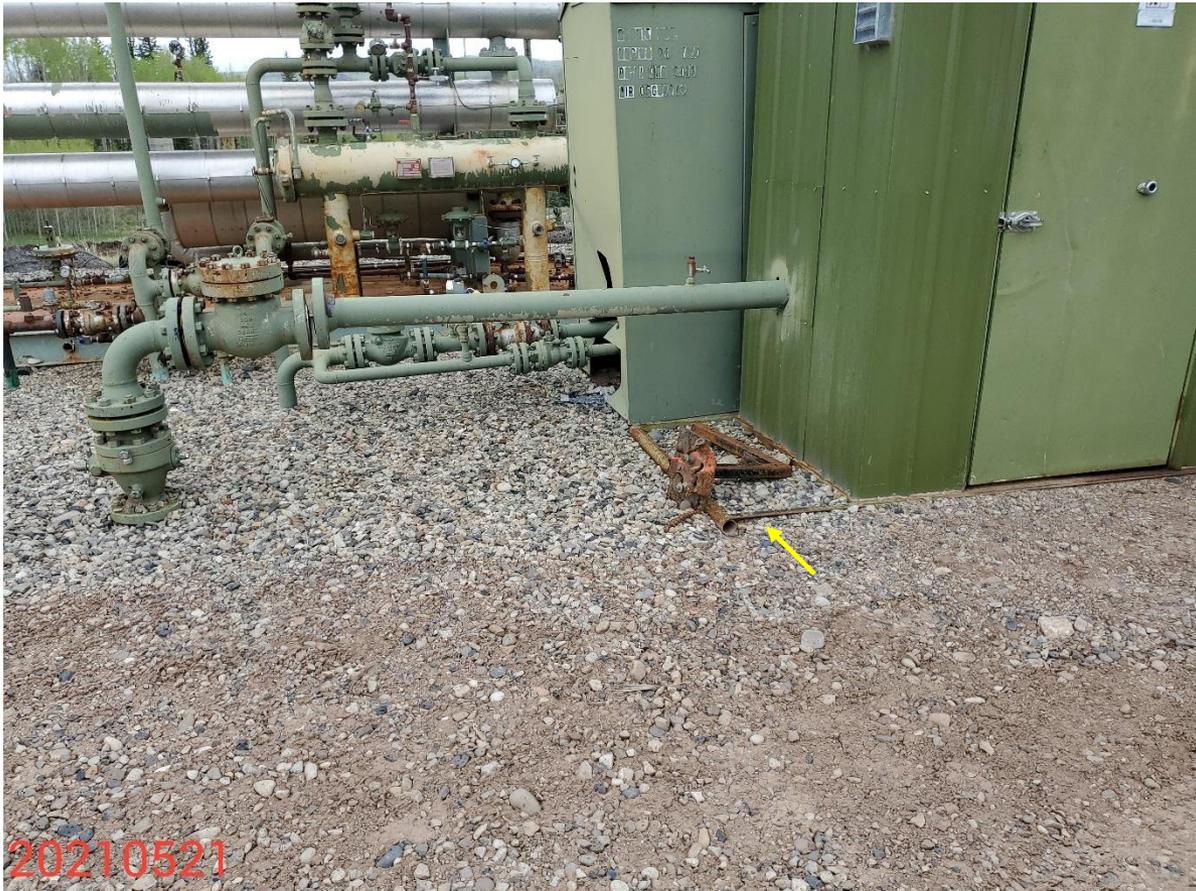
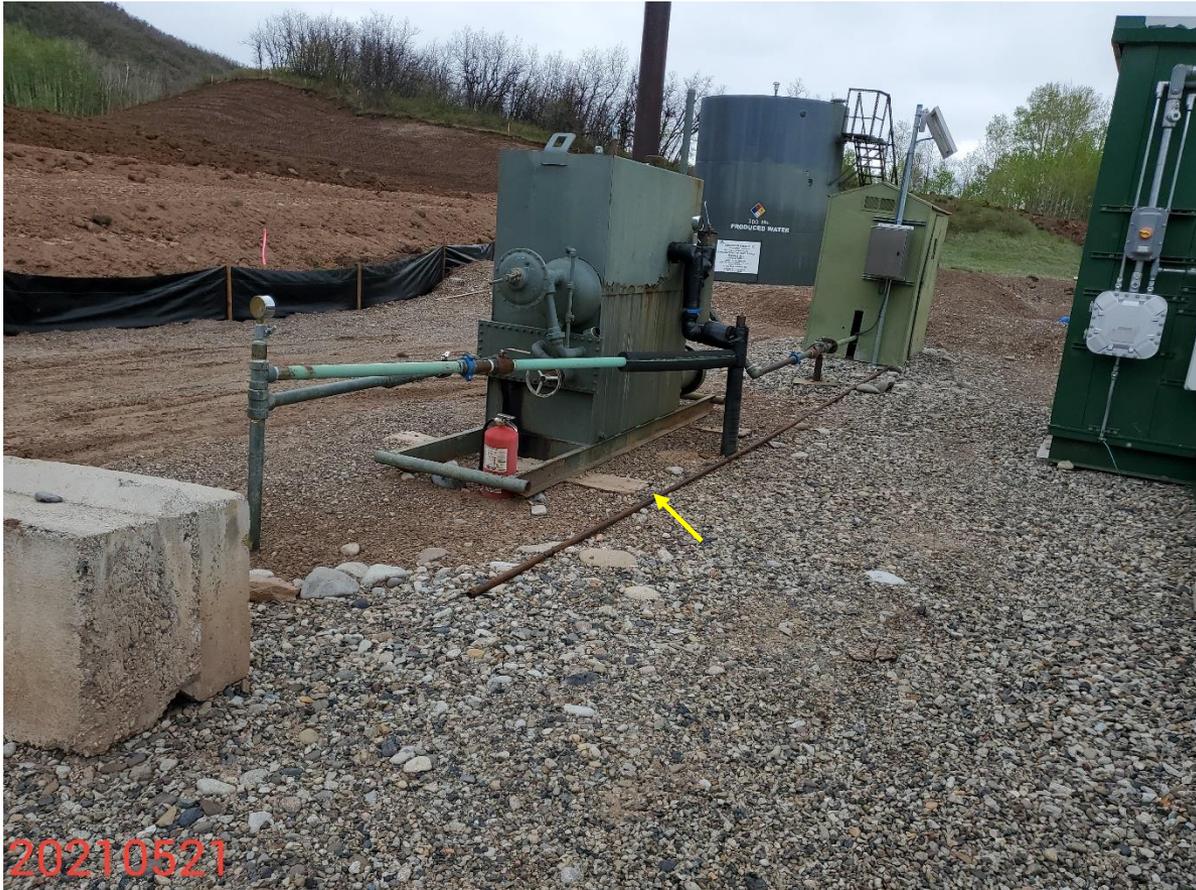
Photo 6: Photos 6-11 provide examples of various trash, debris and unused equipment remaining on the Location.

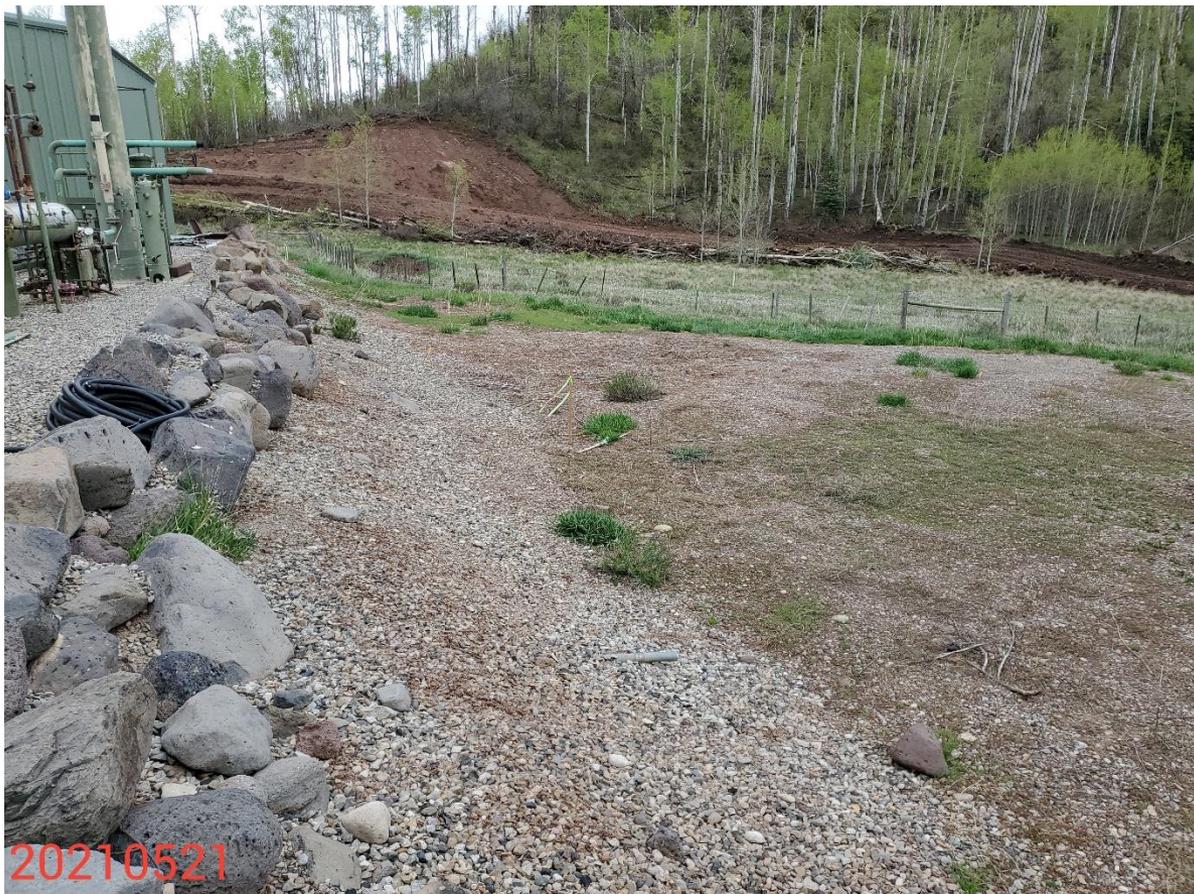
Photo 12: Photo taken from the fill slopes on the southeast end of the Location. Photo shows BMPs to protect/stabilize the fill slopes of the Location remain missing or insufficient.

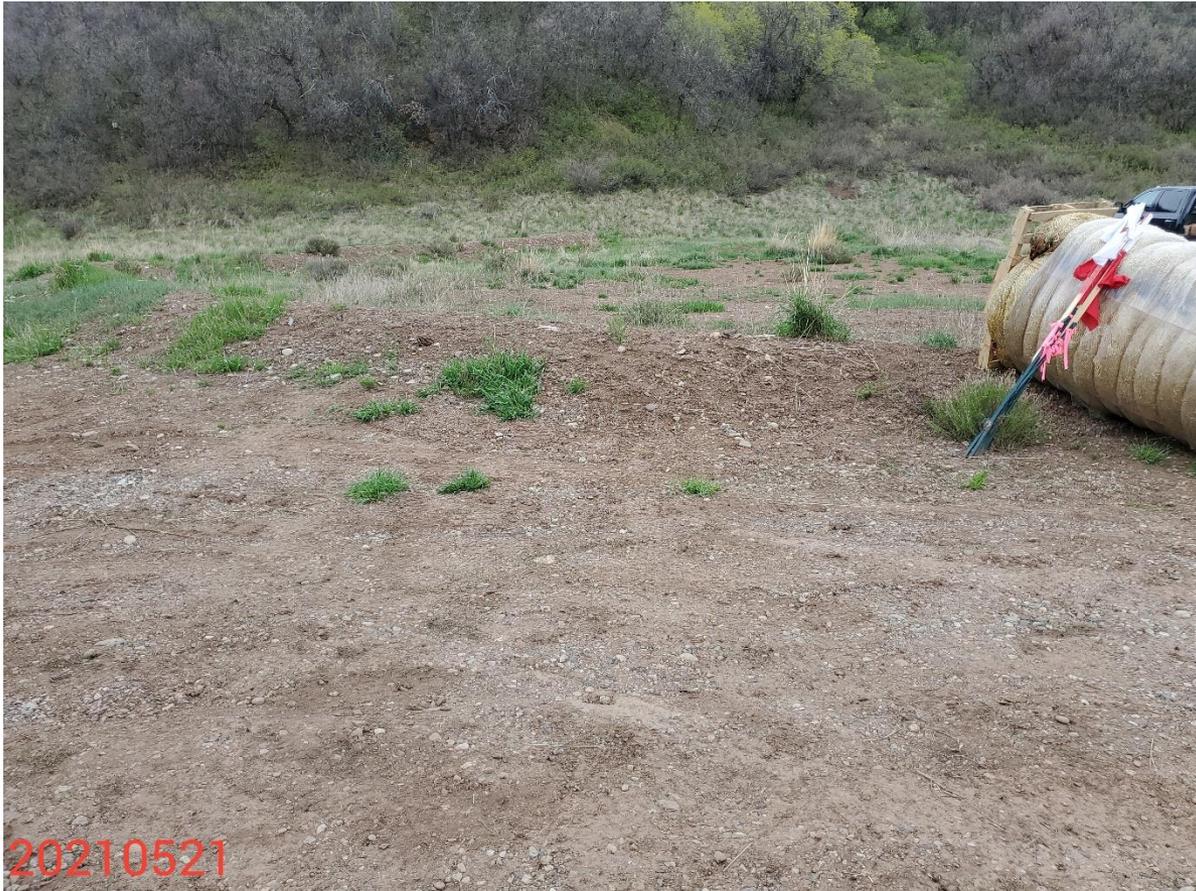
Photo 13: Photo taken from the interim areas on the west end of the Location, facing north. Desirable perennial vegetative establishment is sparse; interim areas largely bare. Vegetation observed on interim areas predominantly undesirable weedy plant species.
