Inspection Photos

Operator: TEP ROCKY MOUNTAIN LLC - 96850

Location ID: 335915

Garfield County, CO

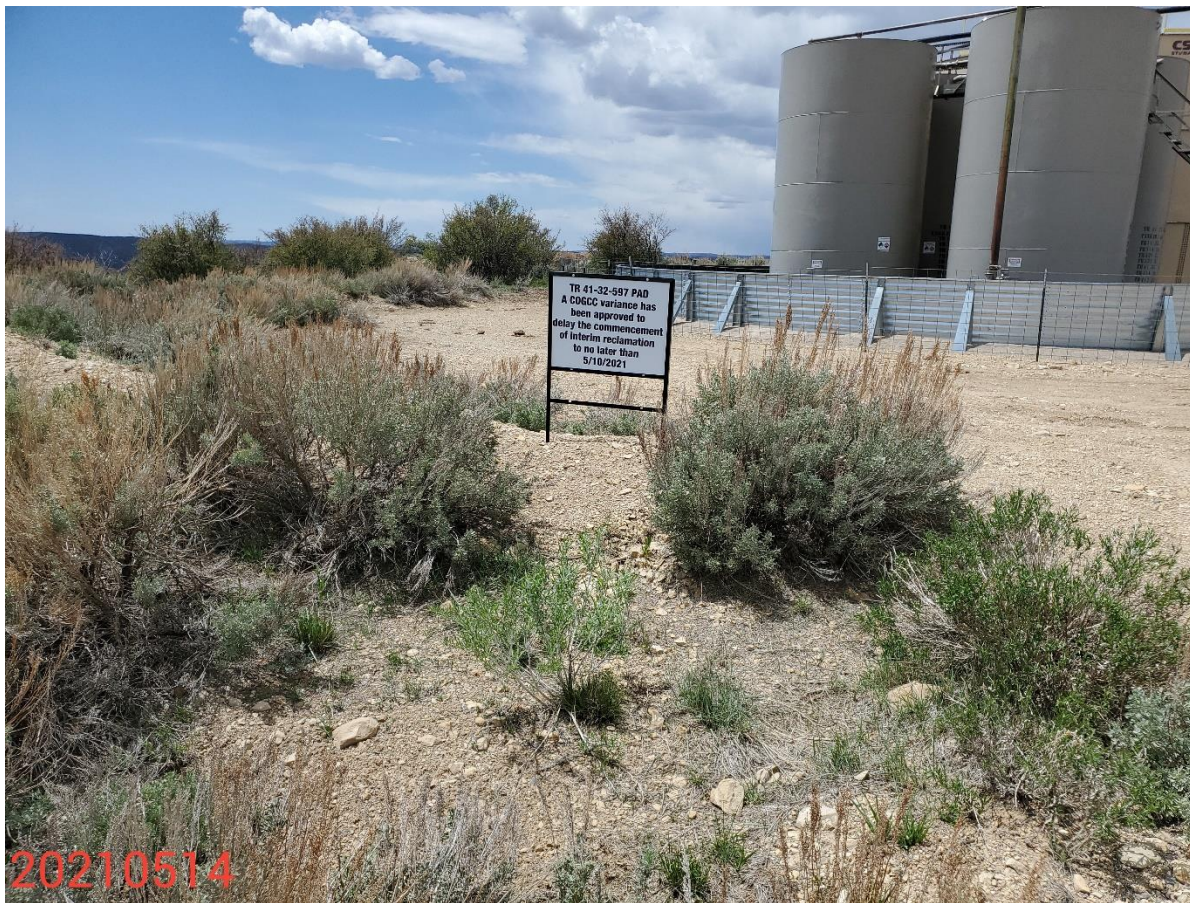
Photo 1: Photo taken from the Location entrance. Photo shows signage stating "Location received an approved variance for delayed interim reclamation". Location did not receive a variance to delay interim reclamation.

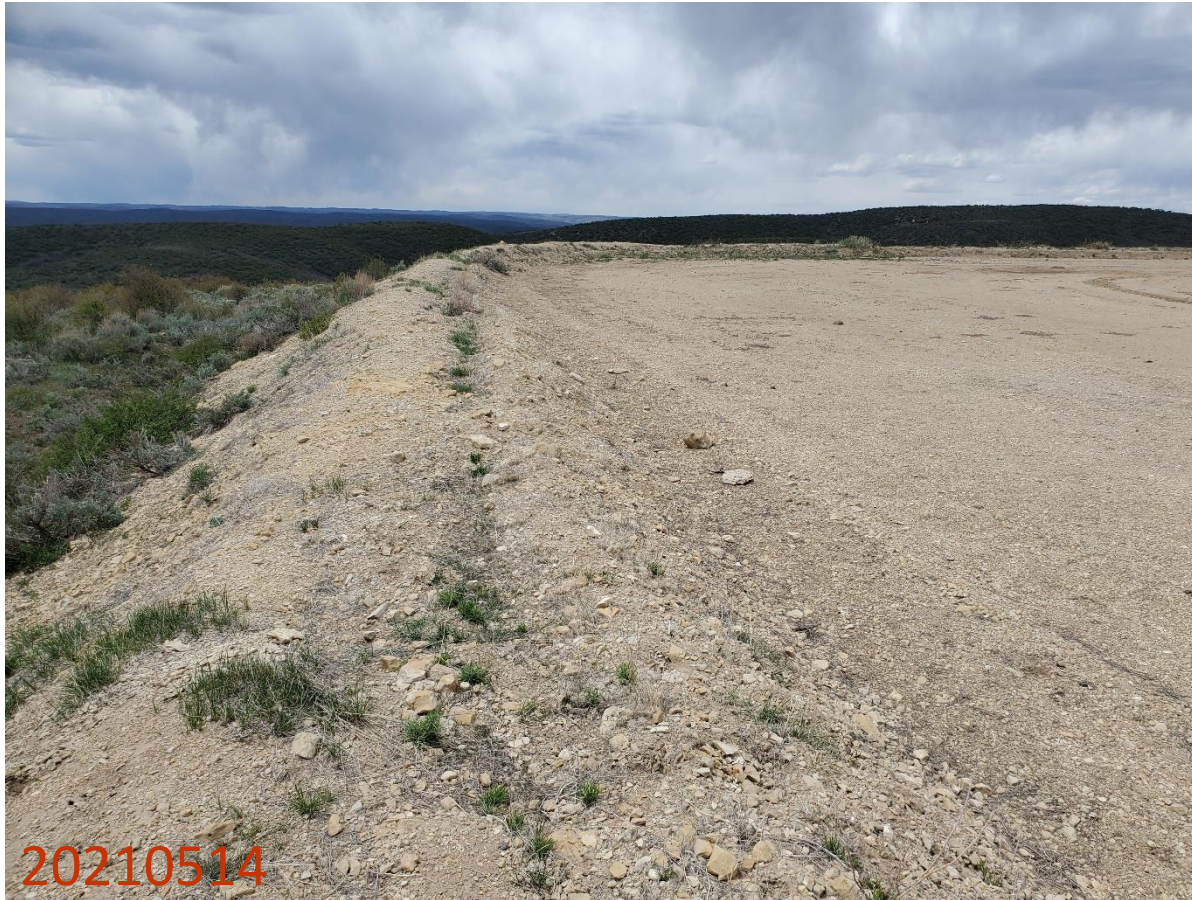
Photo 2: Photo taken from the south end of the Location, facing west Photos 2-5 provide an overview of the Location from west, northwest, northeast to east. Photos show interim reclamation has not been conducted on the Location.

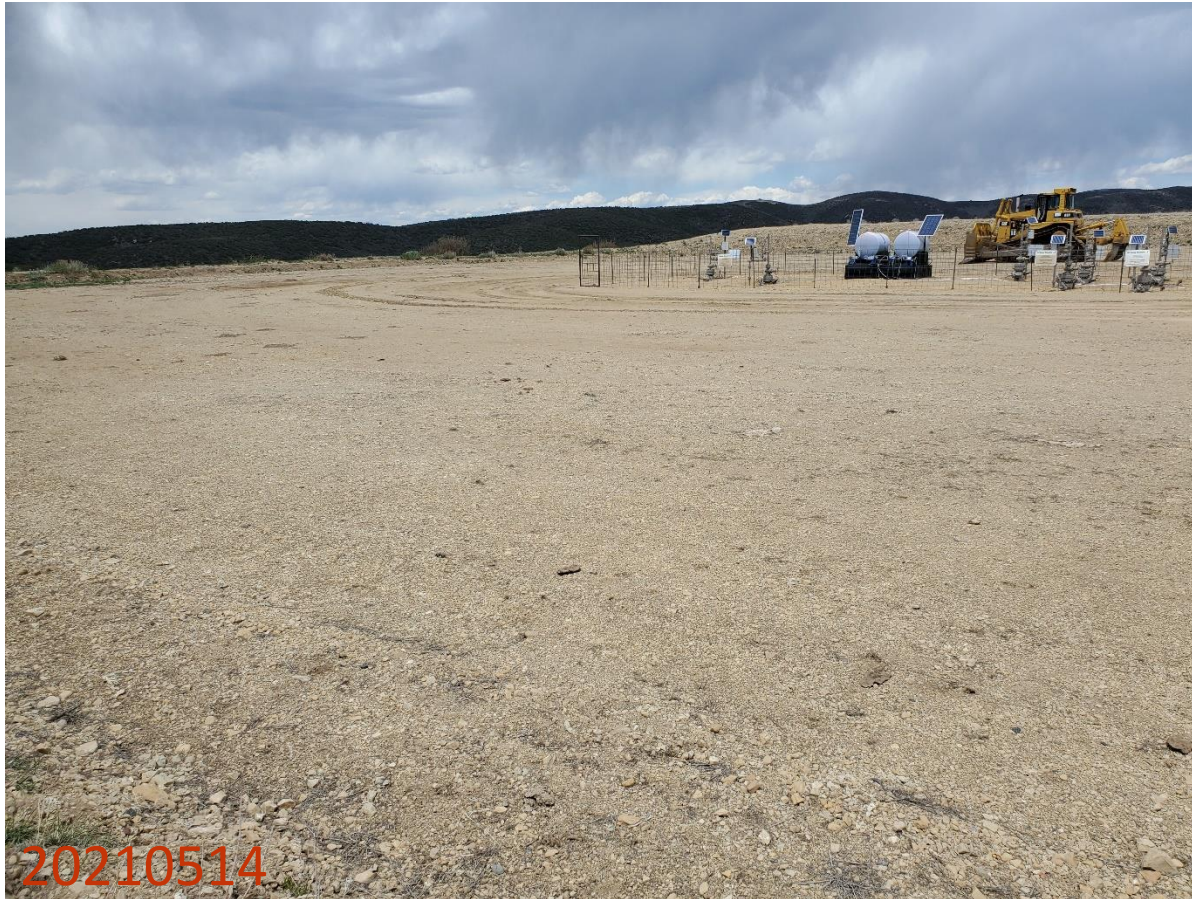
Photo 3: See comments under photo 2.

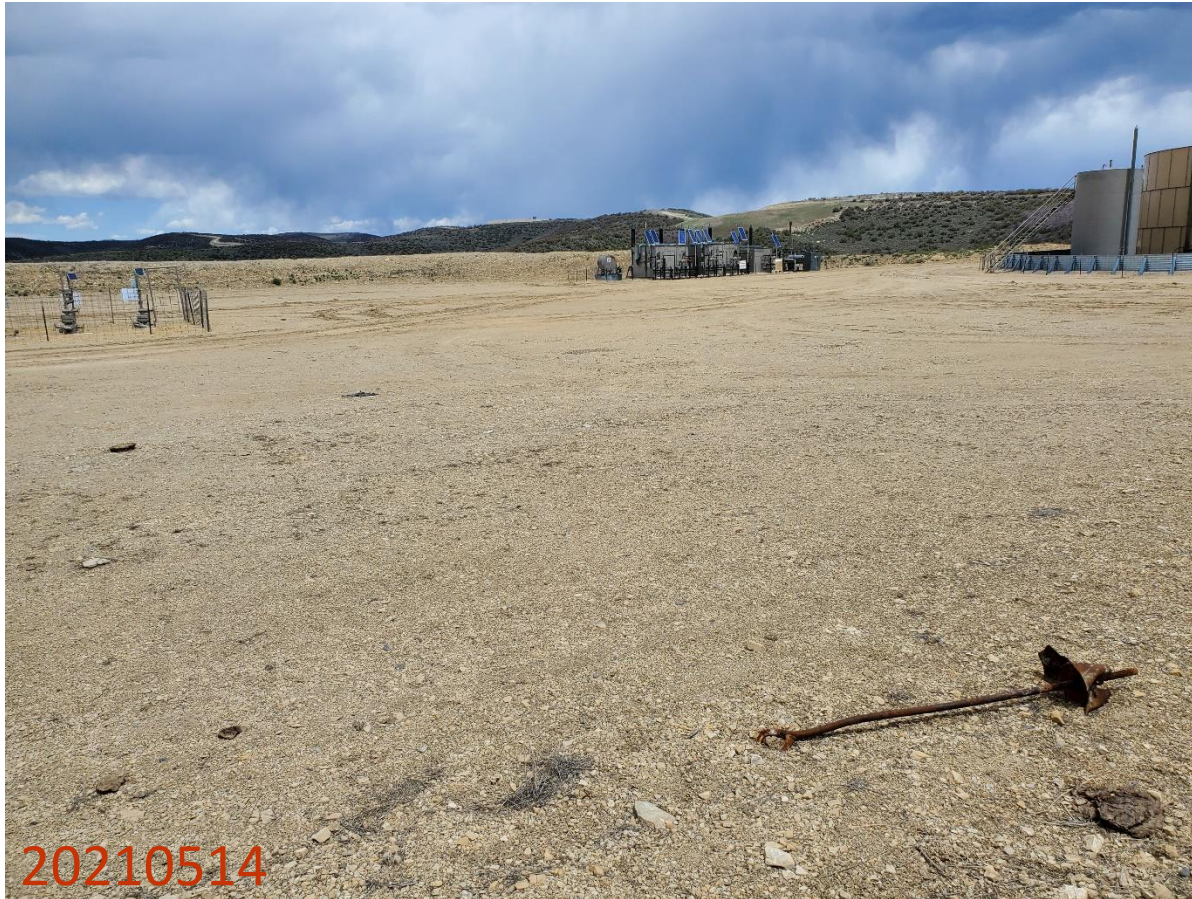
Photo 4: See comments under photo 2. Photo also shows trash debris observed on site.

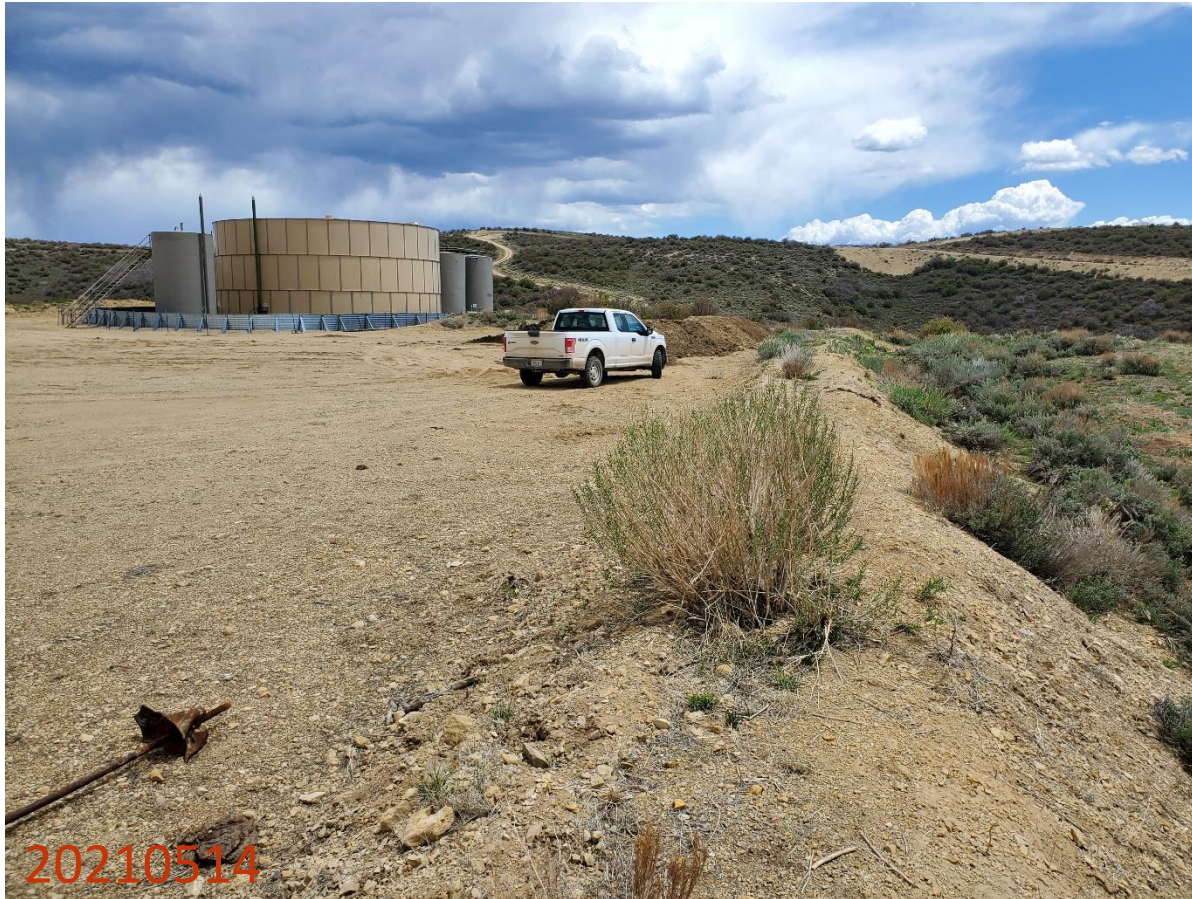
Photo 5: See comments under photo 2.

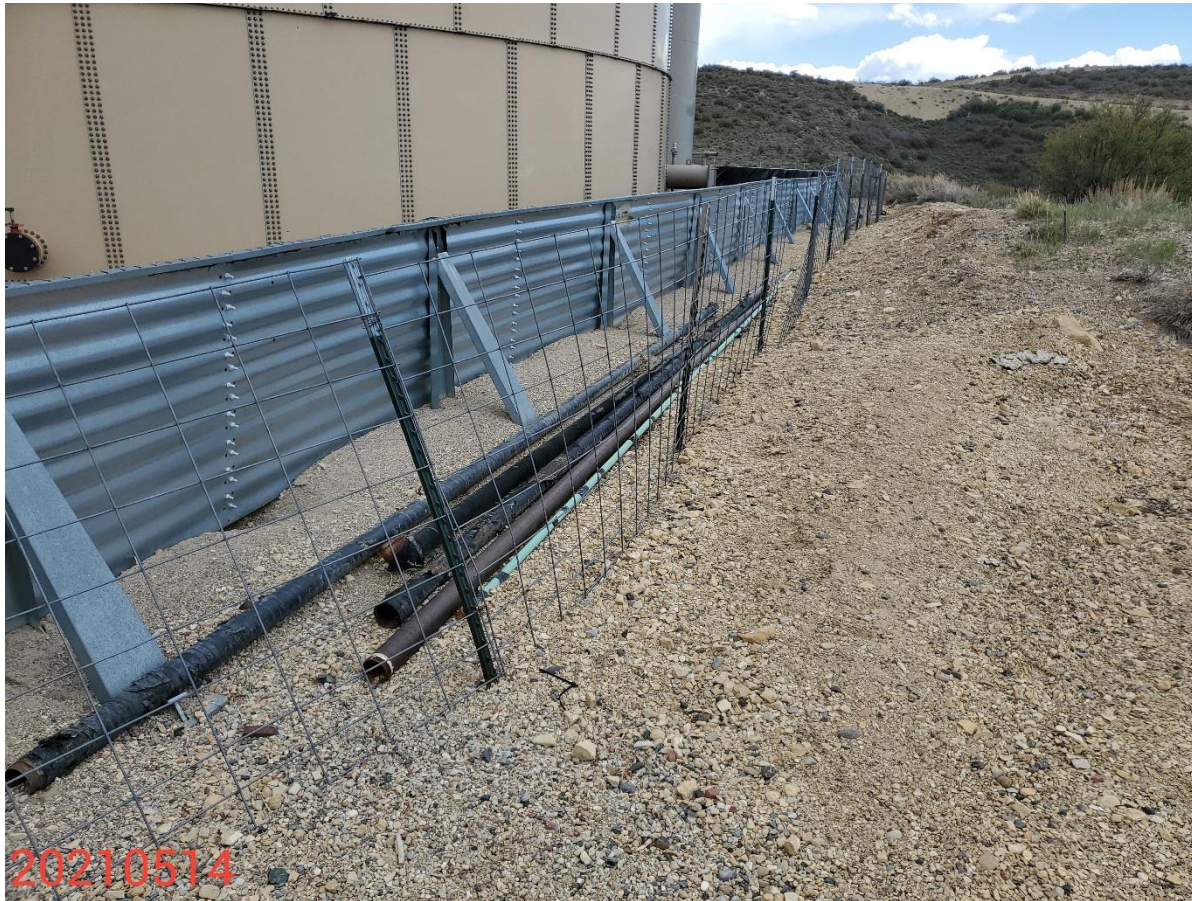
Photo 6: Photo taken from the south side of the tank battery; photo shows various unused pipe equipment stored on the site; unused equipment requires removal.

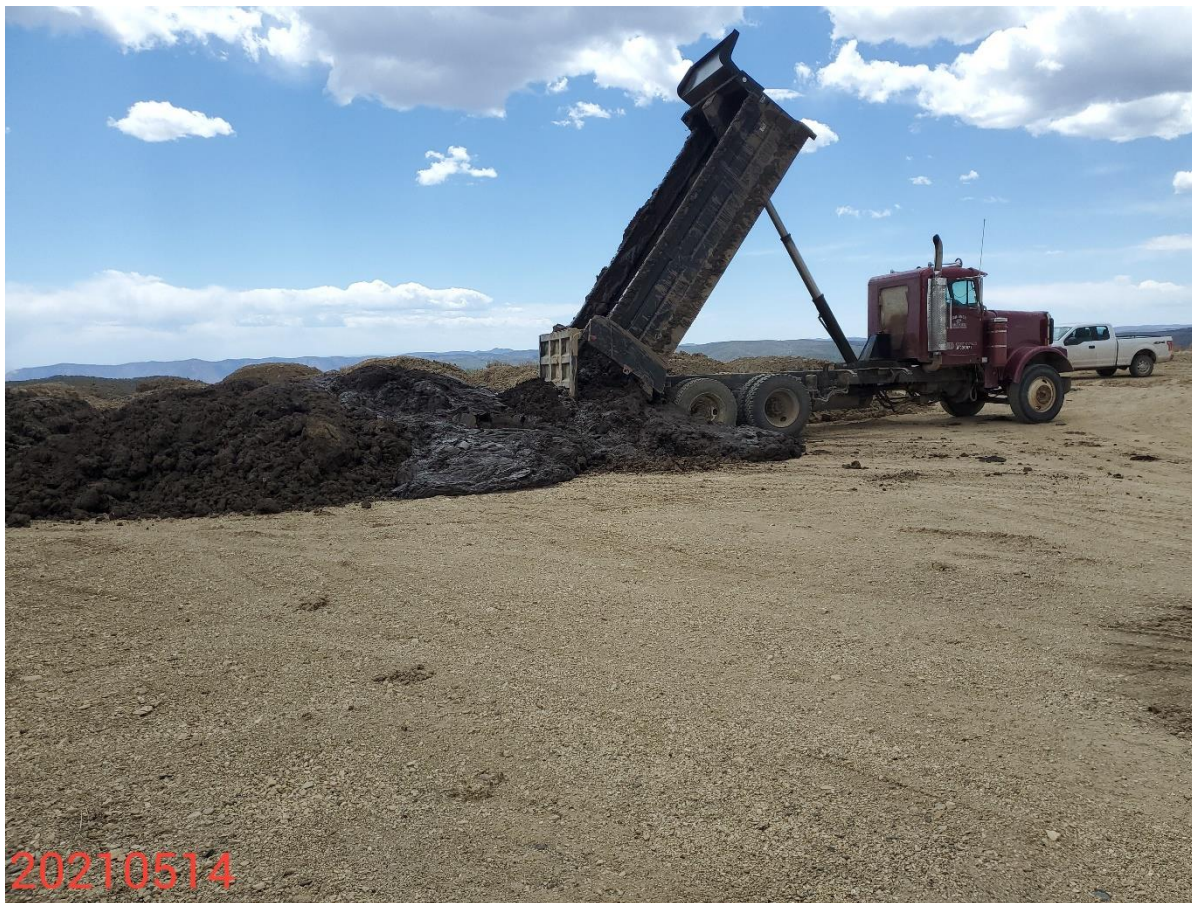
Photo 7: Photo taken from the southeast end of the Location. Photo shows a Operator in process of hauling material from sediment traps in the Crystal Creek area, and placing /storing on the Location. Operator stated in an email that TEP have “historically used sediment trap clean out materials to supplement top soil for any reclaims that may be going on in the local area”.
