# Inspection Photos

Operator: TEP ROCKY MOUNTAIN LLC #96850

Location ID: 324411

Garfield County, CO

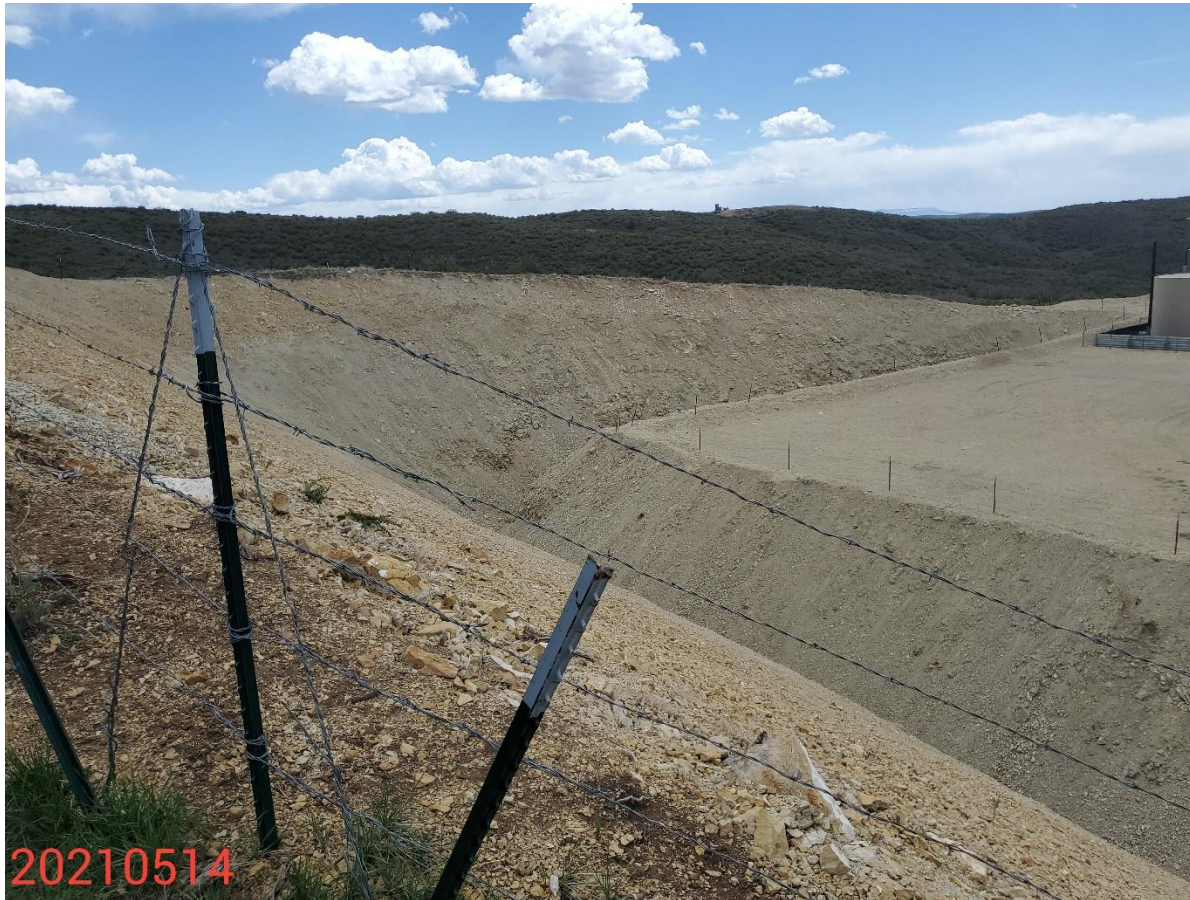
**Photo 1:** Photo taken from the north end of the Location, facing southeast. Photos 1-3 provide an overview of the Location from southeast, south to southwest. Photos show interim reclamation of the Location has not been conducted in accordance with 1003 rules.

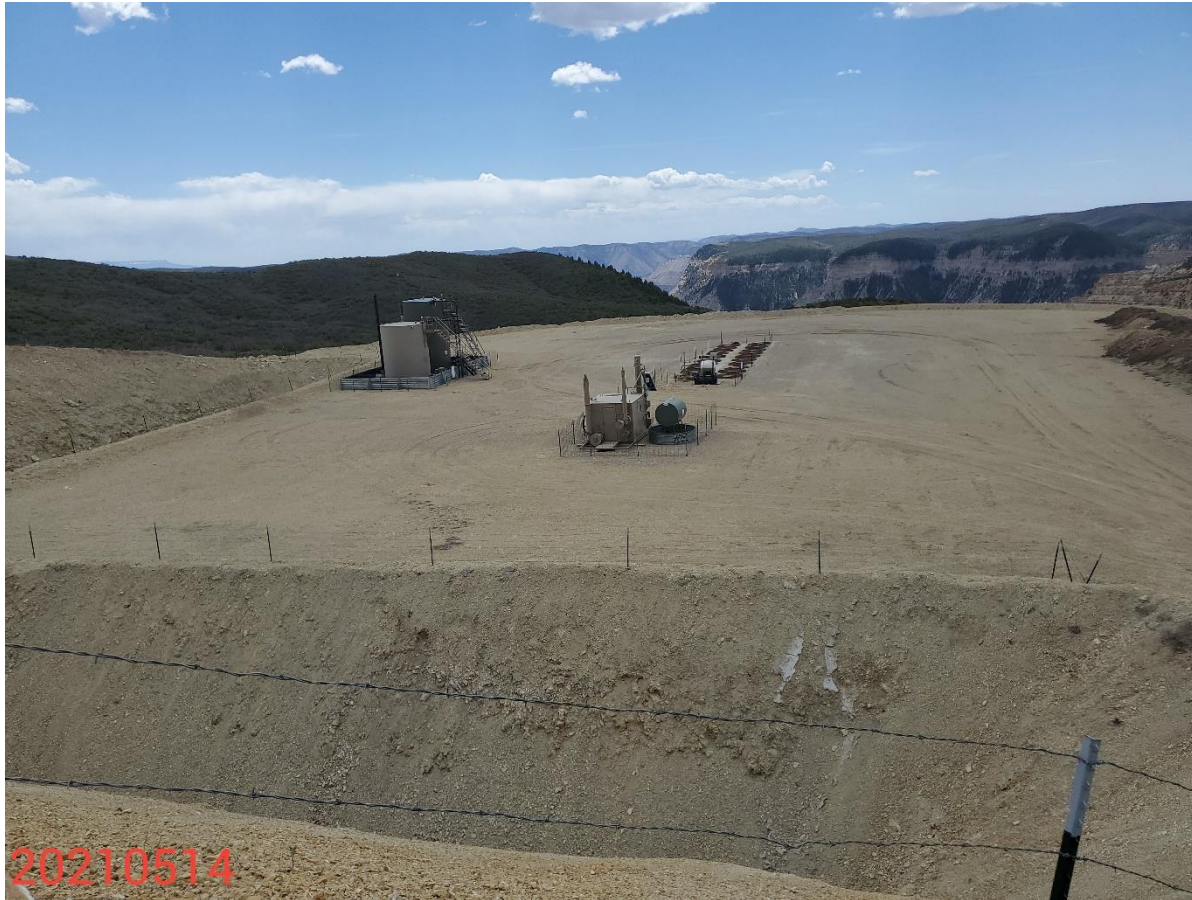
**Photo 2:** See comments under photo 1.

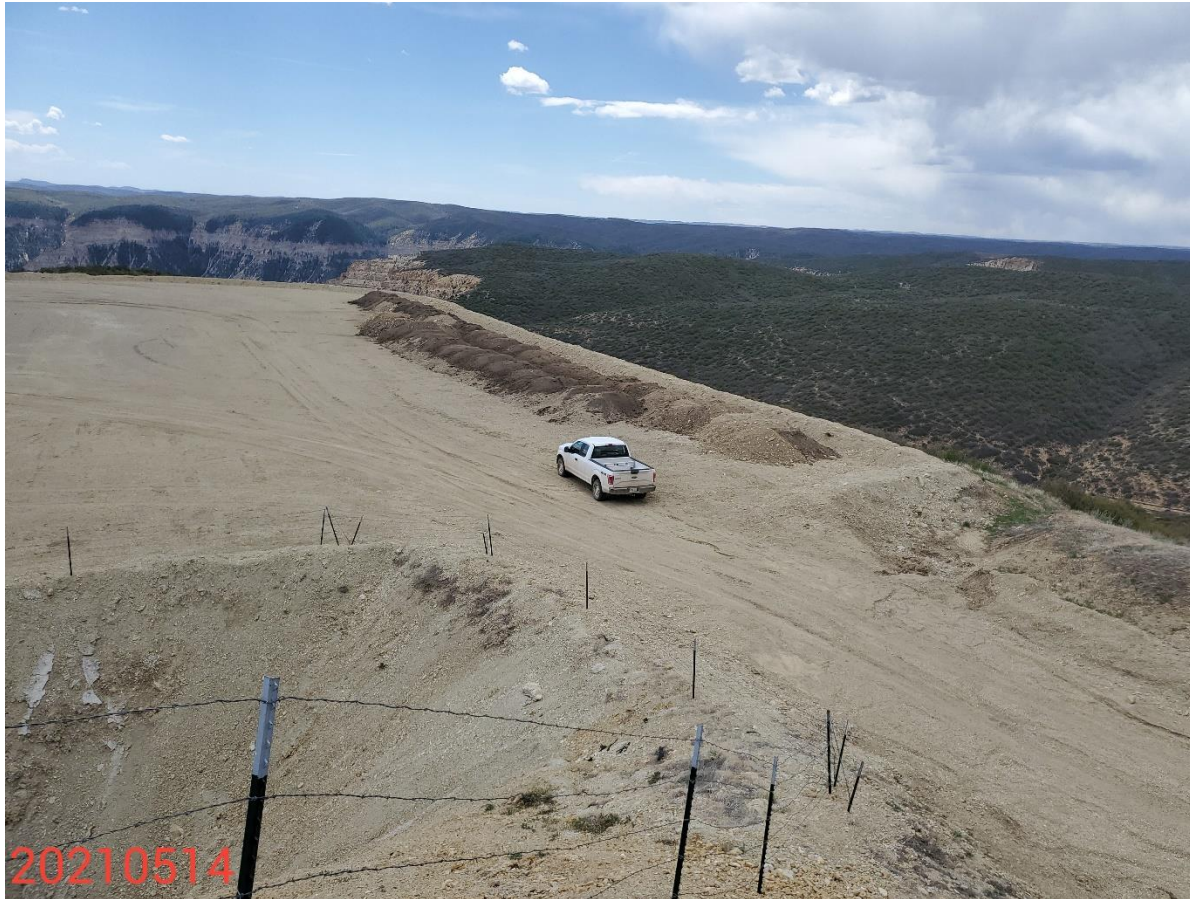
**Photo 3:** See comments under photo 1. Photo also shows soil materials stored on the western area of the Location.

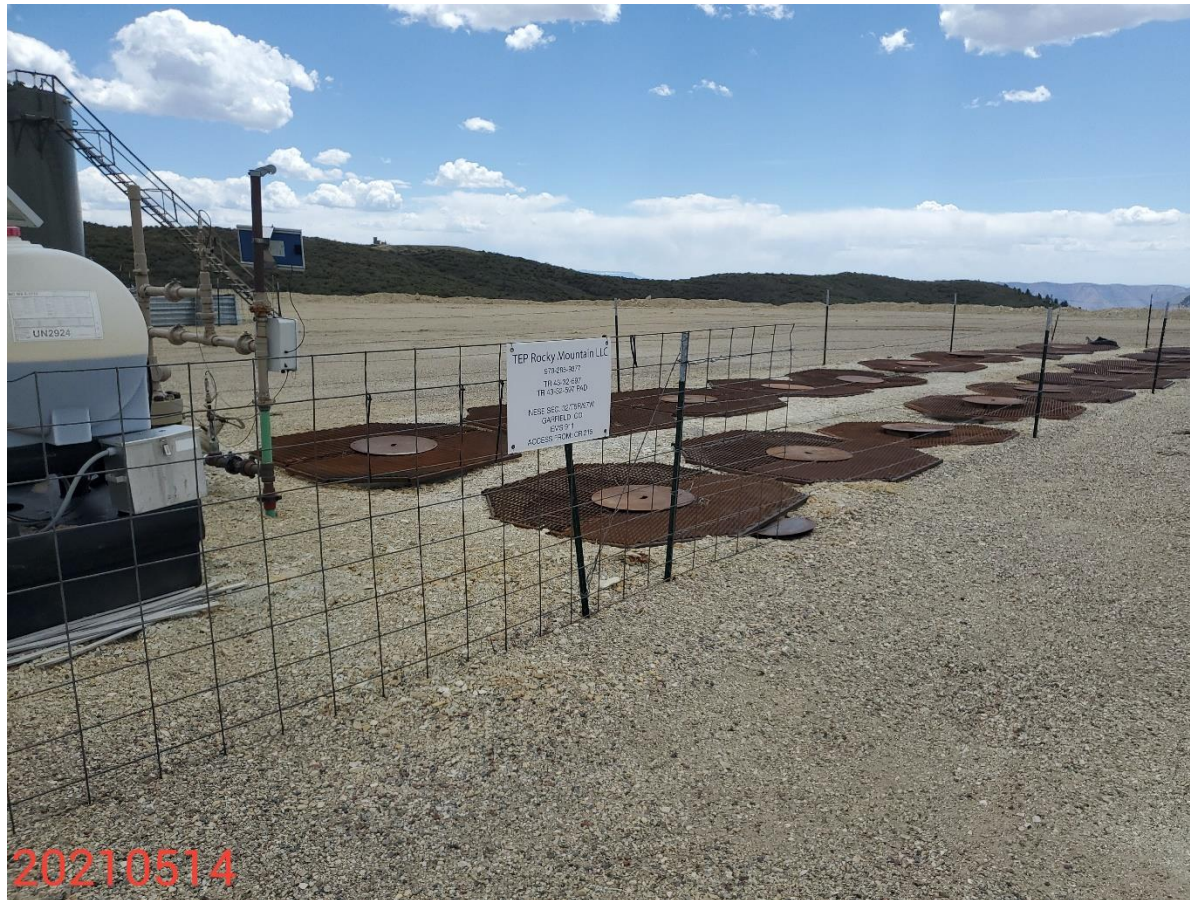
**Photo 4:** Photo taken from the wells. Permits for undrilled wells on the Location have been deleted. Photo shows conductor settings/cellars require closure and reclamation in accordance with Rule 406.e.

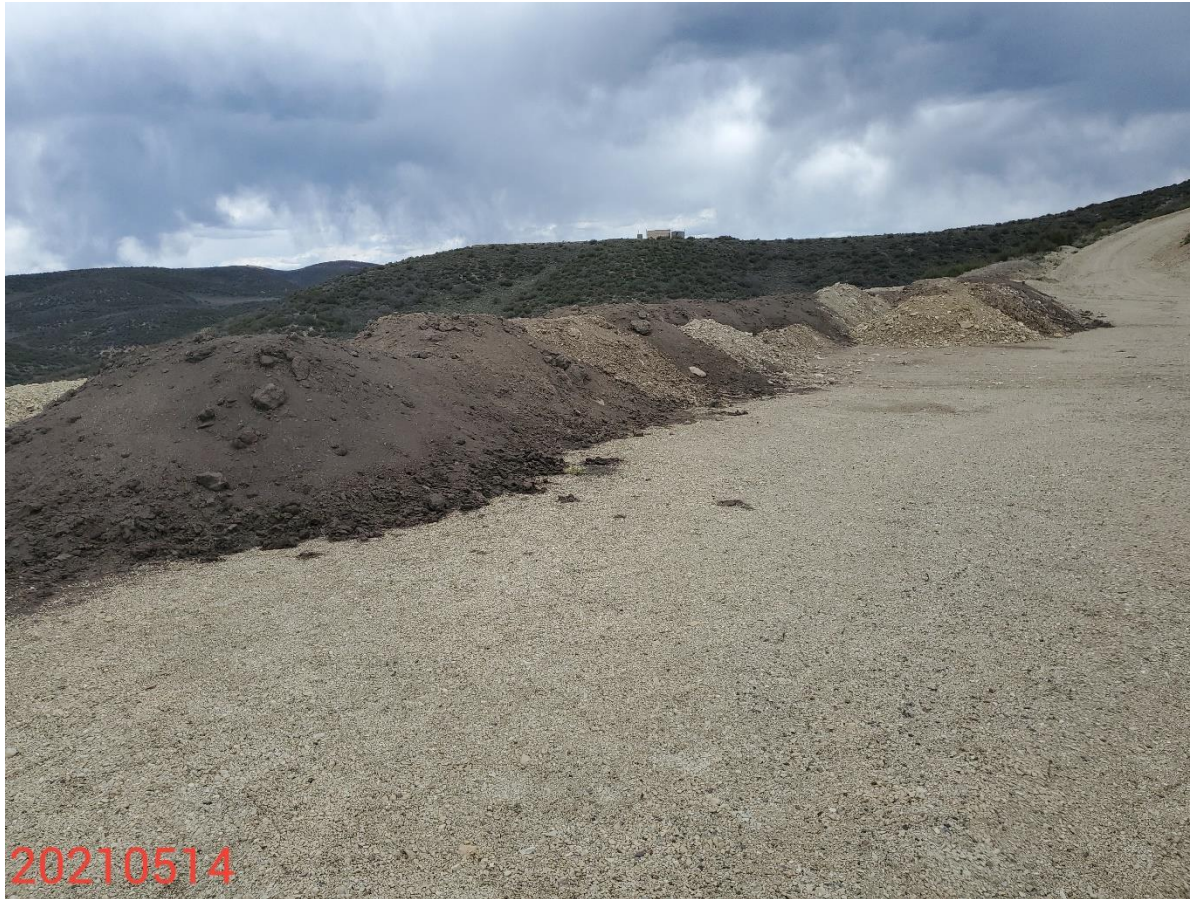
**Photo 5:** Photo taken from the western end of the Location, facing north. Photo shows soil materials stored on the Location.
