Inspection Photos

5/21/2021

Operator: SG INTERESTS I LTD - 77330

Location ID: 422990

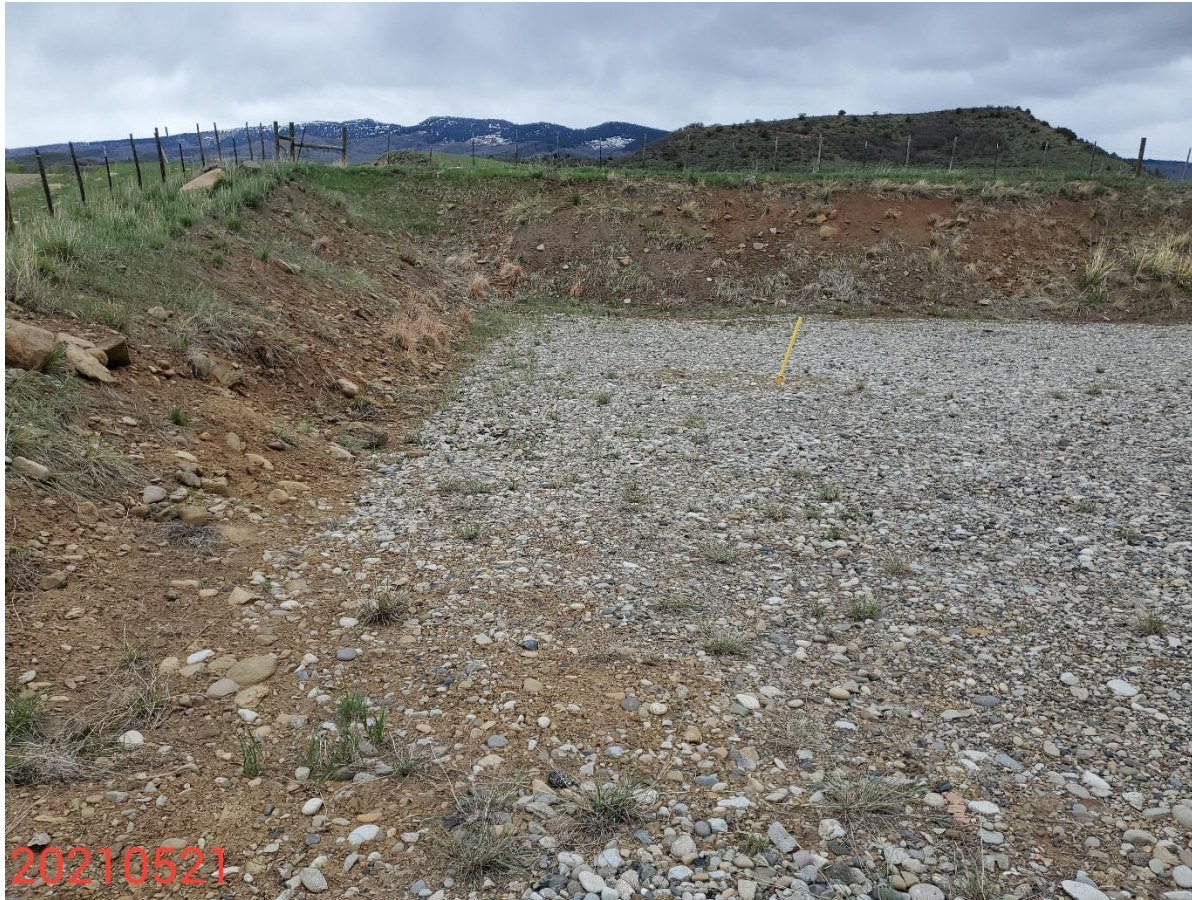
Photo 1: Photo taken from the cut slopes on the north end of the Location, facing east. Previous inspection documented that control measures to protect/stabilize the slopes on the Location were missing or insufficient in accordance with Rule 1002.f.(2)C. Photo shows control measures to protect/stabilize slopes on the Location remain missing or insufficient.

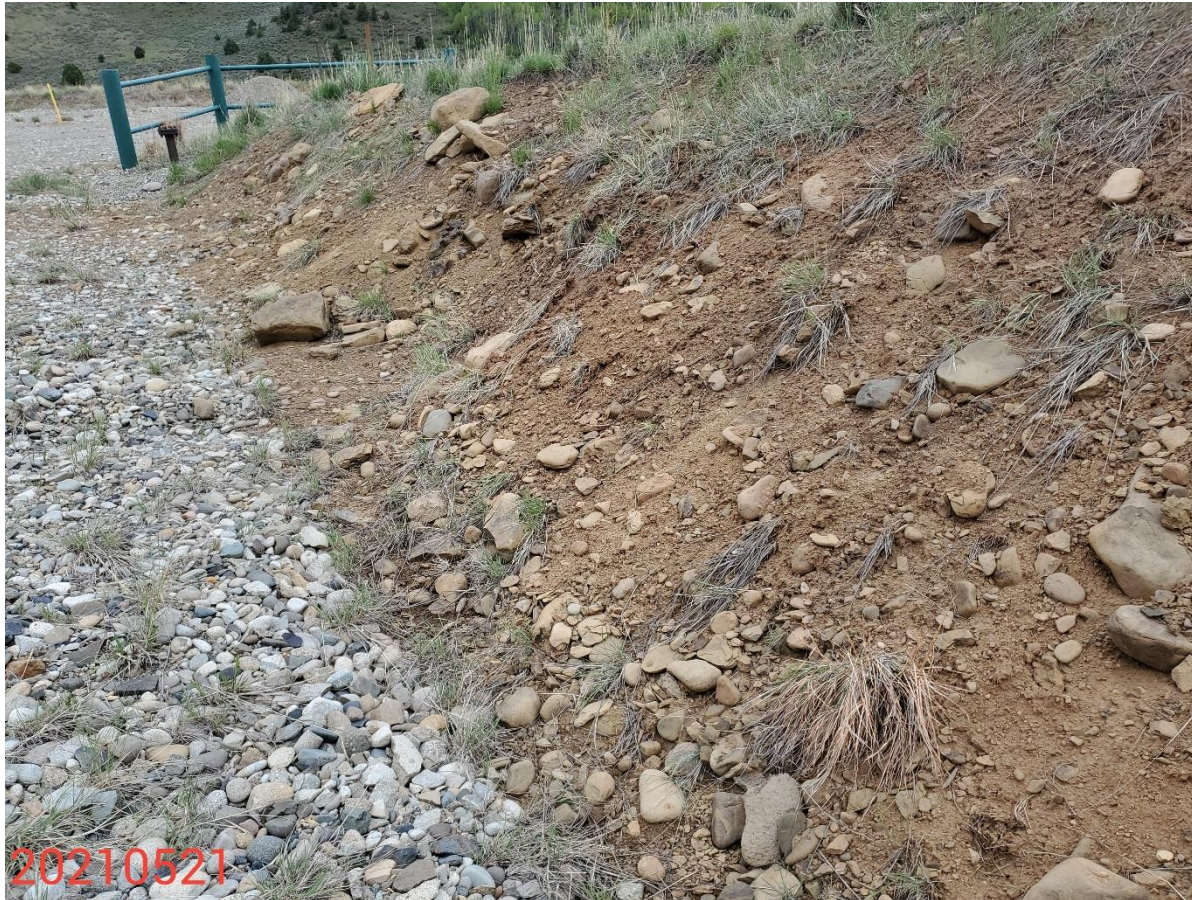
Photo 2: Photo taken from the cut slopes on the north end of the Location, facing west.
See comments under photo 1.

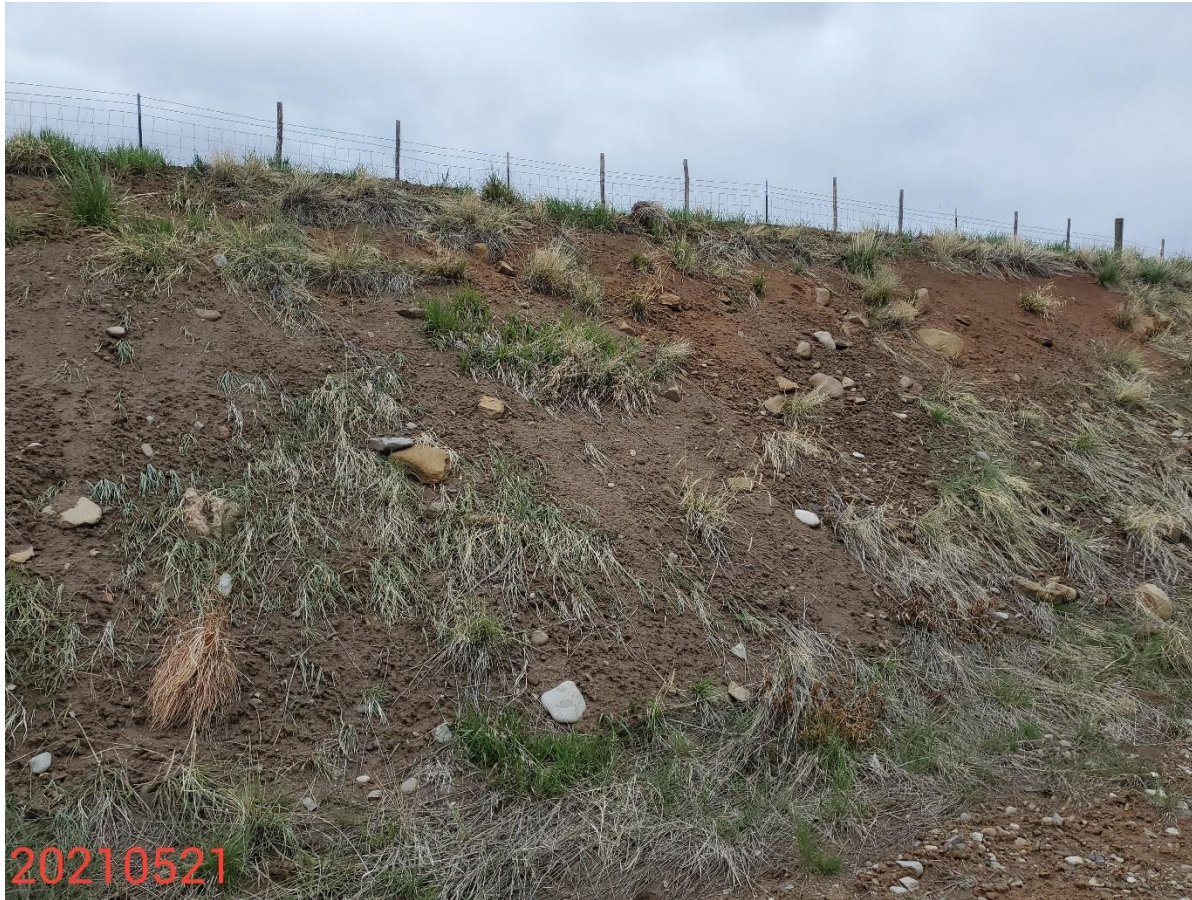
Photo 3: Photo taken from the cut slopes on the north end of the Location, facing east.
See comments under photo 1.

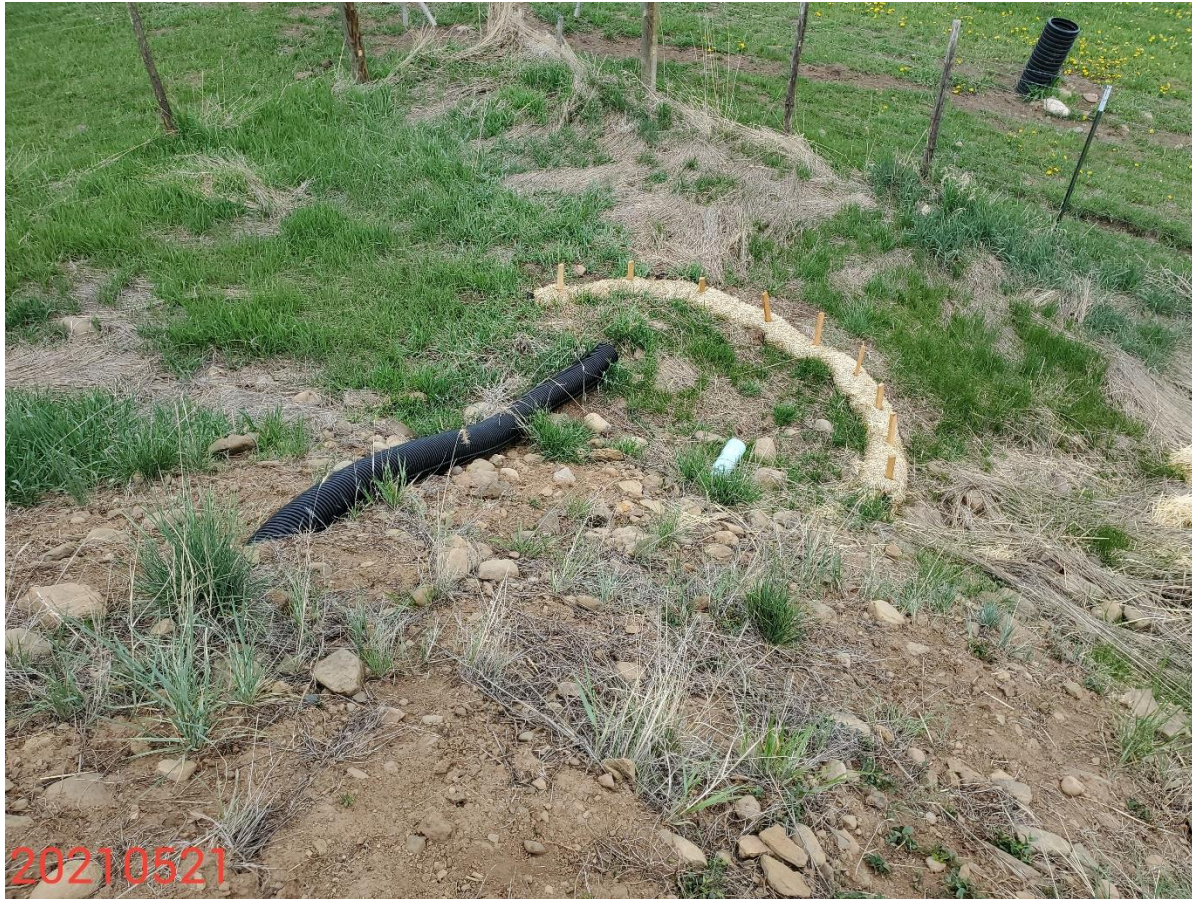
Photo 4: Photo taken from the southeast corner of the Location. Photo shows slope drain. Previous inspections documented that the slope drain was not constructed with an appropriate outlet per good engineering practices. Photo shows slopes drain has not been constructed with an appropriate outlet. Photo also shows slope drain has not been properly secured.

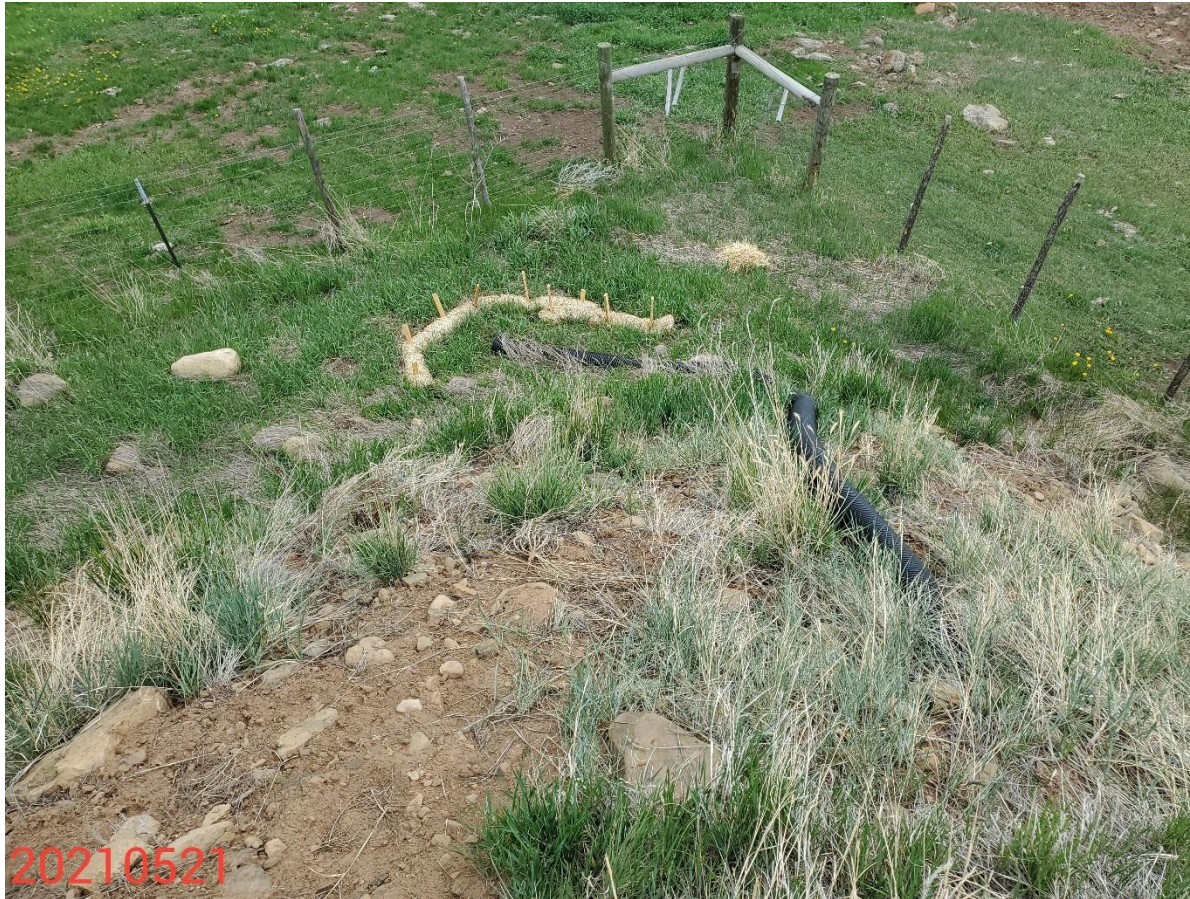
Photo 5: Photo taken from the southwest corner of the Location. Photo shows slope drain. Previous inspections documented that the slope drain was not constructed with an appropriate outlet per good engineering practices. Photo shows slopes drain has not been constructed with an appropriate outlet. Photo also shows slope drain has not been properly secured.
